#### EXPEIRMENTAL PROJECTS PROGRAM

#### HIGHWAYS FOR LIFE (HFL) CULVERT REHABILITATION PROJECT - FINAL REPORT

Project Name:	NH-HFL 8-1(30)23 MacDonald Pass Guardrail/Erosion
FHWA Project Number:	MT 00-17
Project Location:	MacDonald Pass; Powell and Lewis & Clark Counties – The eleven mile project is located approximately 15 miles west of Helena on US 12 (N-8) between RP 23.2 and RP 34.2: The section of the project which contains the experimental portion is located approximately between RP 26.0 and RP 27.0 on the west side of MacDonald Pass
Description:	The relining of 10 (ten) 24" (610 mm) corrugated steel pipe (CSP) culverts with two type of lining applications; Cure In-place Pipe (CIPP) and seam welded High-density Polyethylene Pipe (18"/46cm HDPE). The ten culverts were split evenly for each treatment.
Date of Installation:	September 2008
Evaluation Date:	October 2009-April 2013
Principal Investigator:	Craig Abernathy - Experimental Projects Manager (ExPM)

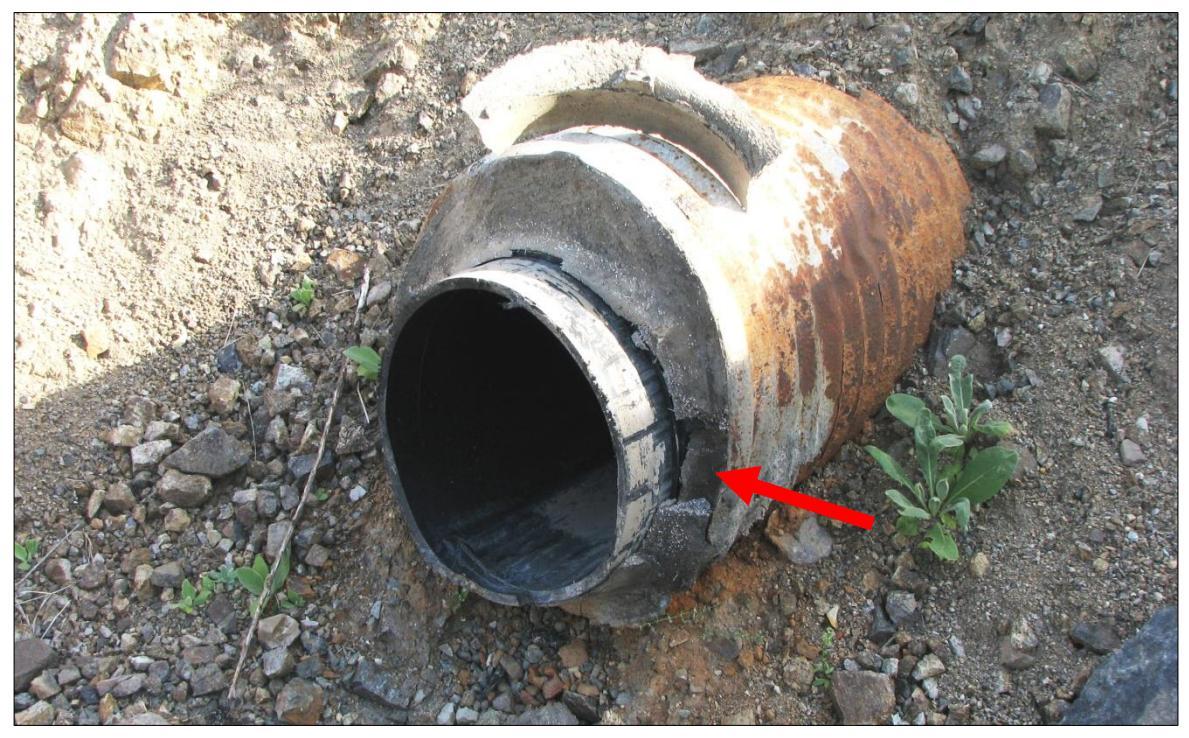
During installation the inlet/outlets were grouted for both types of culverts. The majority of the grouted ends are beginning to fracture and small chunks have fallen off, most likely due to freeze-thaw and expansion/contraction of the dissimilar materials. This issue is solely associated with the HDPE culvert inserts since they required a bulkhead for the grouting phase. At this time it is not an indicator of performance since the bulkheads were considered sacrificial. Visually all treatments are performing well. The following are representative images taken during the annual inspection. The April 2013 reporting begins on page 20.

↑ 2-HDPE Outlet (Sta. 189+47): Note the deteriorating grouted bulkhead. Large sections are beginning to breakoff (red arrow). The piece of grout on top of the CSP came from the bottom of the outlet. The purpose of the grout was to create a bulkhead at the outlet to create a dam to contain the grout used to fill the void between the exiting CSP and the HDPE liner during installation. The fracturing of the bulkhead is not considered a detriment to performance.

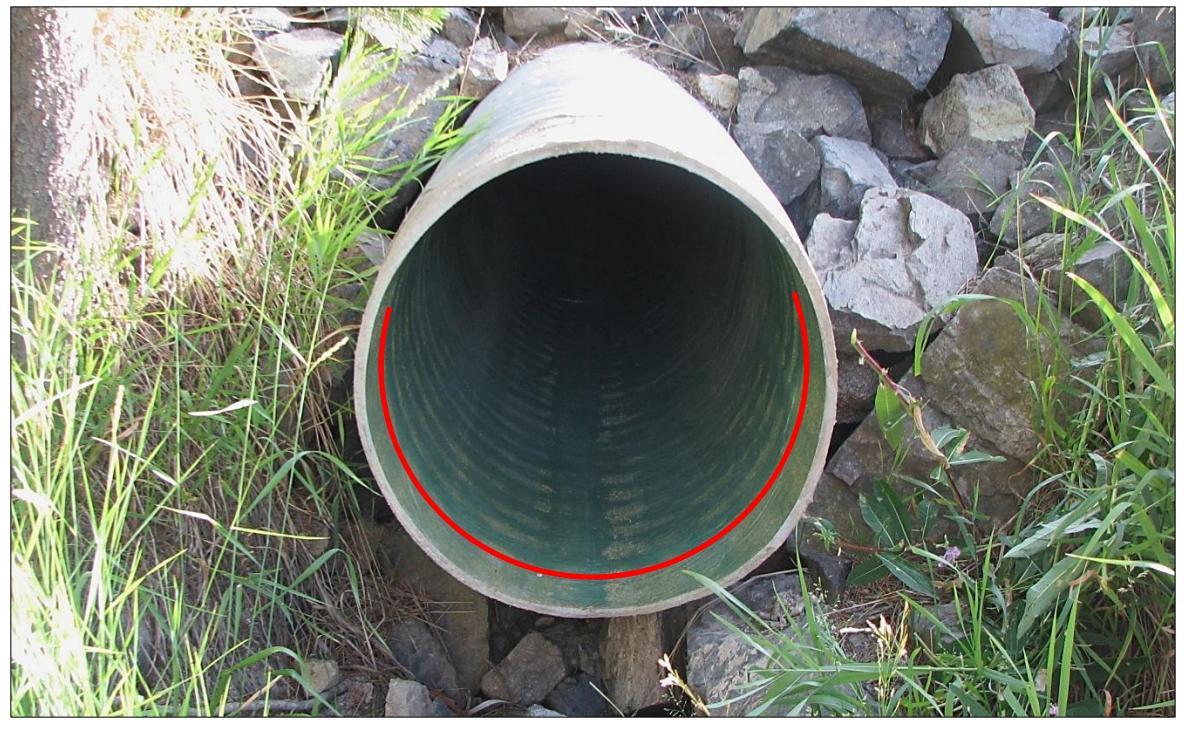
↑ 3-CIPP Outlet (Sta. 194+99): The red line depicts where the CSP is in relationship with the CIPP.

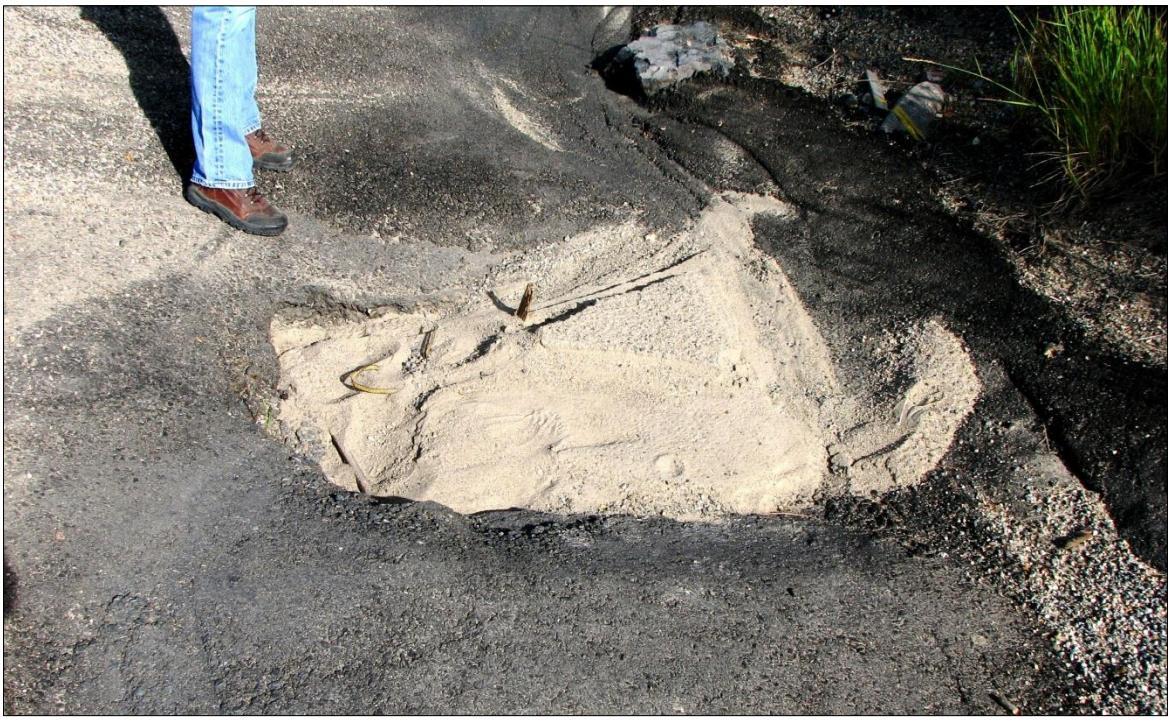
Due to weather constraints, the 2010 project inspection did not take place. All installations were inspected at the inlet and outlets. The majority CIPP and HDPE culverts were free of obstructions and visually intact. One exception was the inlet of unit 4 (CIPP at STA 199+97). During the 2009-2012 inspections it was found to be completely clogged with what was assumed winter sanding material deposited by hard rains. Due to the application of plant mix (asphalt cement) at the shoulder to direct water to the containment ponds down slope, it inadvertently washed the particulates into the inlet blocking it. During the April 2013 inspection this inlet was again found to be obstructed with sanding material. Inspection of the other nine (9) inlets showed them to be relatively unobstructed.

♠ 4-CIPP Inlet: Completely filled with sanding material

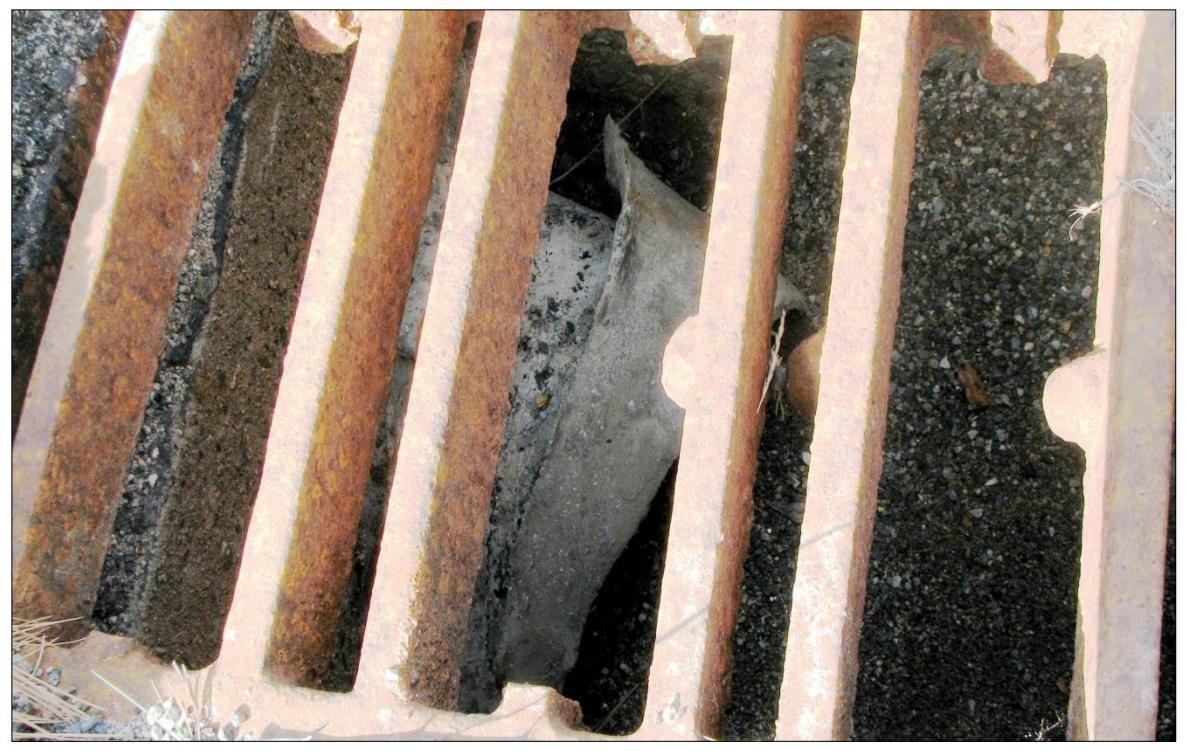
↑ 6-HDPE Inlet: Although difficult to see in this image, the grouted collar has almost completely delaminated from the CSP and HDPE liner. Also it appears to be partially blocked (up to an estimated 70%) by sanding material or other particulates.
