Phase 1 Report

Butte Interstate Traffic Study

Project Number
IM 0002(672)
CN 5098

January 2007

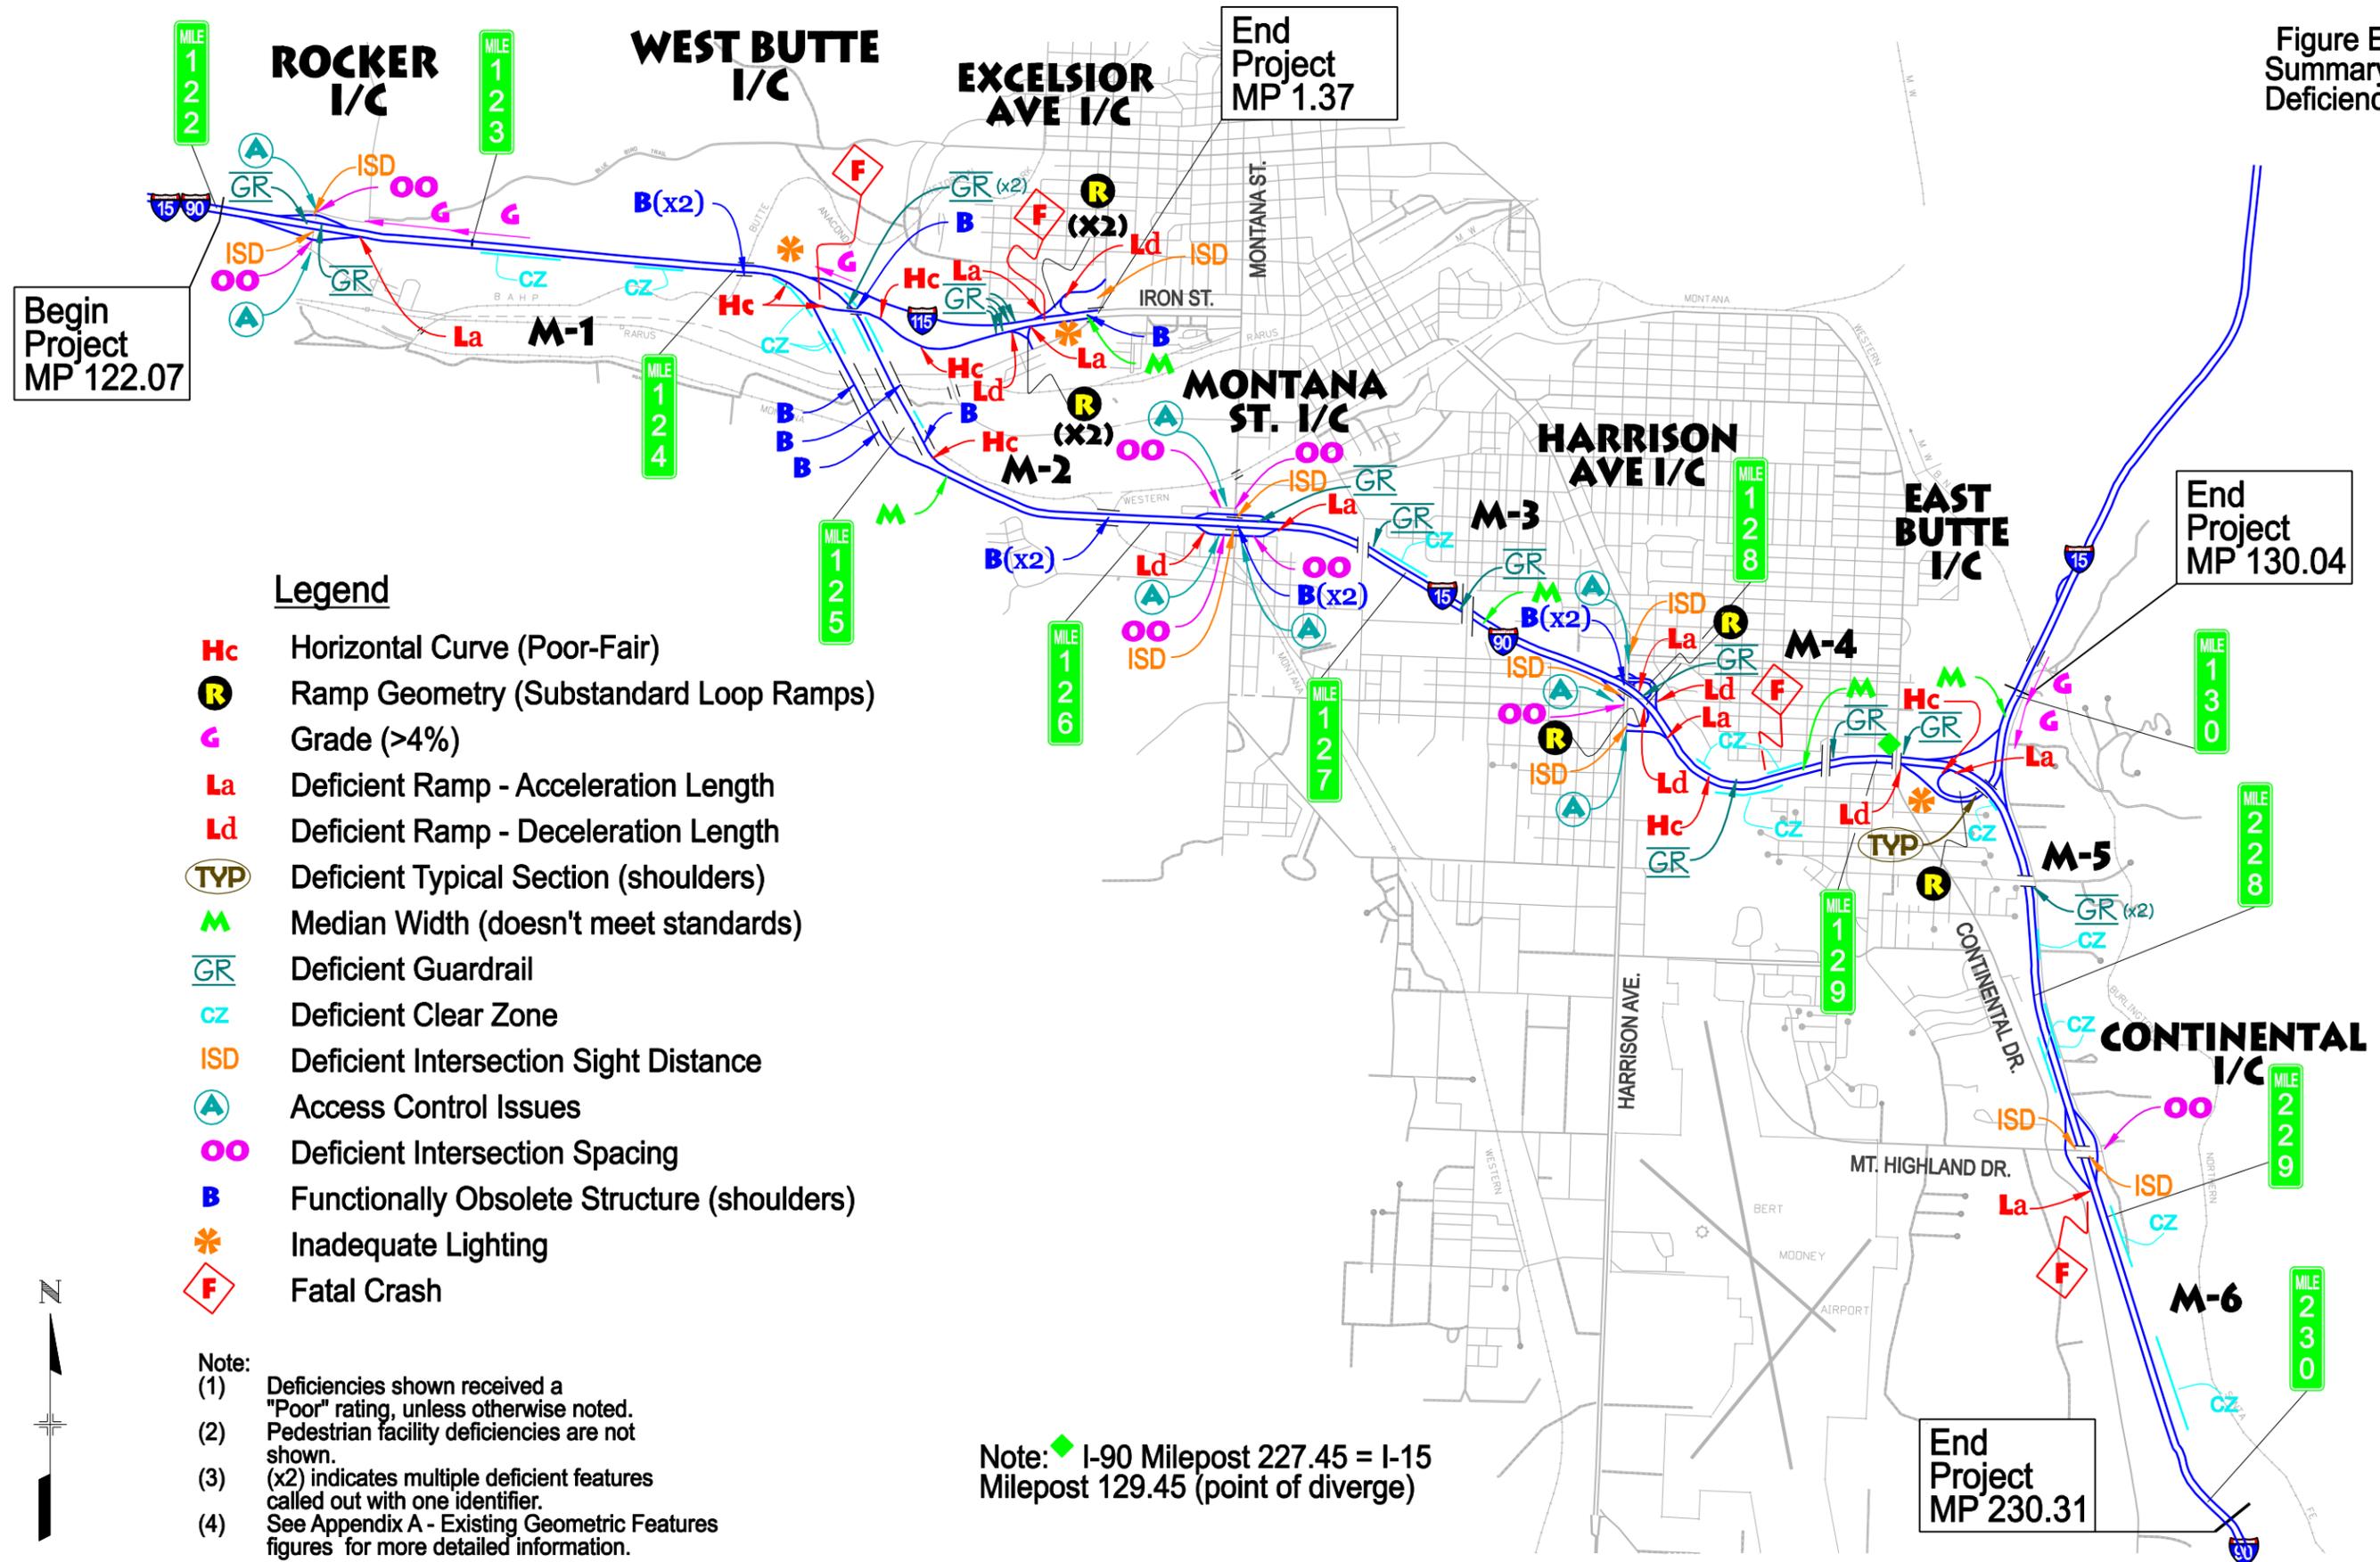
Figure E.1
Summary of
Deficiencies

Geometric elements reviewed for the interstate mainline and at each interchange include cross section elements, horizontal and vertical alignment, ramp geometry, interchange/intersection spacing, adjacent access locations, turning movements, and intersection sight distance. Each of these elements was evaluated and ranked based on the project design criteria, and deficiencies were identified. Deficiencies that were identified during the analysis are illustrated in Figure E.1.

It is anticipated that during Phase 2 numerous alternative treatments for each interchange and interstate segment will be analyzed to determine cost effective solutions to the identified deficiencies. Examples of obvious potential treatments to be analyzed during Phase 2 include:

- Rocker Interchange – full interchange reconfiguration, short term geometric improvements on cross road or short term ramp improvements
- Mainline Segment 1 - auxiliary/truck climbing lanes
- West Butte - full interchange reconfiguration and short term ramp improvements, lighting improvements
- Mainline Segment 2 - structure improvements (widening, mainline realignment, automatic ant-icing systems)
- Montana Street – interchange reconfiguration, ramp terminal treatments
- Harrison Avenue – full interchange reconfiguration, operational improvements on cross road (signal timing, access management)
- East Butte – full interchange reconfiguration, short term lighting improvements
- Excelsior Avenue Interchange – lighting, signing improvements

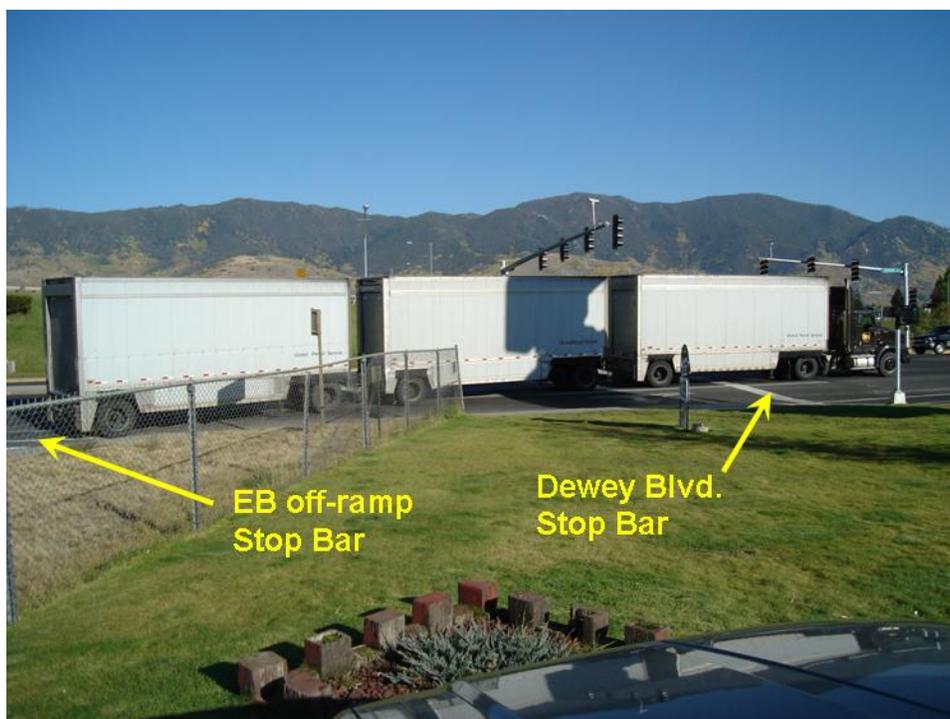
Figure 2.2
Harrison Eastbound Off-Ramp near Dewey Blvd.

Significant operation issues can occur when ramp terminal intersections and frontage or local road intersections are placed too closely together. Field observations show that the spacing of the intersections at the Rocker interchange has a significant effect on the truck turning movements. The spacing of the eastbound off-ramp at Harrison Avenue in relation to Dewey Boulevard affects the traffic operations of the off-ramp. The traffic signal at Dewey often causes queues of vehicles that block the eastbound off-ramp intersection. In peak hours this can cause the queues on the eastbound off-ramp to increase as vehicles wait for gaps in traffic. Field observations revealed that the longest backups occurred when a semitrailer truck was waiting for a gap to pull out onto Harrison Avenue and then take a right on Dewey Blvd. Because a semitrailer truck needs to pull into the center lane to make the nearly 180 turn degree it can take several minutes for a large enough gap in traffic. The longest observed queue on the eastbound off-ramp was 11 cars, which gets close to backing up onto the interstate mainline. Traffic counts show that anywhere from 20-30 percent of the vehicles in a given peak hour on the eastbound off-ramp

make the movement to Dewey Blvd. Figure 2.2 shows a semitrailer truck making the right turn from the eastbound off-ramp south towards the Harrison Avenue and Dewey Blvd. intersection.

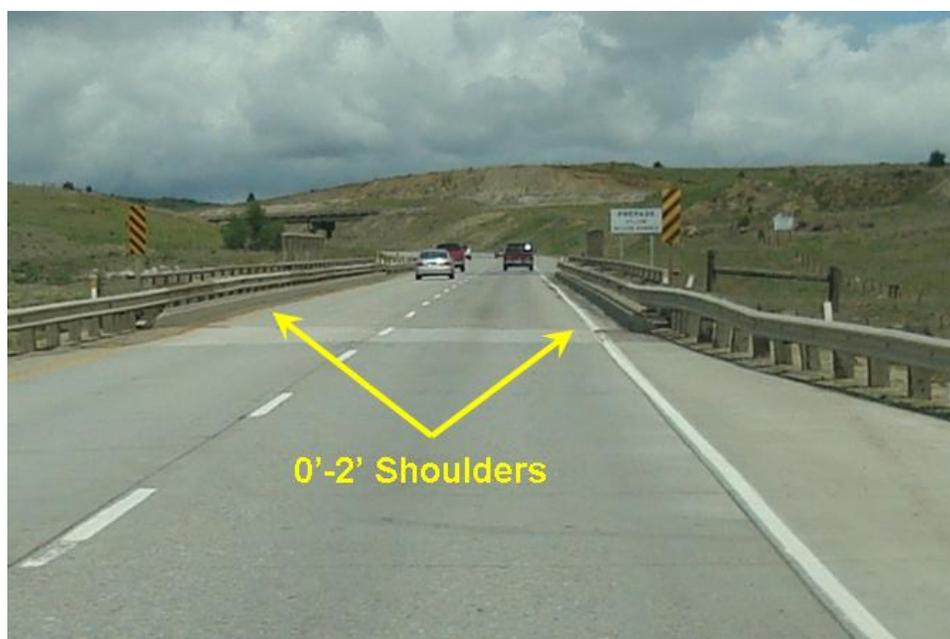
Figure 2.5
Typical Functionally Obsolete Structure

There are 18 structures totaling nearly 3,240 linear feet (~5 percent of total project length) of the interstate system in this study area and all but two (East Butte and Rocker interchanges) are functionally obsolete. Fourteen of the structures are functionally obsolete because the inside and outside shoulders do not meet current criteria. Most of the shoulders on these structures are 2-foot or less. MDT is currently developing a project to replace two railroad structures to current AASHTO standards, just west of the Montana Street interchange. Additional discussion on the impacts of the structure shoulder widths is included in the safety analysis section.

Mainline Segment 2: This segment is characterized by the two sets of long structures and the guardrail on both sides of the interstate for the majority of this segment. These characteristics most likely contributed to 77.5 percent of the crashes occurring during poor road conditions. Additionally, approximately 35-40 percent of the crashes involved a bridge. Field observations reveal that the guardrail in this area has been hit numerous times. Figure 2.5 shows a typical bridge cross section and guardrail application found in this section.

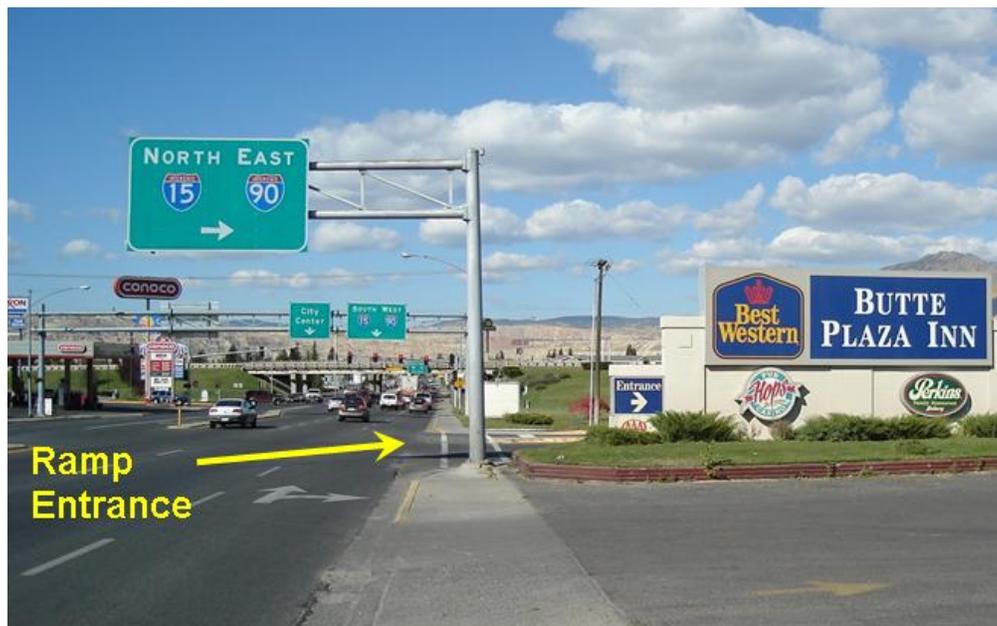
Figure 2.6
Harrison & EB On/Off-Ramp Intersection

It is worth noting that field observations show that there is a significant lane balance issue on Harrison approaching Amherst Avenue because of the third lane drop at Cornell Avenue. This causes a speed differential between the inside and outside lanes, which combined with weaving from the dropped outside third lane could contribute to a higher percentage of rear-end crashes. Field observations of the Harrison and Eastbound On/Off-ramps reveal that the existing hotel sign in combination with the accesses immediately south of the intersection cause a visual block of the physical on-ramp (see figure 2.6). Additionally, the restaurant and casino south of the gas station on the east side of Harrison has overgrown shrubs which restrict sight distance at the access to the hotel. This causes vehicles to pull slightly into the through lane in order to see oncoming traffic. These factors may contribute to the high number of crashes at this intersection.

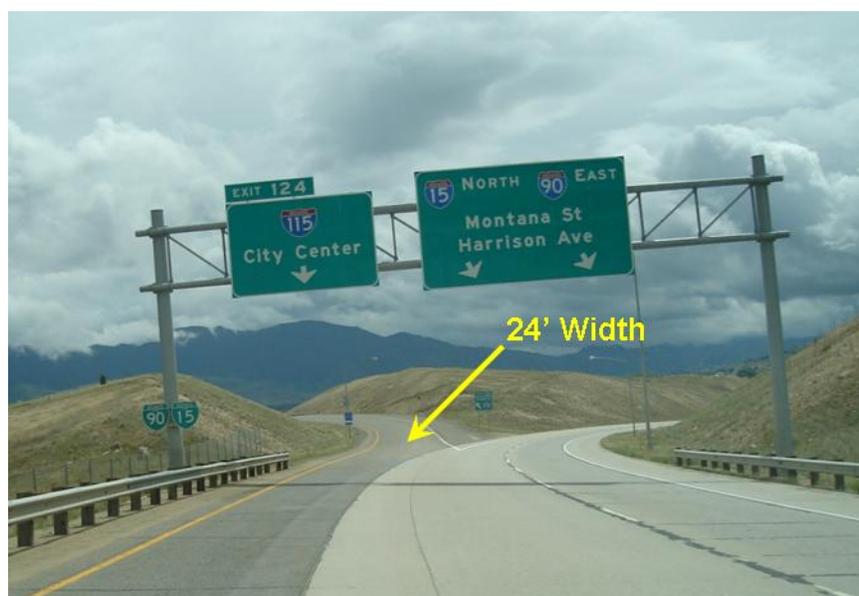
Figure 2.7
EB I-115 Ramp Gore Area

- Pavement markings are in good condition throughout the corridor with the exception of the Rocker Interchange cross road striping, which is worn away due the high number of trucks crossing the centerlines and shoulder lines around the intersections.
- The pavement markings on the eastbound I-115 ramp from I-15/90 do not adequately guide vehicles through the interchange and compromise its' operation and safety. The original design and construction provided a double left-hand off-ramp at this location. As shown in figure 2.7 the current off-ramp is marked with one lane 24' wide, which causes some uncertainty because of the wide roadway and the curvature that causes the mainline to go the right, while the ramp continues straight.

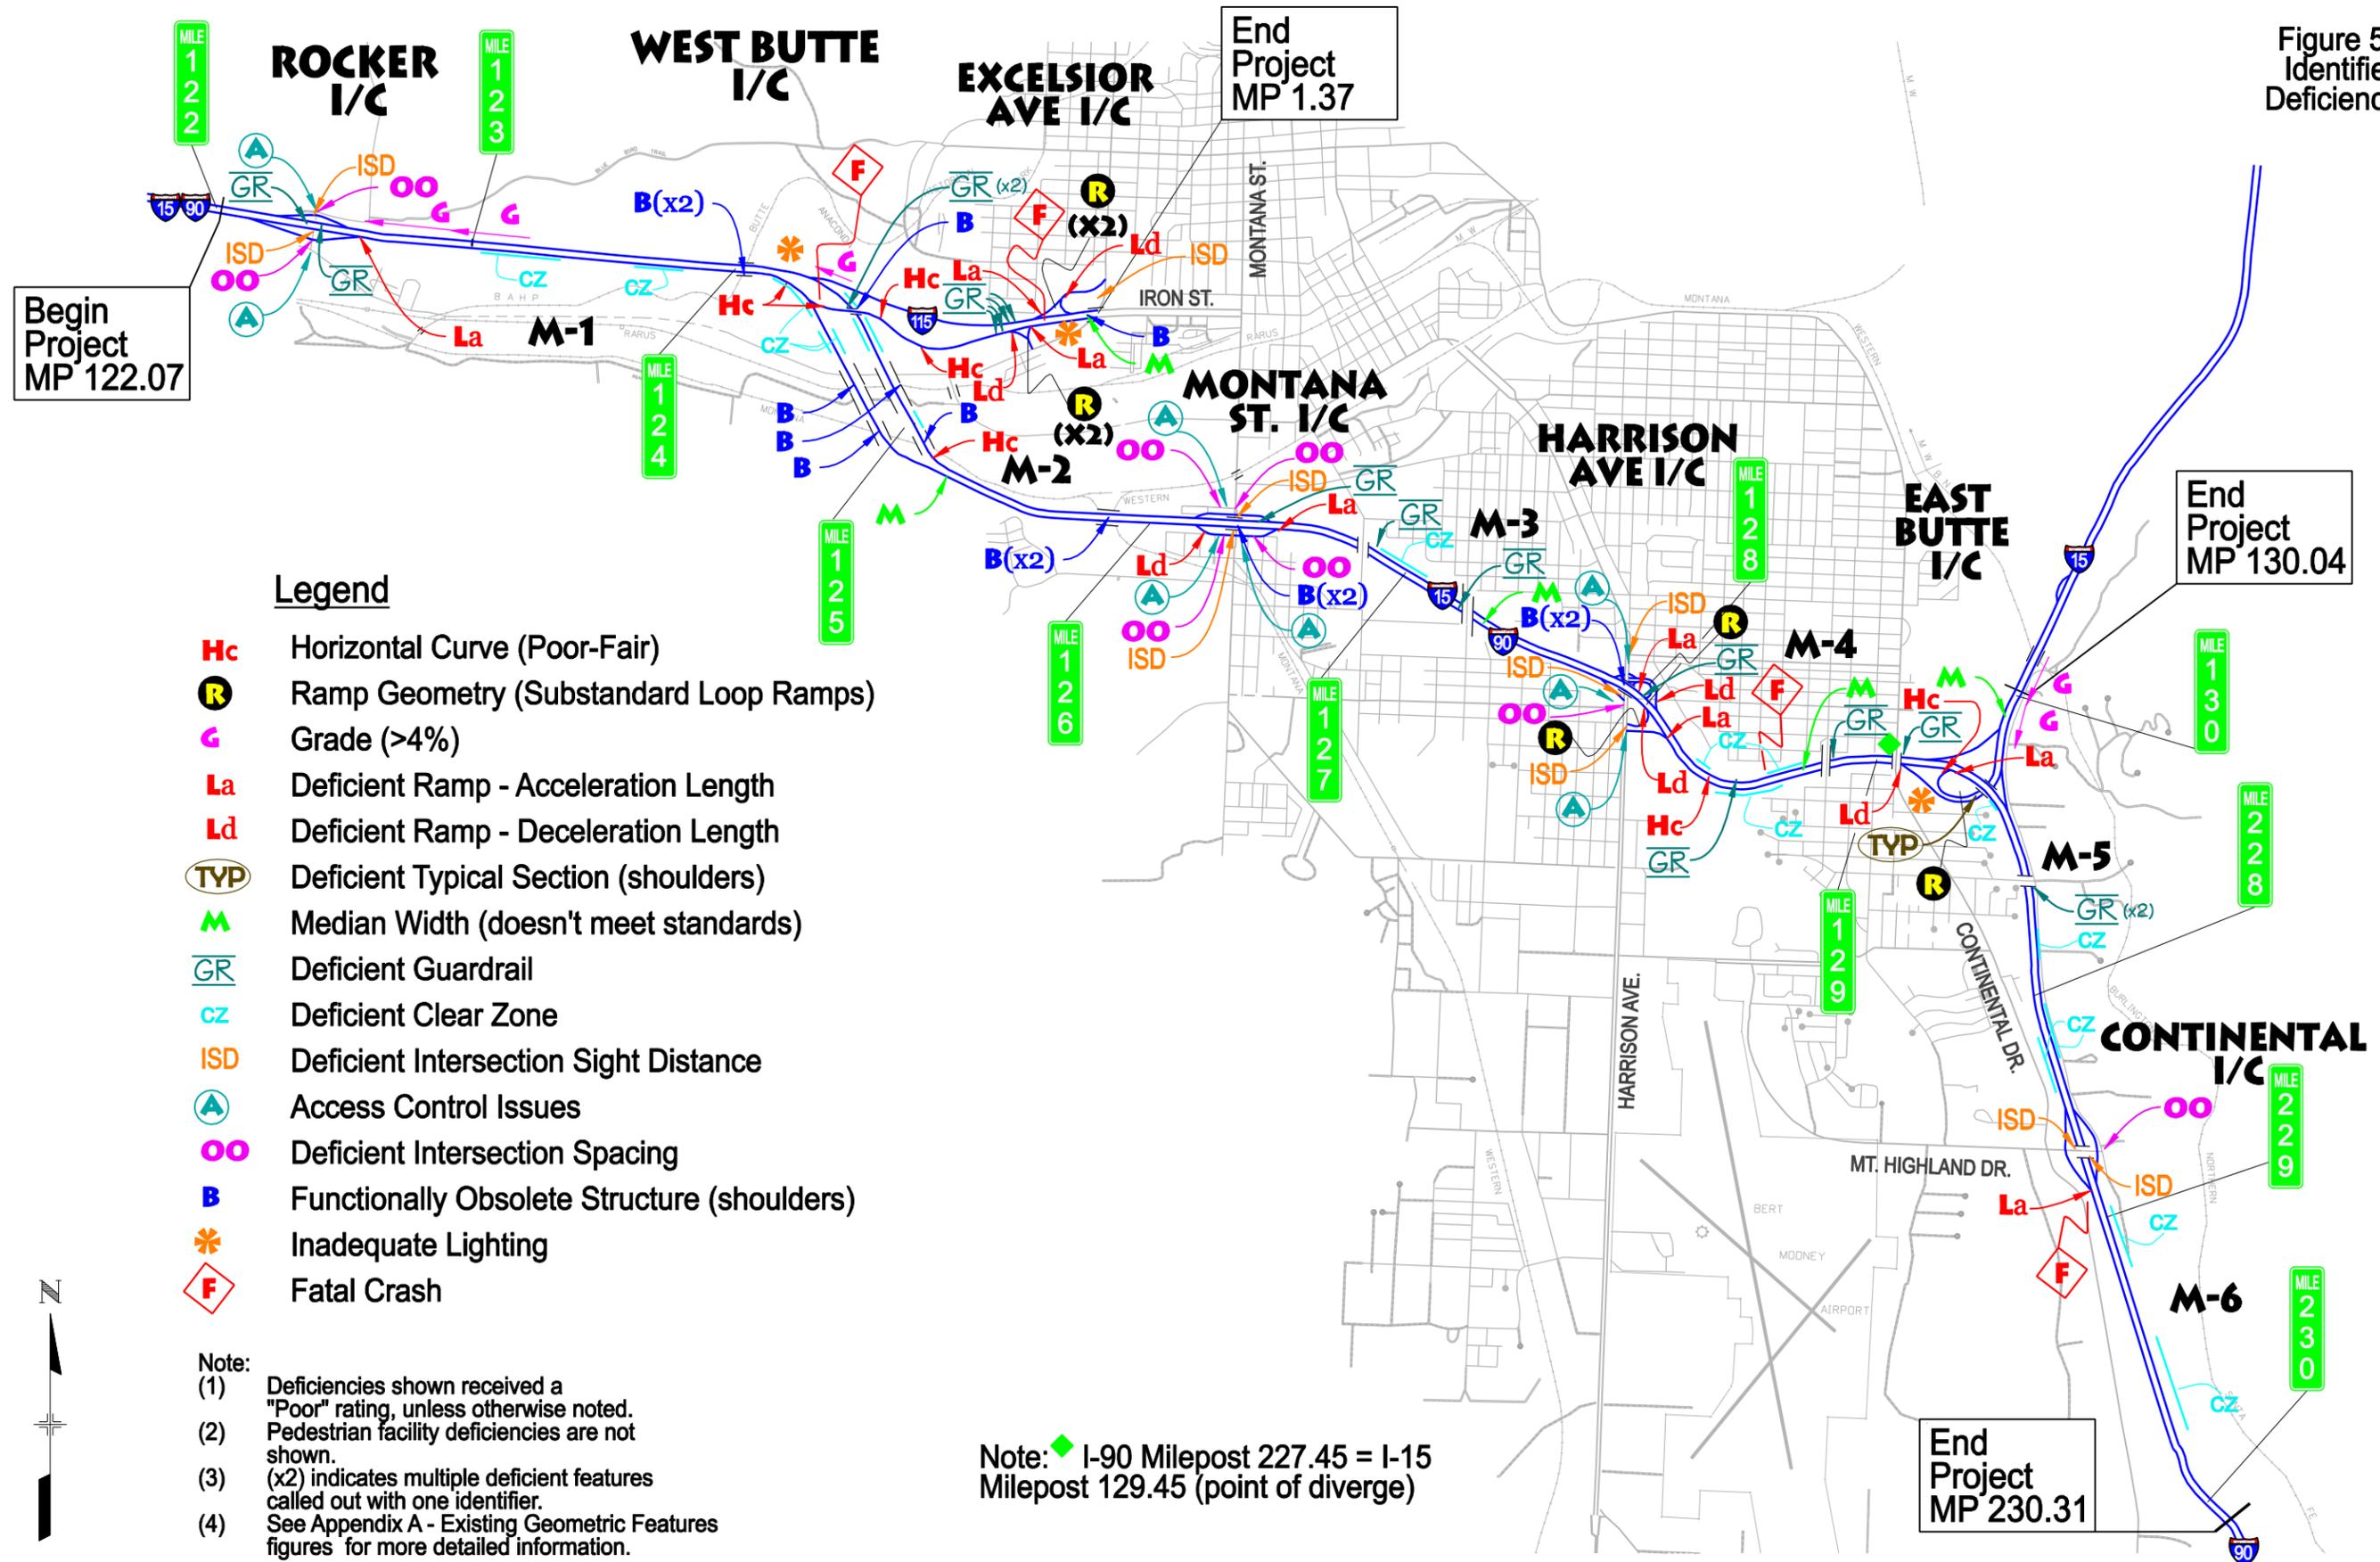
Figure 5.1
Identified
Deficiencies

- Ramp Geometry (acceleration/deceleration length, horizontal curvature, typical section)
- I-115 Mainline design deficiencies (horizontal, vertical and typical section (median))
- Signing deficiencies
- No lighting at interchange
