Electrified Barriers for Carnivore Species and Lowered Jump-Outs for Deer along US Hwy 93N, Montana

Solicitation Number 21-011

Marcel P. Huijser, PhD
Western Transportation Institute - Montana State University
P.O. Box 174250
Bozeman, MT 59717-4250

A proposal prepared for the
Montana Department of Transportation
2701 Prospect Avenue
PO Box 201001
Helena MT 59620-1001

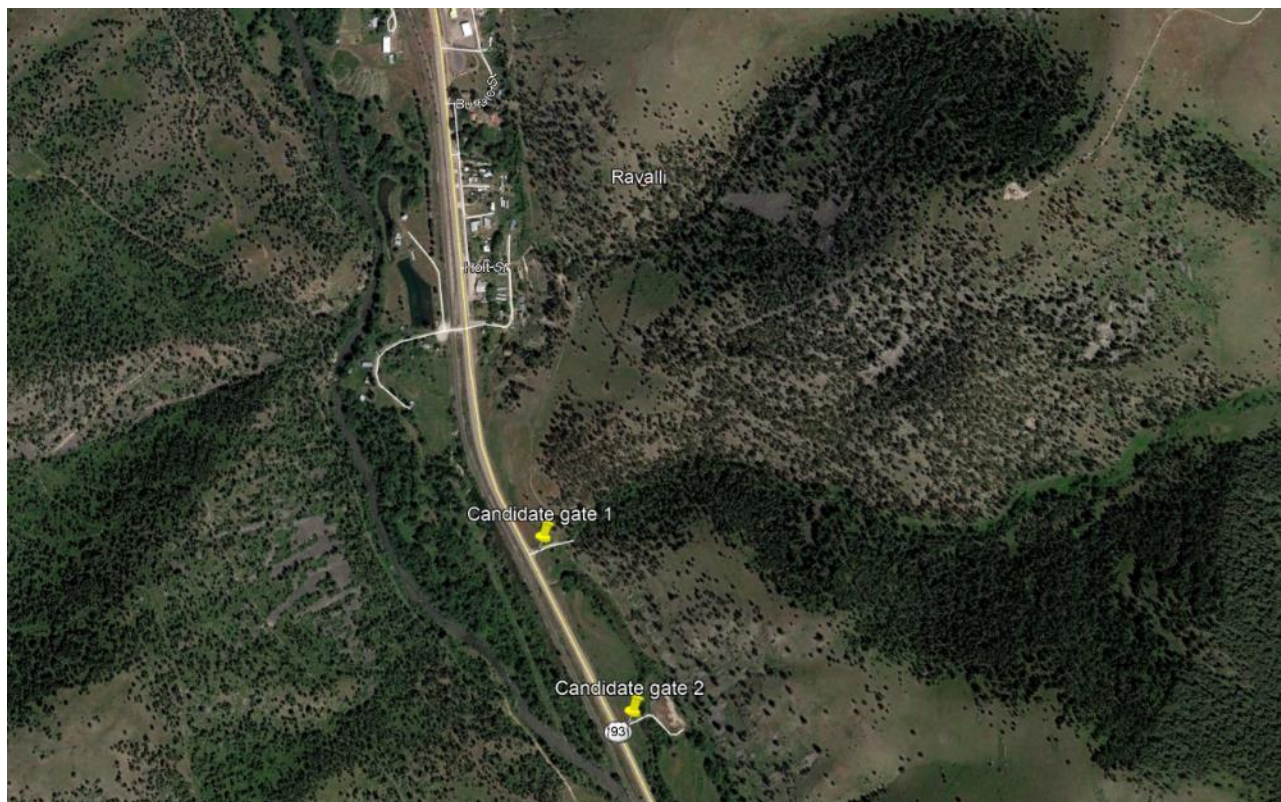
Figure 1: The two locations that appear suitable for the installation of electrified barriers, just south of Ravalli. Note that these are the same two sites that were part of the study by Allen et al. (2013).

Based on field visits there are two suitable sites for electrified barriers (Figure 1, 2, 3). These two locations meet the following criteria:

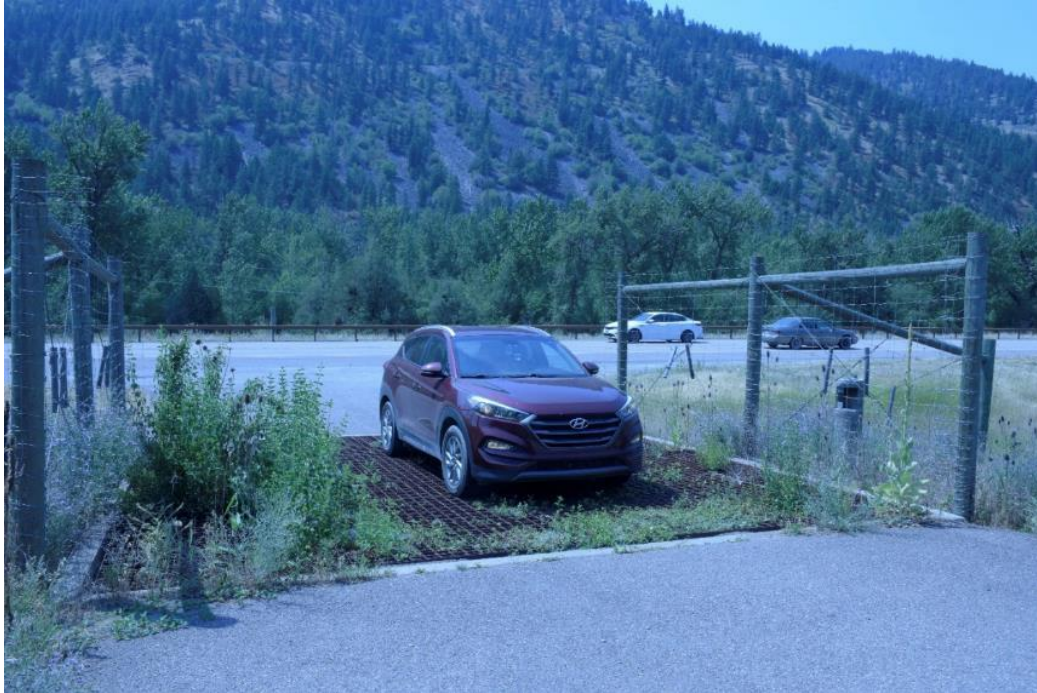
Figure 2: Candidate site 1, just north of underpass RC432 (Copper creek), east side of US Hwy 93N, just south of Ravalli and the Jct with MT Hwy 200. Occasional use by fire fighters, hunters, and locals exists (graffiti on the nearby underpass suggests people sometimes use the area) (Personal Comment Whisper Camel, CSKT).

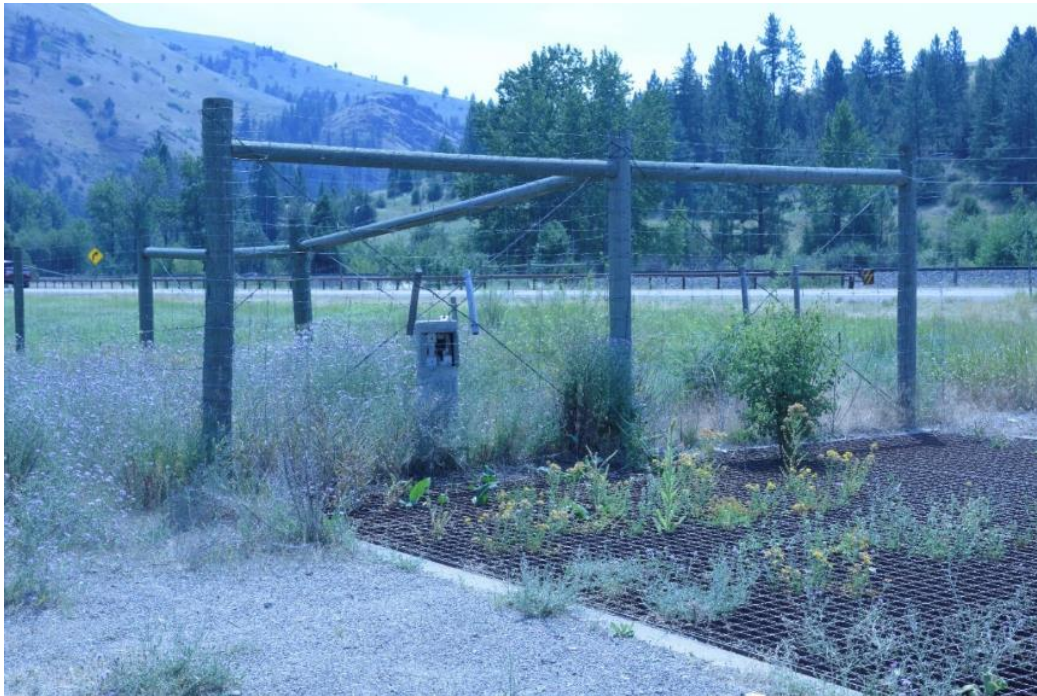
Figure 3: Candidate site 2, just south of underpass RC432 (Copper creek), east side of US Hwy 93N, just south of Ravalli and the Jct with MT Hwy 200. This provides access to an old MDT gravel pit / storage area only, extremely low current use (Personal Comment Whisper Camel, CSKT).

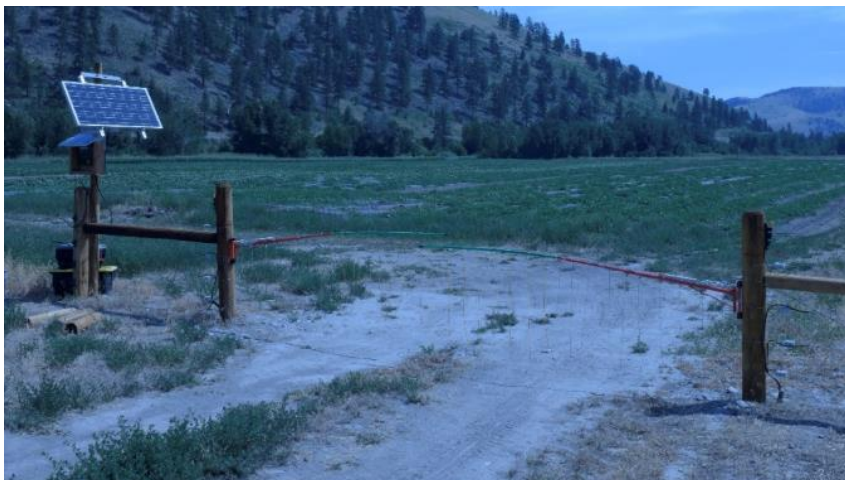
Figure 4: Electrified bump gate. The horizontal poles and the vertical strands are electrified. When a vehicle pushes on the two horizontal poles, the poles swing open and close automatically behind the vehicle.

Based on these criteria, we propose two designs that have already been installed at a private farm to keep black bears out of an agricultural crop (Figures 4, 5).

Bump gates: The arms of the bump-gates have a rubber end cap. When a vehicle pushes open the gate, the rubber end cap can rub against the side of the car. The rubber end cap itself will not scratch the paint. However, dirt on the car, or dirt on the rubber end cap can scratch the paint of a vehicle.

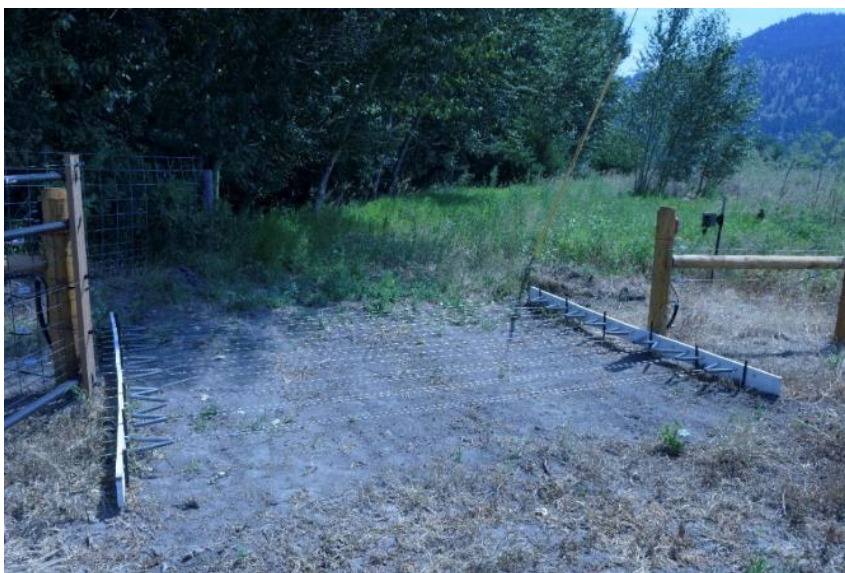
Figure 5: Electrified wires above the ground. Note that a vehicle can drive over these wires.

Drive-over electrified wires: The wires would be positioned a few inches above the modified bridge grate material of the wildlife guard. Unless a vehicle has exceptionally low clearance, it should be able to drive over these wires without an issue. However, it is unknown what the damage to the wires would be with snow chains or aggressive tire treads.

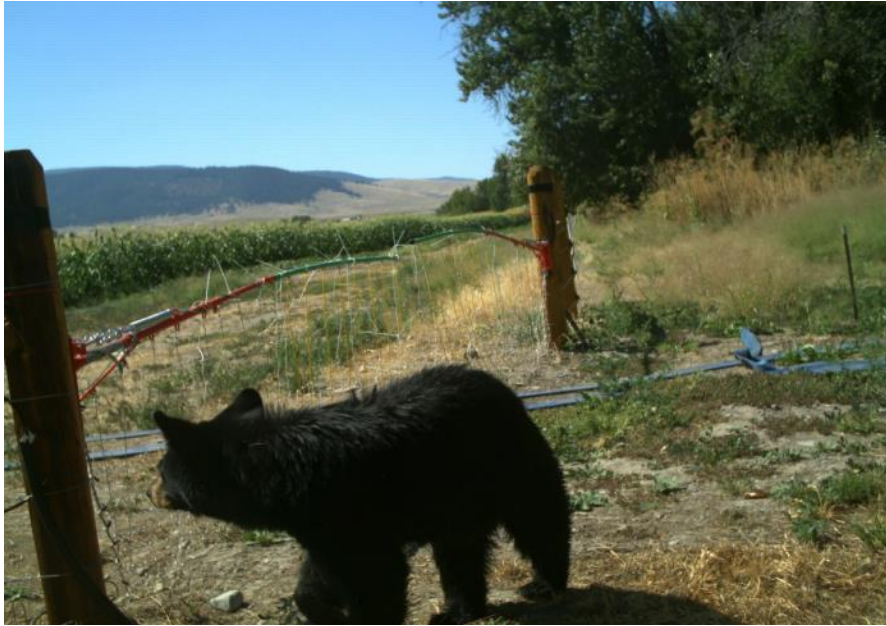
Figure 6: Black bear investigates electrified bump gate.

Preliminary data on the barrier effect of these two gate designs at the farm suggest that both are a substantial barrier to black bears. While the unmodified bump gate was often passed by black bears, a recent modification to the bump gate with electrified netting in addition to the strands showed zero passages out of 11 approaches by black bears (100% barrier) (Unpublished data Marcel Huijser, WTI-MSU). The design with the electrified wires above the ground showed one passage out of about 25 approaches by black bears (about 96% barrier) (Unpublished data Marcel Huijser, WTI-MSU) (Figures 6, 7). Though the sample sizes are still limited, this is substantially better than the 45-52% barrier for black bear (based on 2-3 years of research and of the existing wildlife guards along US Hwy 93N (Allen et al., 2013; Huijser et al., 2016b).

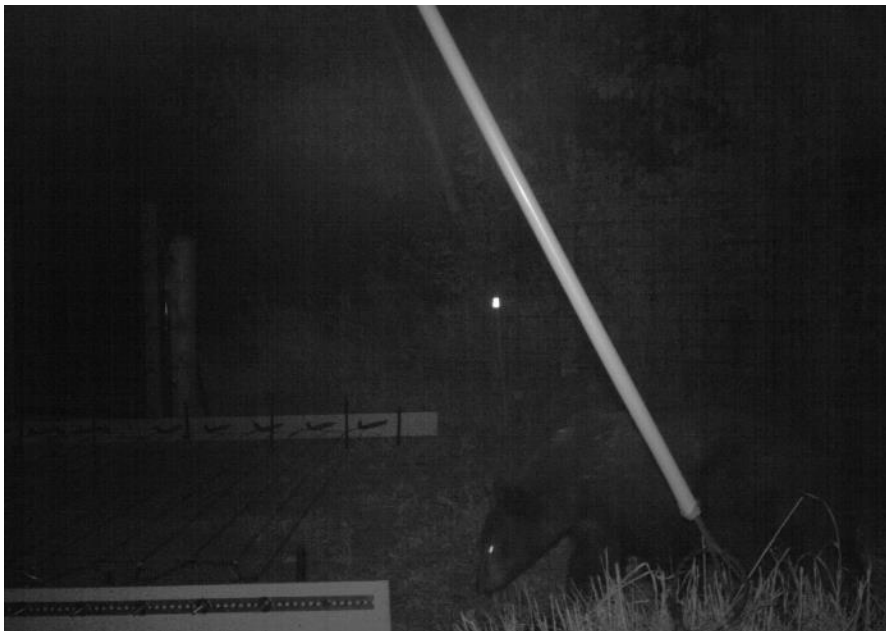
Figure 7: Black bear investigates barrier with electrified wires above the ground.

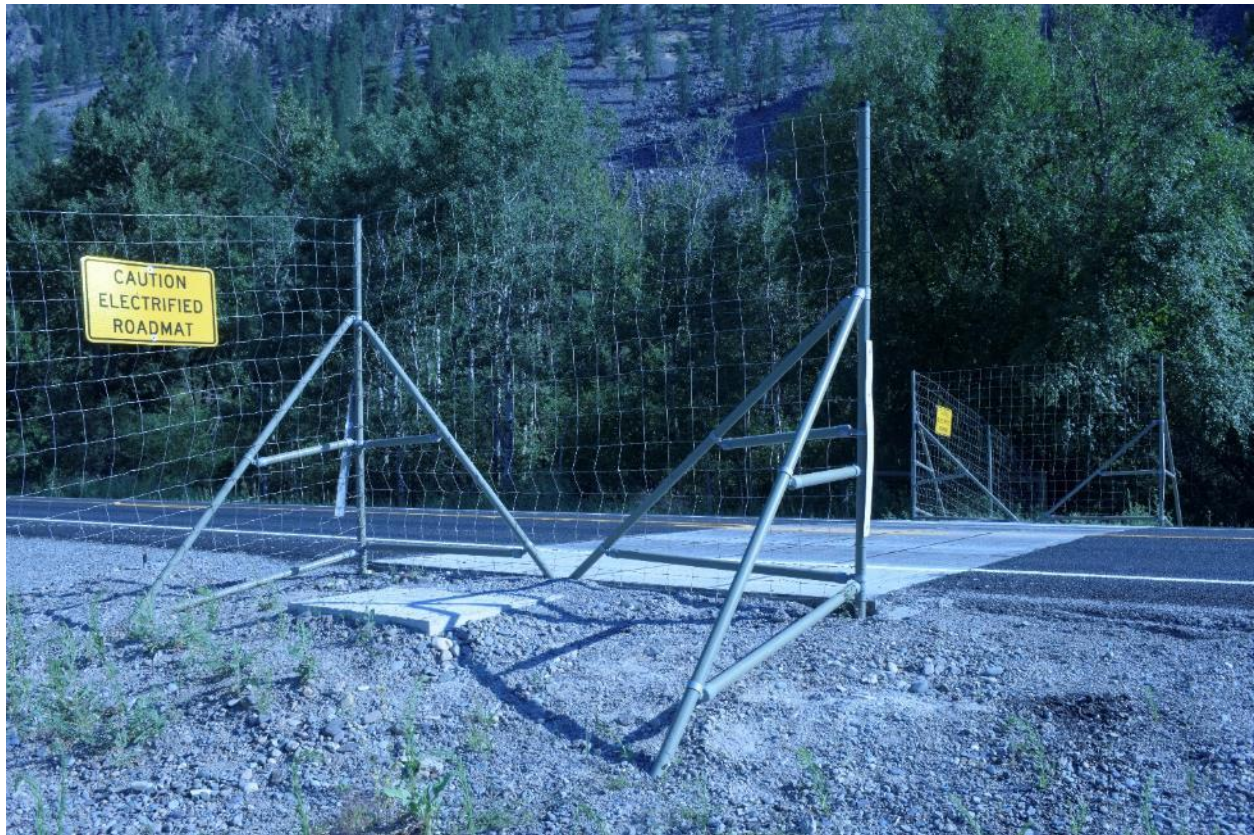
Figure 8: “Caution Electrified Roadmat” sign along MT Hwy 200 near Thompson Falls, Montana.

Examples of existing signage on electrified fences and barriers are in the images below (Figures 8, 9, 10, 11, 12, 13).

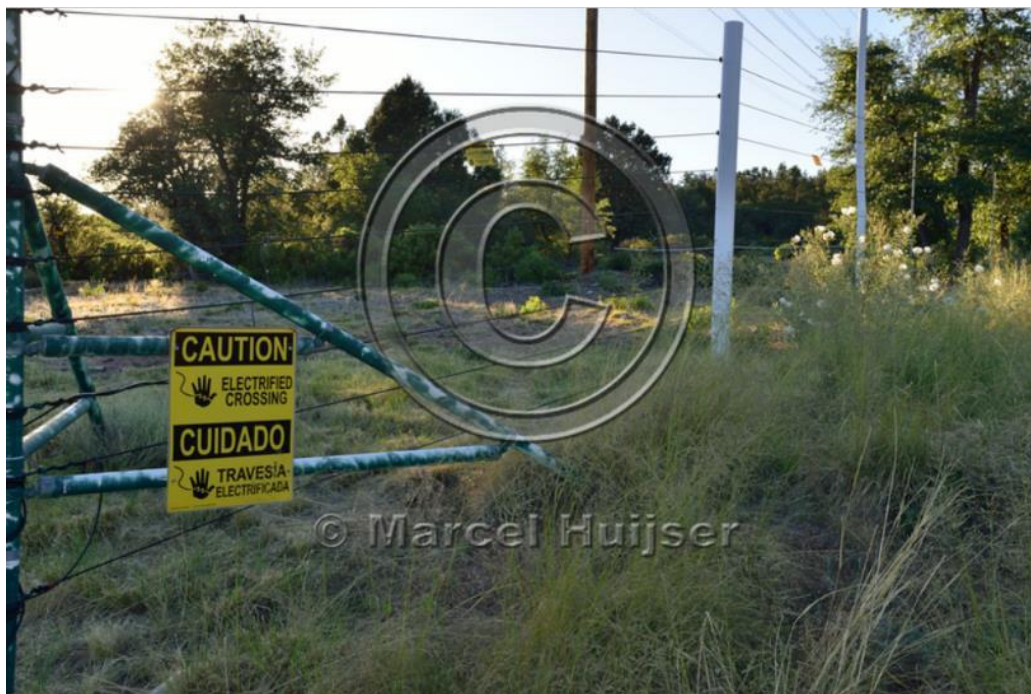
Figure 9: Electric fence associated with an animal detection and driver warning system at a fence end, S.R. 260 east of Payson, Arizona (see Gagnon et al., 2010).

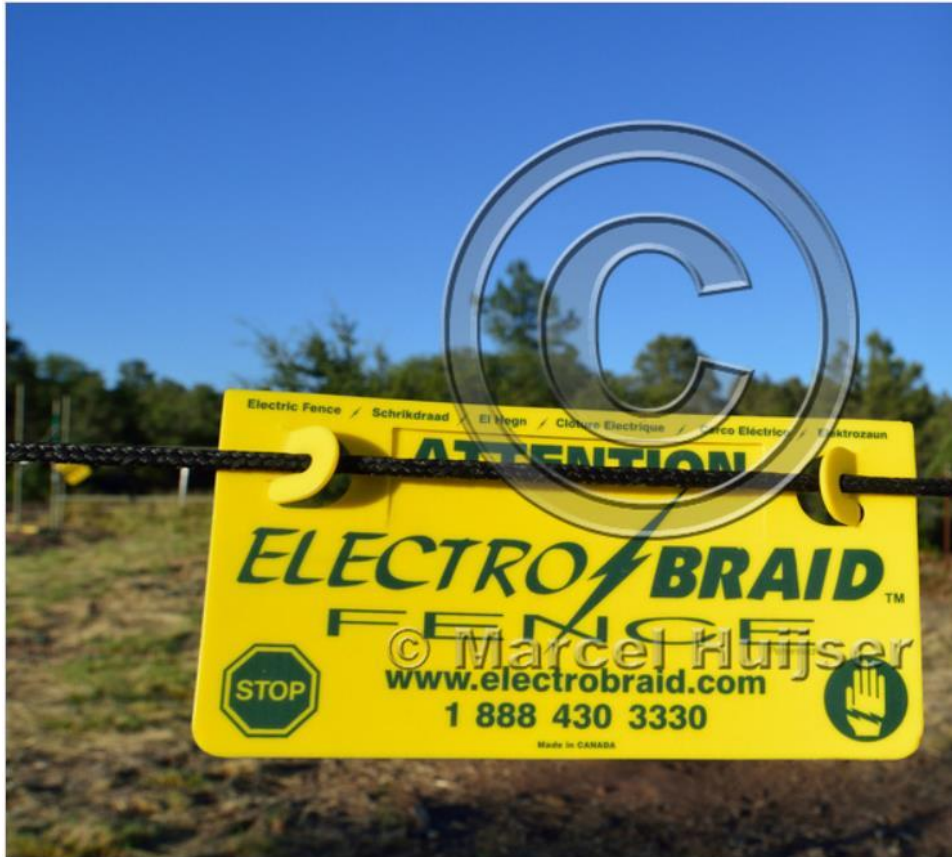
Figure 10: Electric fence associated with an animal detection and driver warning system at a fence end, S.R. 260 east of Payson, Arizona (see Gagnon et al., 2010).

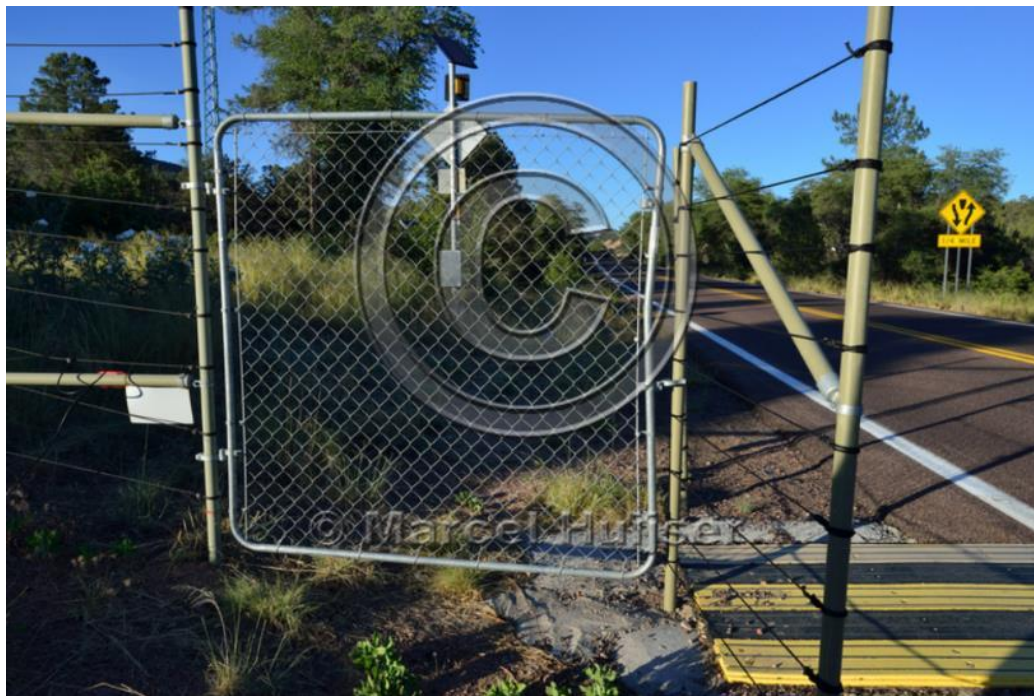
Figure 11: Pedestrian gate at electric fence associated with an animal detection and driver warning system at a fence end, S.R. 260 east of Payson, Arizona.

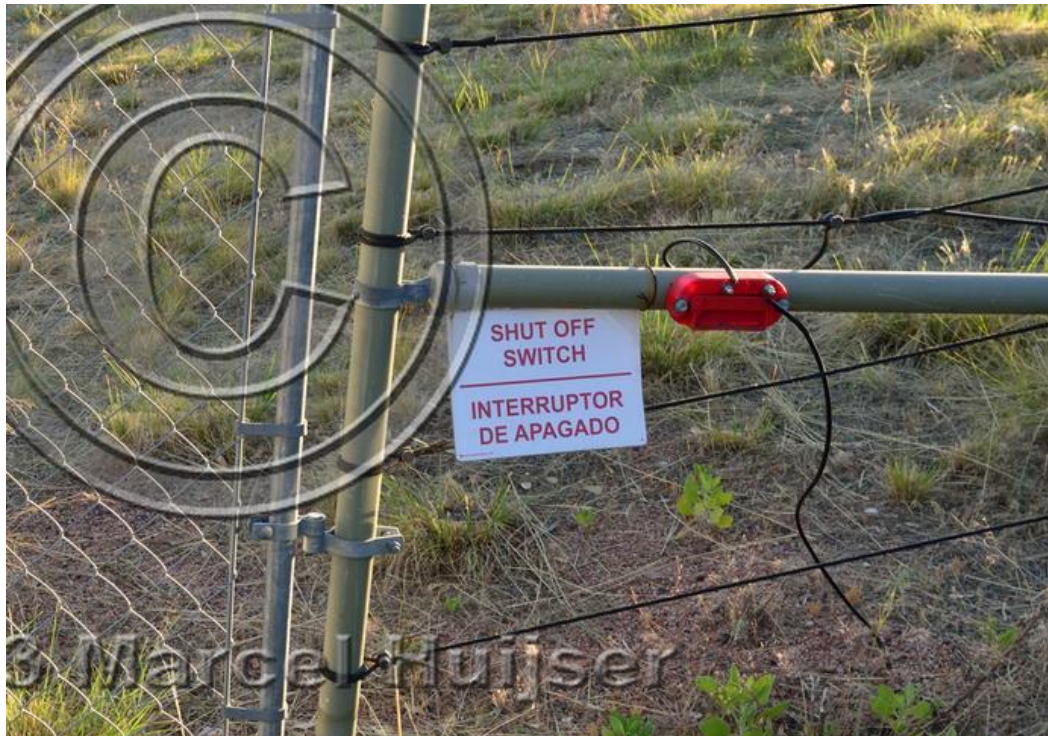
Figure 12: Shut off switch at pedestrian gate at electric fence associated with an animal detection and driver warning system at a fence end, S.R. 260 east of Payson, Arizona.

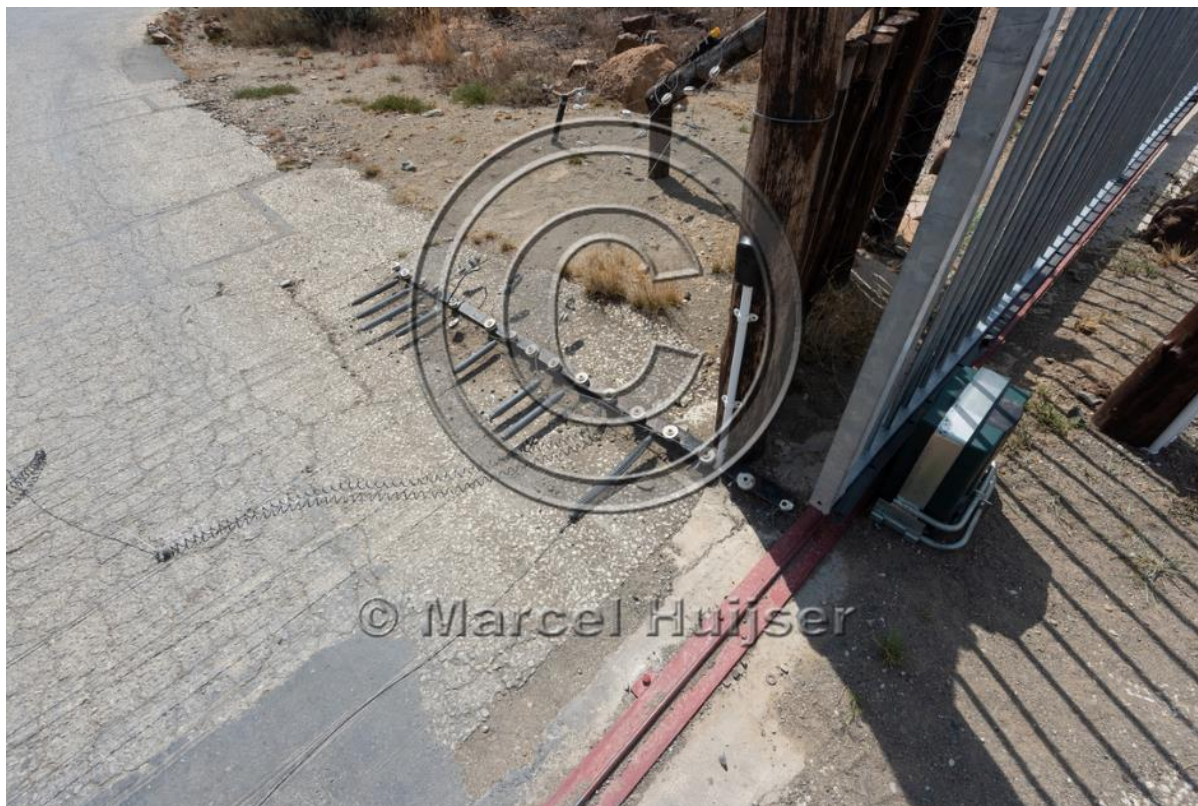
Figure 13: Electrified wires on road surface at gate, South Africa.
