GLENDIVE TRAFFIC STUDY

STPX 5099(4)
UPN 8934000

MERRILL AVENUE – DOUGLAS
STREET TO OREGON LANE

MAY 2016

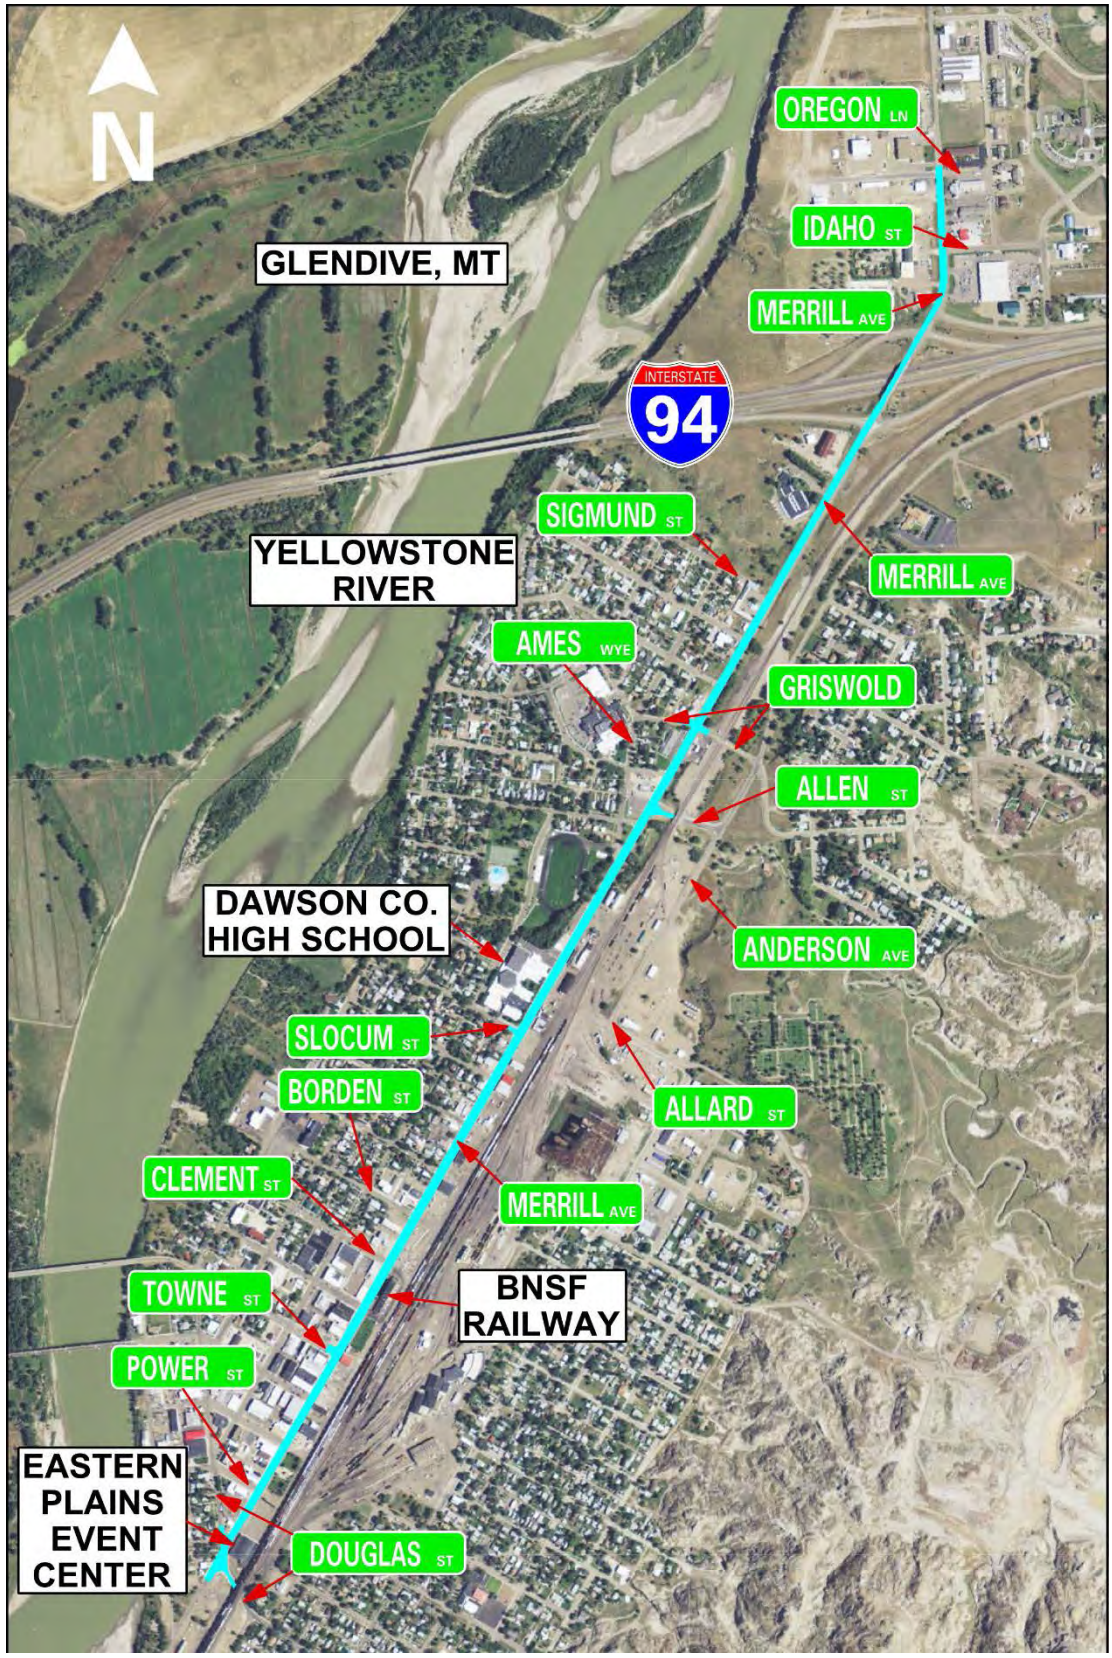
FIGURE 1-1 - Study Area

The study area is shown in **Figure 1-1**. It includes the Merrill Avenue corridor between Douglas Street and Oregon Lane, north of the I-94 interchange. Key land uses within the study area include Eastern Plains Event Center and Dawson County High School.

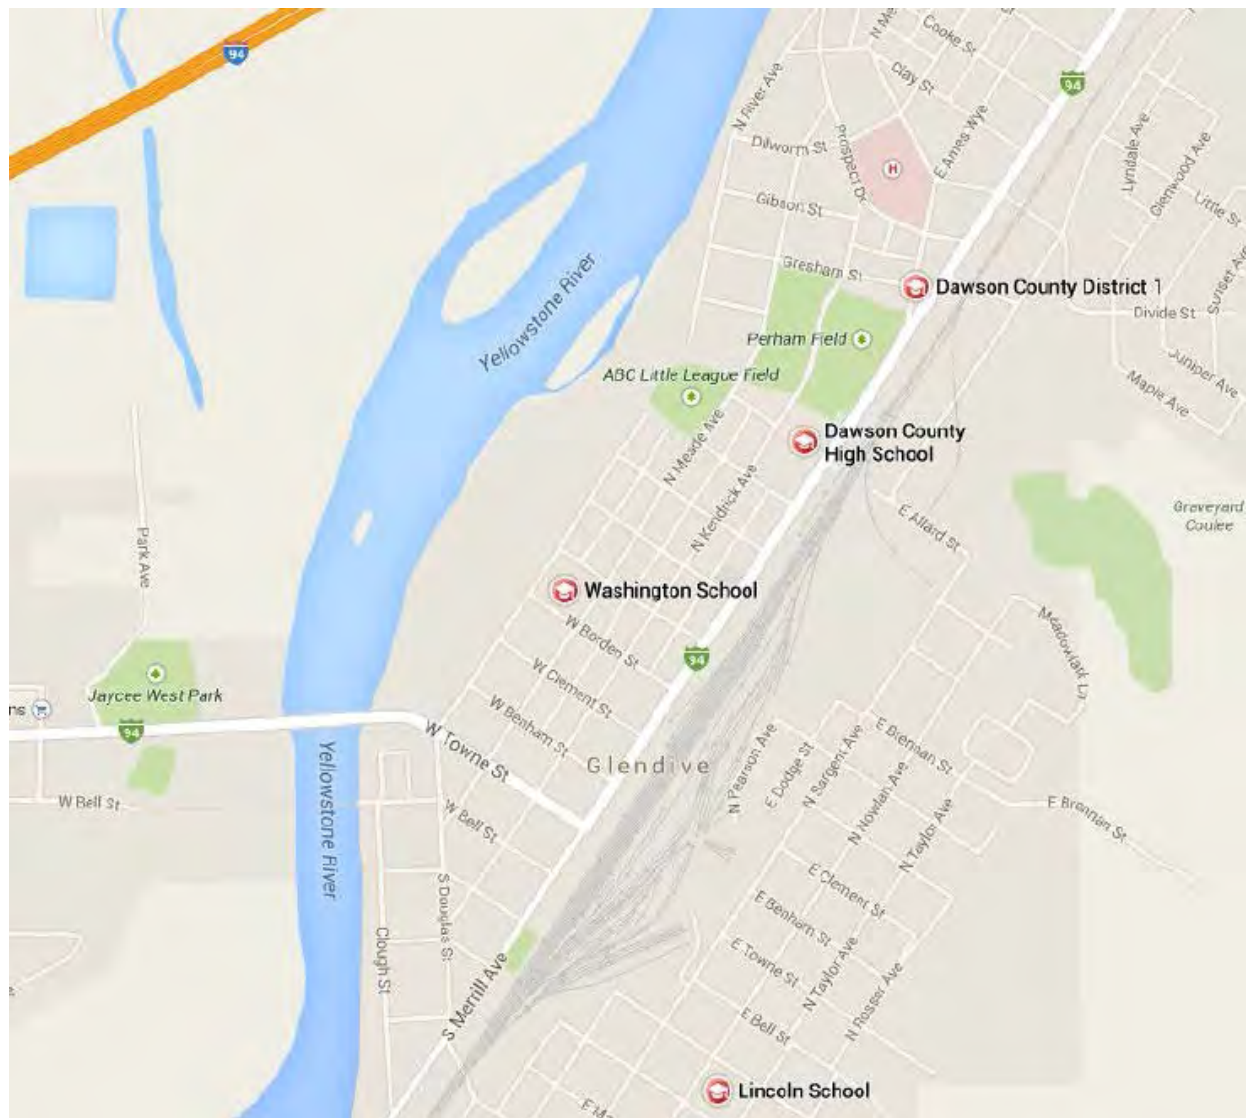
Figure 2-5 - Merrill Avenue Vicinity Schools and Parks

Schools and parks are typically high generators of pedestrian and bike traffic. Locations of schools and parks in the vicinity of Merrill Avenue are shown in Figure 2-5. Additionally, the Eastern Plains Event Center and some restaurants such as the Subway at Allen Street can be high traffic generators.

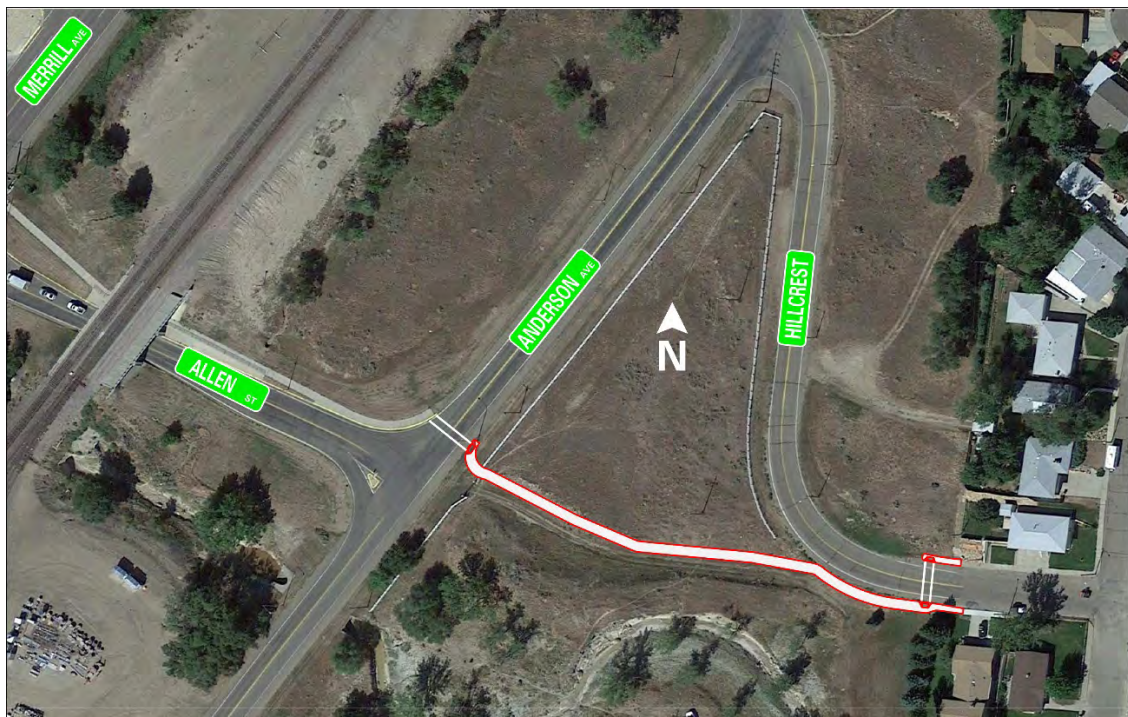
Figure 3-19 - Hillcrest to Allen Street Connection Alternative

There was very little pedestrian or bike activity observed at the Allen Street crossing. This may be because there is no direct connection between Hillcrest and Allen Street. An alternative was prepared to provide a separated multi-use path providing a more direct connection between Allen Street and the neighborhood southeast of the railroad tracks. This alternative is shown in **Figure 3-19**. We believe this would benefit the overall community but it is not an alternative that MDT would be funding.

It is recommended that the Glendive community pursue a Hillcrest to Allen Street Multi-use Path connection. It is further recommended that Allen Street/Subway Pedestrian Safety Alternative 2 be implemented at this location.

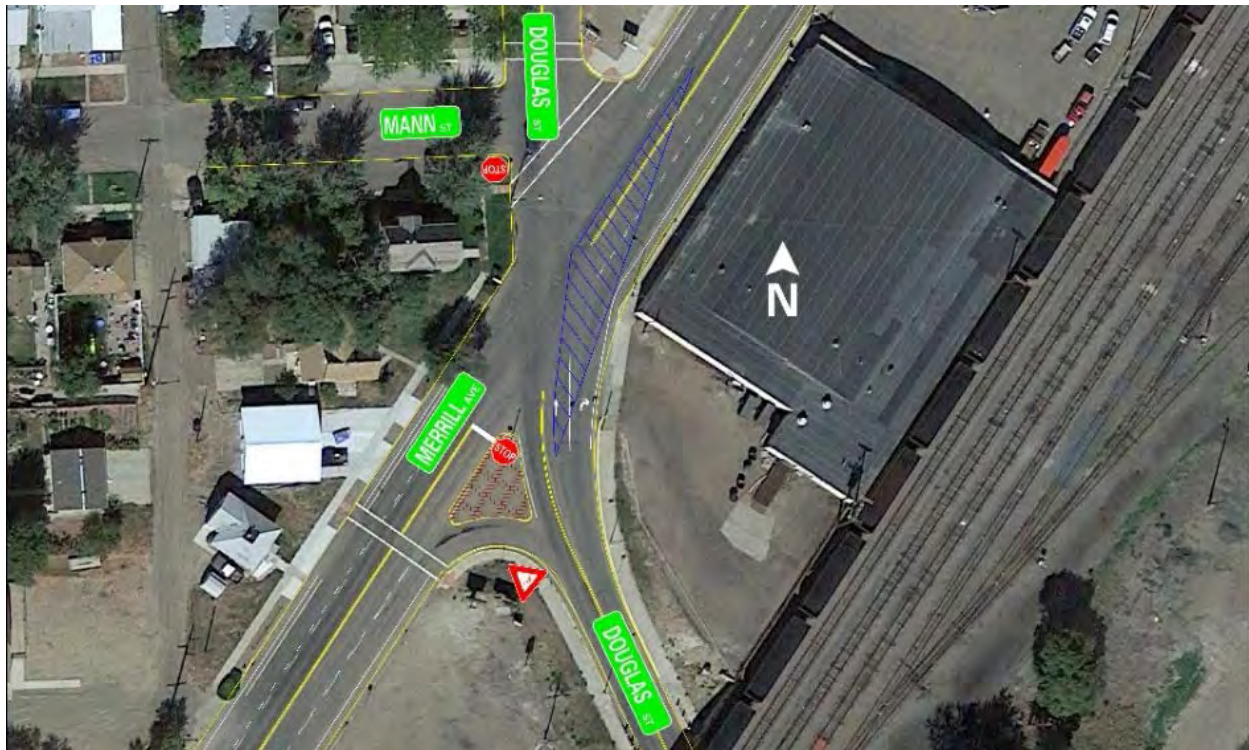
Figure 3-22 - Douglas Street Existing Conditions

Existing conditions at Douglas Street are shown in **Figure 3-22**. The blue shading represents the sight triangle on Douglas Street for northbound traffic.

Three alternatives were prepared to address traffic operational and safety issues at the Douglas Street intersection. This intersection has substandard geometrics due to the skewed approaches and the presence of private driveways and a public street approach in the operational influence of the intersection. Use of traffic control signs is also substandard, as stop signs control the north and west approaches as shown in **Figure 3-22**. This results in conflicts between concurrent northbound through traffic and westbound through and left turning traffic.

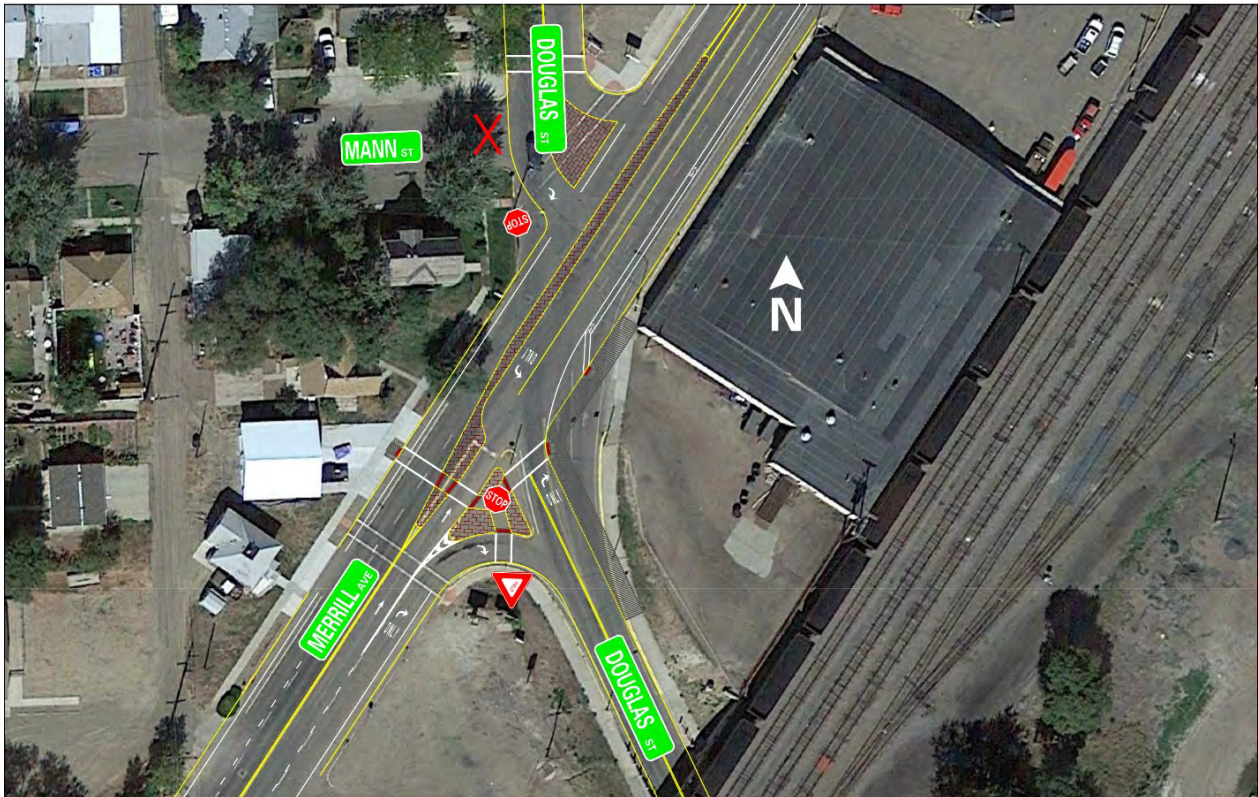
Figure 3-23 - Douglas Street Improvements Without Signalization

This alternative provides a long-term solution to traffic movements at Douglas Street without implementation of traffic signals. A median would be installed to limit movements on Douglas Street to right in and right out movements only. See Figure 3-23. This solution reduced the impact of the skewed approaches and provides significant safety benefits to the intersection. However, it would stop the major movement of traffic and would likely back up traffic on the underpass.

Since through traffic on Douglas would be eliminated, additional left turns would be introduced onto Merrill Avenue at intersections to the northeast to facilitate north-south traffic flow.

Given the number of crashes that have occurred at the Douglas Street intersection and the substandard placement of approach stop signs, it is recommended that Alternative 1 - Improvements Without Signalization be implemented as soon as is practical. Alternative 2 - Minor Improvements could be an acceptable interim alternative if changes in traffic control are desired prior to implementation of Alternative 1.

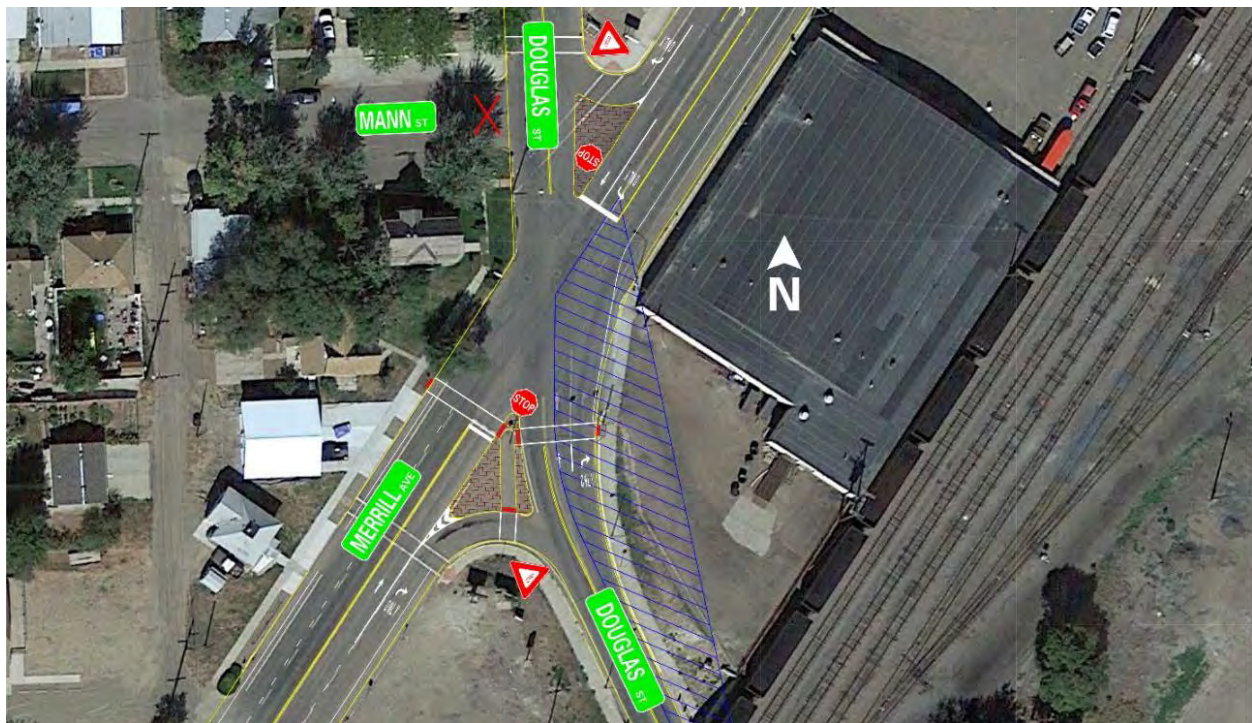
Figure 3-24 - Douglas Street Minor Improvements

Given that traffic signals are not warranted yet (projected to be warranted in 2020) and that placement of existing stop signs is substandard, this alternative was prepared as a low cost, measure to provide standard stop control. The MDT District and City of Glendive have discussed the potential to eliminate the southwest bound left turn lane on Merrill Avenue in favor of a raised median. This option was analyzed and the change in level of service was negligible. It is anticipated that the decision of whether to use a left turn lane as shown or a raised median will be made during the design process. The blue shading in Figure 3-24 represents the sight triangle for southbound traffic on Merrill Avenue.

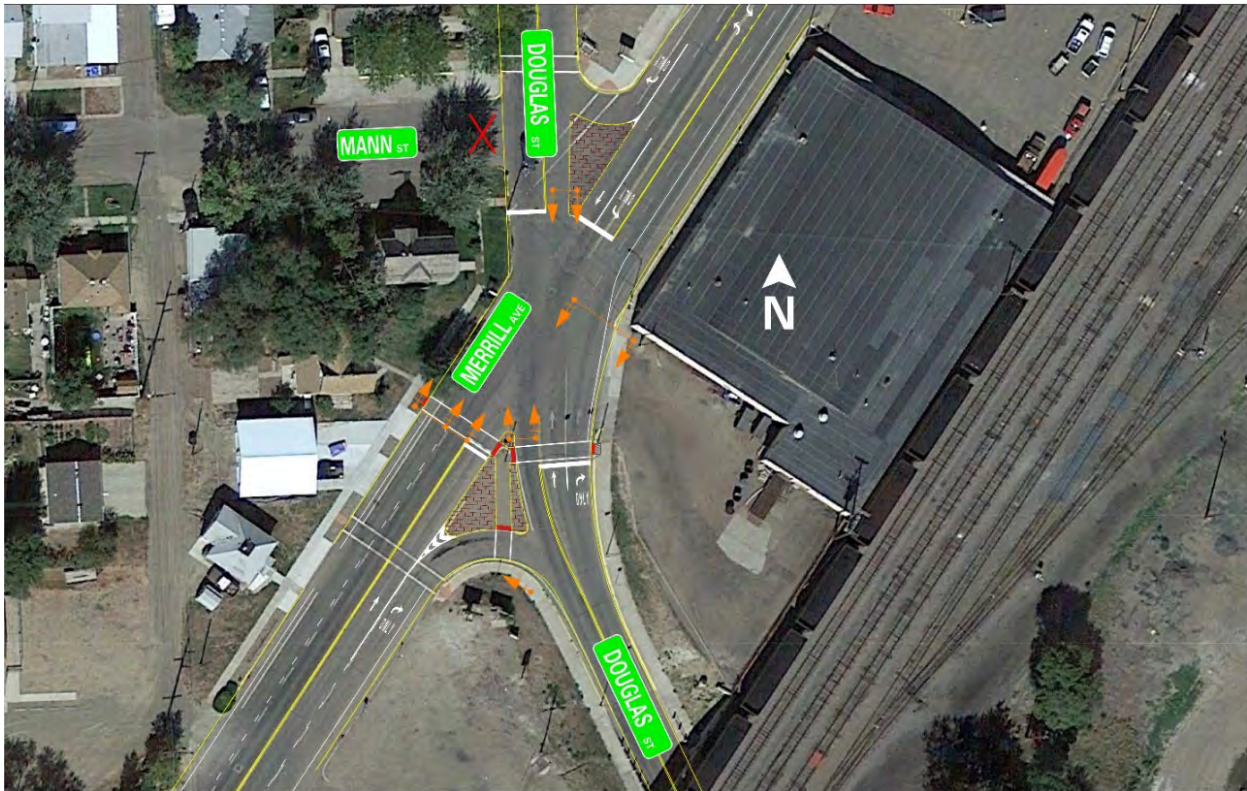
Figure 3-25 - Douglas Street Signalization Improvements

Traffic signals are projected to be warranted by the year 2020. Once warranted, the proposed minor improvements seem to work well once the intersection is signalized. See **Figure 3-25**. The MDT District and City of Glendive have discussed the potential to eliminate the southwest bound left turn lane on Merrill Avenue in favor of a raised median. This option was analyzed and the change in level of service was negligible. It is anticipated that the decision of whether to use a left turn lane as shown or a raised median will be made during the design process.
