Experimental Features  
Evaluation Report

**EVALUATION OF STRIETER-LITE WILD ANIMAL HIGHWAY WARNING REFLECTOR  
SYSTEM™ ON REDUCING VEHICLE-ANIMAL COLLISIONS**

**Project Name:** Safety Improvement Project  
Fencing – East of Whitehall

**Project Number:** HSIP 69-1(22)2

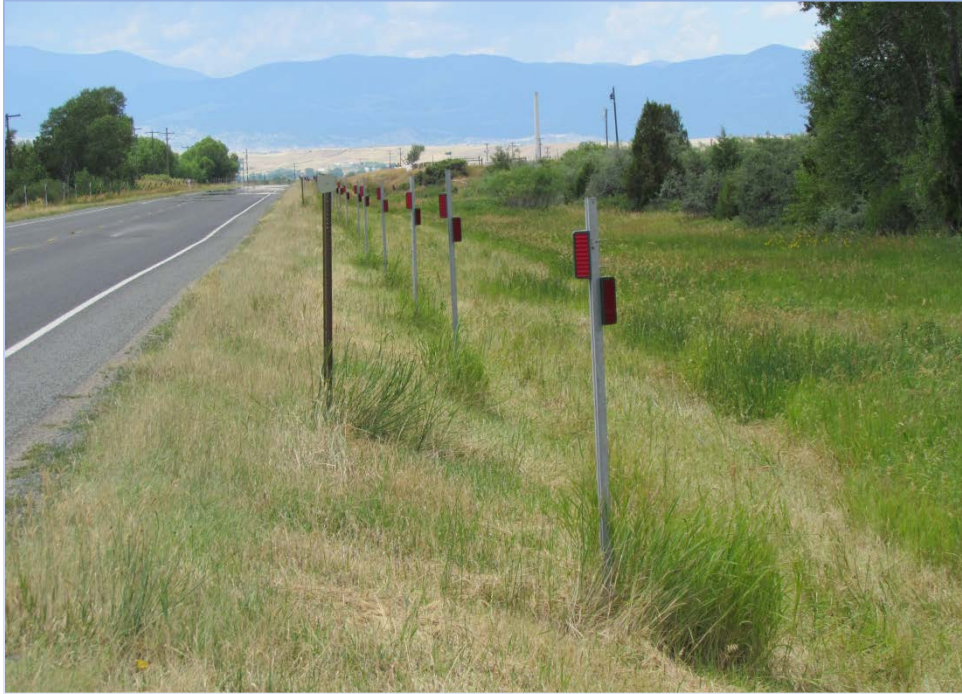
The site was visited August 3, 2011 by Research staff to observe any visual changes. The reflectors were clean and surrounding vegetation had been mowed (see Figure 1).

**Figure 1- Reflector system cleaned and mowed**

As mentioned above, the reflectors were cleaned in July 2011 by MDT maintenance staff with windshield washer fluid and a squeegee. The vegetation was also mowed in this general time frame. Mowing of the study area did take longer, approximately a day longer than it did for this area before the installation of the reflector system.

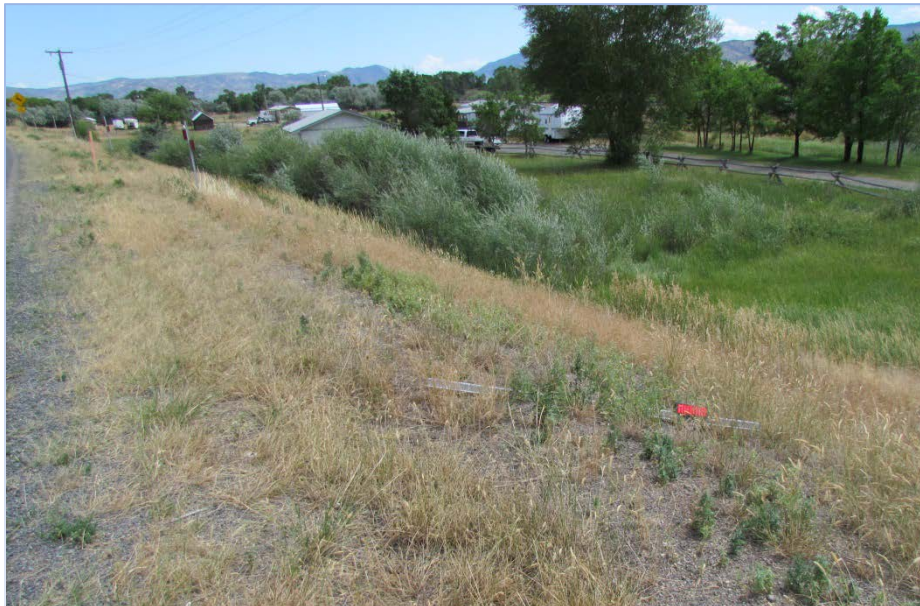
One reflector was knocked down near the beginning of the study area near Briggs Lane on the eastbound side of the road. On the same side of the road, two reflectors had been bent forward.

**Figure 2-Reflector on ground near Briggs Lane**

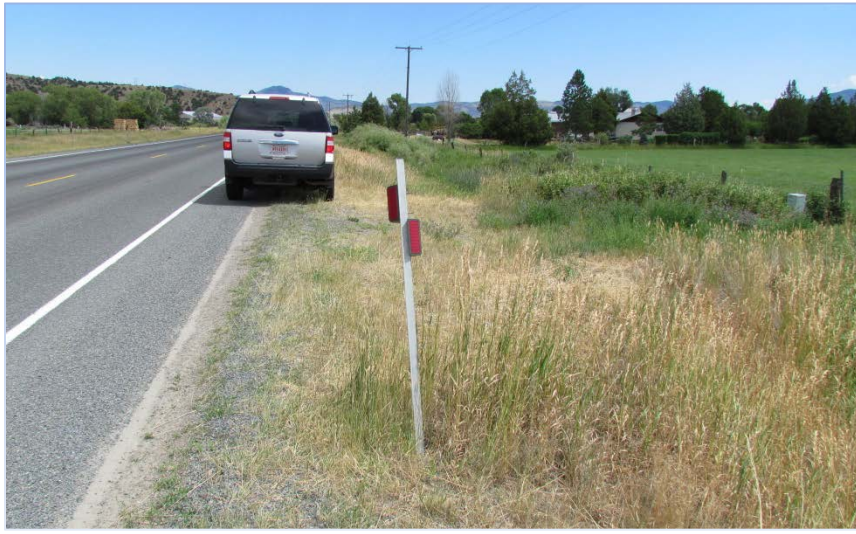
**Figure 3- Reflector bent forward**

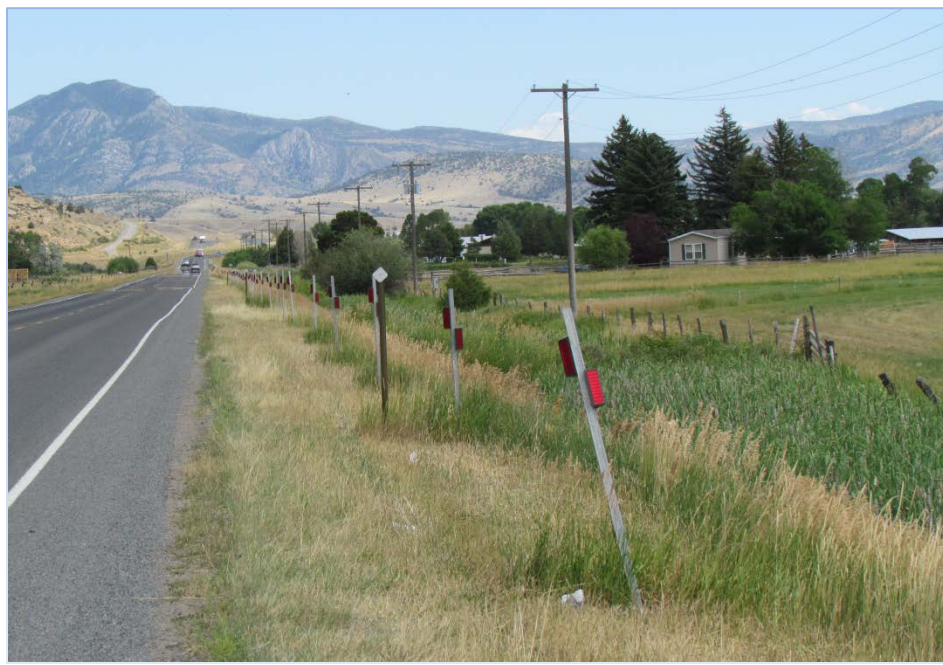
**Figure 4- Reflector bent forward**
