MONTANA DEPARTMENT OF TRANSPORTATION WETLAND MITIGATION MONITORING REPORT: YEAR 2005

*Beaverhead Gateway
Dillon, Montana*

December 2005

Project No: B43054.00 - 0202

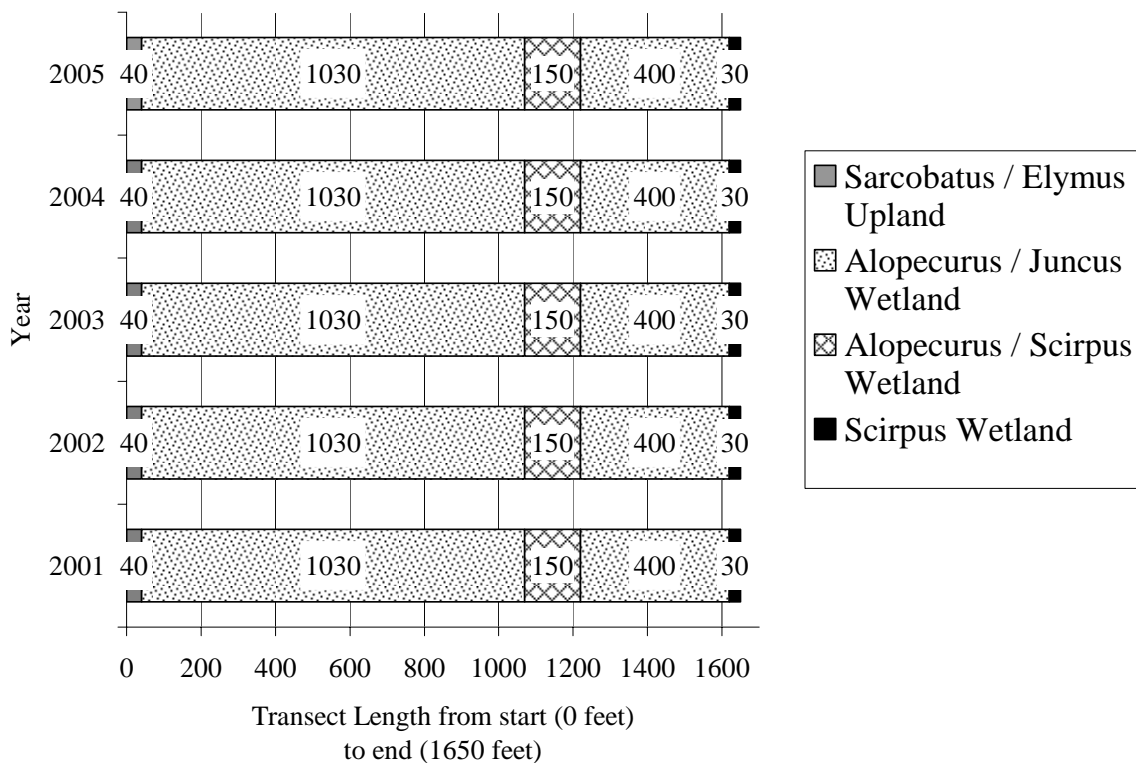
Chart 1: Transect maps showing vegetation types for Transect 1 from start (0 feet) to end (1650 feet) for each year monitored.

Monitoring Year	2001	2002	2003	2004	2005
Transect Length (feet)	1650	1650	1650	1650	1650
# Vegetation Community Transitions along Transect	5	5	5	5	5
# Vegetation Communities along Transect	4	4	4	4	4
# Hydrophytic Vegetation Communities along Transect	3	3	3	3	3
Total Vegetative Species	22	22	22	22	22
Total Hydrophytic Species	12	14	14	14	14
Total Upland Species	10	8	8	8	8
Estimated % Total Vegetative Cover	95	95	95	95	95
% Transect Length Comprised of Hydrophytic Vegetation Communities	98	98	98	98	98
% Transect Length Comprised of Upland Vegetation Communities	2	2	2	2	2
% Transect Length Comprised of Unvegetated Open Water	0	0	0	0	0
% Transect Length Comprised of Bare Substrate	0	0	0	0	0

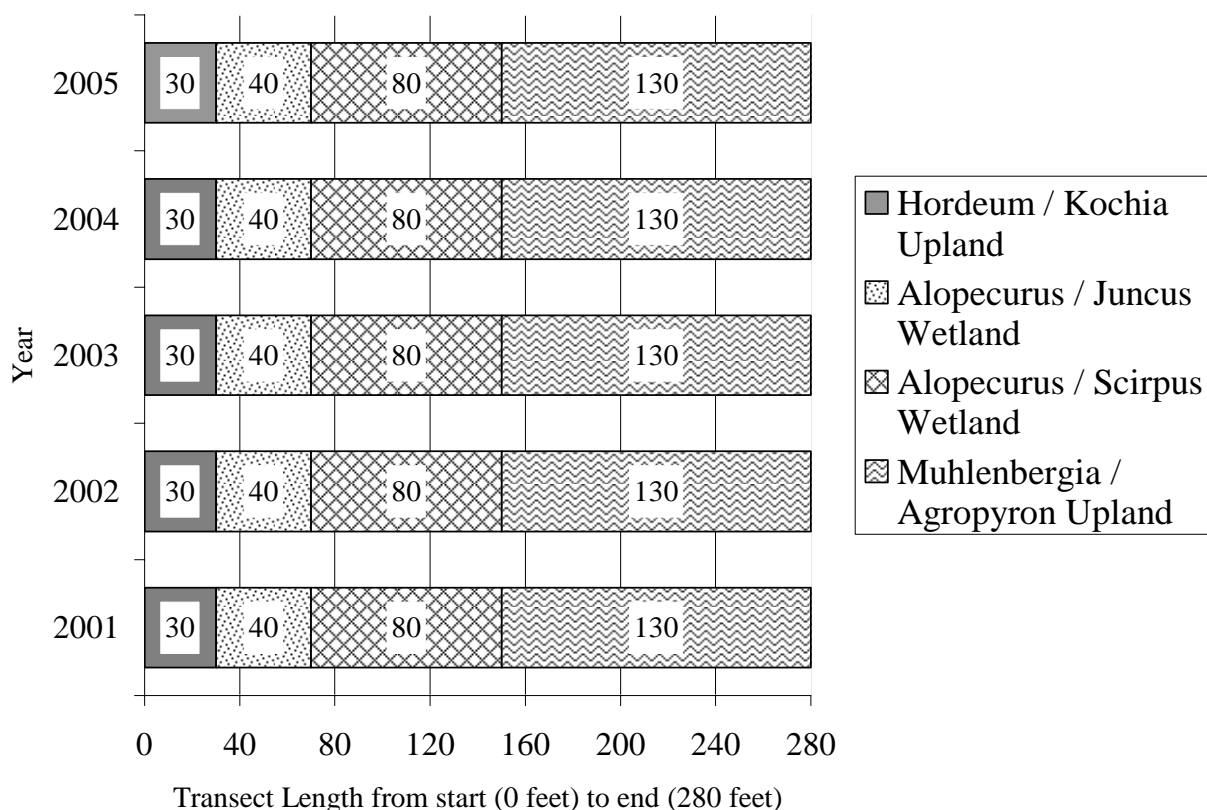
Chart 3: *Transect maps showing vegetation types for Transect 2 from start (0 feet) to end (280 feet) for each year monitored.*

Monitoring Year	2001	2002	2003	2004	2005
Transect Length (feet)	280	280	280	280	280
# Vegetation Community Transitions along Transect	4	4	4	4	4
# Vegetation Communities along Transect	4	4	4	4	4
# Hydrophytic Vegetation Communities along Transect	2	2	2	2	2
Total Vegetative Species	18	21	21	21	21
Total Hydrophytic Species	11	10	10	10	10
Total Upland Species	7	11	11	11	11
Estimated % Total Vegetative Cover	80	80	80	80	80
% Transect Length Comprised of Hydrophytic Vegetation Communities	43	43	43	43	43
% Transect Length Comprised of Upland Vegetation Communities	57	57	57	57	57
% Transect Length Comprised of Unvegetated Open Water	0	0	0	0	0
% Transect Length Comprised of Bare Substrate	0	0	0	0	0

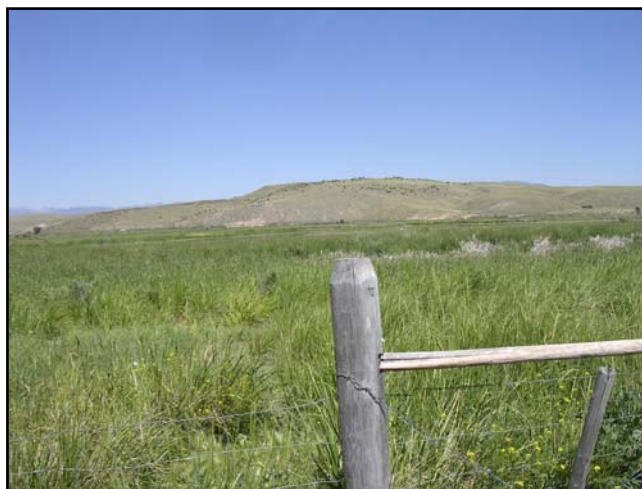
Photo Point No. 1: View looking northwest across mitigation site. Upland to wetland vegetation transition (300°)

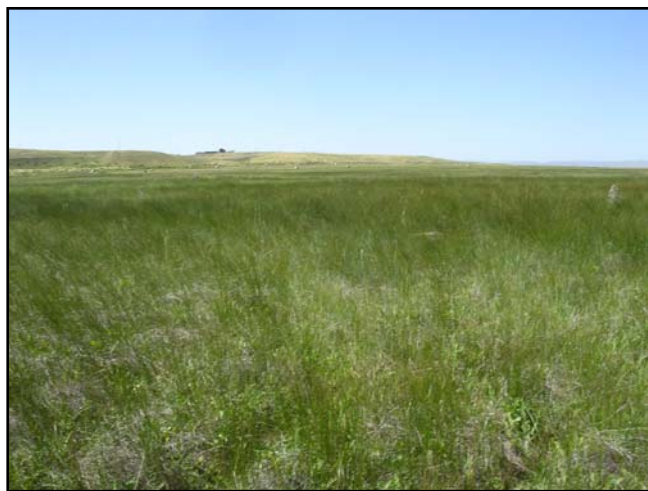
Photo Point No. 3: View looking southwest along the end of Transect 1, emergent wetland vegetation dominated by bulrush (225°).

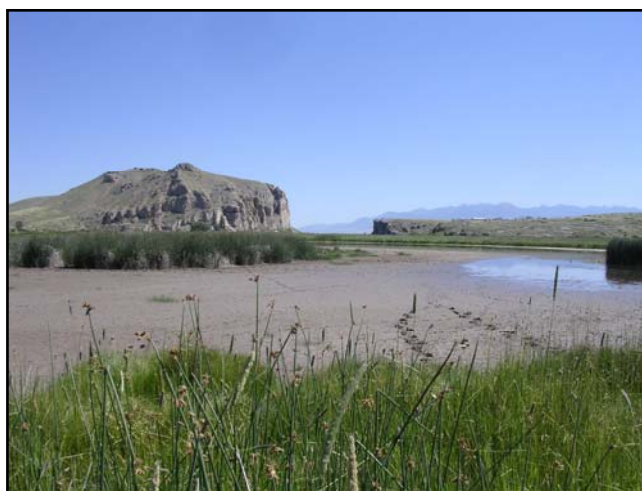
Photo Pont No. 3: View looking northeast, open water and emergent wetland vegetation dominated by bulrush (45°).

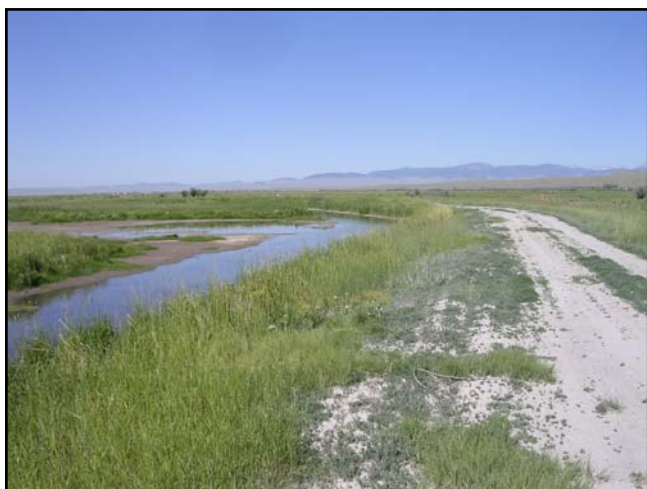
Photo Point No. 9: View looking west along dike shore and open water (270°).

Dike erosion and sediment production from the poorly vegetated shoreline could be monitored more closely by installing permanent markers or by periodic surveys. MDT was monitoring erosion on the dike using bank pins from 1998-2001, but the pins are no longer present indicating that erosion has occurred (Urban pers. comm.). The dike was examined by a DNRC dam inspector in 2005, and the erosion was considered to be a maintenance issue, but not a dam safety concern (see letter in **Appendix D**). The DNRC recommended periodically adding fill to

the face of the dike where breaching is taking place and vertical slopes are developing. Fill was added to the face of the dike in 2004 to replace eroded material, but has not yet vegetated. Additional examples of potential solutions to erosion problems include shoreline reinforcement, off-shore wave protection, protected off-shore plantings, shoreline plantings, and placement of vegetated sod mats.

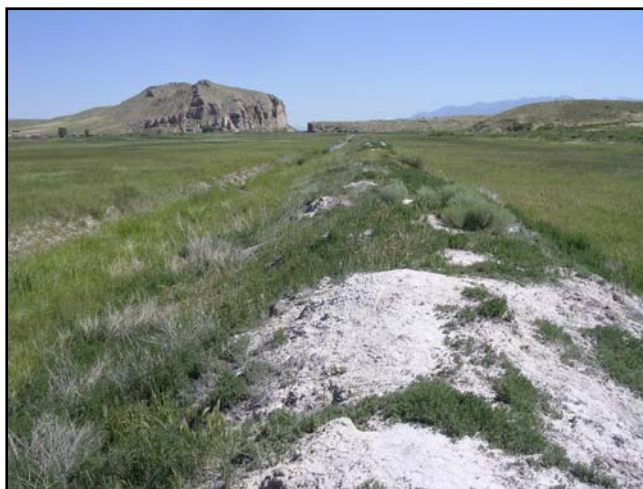
Photo Point No. 10: View looking northeast along spoil pile dominated by a weedy plant community (45°).

Spoil piles left from ditch excavation will continue to create a weed problem, a wind and water erosion hazard and a sedimentation source. This same issue applies to portions of the dike and other poorly vegetated sites. A possible remedy would entail chemically treating weeds and re-seeding the spoil piles with desirable grasses.

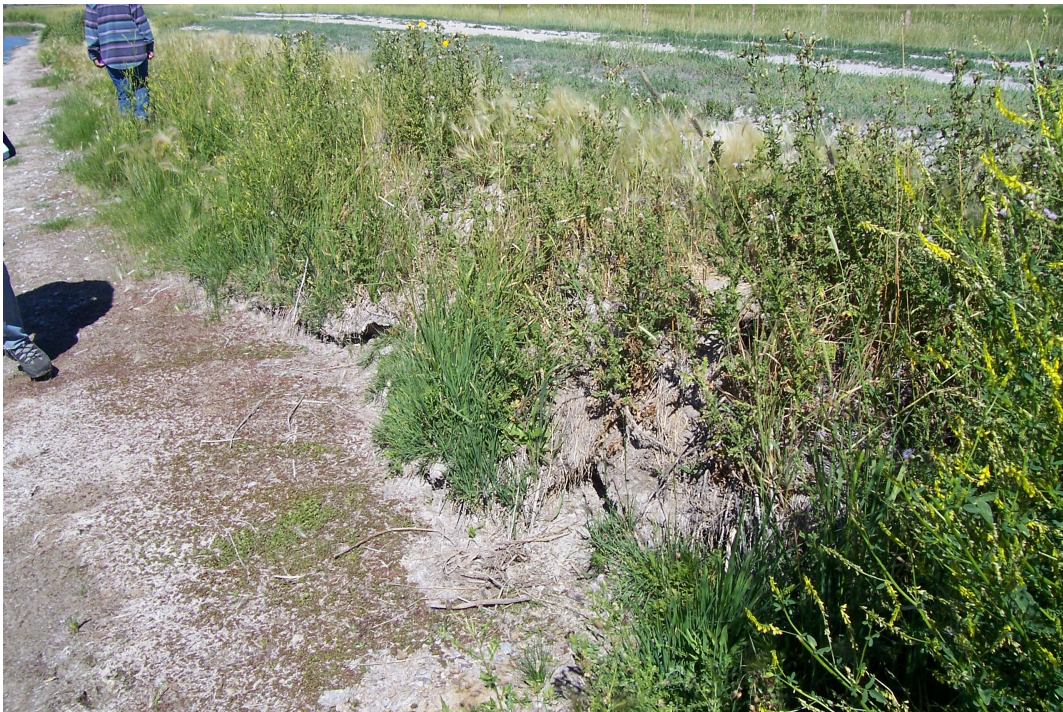
Figure 1. Erosion of upstream face, slowly moving toward crest of dike approximately 375 feet west of overflow structure. Note lack of vegetation on vertical slopes.

I would recommend that the dike owner periodically add fill to the areas of the dike where beaching is taking place and vertical slopes are developing. The upstream face should be annually monitored, and a regular maintenance plan developed.

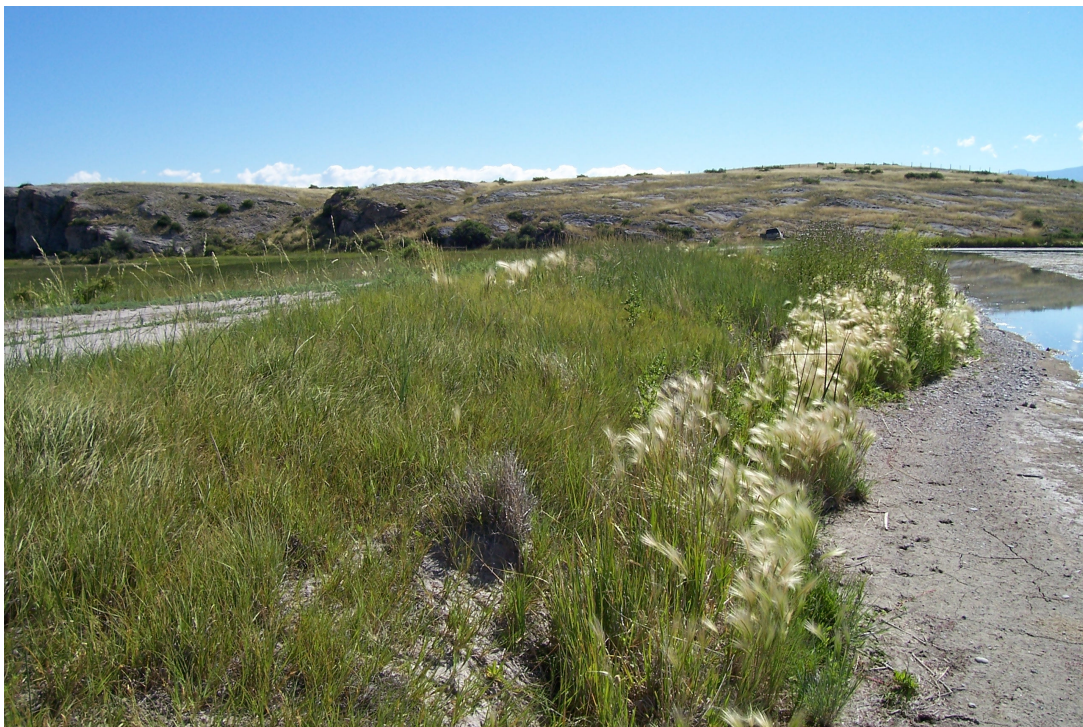
Figure 2. View of upstream face looking east. Note gentle slopes.

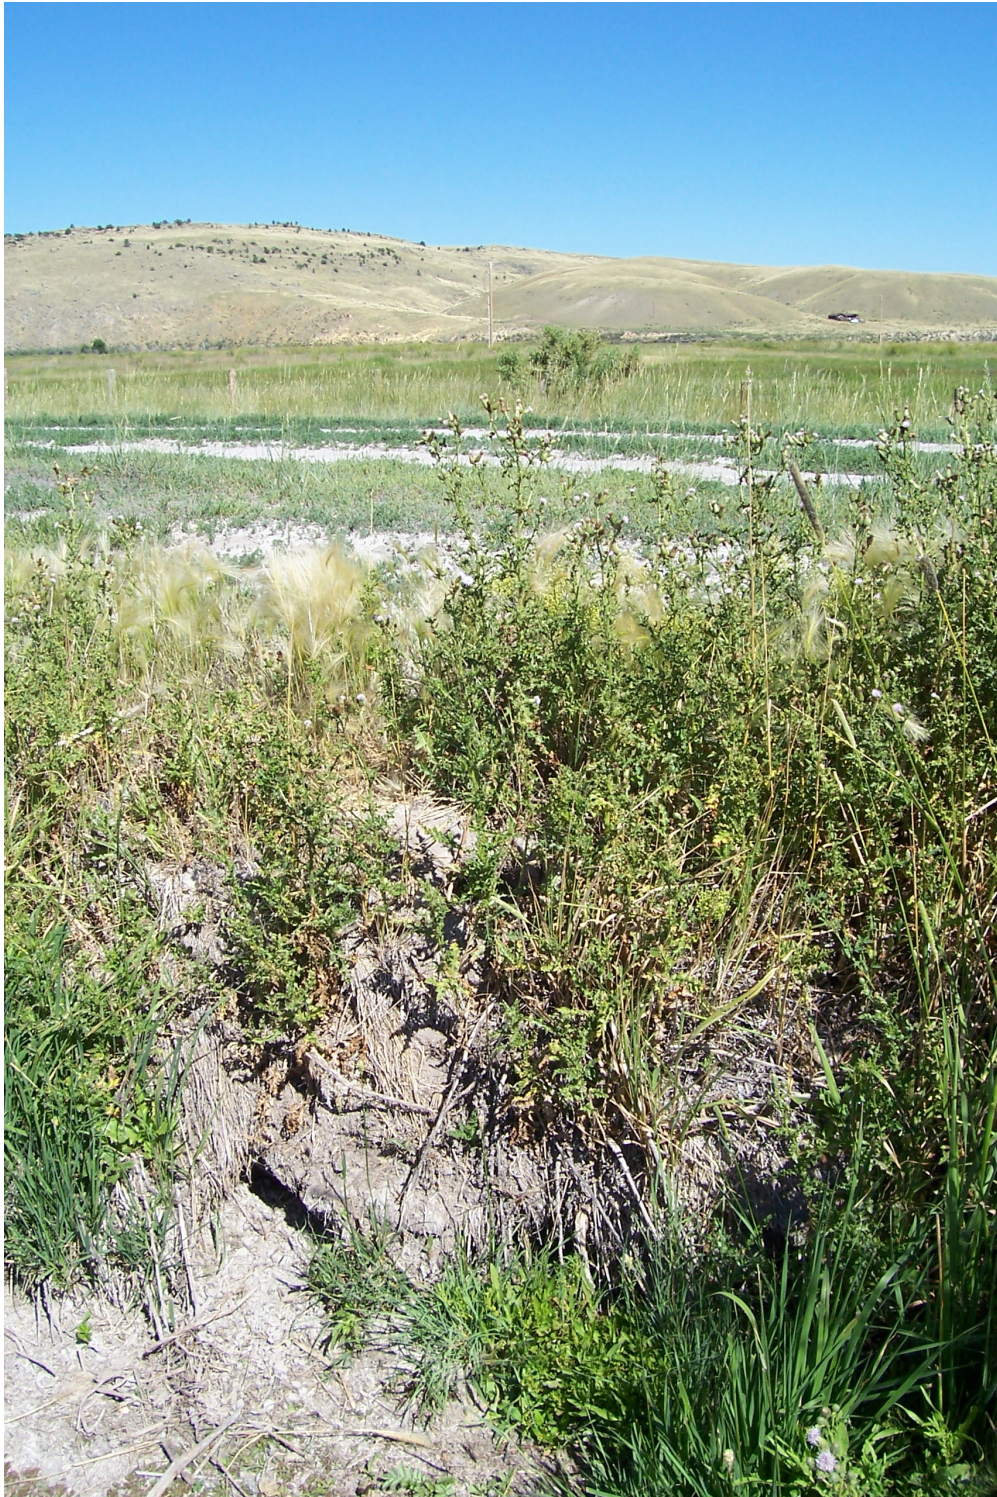
Figure 3. View of upstream face erosion approximately 870 feet west of overflow structure. Vegetation has a difficult time establishing on vertical slopes, so erosion will likely continue. Crest is still 3 feet away, and very wide in this location, so the erosion is not a threat to the safety and stability of the dam at this time.

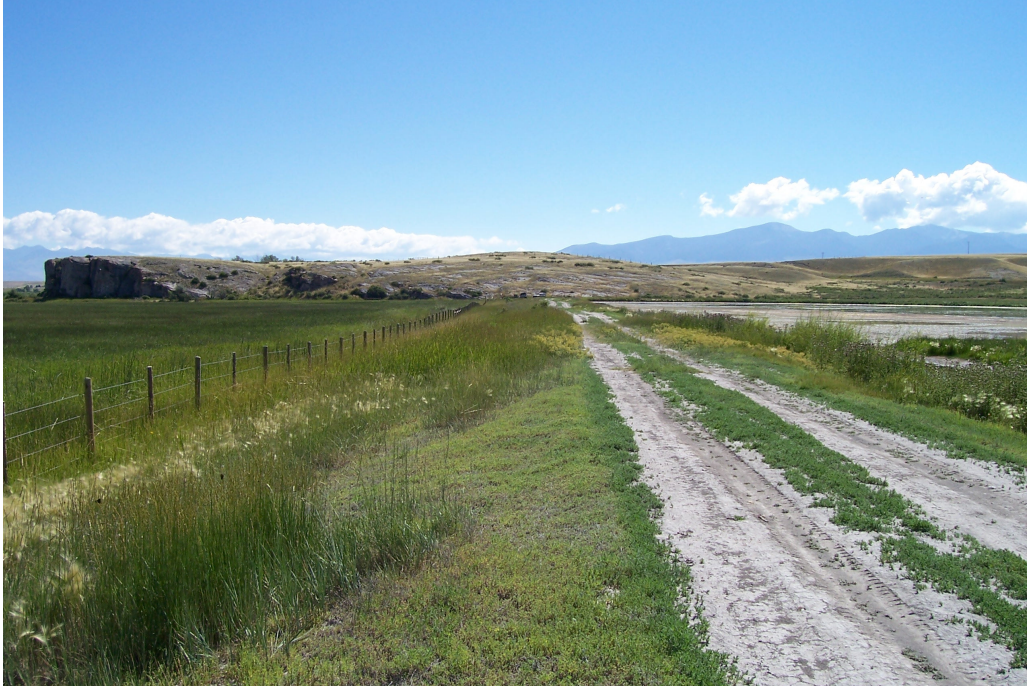
Figure 4. Gentle downstream slopes make for a failure resistant structure.
