## MONTANA DEPARTMENT OF TRANSPORTATION WETLAND MITIGATION MONITORING REPORT: YEAR 2015

*US Highway 93 Onsite:  
Peterson Property  
Lake County, Montana*

Constructed: 2007

NH 5-2 (122) 31 (Mission Creek, Peterson)

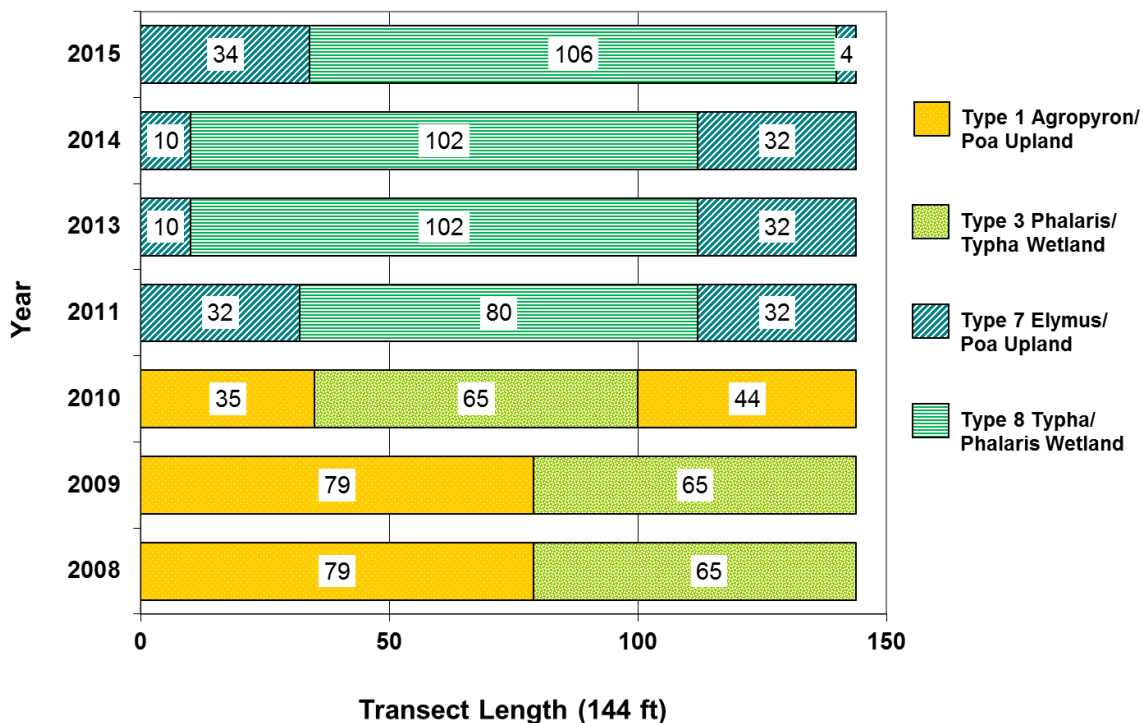
Chart 1. CSKT Peterson Transect 1 maps showing vegetation types from transect start (0 feet) to finish (144 feet) from 2008 to 2011 and 2013 to 2015.

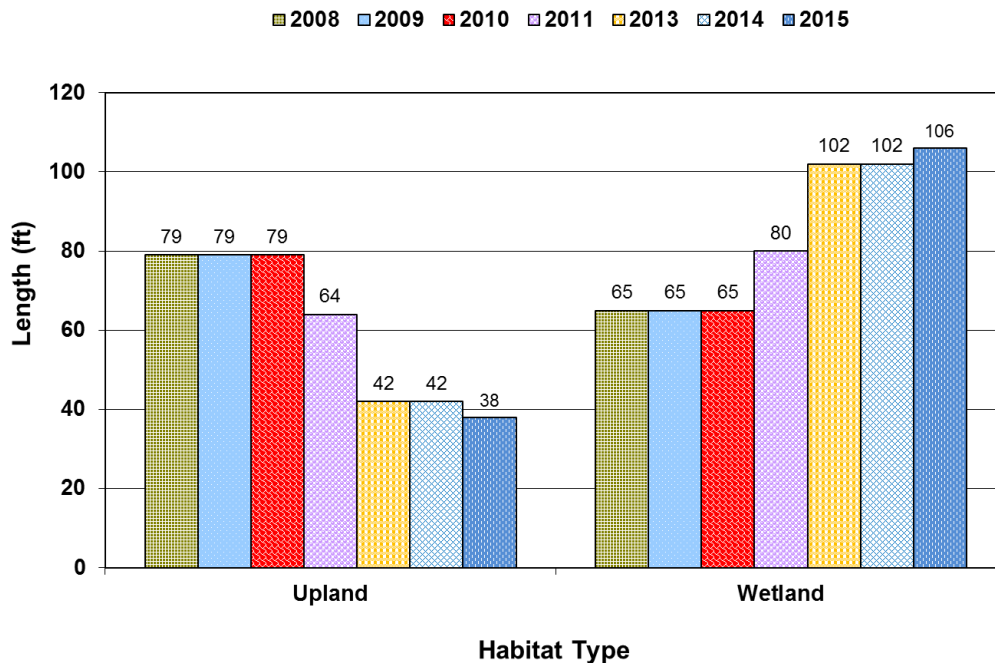
Chart 2. Length of vegetation habitats within CSKT Peterson Transect 1 from 2008 to 2011 and 2013 to 2015.

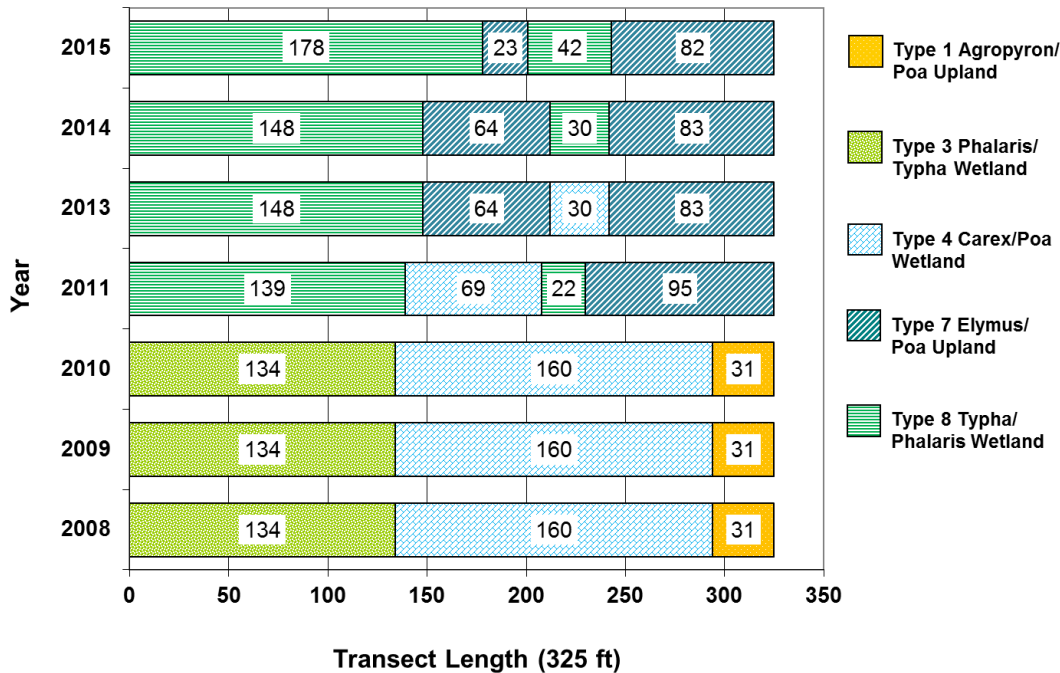
Two community types were present along Transect 2 in 2015 and included wetland community Type 8 and upland community Type 7 (Table 6, Charts 3 and 4). The transect contained 67.7% hydrophytic species in 2015, a 13 percent increase since 2014 and a 23 percent decrease since 2010 (Table 20, Chart 12). The decrease of wetland habitat within the belt transect since 2010 may be the result of the contraction of the wetland exacerbated by the location of the transect along the wetland/upland boundary. The previous failure of a crib dam to impound water at this location may have contributed to the decrease in the extent of wetland habitat.

**Chart 3. CSKT Peterson Transect 2 maps showing vegetation types from transect start (0 feet) to finish (325 feet) from 2008 to 2011 and 2013 to 2015.**

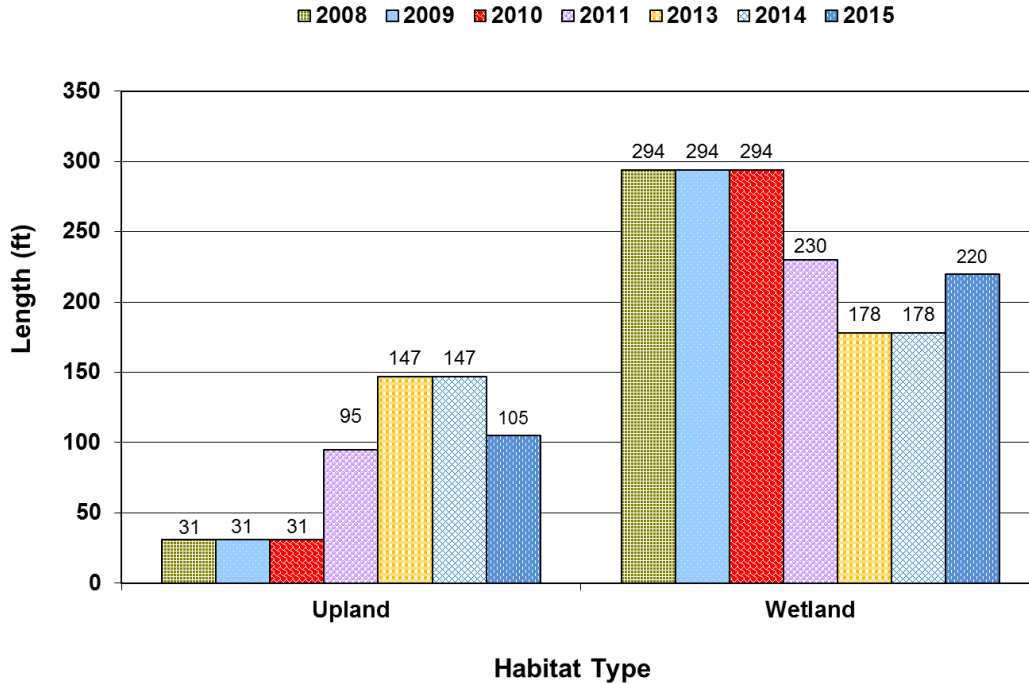
**Chart 4. Length of vegetation habitats within CSKT Peterson Transect 2 from 2008 to 2011 and 2013 to 2015.**

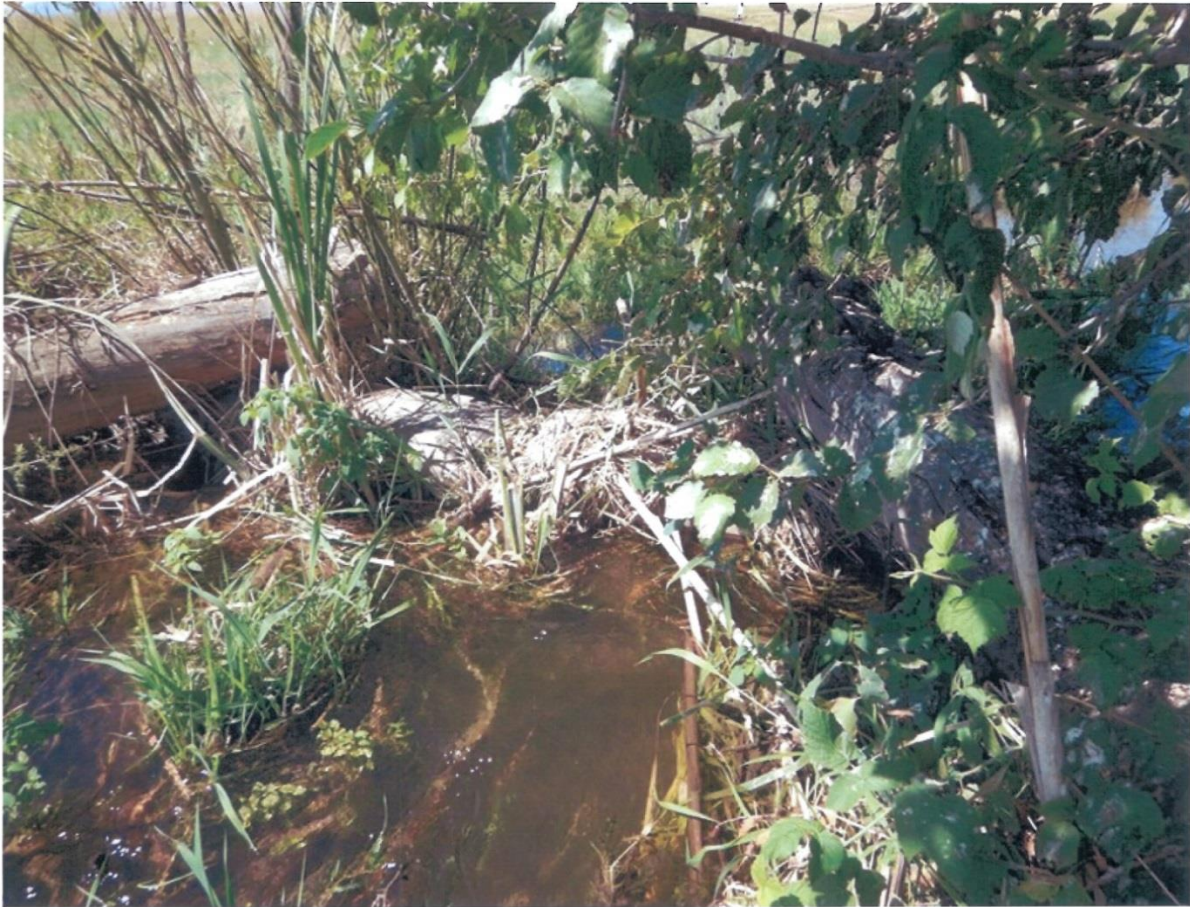
Downstream side of failed log crib structure showing water coming out under the logs at several locations.

prevent the failures using coir bio-logs have met with limited success as the identified failed structures indicate. MDT has proposed to the USACE to make permanent fixes in the spring of 2016 via the construction of woven willow beaver analog dam structures to repair the failing portions of the existing crib structures, to prevent future undermining by water flows (Appendix F).

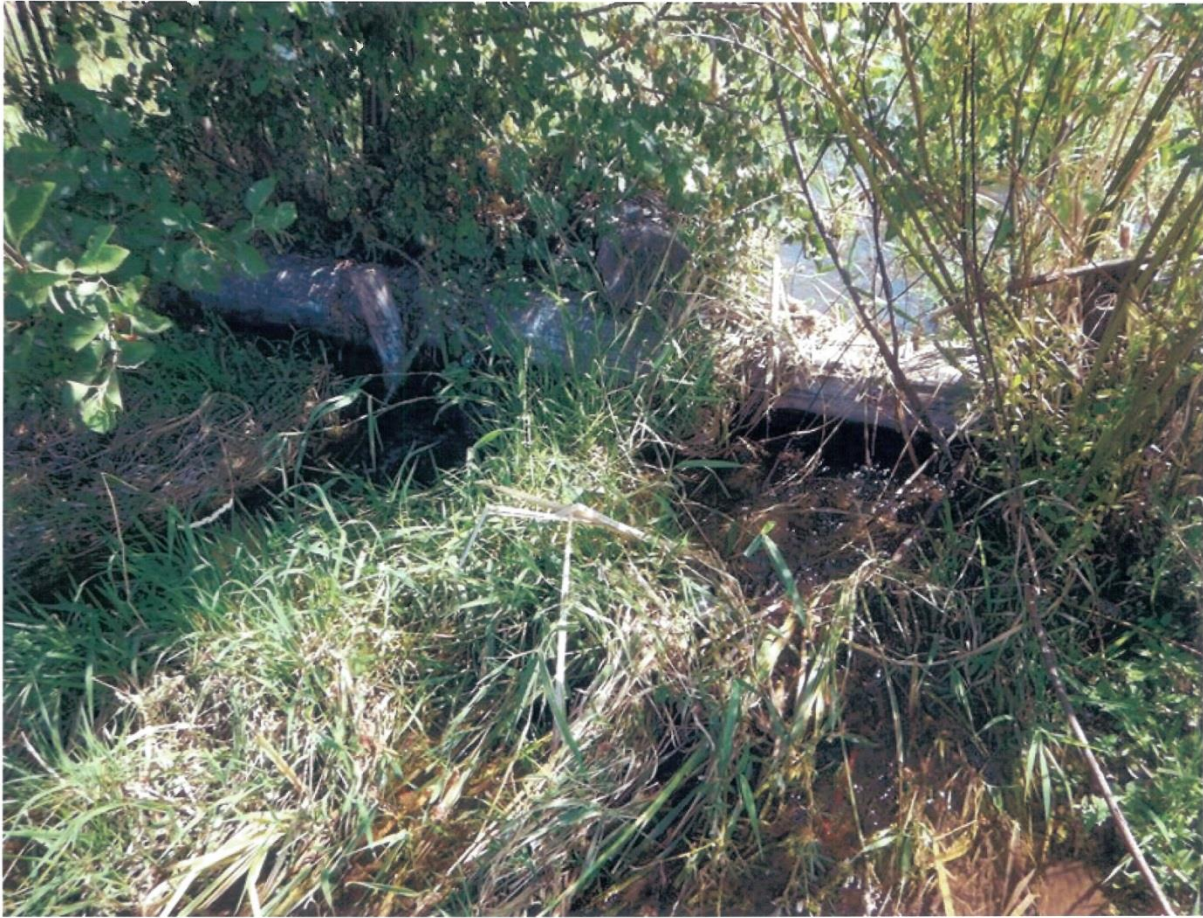
Proposed analog beaver design drawing showing the approximate fix in front of existing log crib structure.

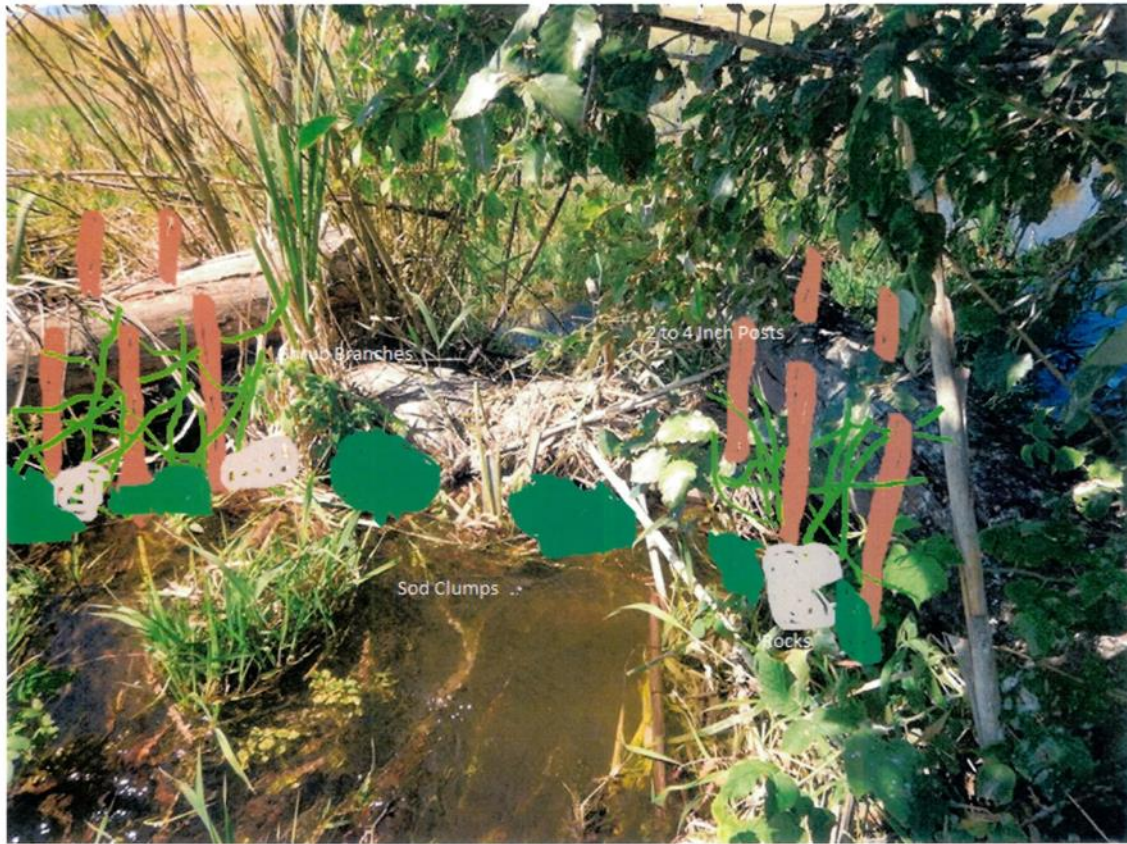
Plan View  
(Convex Primary Dam)

Diagram of proposed Beaver Analog design repair for the failed log crib structures at the US 93 CSKT Peterson mitigation site.
