Montana Department of Transportation

Concrete Sidewalk Warranty Administration Guide

This guide presents criteria for evaluating concrete sidewalk, curb, gutter, and median islands. Although concrete sidewalk, curb and gutter, and median islands may eventually show additional distresses, this guide seeks to identify and describe those most relevant to a yearlong warranty period post construction.

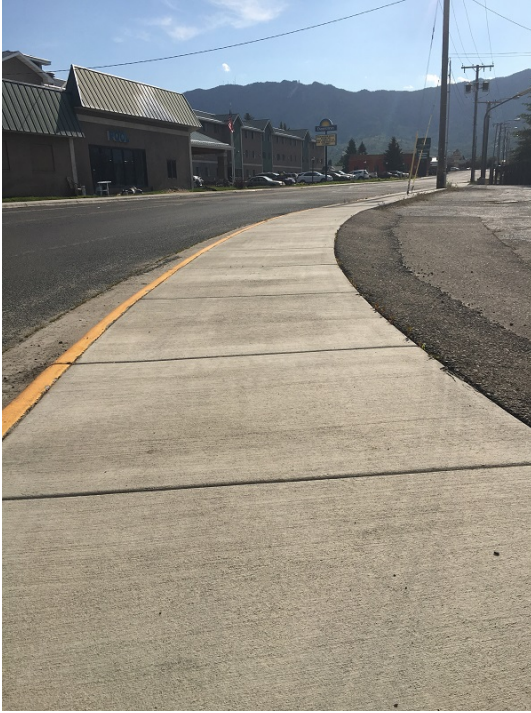
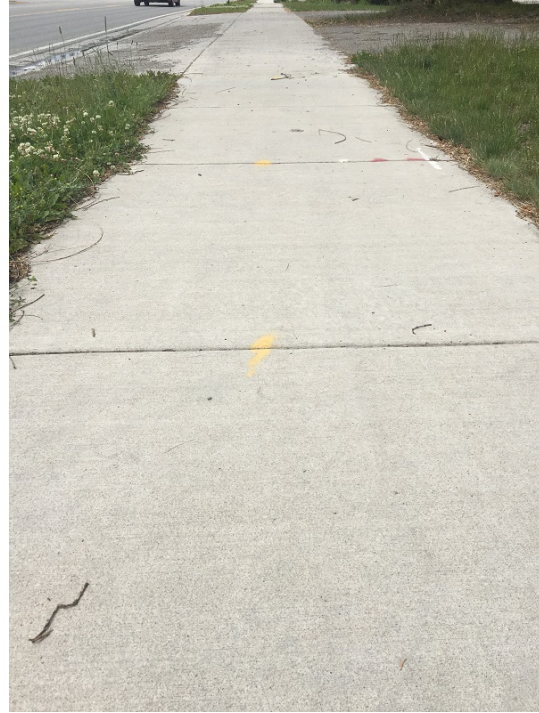
Panel Condition: Ideal

- Both pictures exhibit a smooth panel surface with no evidence of scaling, cracking, spalling, or unusual wear.

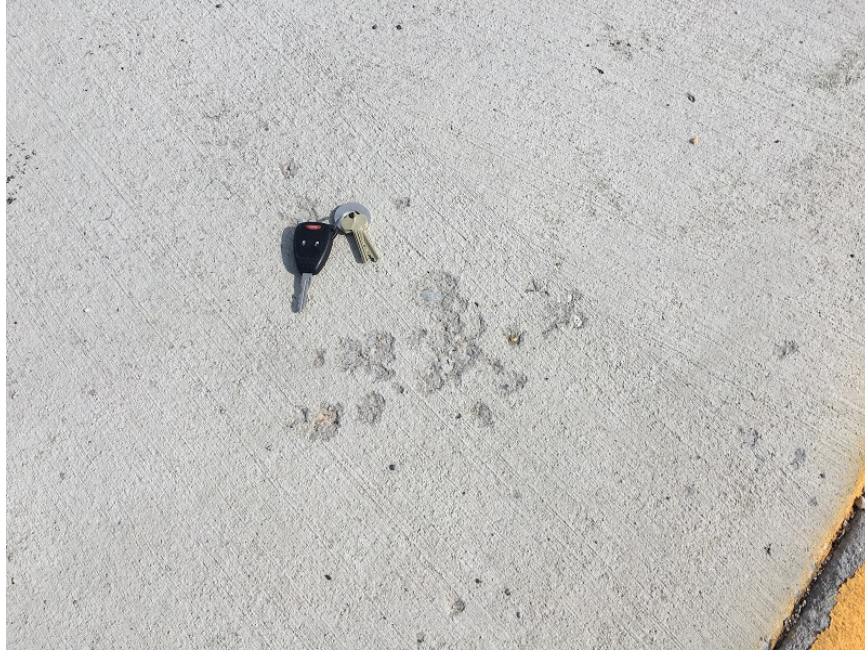
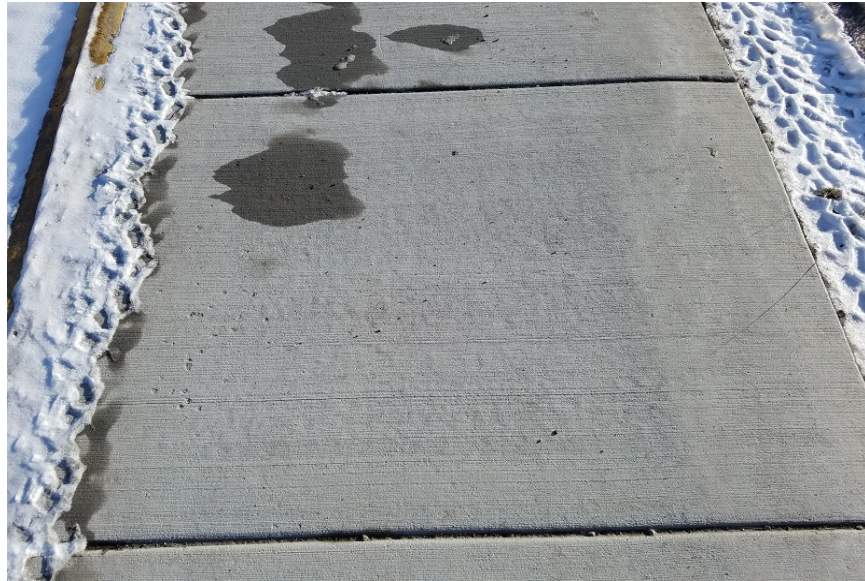
Panel Condition: Surface Scaling (mild)

- Surface paste formation causes concrete surface to flake off in “scales”.
- Exposed subsurface aggregate.
- <10% of panel affected.
- **Recommendation:** Accept work without deduction.

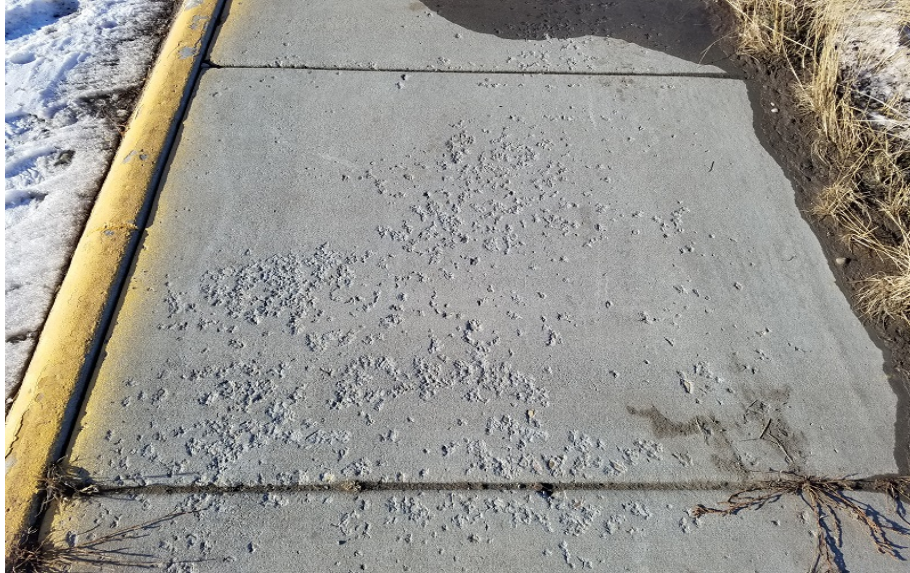
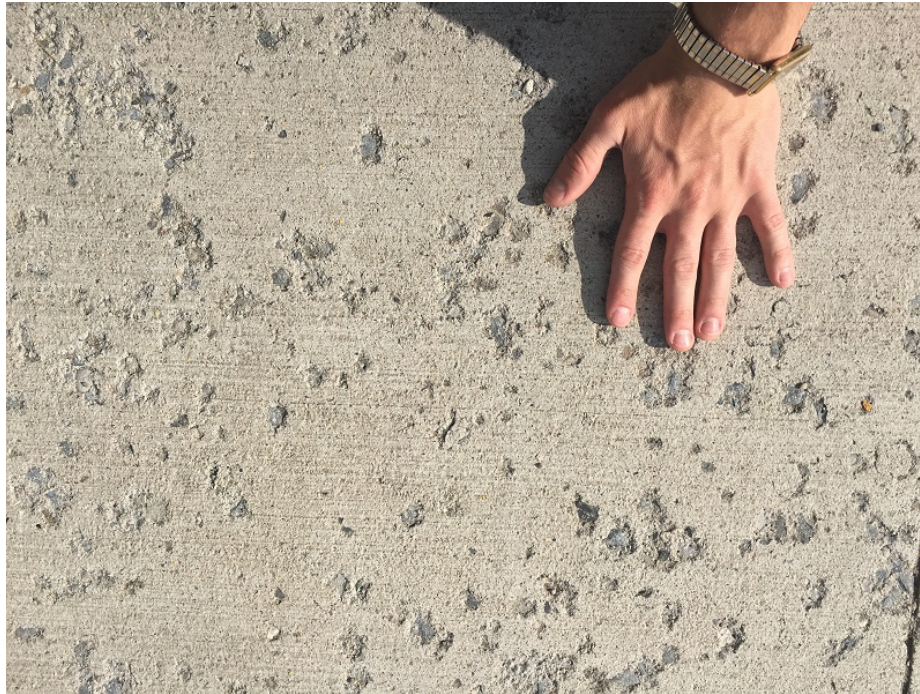
Panel Condition: Surface Scaling (Moderate)

- 10-50% of panel affected by scaling.
- **Recommendation:** 50% price deduction for panels with 10-50% scaling.

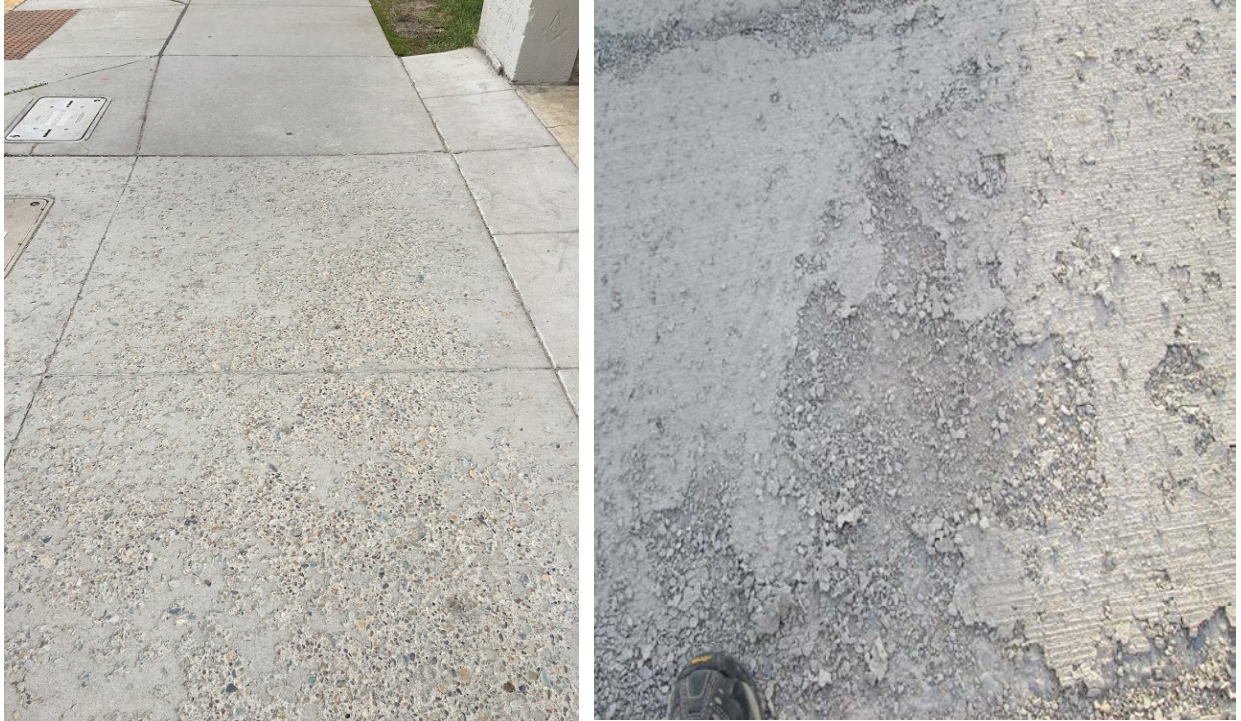
Panel Condition: Surface Scaling (Severe)

- Scaling covers > 50% of panel, and may penetrate deeper than ¼ inch.
- **Recommendation:** Remove and replace.

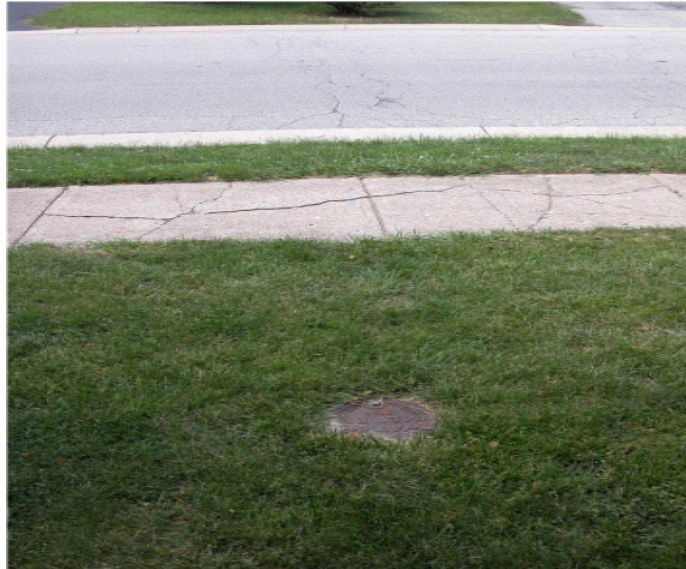
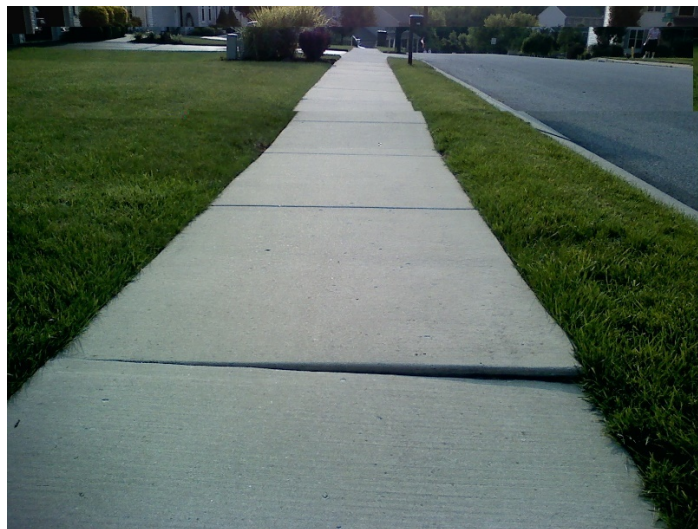
Panel Condition: Subsidence/Faulting

- Faulting panel due to improper base preparation and differential settlement in pour area. Panels may tilt in different directions due to inconsistent base support.
- **Recommendation:** If panel is faulted and cracked (top picture), remove and replace. For faulted panels without cracking (bottom picture), repair panel if faulting is greater than 1/8-inch.

Note: Frost Heaving also causes faulting, but is caused by improper drainage. Faulting resulting from conditions beyond contractor control may not be subject to warranty work.

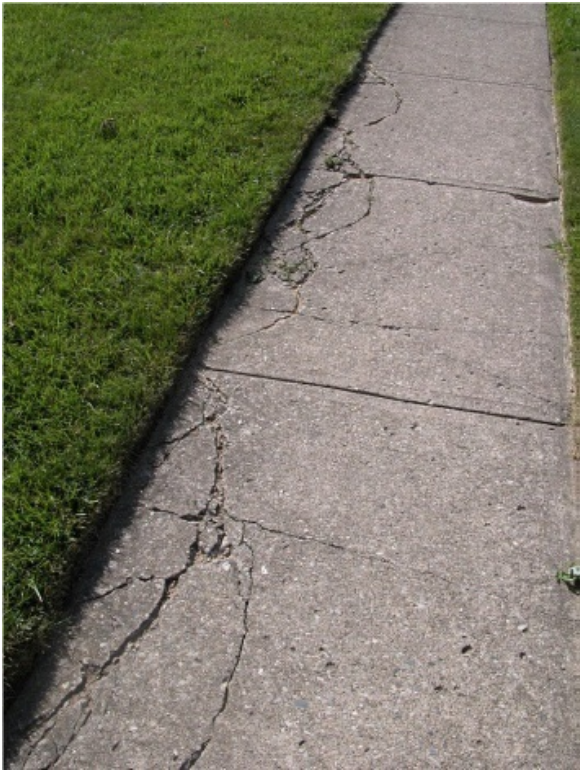
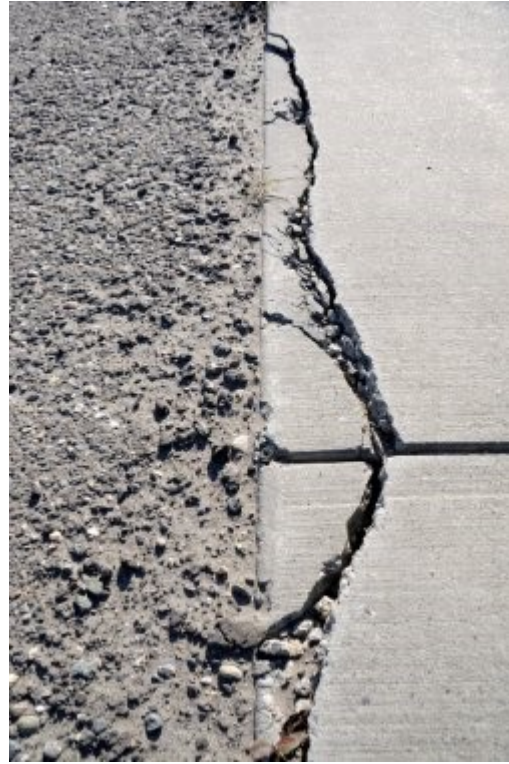
Panel Condition: Overloading

- Structural cracking caused by overloading often occurs diagonally across corners and along edges as curves or half-circles.
- **Recommendation:** Remove and replace.

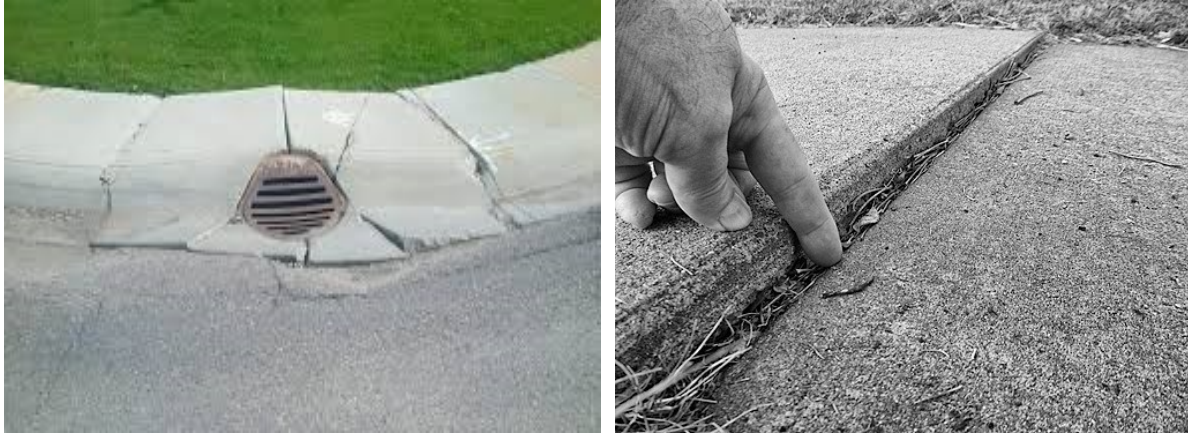
Panel Condition: Frost Heaving

- Frost heave occurs when moisture under the sidewalk freezes, and the panel is forced upward. Heaves often are alleviated with warmer weather. Frost heaving and subsidence may both cause faulting, but frost heaving is an upward movement caused by inadequately drained base materials, whereas subsidence is usually a downward movement caused by inadequate compaction. Frost heaving elevates affected areas, whereas subsidence lowers an affected area. Frost heaving may not be subject to warranty work in cases where drainage is beyond contractor control.

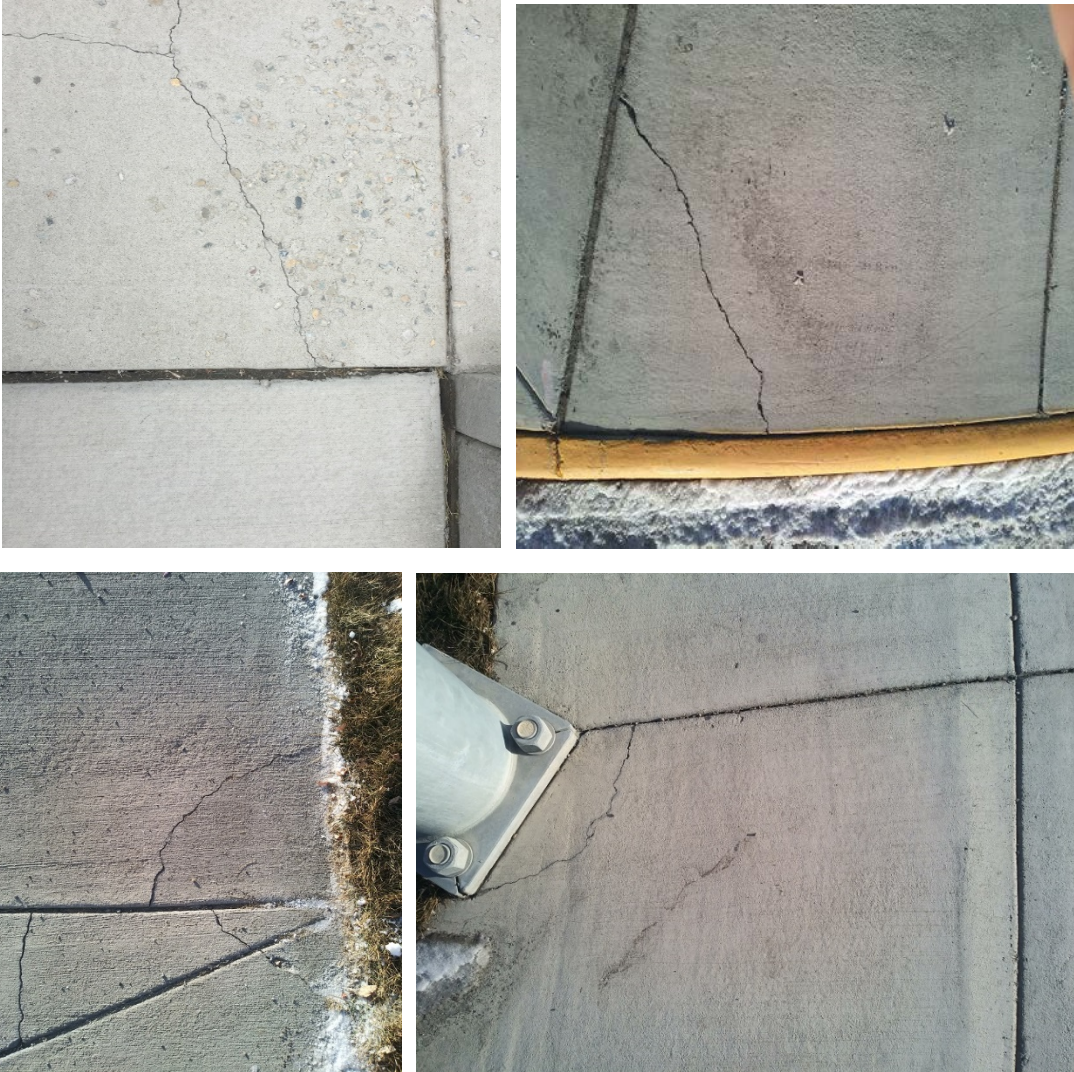
Panel Condition: Cracking

- **Recommendation:** If panel is cracked into three or more sections between control joints, remove and replace.

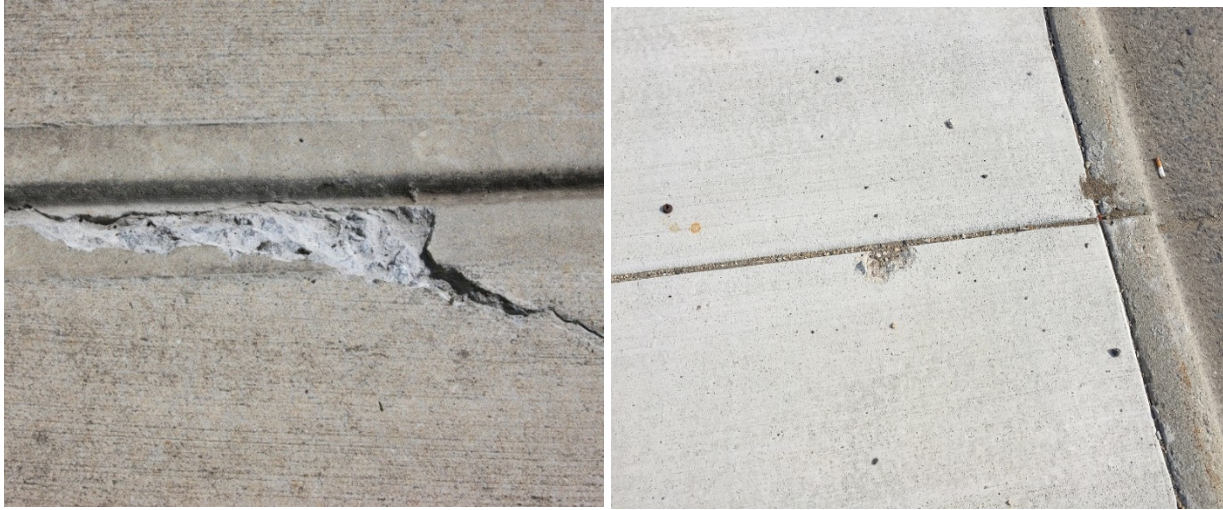
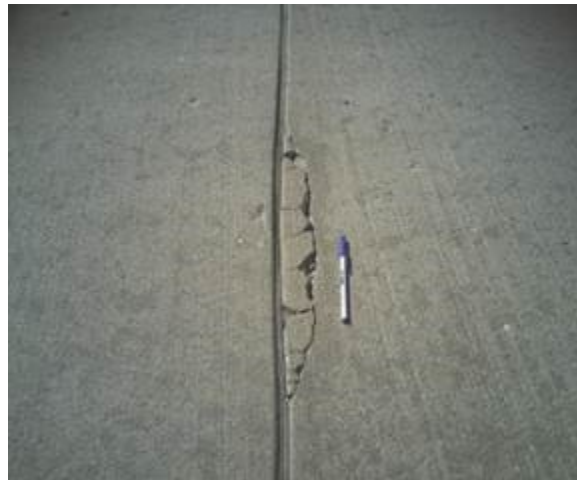
Panel Condition: Spalling (incidental)

- Damage usually occurs near edges and relief joints.
- **Recommendation:** Price reduction based on defect severity and frequency per panel. If > three spalls greater than 1" are present on a single panel, remove and replace. If >40% panels within the job are price reduced or assessed as remove and replace, replace all panels. If more than 40% of adjoining panels are identified by the Project Manager to be replaced, replace all panels in that span.

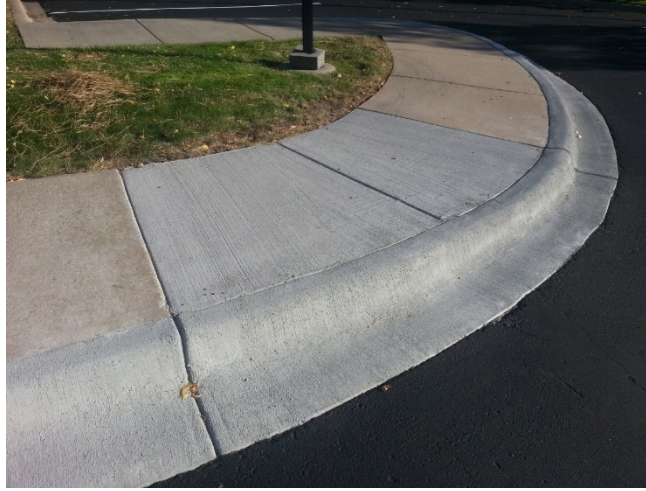
Curb Condition: Desired Final Appearance

- **Ideal Curb:** no evidence of scaling, cracking, spalling, or un-usual signs of wear on curb and gutter.

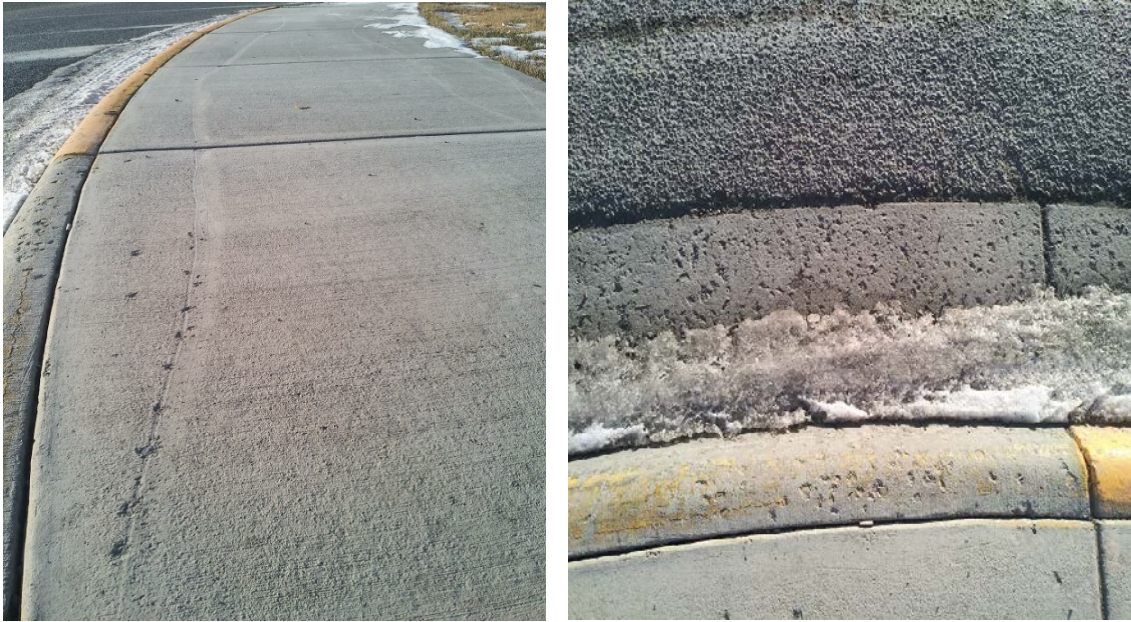
Curb Condition: Moderate Scaling

- Inadequate Curb: presence of scaling deterioration on curb and gutter.
- **Recommendation:** 10-50% affected area corresponds to a 50% reduction in contract bid price for square yard curb and gutter affected. Remove and replace curb with > 50% scaling between relief joints, or those identified by Project Manager.

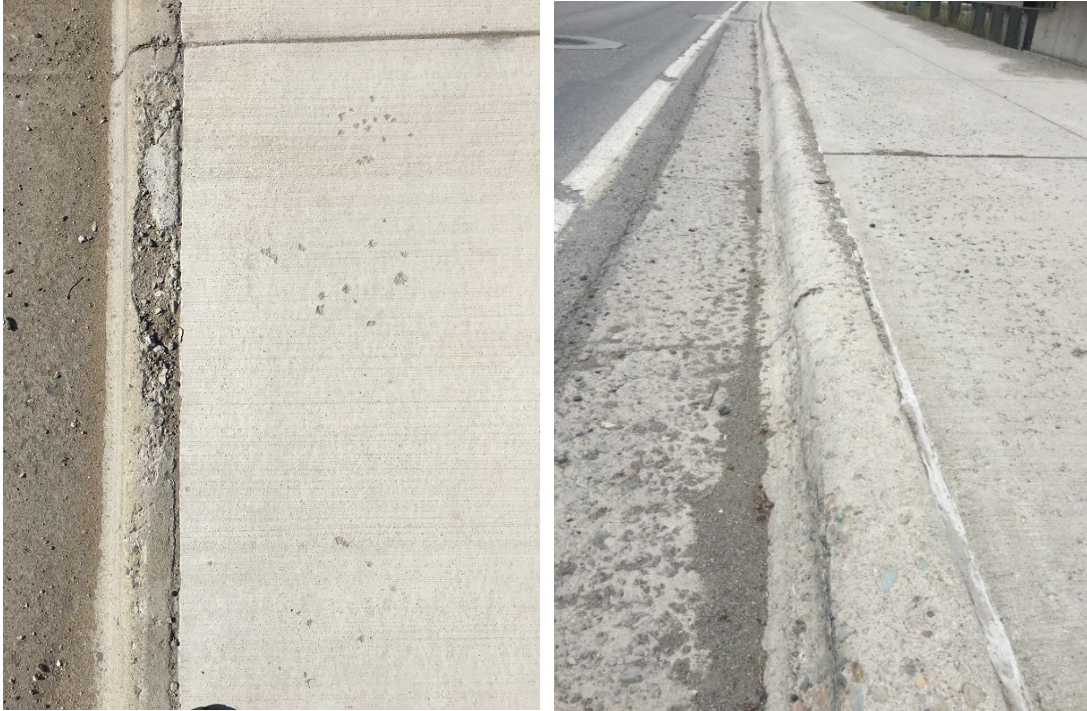
Curb Condition: Significant Spalling and Scaling

- Significant spalling (left) and significant scaling (right).
- **Recommendation:** Remove and replace if >10% of curb length between relief joints is affected, or prescribe warranty work as decided by Project Manager.

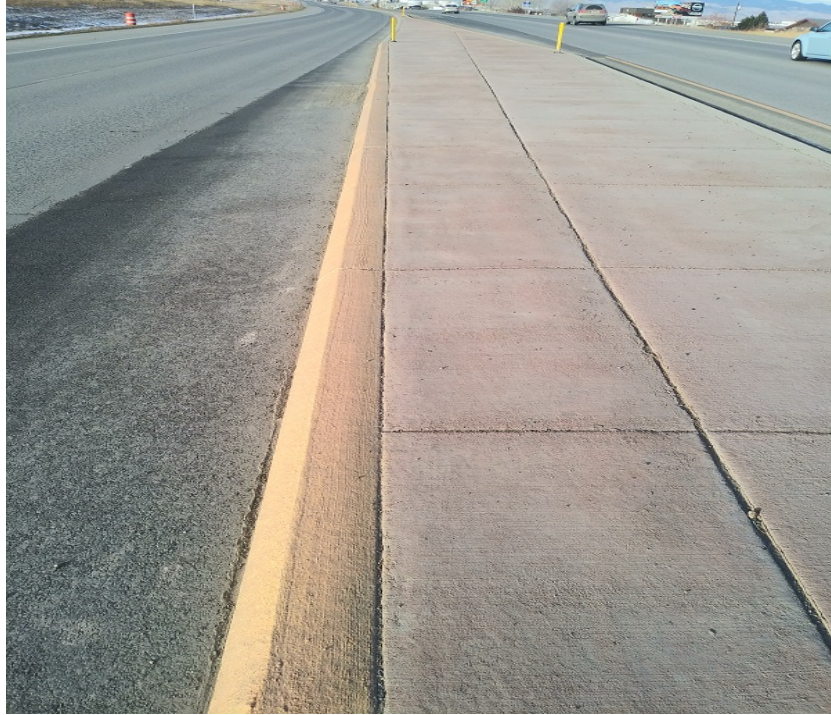
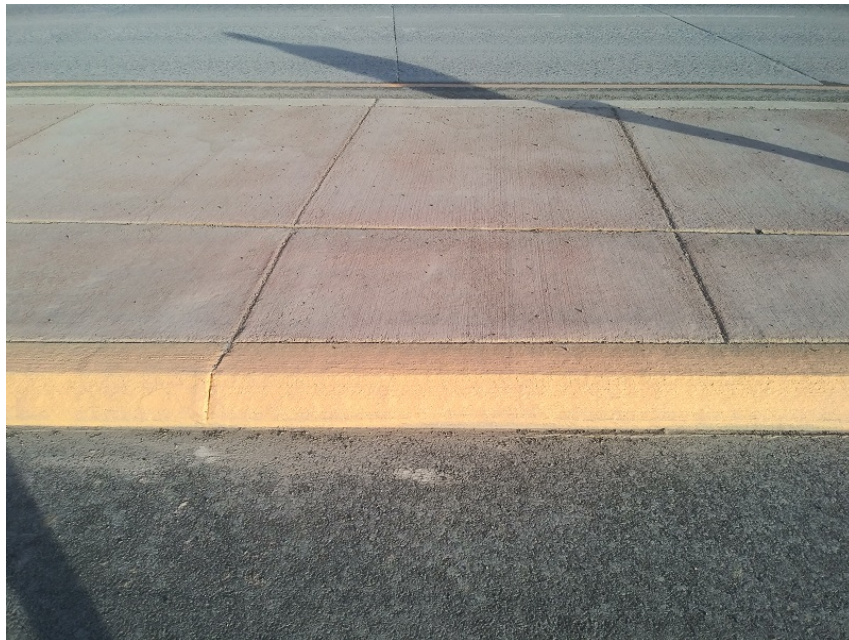
Median Cap and Curb: Ideal Condition

- Ideal Median Curb: No scaling, cracking, spalling, or unusual signs of wear.

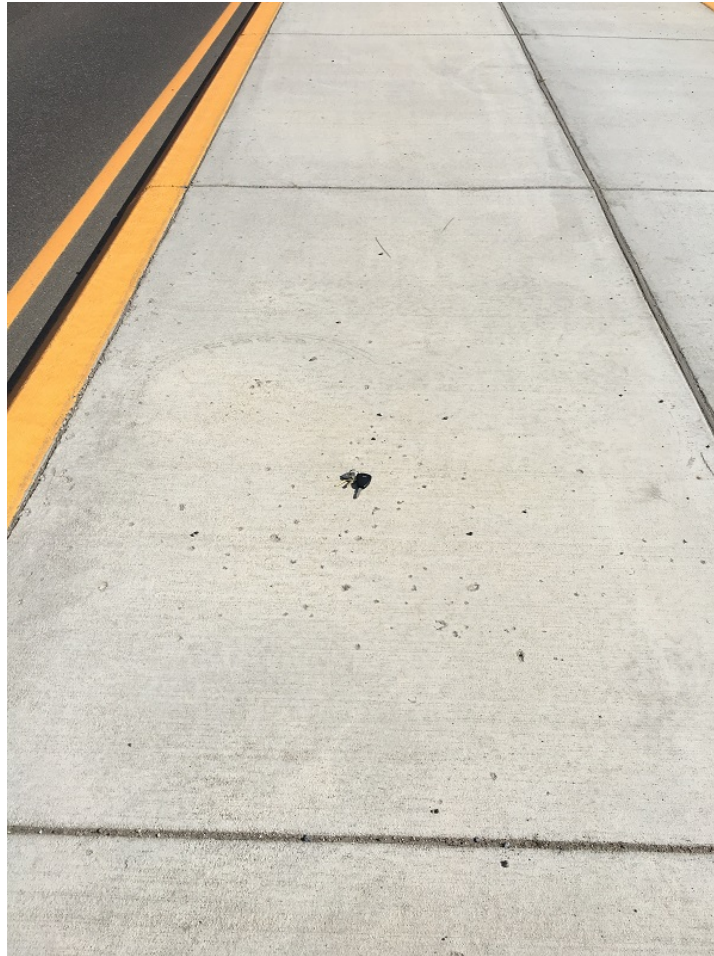
Median Cap Condition: Minor Deterioration

- Minor scaling on < 10% of panel surface.
Recommendation: Accept work.
- If median surface is scaled over 10-50%, impose 50% price reduction. Remove and replace panels with >50% scaling.

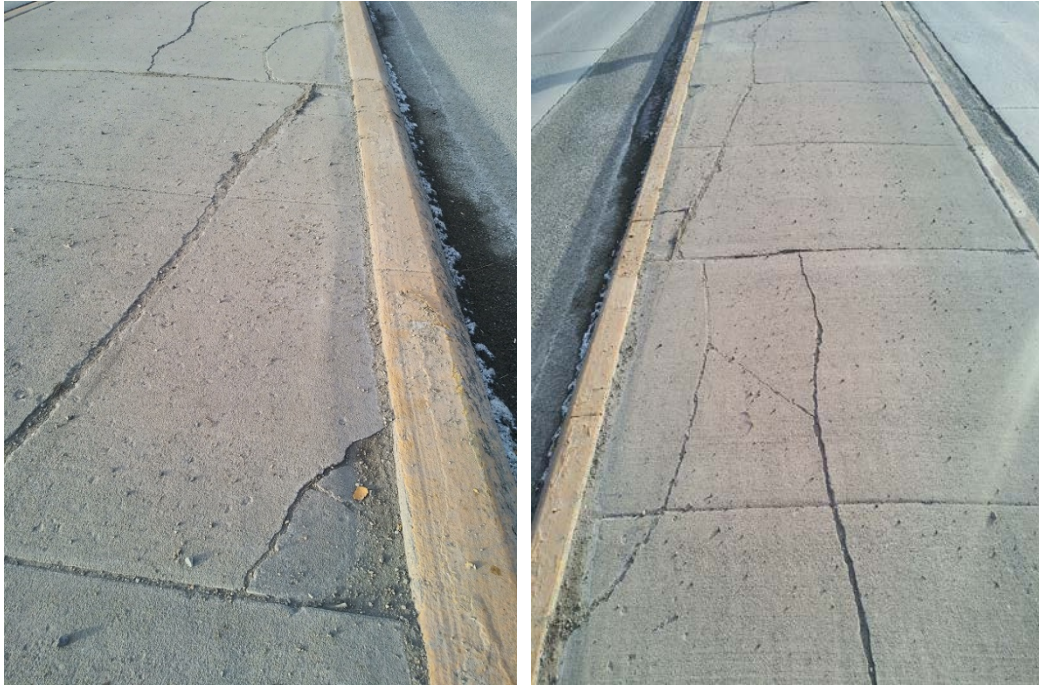
Median Cap Condition: Severe Deterioration

- Significant panel cracking with minor scaling
- **Recommendation:** Remove and replace.

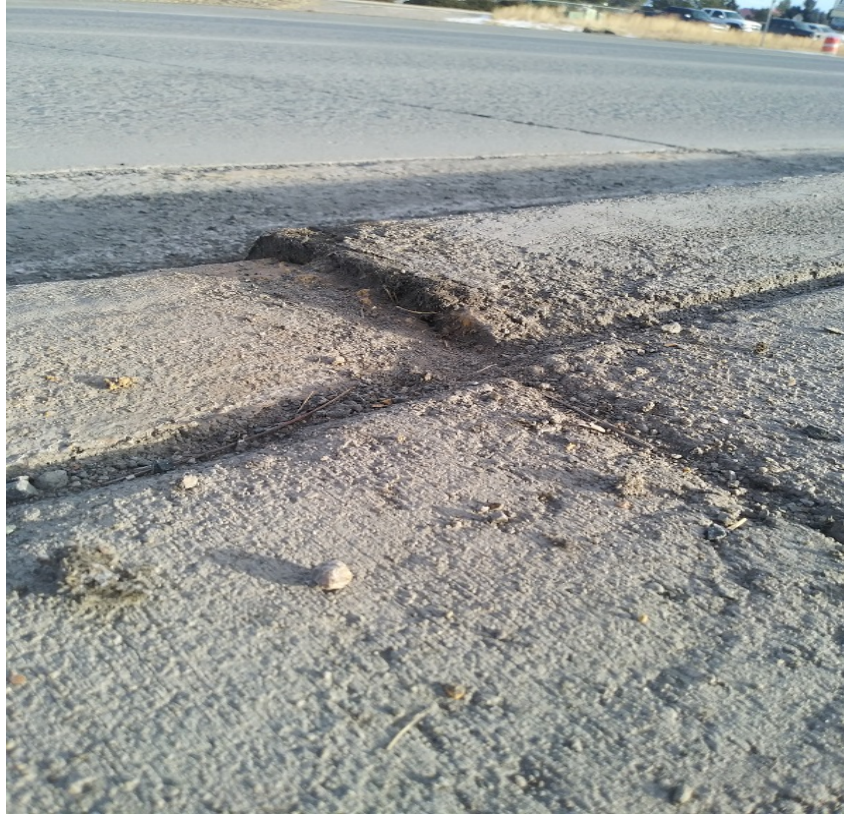
Median Curb Condition: Faulting

- Edge of curb faulted upwards at relief joint.
- Curb susceptible to snow plow damage.
- **Recommendation:** Accept work if acceptable to Project Manager.

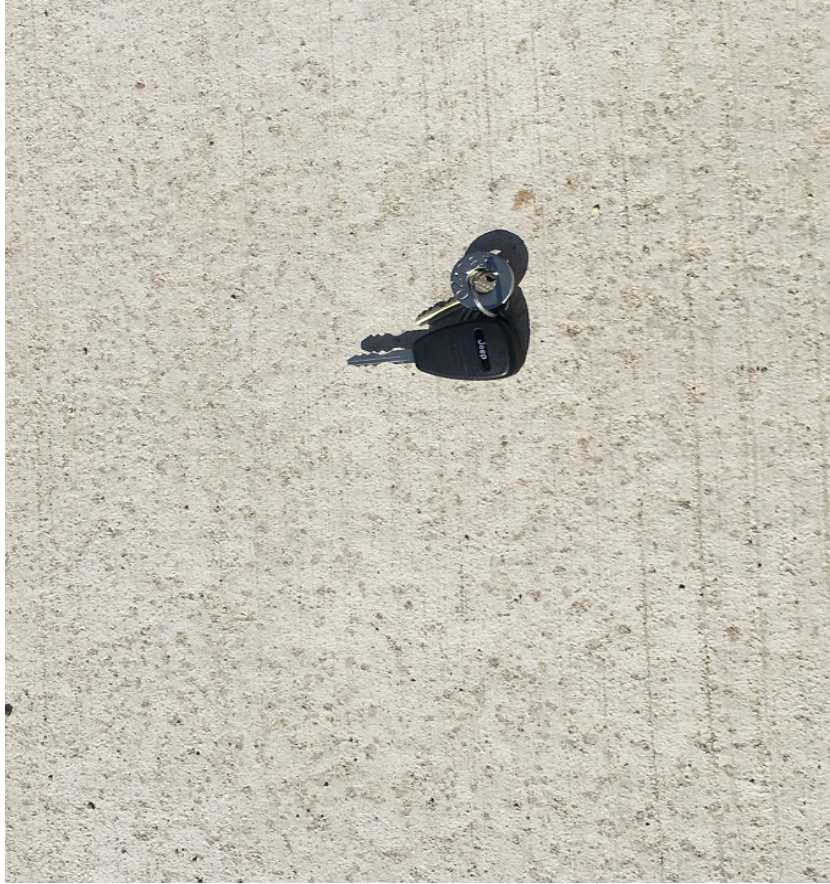
Panel Condition: Rain Damage

- Pock marks distributed over entire panel surface from rainfall not long after concrete finishing.
- **Recommendation:** Negotiate price reduction or remove and replace depending on pock mark severity.

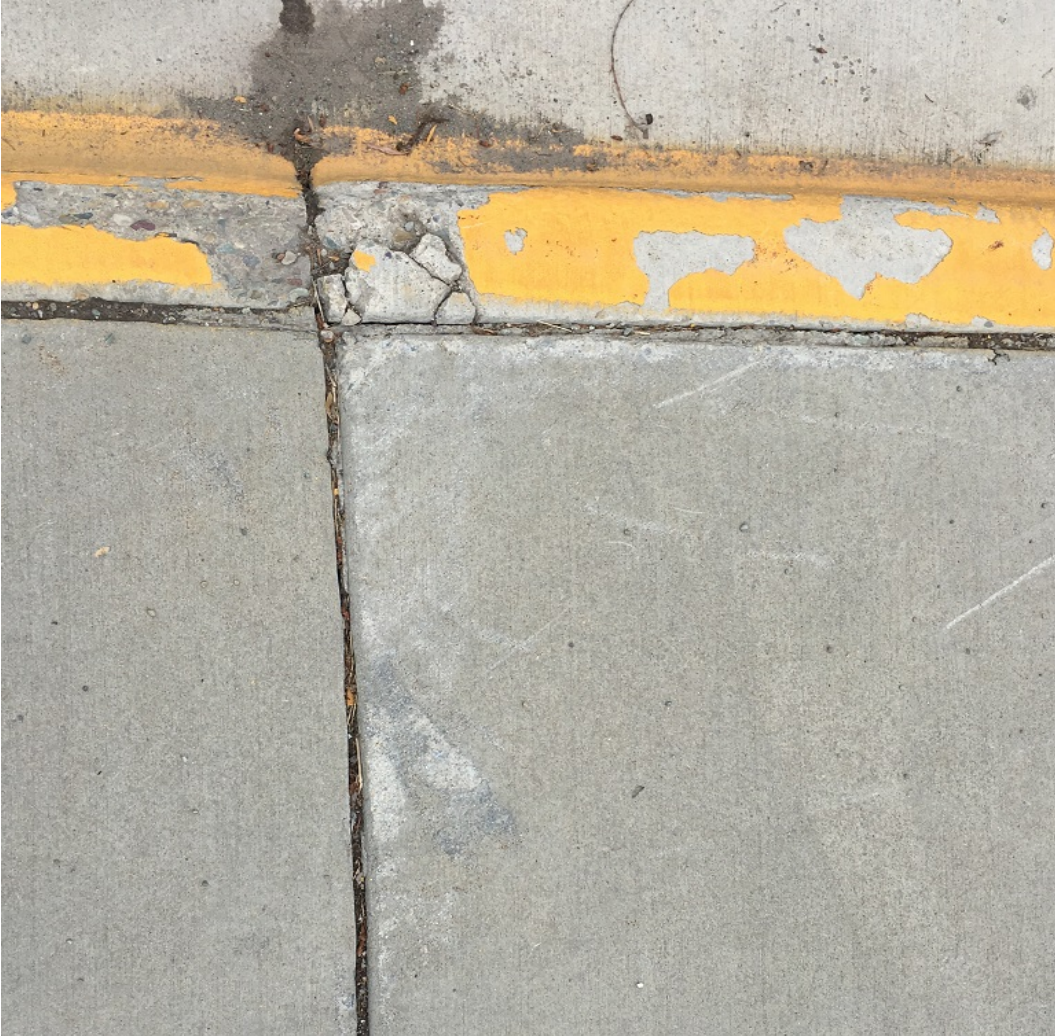
Condition: Snow Plow Damage

- Damage results from plow blade impacts to concrete edges and joints, typically near curbs or ramps.
- Ordinarily contractor is not responsible, unless defects such as construction related faulting or settlement may have significantly exposed edges to blade impact.

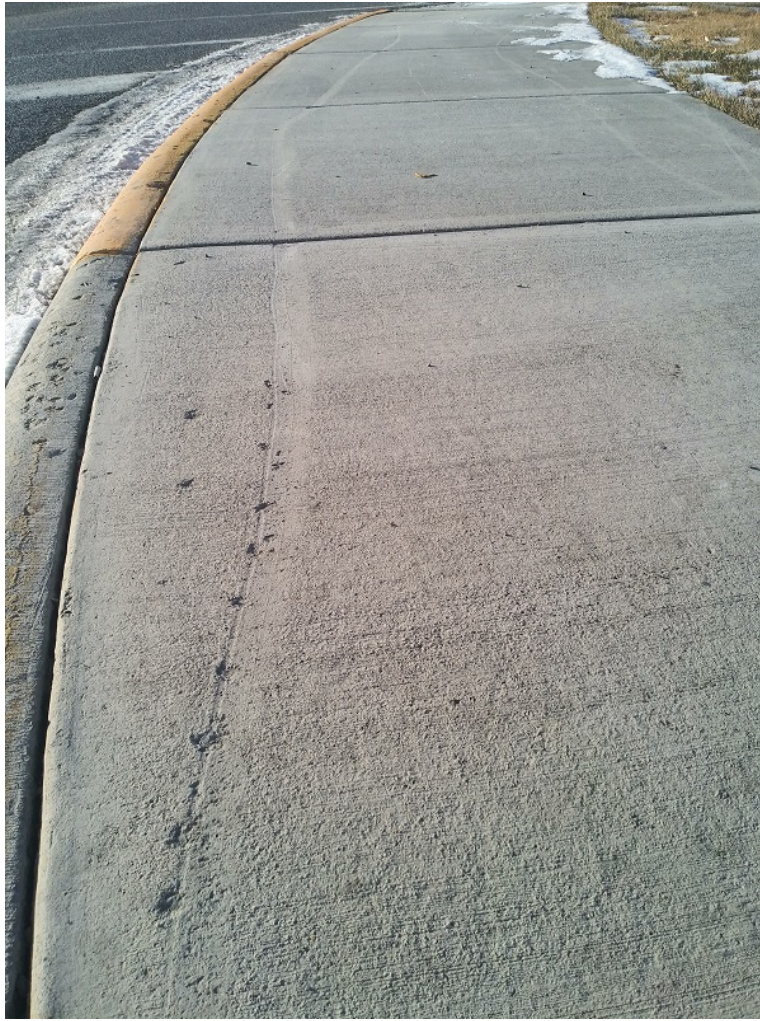
Condition: Contractor Equipment Damage

- Damage results from equipment dragging on freshly placed concrete.
- Contractor is responsible for defect.
- **Recommendation:** 50% price deduction or remove and replace based upon defect severity.

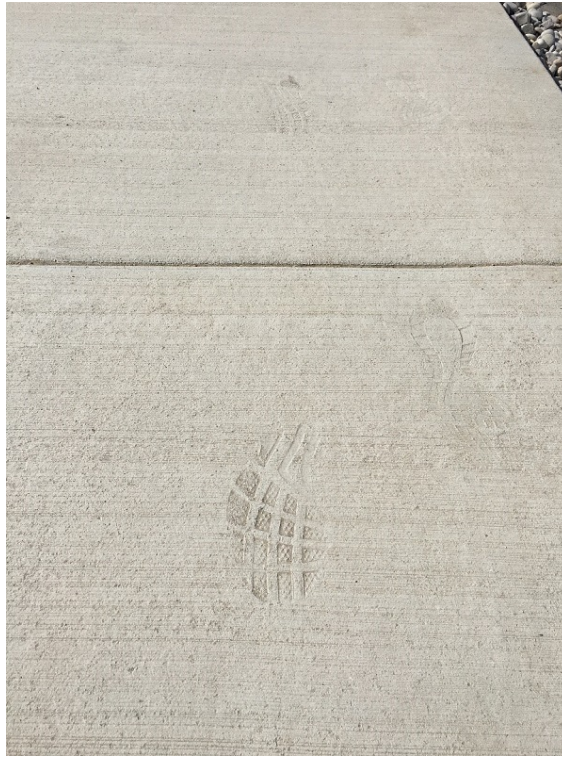
Panel Condition: Pedestrian Damage

- Imprints or vandalism.
- Imprints may be caused by placing cold weather concrete protection on green concrete. The contractor is at fault for this form of damage.
- If pedestrian traffic control meets specifications, contractor may not be at fault.
- Negotiate price reduction if damage is significant.

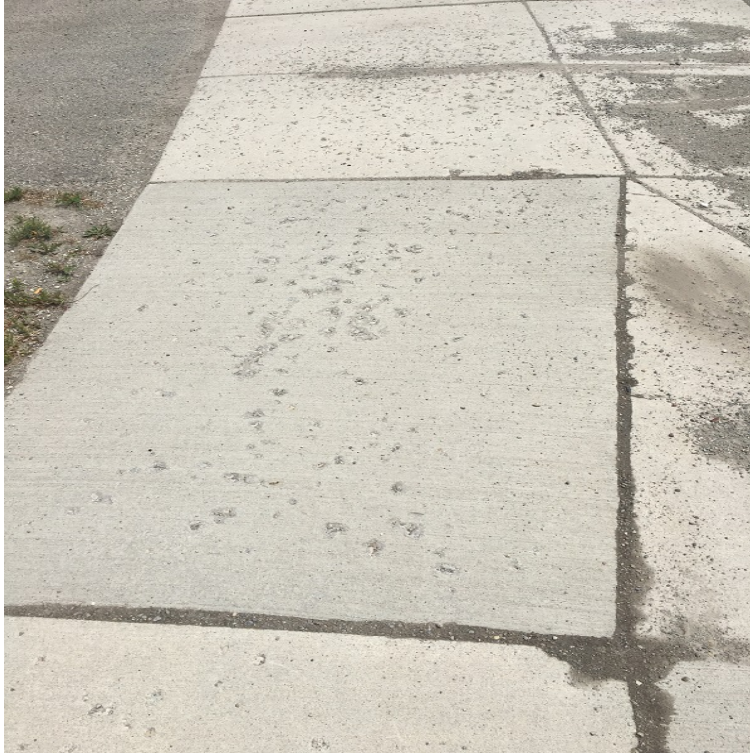
Example Price Reduction Calculation for Scaling

- panel is greater than 10% and less than 50% affected
- standard price reduction is 50%
- panel area 2.5 sq yd
- panel thickness 4 in
- concrete price \$90 sq yd

Price reduction: $R = \text{price per sq yd } (2.5 * 90) (.5) = \112.50 per panel
