Subject: Construction Review Report-Glendive District - STPS 254-1 (23) 0 JCT MT 16 - Northwest CN 6242

CONSTRUCTION ENGINEERING SERVICES PROJECT REVIEW REPORT	
Project Number: Project Description: STPS 254-1 (23) 0 JCT MT 16 - NW Control Number 6242	MDT District: Glendive EPM: Jim Slaska
Review Date: August 18, 2008	
Review Made By: Doug Martin	In Company With: N/A
Project Description: Cold in Place Recycle, plant mix surfacing, and seal & cover on 9.4 miles of Secondary 254 in Dawson County. The project begins at the JCT of MT 16 at mile post 0.0 and extends northwest.	
Review Type: (See attached sheet on review report types)	
<input checked="" type="checkbox"/> Oversight <input type="checkbox"/> Subject Specific- <input type="checkbox"/> Constructibility <input type="checkbox"/> Post Construction <input type="checkbox"/> Training <input type="checkbox"/> Investigatory

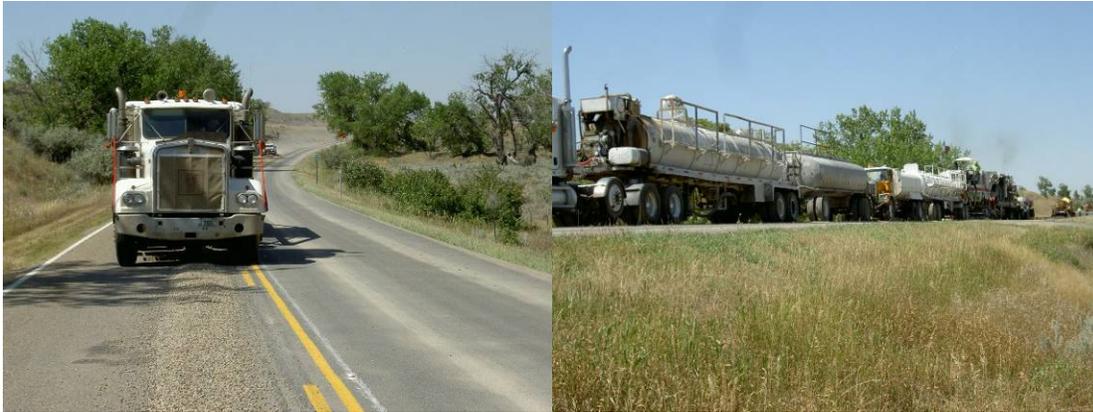
Add-rock placed ahead of CIR train. A CIR train that has a paver following.

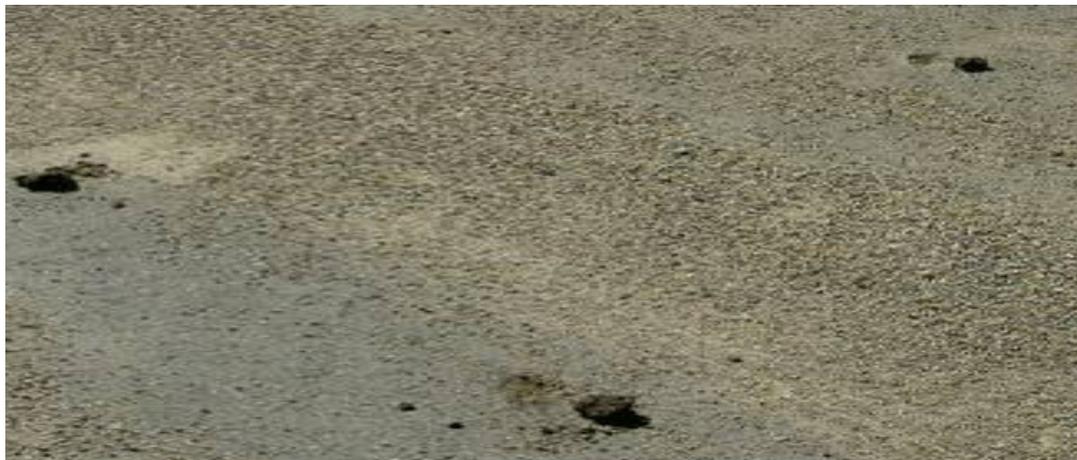
- 1) Crack sealant used on the existing pavement was milled up and over a scalping screen. However, pieces about the size of a golf ball were sent through the paver. When these chunks were on the surface, the possibility of the chunks loosening and creating a surface void existed. After discussions, the project personnel decided to leave these pieces in place, rather than extract and try to patch with the cold mix. These pieces were too numerous to find them all, and with seal/cover operations within a week, the thought was those operations would help hold the majority of these chunks of sealant in place.

- When nominating projects for this type of CIR construction, preliminary data from samples taken, should be scrutinized closely for any and all properties for the end results of the pavement when finished with construction.
- The amount of crack sealant on the existing roadway may be cause for concern when analyzing whether a project is a good candidate for a CIR project. Time will tell if the small concentrated chunks of sealant just below the seal/cover will become a maintenance problem in the future.

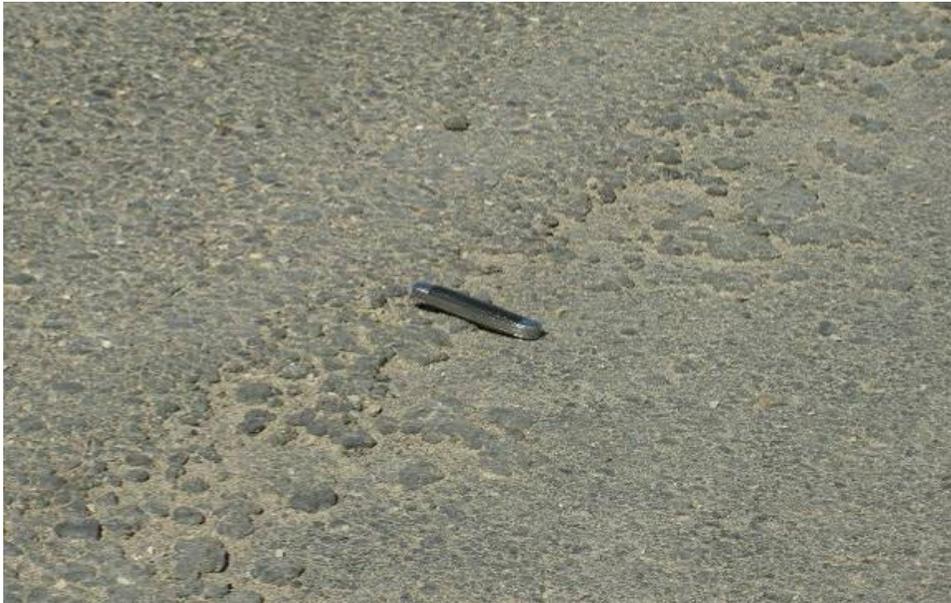
- 2) The approaches and mailbox turnouts were previously placed with PMS Gr. D Commercial mix. This created a challenge to match the elevations at the horizontal joints evenly outside the shoulder line. This was especially difficult within horizontal curve sections of the alignment. There will probably be some surface raveling at these joints, but it should be contained to a minimum upon a timely seal and cover.

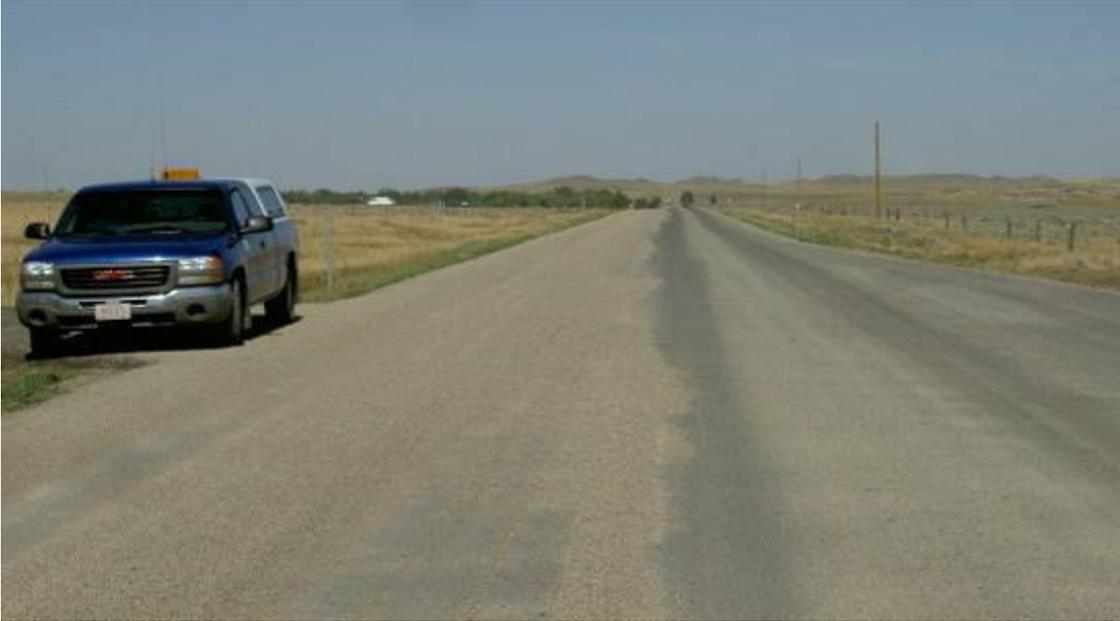
Fog Seal & Blotter: Fog and seal operations were performed for the day from station 397+98 to 358+20 on the left (eastbound). This operation was generally done on the previous days CIR work. However, due to a breakdown with the spreader for the blotter material, the contractor was contemplating using other means (cracked tailgate on an end dump truck) to complete the operation after this reviewer left the project. The blotter material was initially left in place, without brooming to allow the surface to cure. After a few days, the blotter material was basically gone due to traffic and weather conditions. The lane on the left was fogged the day before, while the other lane was fogged 3 days earlier.

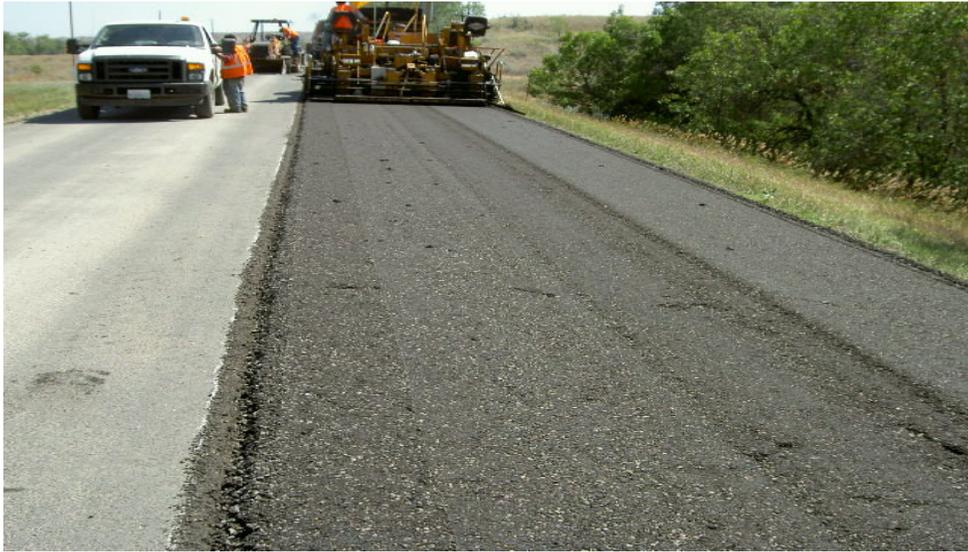
This picture is CIR pavement after going through the paver.

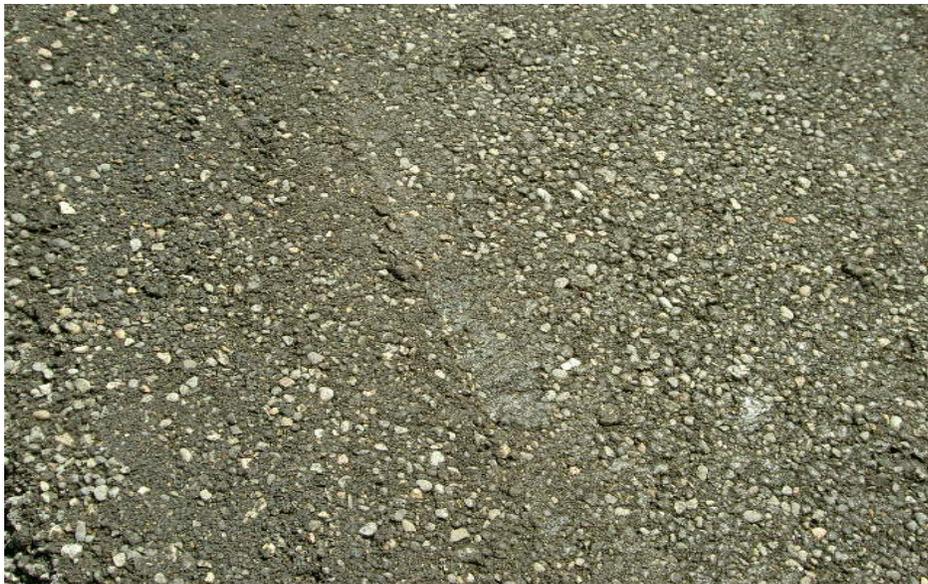
This close up shows the pavement after rolling and prior to fog seal.

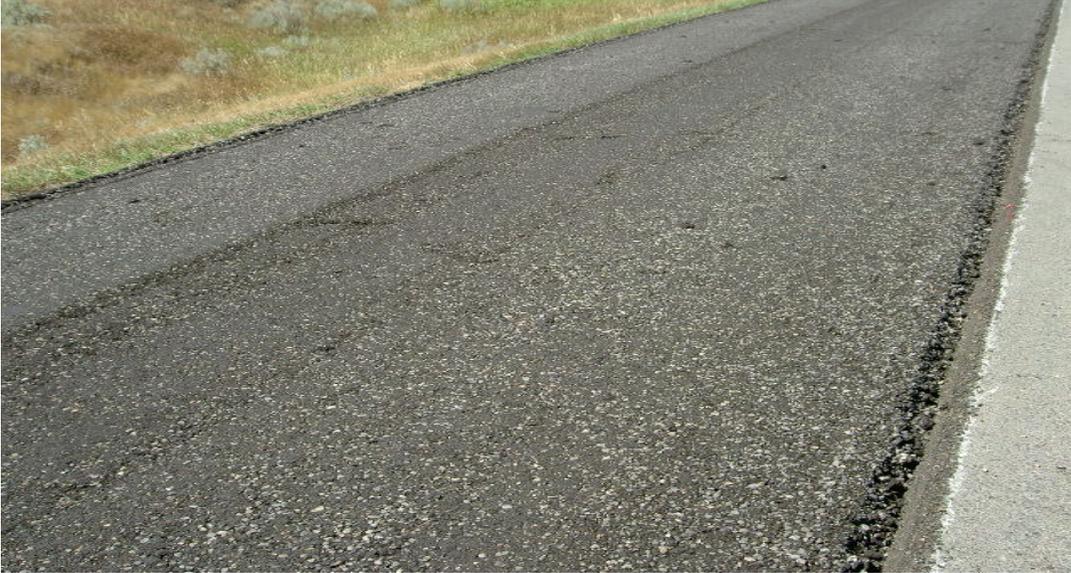
After going through the paving machine, but prior to rolling, care must be taken to match the previously constructed lane at the horizontal line (centerline).
