MONTANA DEPARTMENT OF TRANSPORTATION WETLAND MITIGATION MONITORING REPORT: YEAR 2002

*Camp Creek
Sula, Montana*

February 2003

Project No: 130091.039

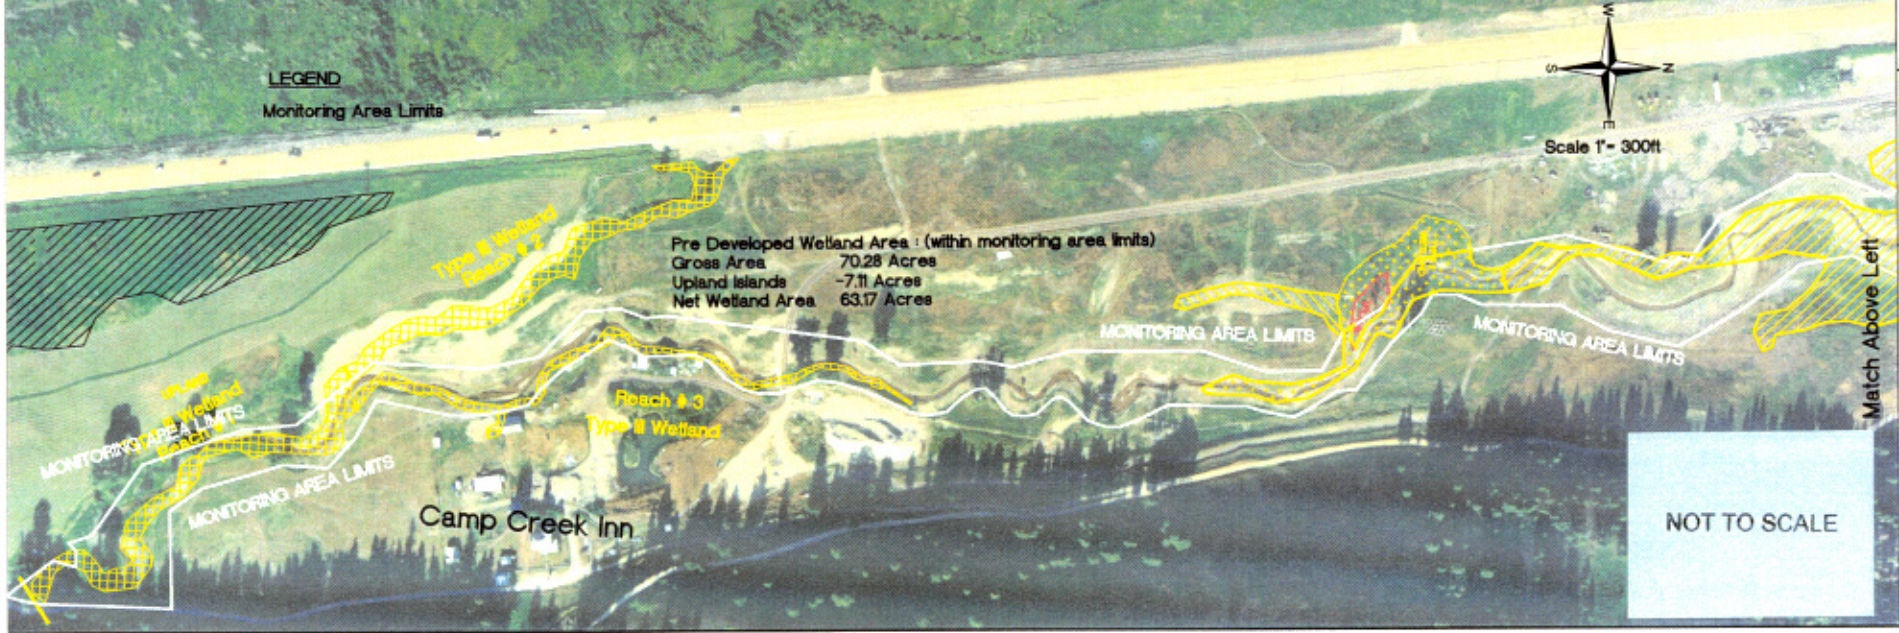
Figure 4 - Pre-Developed Wetland

Pre Developed Wetland Area : (within monitoring area limits)
 Gross Area 70.28 Acres
 Upland Islands -7.11 Acres
 Net Wetland Area 63.17 Acres

Delineated wetland boundaries are illustrated on **Figure 3**. Completed wetland delineation forms are included in **Appendix B**. Soils, vegetation, and hydrology are discussed in preceding sections. Pre-construction wetland delineation documented 63 acres of wetlands throughout the current mitigation site (Turnstone Biological, 2001), see **Figure 4** in **Appendix A**. Monitoring in 2002 identified the following conditions:

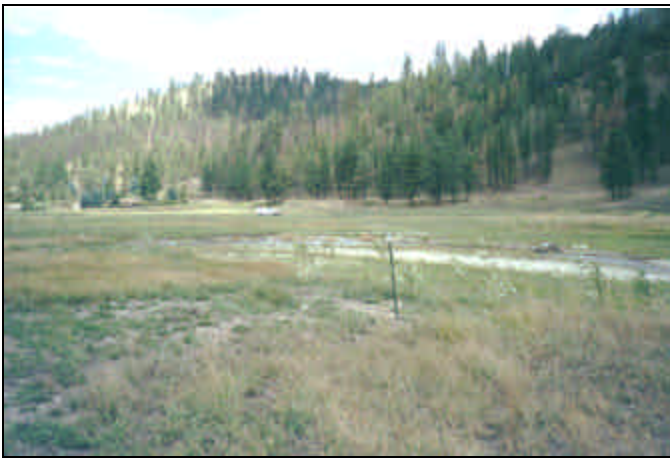
Photo Point No. 1: View looking northeast along vegetation transect, end point in foreground.

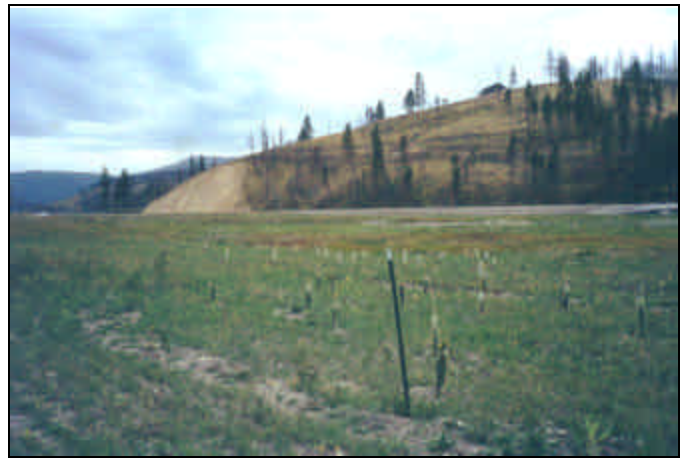
Photo Point No. 2: View looking southwest along vegetation transect, starting point in foreground, located in upland community type.

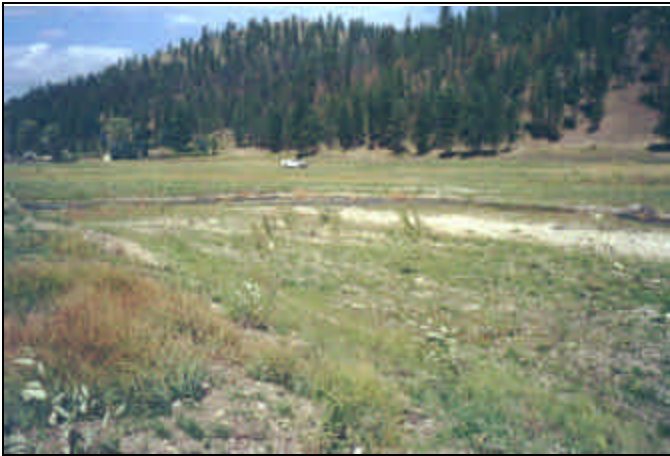
Photo Point No. 3: View looking northeast, constructed Camp Creek channel and floodplain margins.

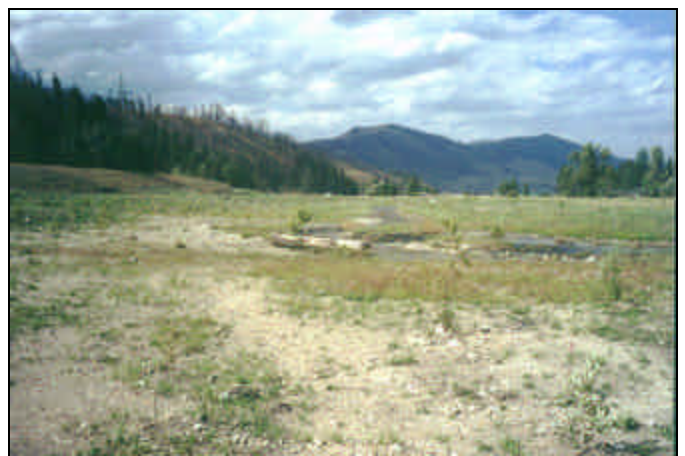
Photo Point No. 4: View looking north, floodplain margins with emergent wetland and riparian vegetation enhancements. Large containerized cottonwood and aspen plantings.

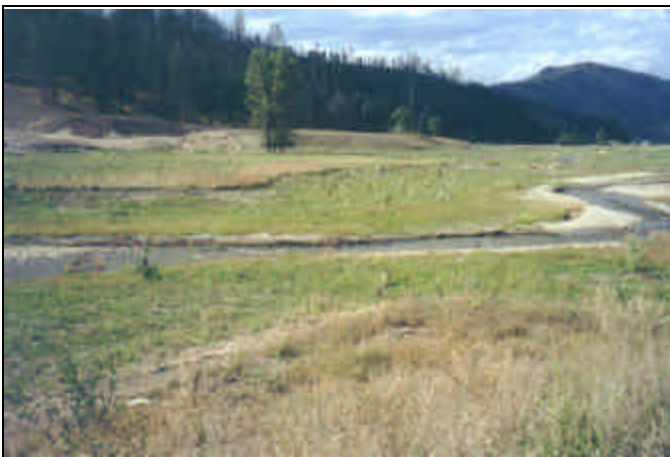
Photo Point No. 5: View looking north, Camp Creek and floodplain margins.

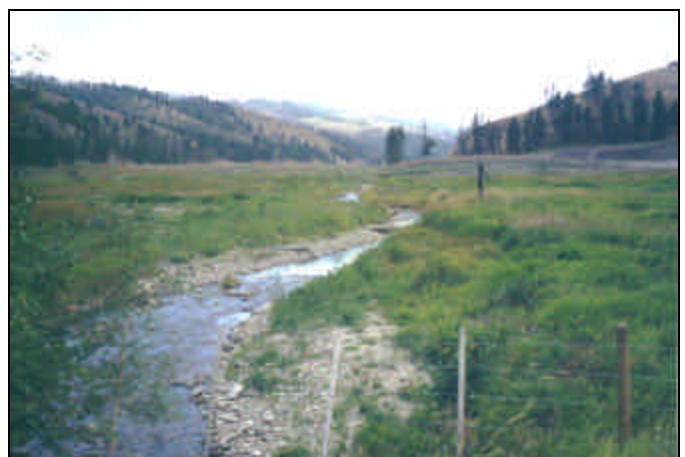
Photo Point No. 7: View looking south; lowest section of Camp Creek channel, north boundary of MDT parcel.

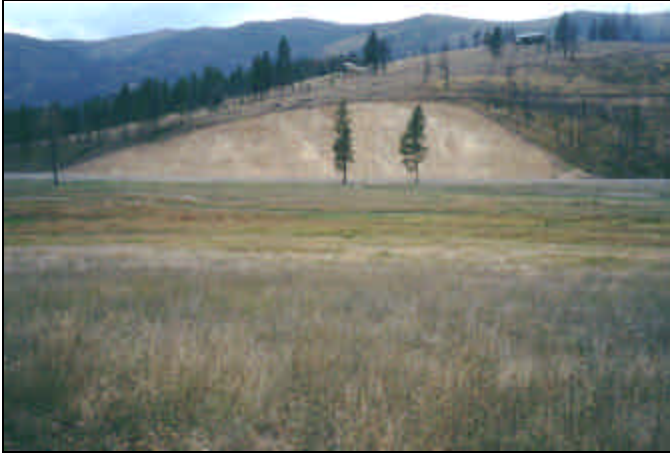
Photo Point No. 8: View looking west across mitigation site, upland community type in foreground. Emergent wetland and main channel beyond upland areas.

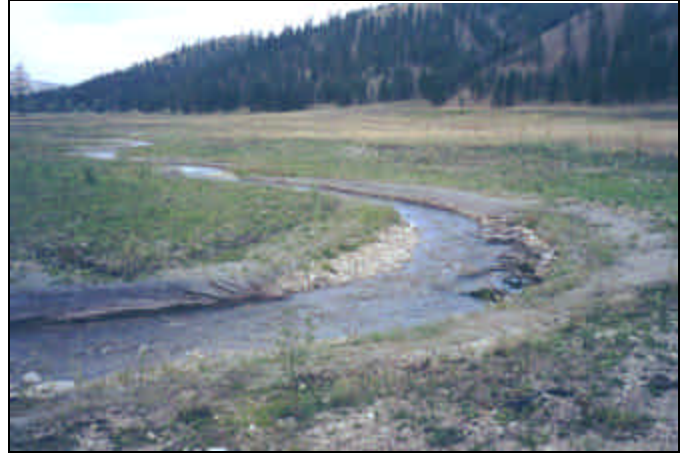
Photo Point No. 9: View looking north, main channel just below second culvert. Example of fabric work along constructed streambanks.

COMMENTS/PROBLEMS: Restored Camp Creek, main channel with areas of fabric work failing. Loss of fill materials used to hold fabric in place. Fabric placed along stream banks is loose, being held in place by willow sprigs and seeded grass mix. Floodplain and upland restoration/enhancement areas planted w/ large containerized plantings. Toward eastern side of project, lower and northern half, historic wetlands exist. Historic oxbows and remnant channels of Camp Creek are present, evidence of past surface flows through these areas.

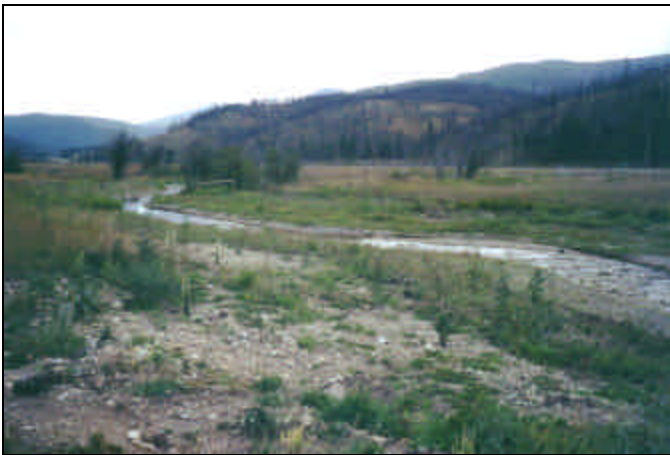
Photo Point No. 10: View looking south, section of channel with remnant shrub communities present.

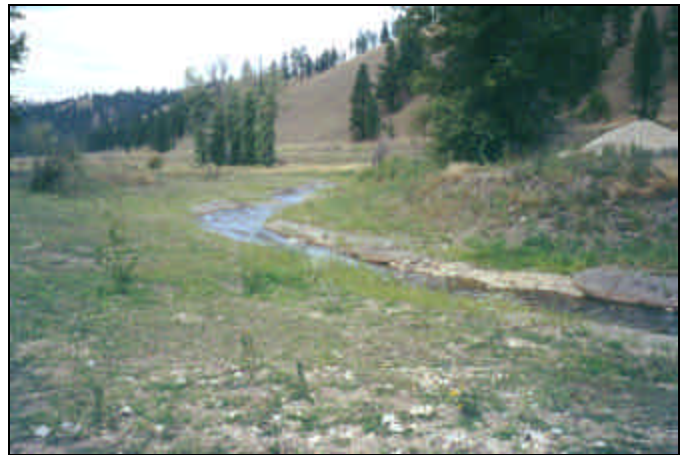
Photo Point No. 11: View looking north, mature cottonwoods located along the main channel. Floodplain margins planted with containerized shrub & trees.

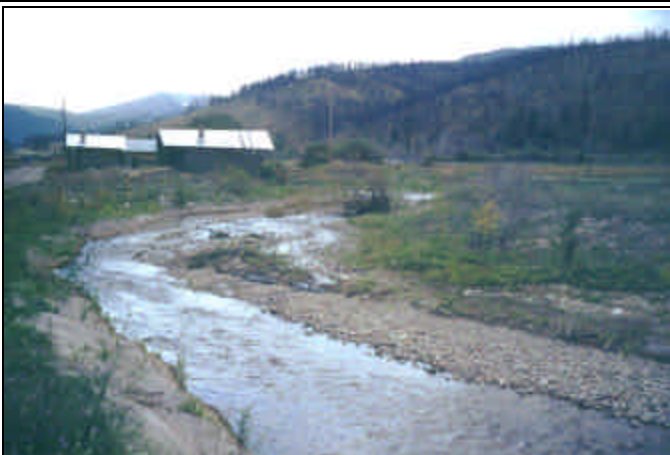
Photo Point No. 12: View looking south, main channel running along Grasser structures, remnant shrub community present.

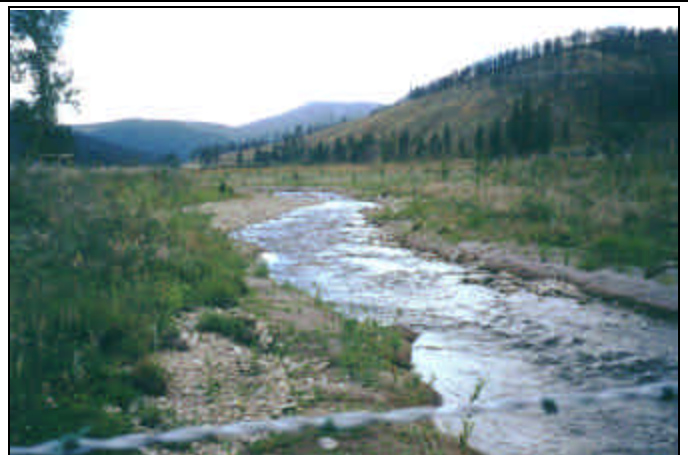
Photo Point No. 13: View looking south, straight sections of main channel running across upper portion of Grasser parcel.

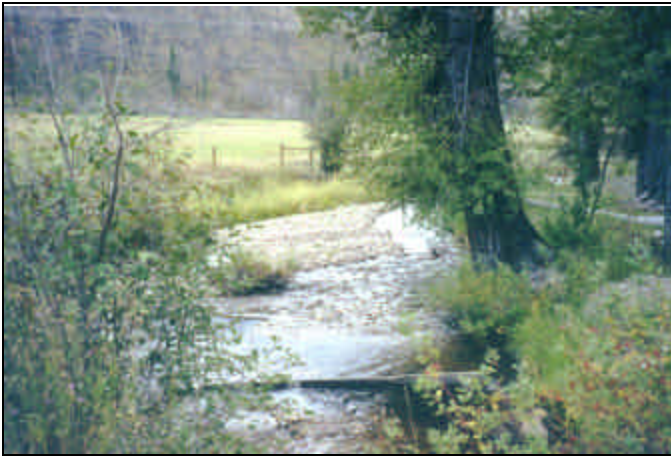
Photo Point No. 14: View looking west, an undisturbed section of Camp Creek entering Grasser parcel. Mature cottonwoods, alder, and willow.

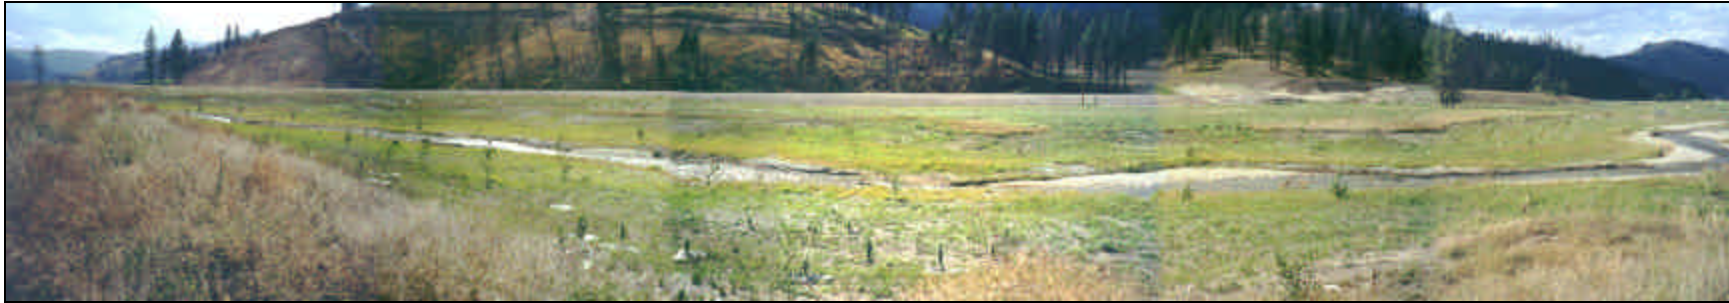
Photo Point No. 5: Panoramic looking west across site. Representative photo of typical channel and floodplain section present at Camp Creek. Transect located towards right side of photo. Photo taken from atop created upland slopes.

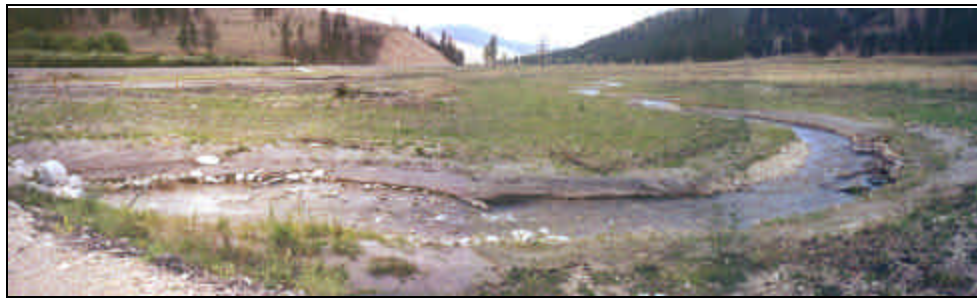
Photo Point No. 9: Panoramic looking north along main channel. Photo taken along road crossing and culvert. Representative photo of fabric work along streambank and floodplain margins with emergent wetlands.

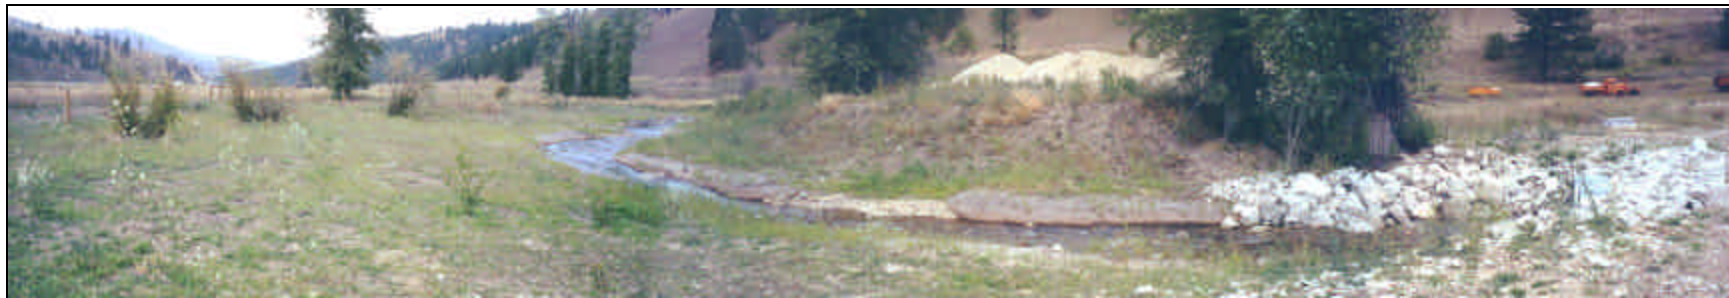
Photo Point No. 11: View looking north along main creek, below upper road crossing and culvert near Grasser complex. Mature cottonwoods and remnant shrub communities present along creek. Example of intact fabric work along streambank, floodplain margins planted with riparian shrubs and trees.
