**MONTANA DEPARTMENT OF TRANSPORTATION
WETLAND MITIGATION MONITORING REPORT: YEAR 2011**

*Big Hole Grazing Association
Beaverhead County, Montana*

MDT Project Number STPX-0001(45)
Control Number 4668

Confluence Consulting, Inc.
P.O. Box 1133
Bozeman, MT 59771

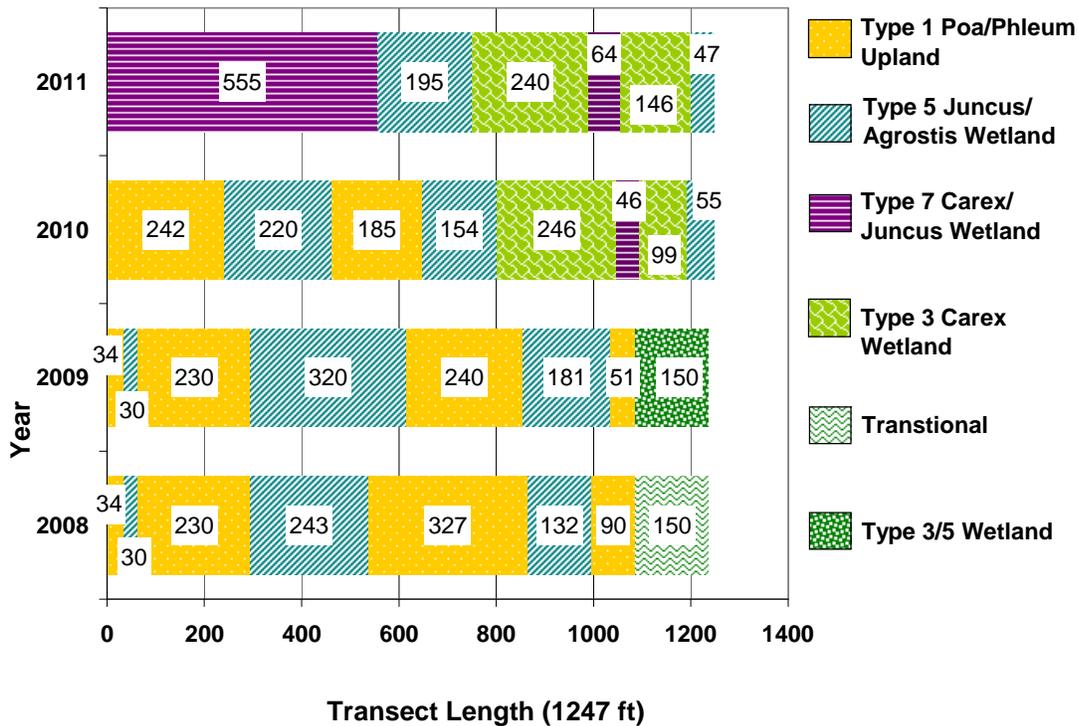
Chart 1. Transect map showing community types on Transect 1 from beginning (0 feet) to end (1,247 feet) identified from 2008 to 2011.

The transect intercepted communities 7 – *Carex spp./Juncus spp.*, community 5 – *Juncus spp./Agrostis alba*, and community 3 – *Carex spp.* Hydrophytic species dominated 100 percent of the transect in 2011, an increase of 34.2 percent from 2010 and an increase of 44.2 percent since 2009. This data reflects the continued increase of wetland hydrology, development of hydrophytic vegetation, and expansion of wetland acreage within the BHGA mitigation site since construction. Photographs of the transect end points from 2009 to 2011 are shown on pages C-12 and C-13 of Appendix C.

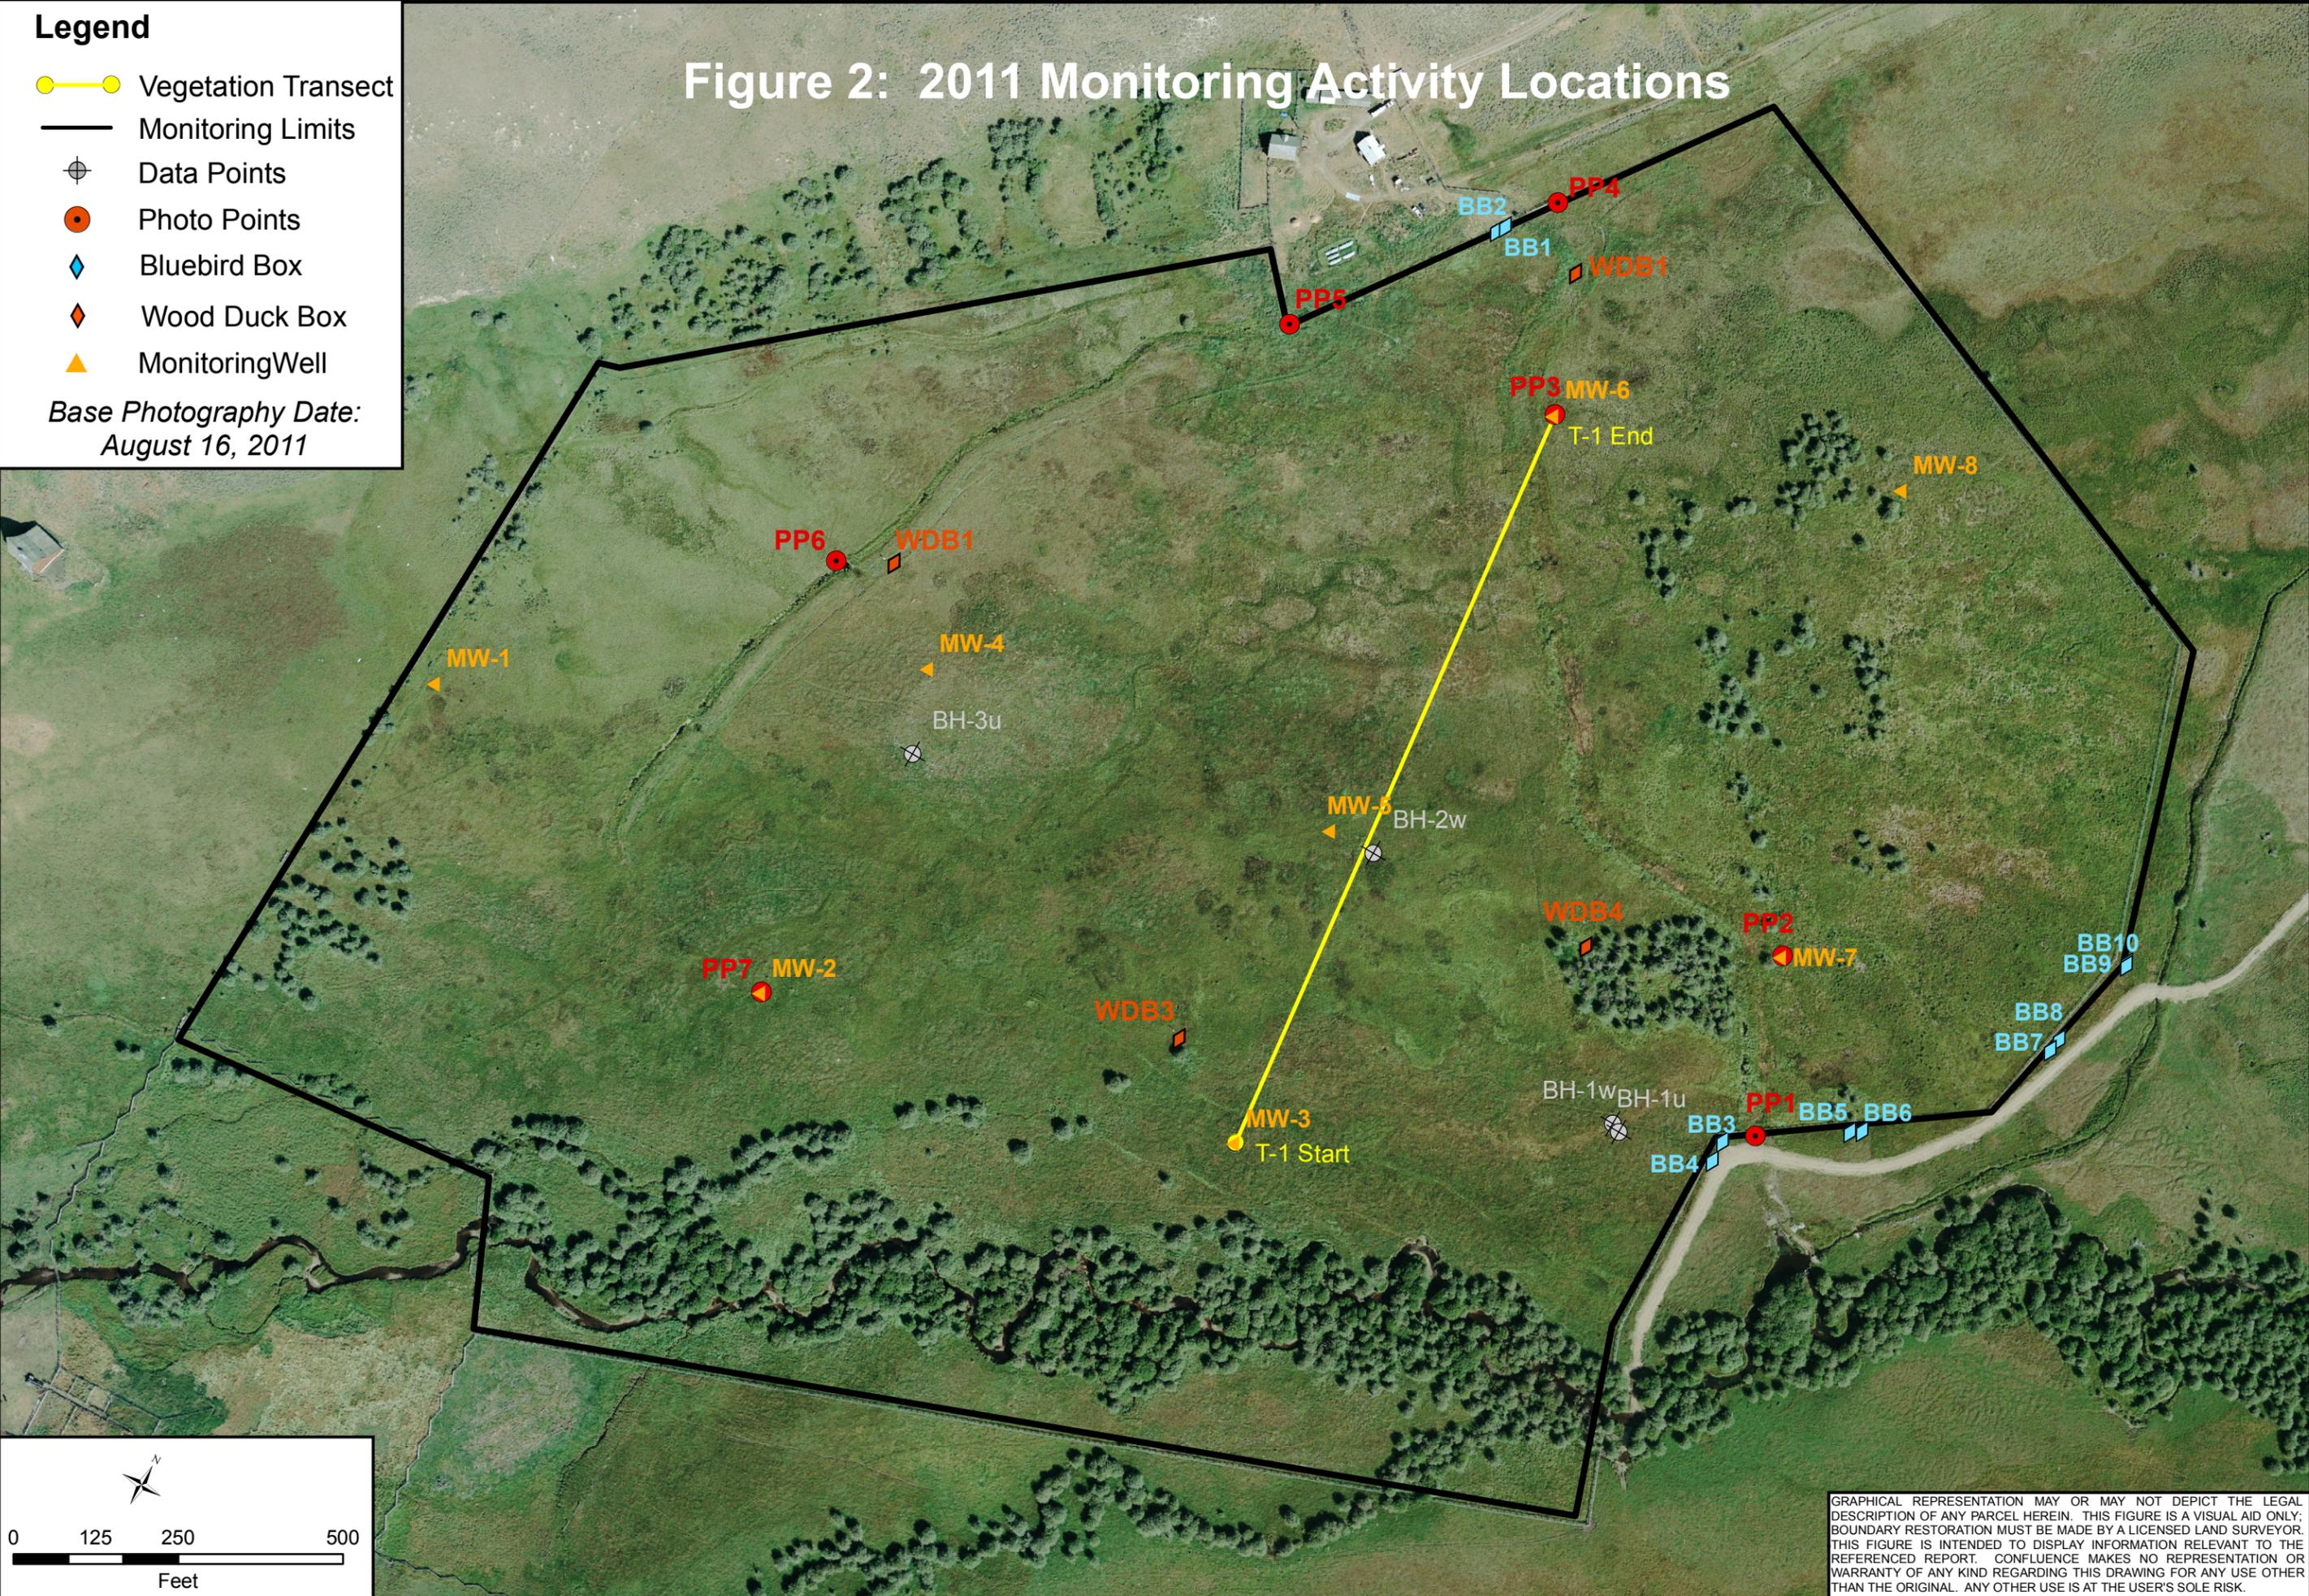
Figure 2: 2011 Monitoring Activity Locations

When present, hydrological indicators as outlined on the Wetland Data Form were documented at four data points established within the project area (Figure 2, Appendix A). Hydrologic indicators were evaluated according to features observed during the site visit. The data were recorded on electronic field data sheets (Appendix B). Hydrologic assessments allow evaluation of mitigation goals addressing inundation/saturation requirements.

Monitoring at photo points provides supplemental information documenting wetland and upland conditions, trends, current land use surrounding the site, the monitored area, and the vegetation transects. Photographs were taken at established photo points and transect end points throughout the mitigation site during the site visit (Appendix C). Photo point locations were recorded with a resource grade GPS unit (Figure 2, Appendix A).

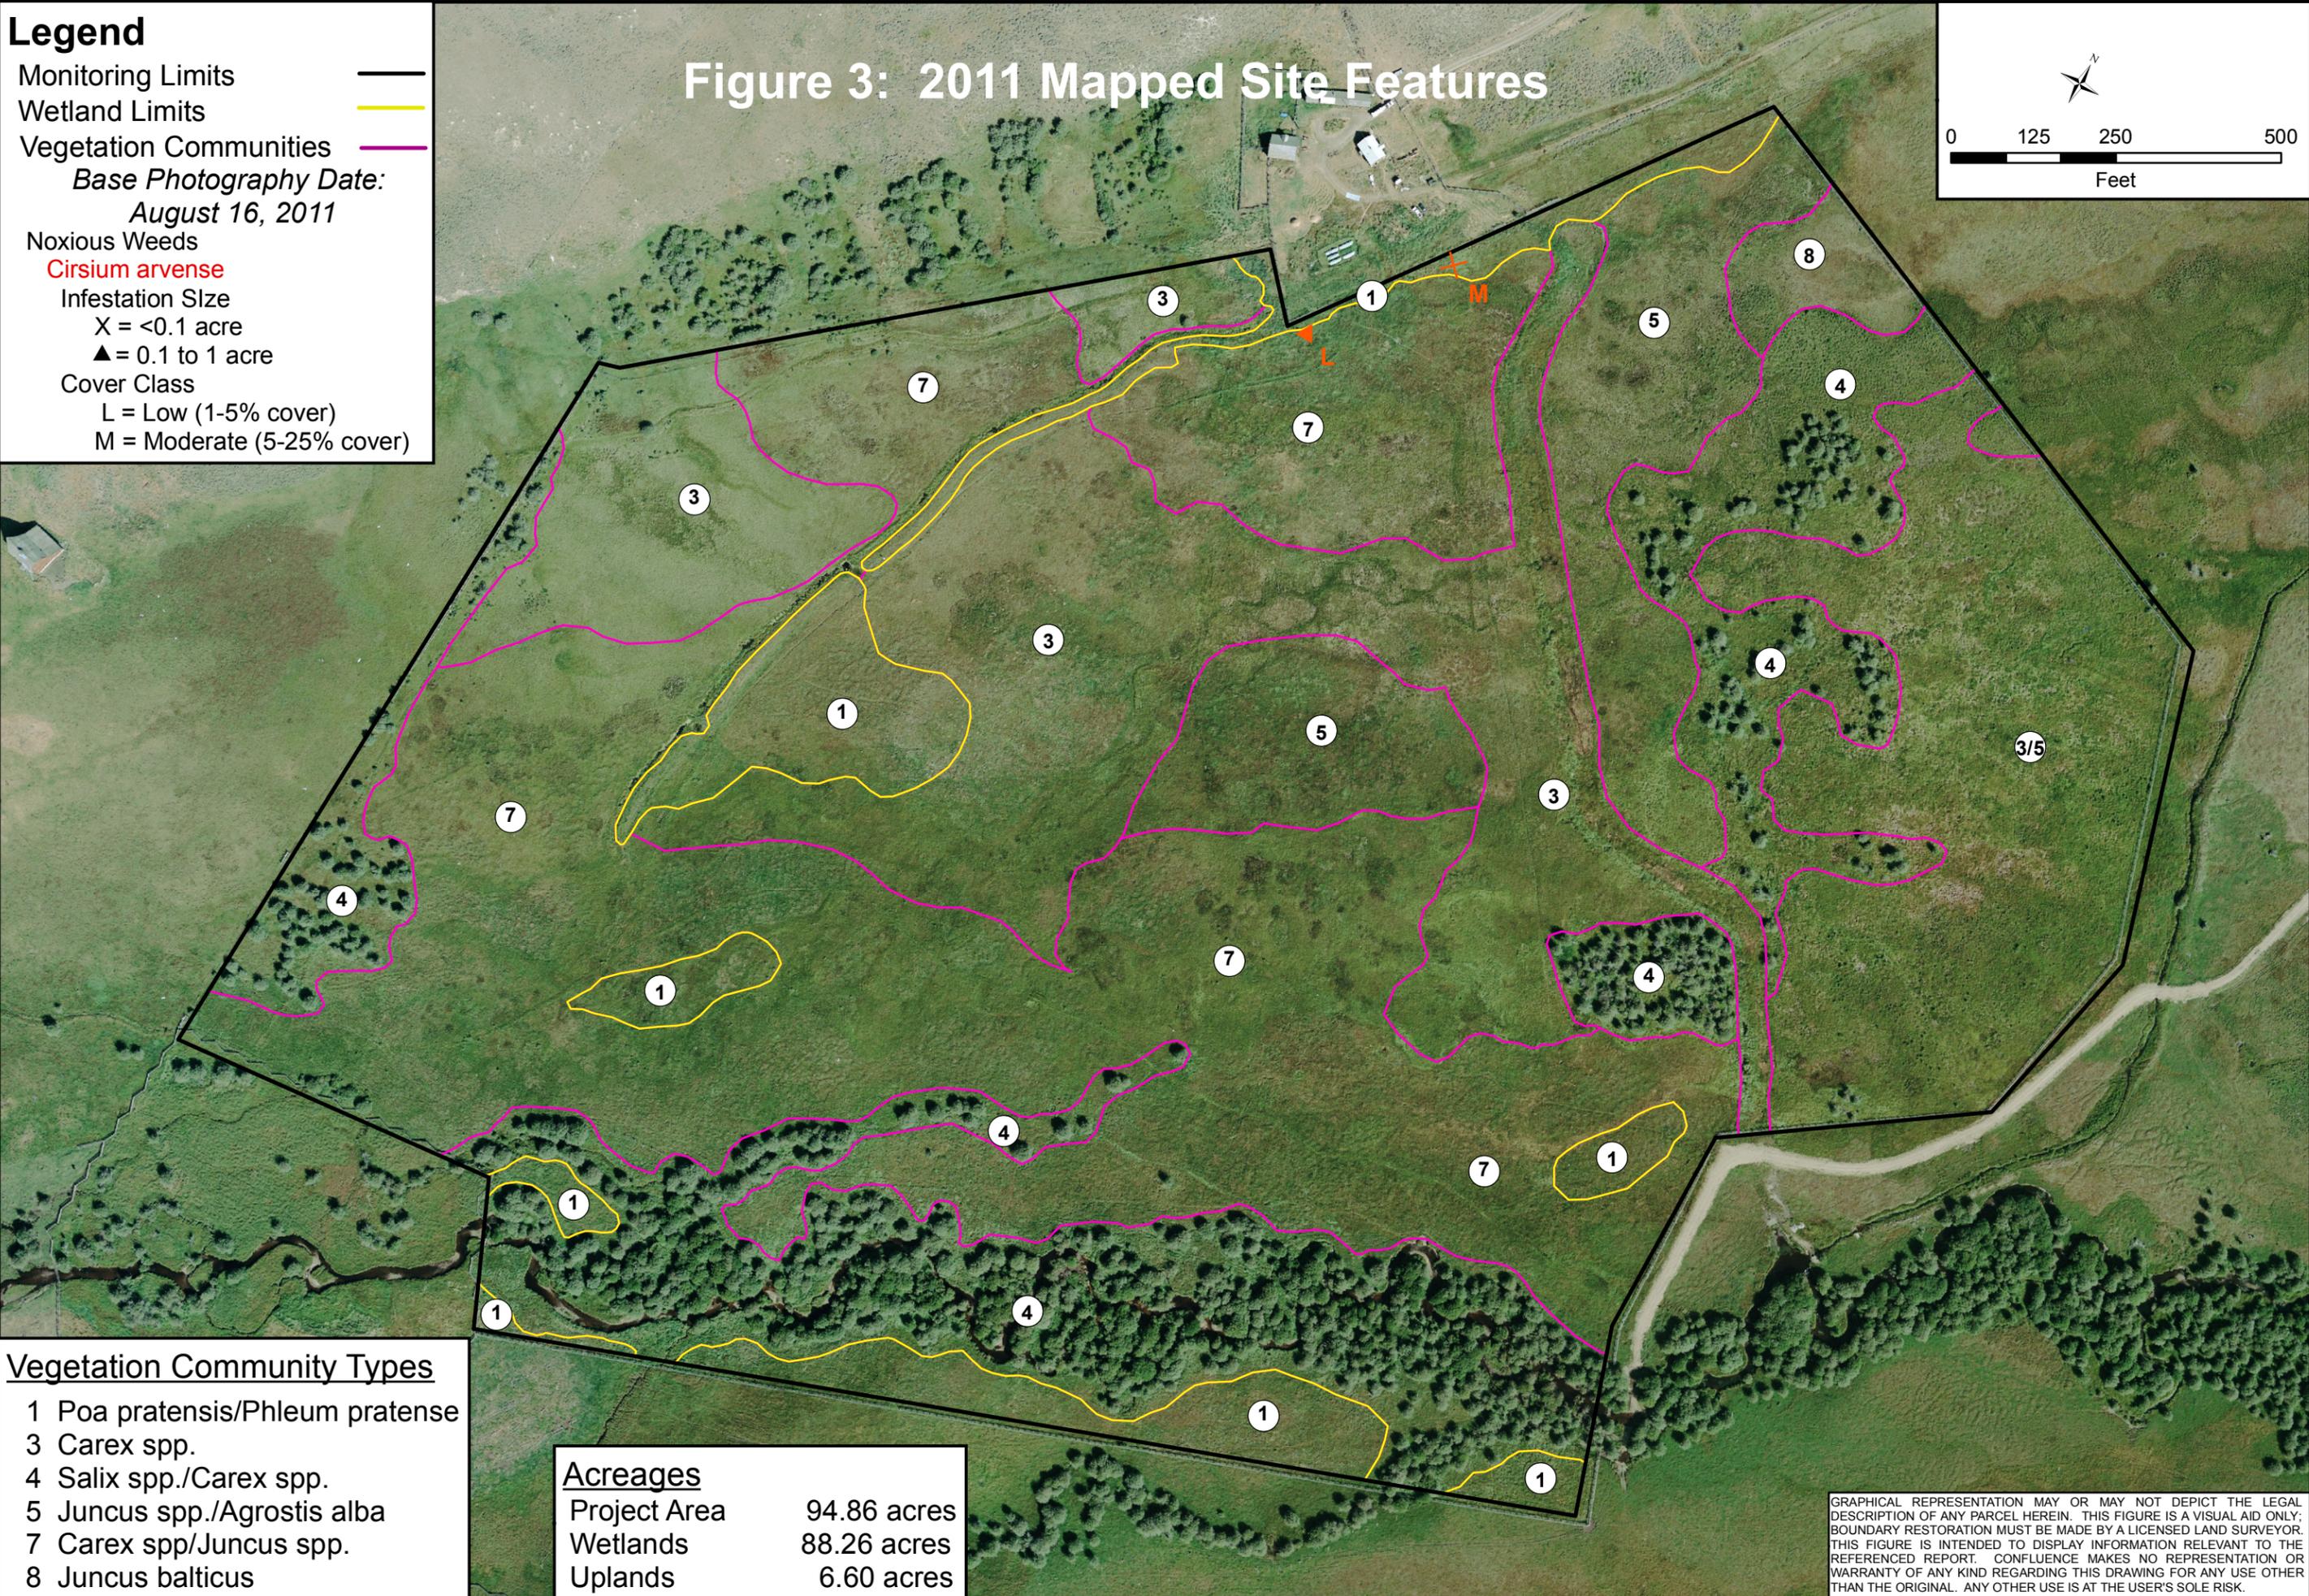
Figure 3: 2011 Mapped Site Features

The location of noxious weeds was noted in the field and mapped on the aerial photo (Figure 3, Appendix A). The noxious weed species identified are color-coded. The locations are denoted with the symbol “X”, “▲”, or “■” representing 0 to 0.1 acre, 0.1 to 1.0 acre, or greater than 1.0 acre in extent, respectively. Cover classes are represented by T, L, M, or H, for less than 1 percent, 1 to 5 percent, 2 to 25 percent, and 25 to 100 percent, respectively, as listed on Figure 3 (Appendix A).

The northwest corner of the project contained a sedge-dominated fen (community 3) that was not impacted by historic ditching activities. The northeast side of the easement area had been dominated by willow communities that transitioned to upland and wet meadow habitat after years of dewatering and grazing. Since 2009, the area has shown evidence of reverting to historical conditions with the restoration of site hydrology and natural regeneration of willows (Community 6, Figure 3, Appendix A).

Canada thistle (*Cirsium arvense*), a Priority 2B noxious weed, was identified in two areas on the north mitigation boundary near the home site (Figure 3, Appendix A). The infestations covered 0.1 to 1.0 acres and less than 0.1 acres, comprising between 1 and 5 percent of cover and 5 to 25 percent of cover, respectively.

- Vegetation Community Types**
- 1 Poa pratensis/Phleum pratense
 - 3 Carex spp.
 - 4 Salix spp./Carex spp.
 - 5 Juncus spp./Agrostis alba
 - 7 Carex spp/Juncus spp.
 - 8 Juncus balticus

Acreages	
Project Area	94.86 acres
Wetlands	88.26 acres
Uplands	6.60 acres

Containerized plant survival declined significantly from 2008 to 2010. Mortality may have been linked to excessively wet conditions. Survival seemed to stabilize during this past growing season and may reflect suitable micro-habitats within the inundated/saturated wetlands. Sufficient natural regeneration of willows is occurring at the site and no supplemental planting is recommended for the BHGA site. Canada thistle infestations were consistent between 2010 and 2011 (Figure 3, Appendix A). The total infestations covered less than 1.0 acre, with cover classes between 1 and 25 percent in two locations near the home site. Continued weed spraying is recommended to control these two populations.
