ROSTAD RANCH MITIGATION SITE

Project Overview

Monitoring Year: 2019

Corps Permit Number: NWO-2006-90851-MTB

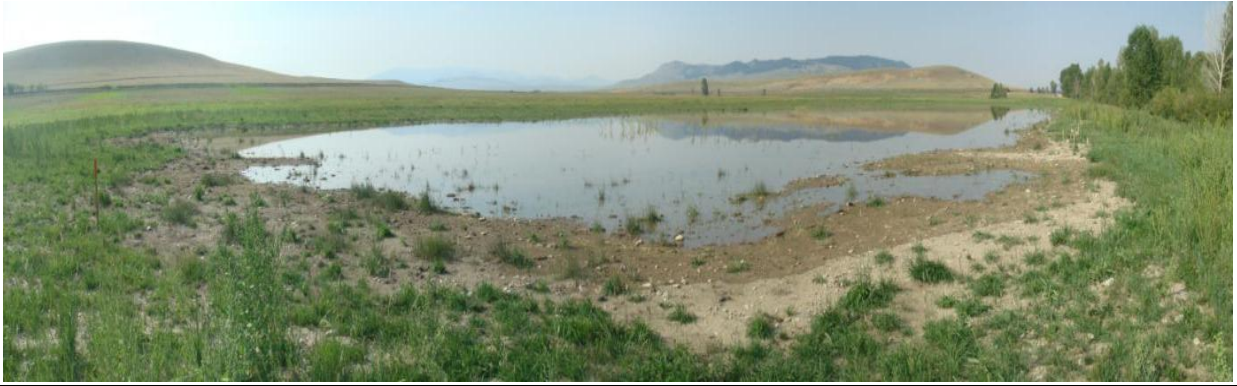
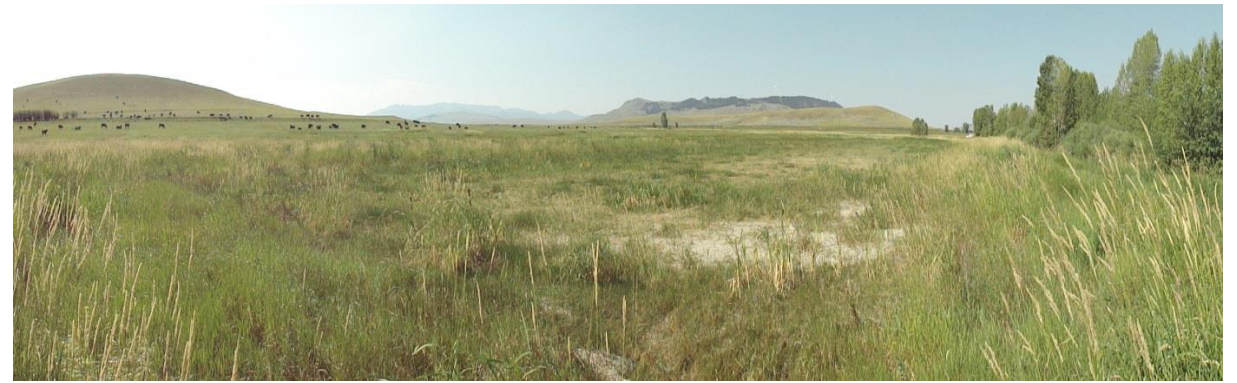
Photo Point 1 – Panorama; Location: Northeast Corner; Bearing 200 degrees; Year 2013

Photo Point 1 – Panorama; Location: Northeast Corner; Bearing 200 degrees; Year 2019

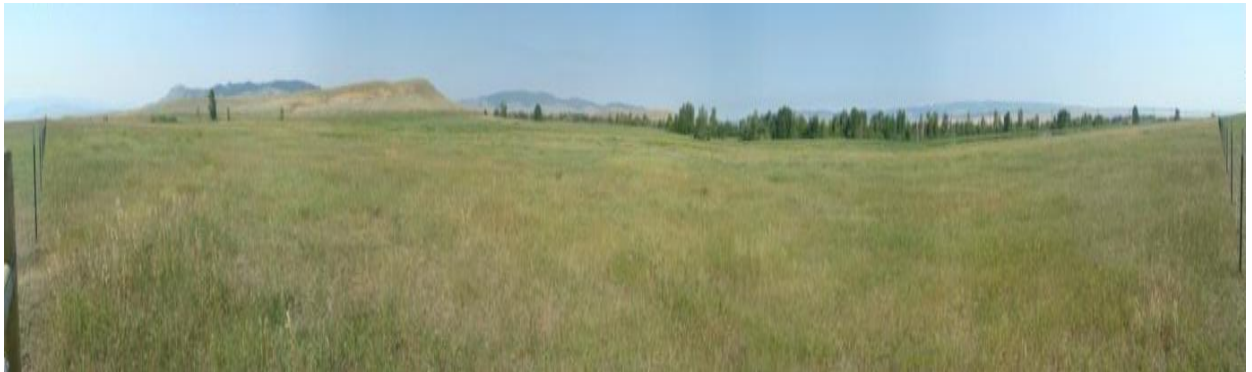
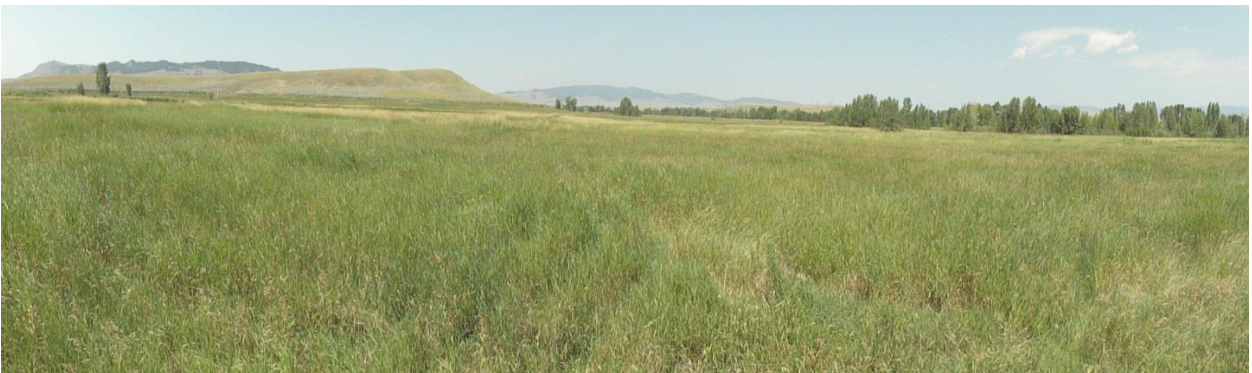
Photo Point 2 – Panorama; Location: East Fence Corner; Bearing 125 degrees; Year 2013

Photo Point 2 – Panorama; Location: East Fence Corner; Bearing 125 degrees; Year 2019

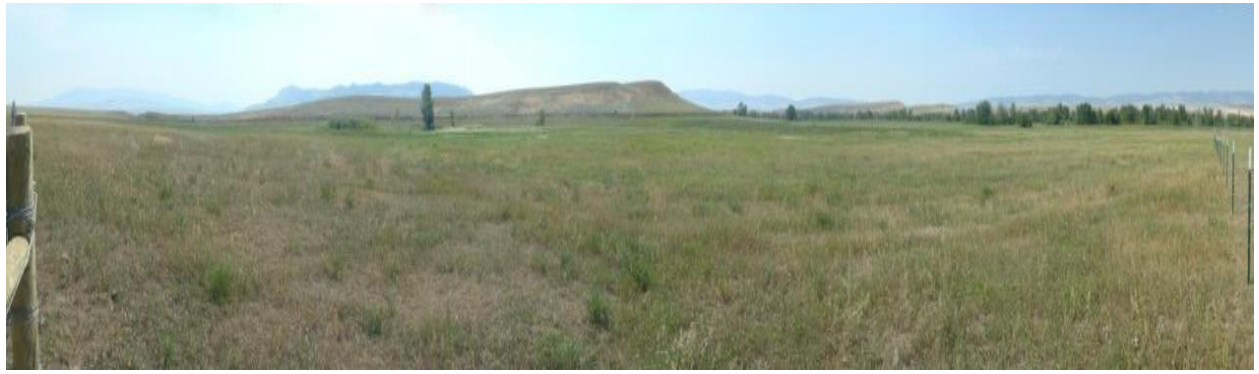
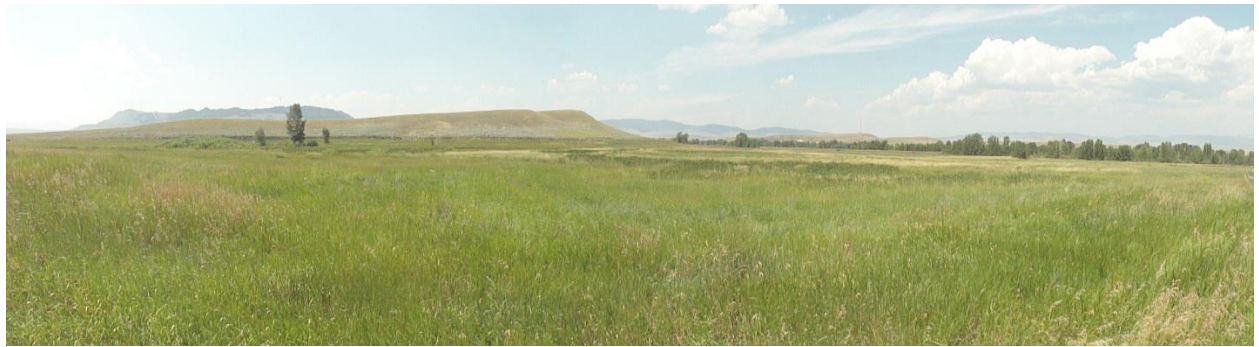
Photo Point 3 – Panorama; Location: East Fence Line; Bearing 280 degrees; Year 2013

Photo Point 3 – Panorama; Location: East Fence Line; Bearing 280 degrees; Year 2019

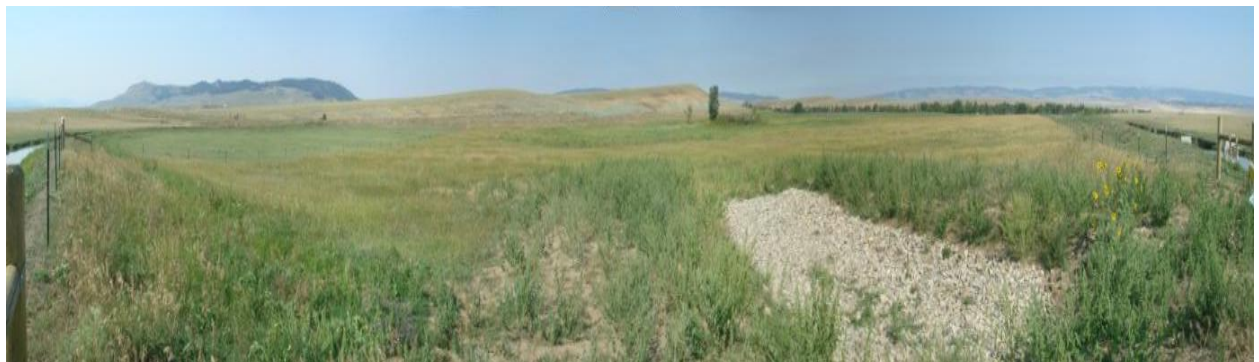
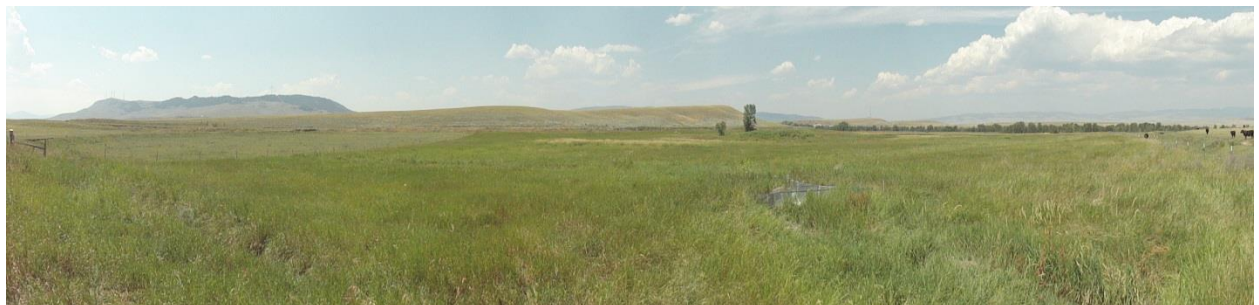
Photo Point 4 – Panorama; Location: SE Fence Corner; Bearing 240 degrees; Year 2013

Photo Point 4 – Panorama; Location: SE Fence Corner; Bearing 240 degrees; Year 2019

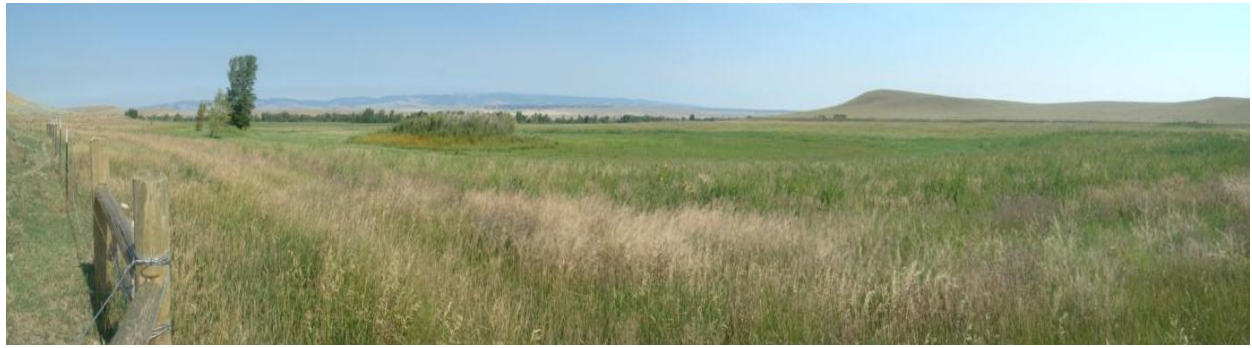
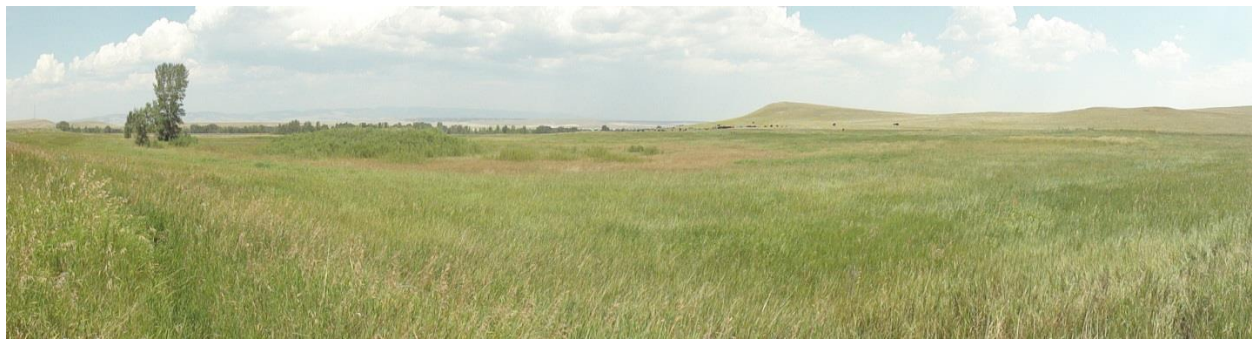
Photo Point 5 – Panorama; Location: SW Fence Corner; Bearing 200 degrees; Year 2013

Photo Point 5 – Panorama; Location: SW Fence Corner; Bearing 200 degrees; Year 2019

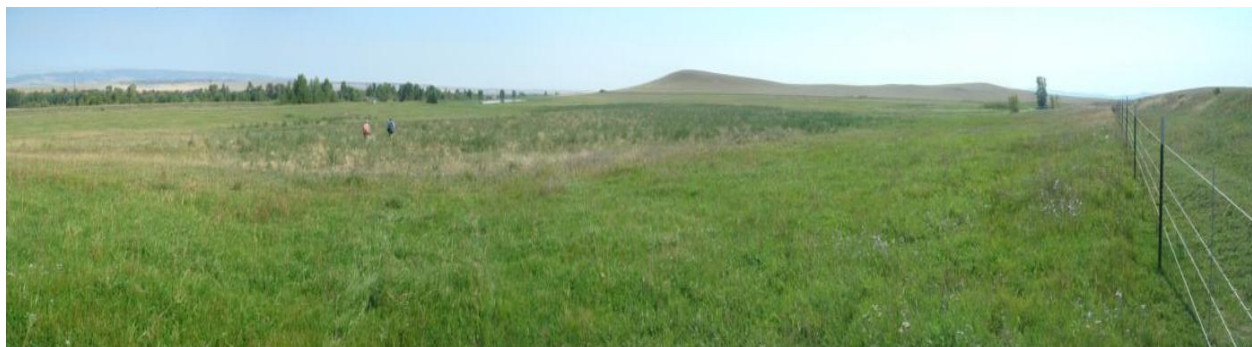
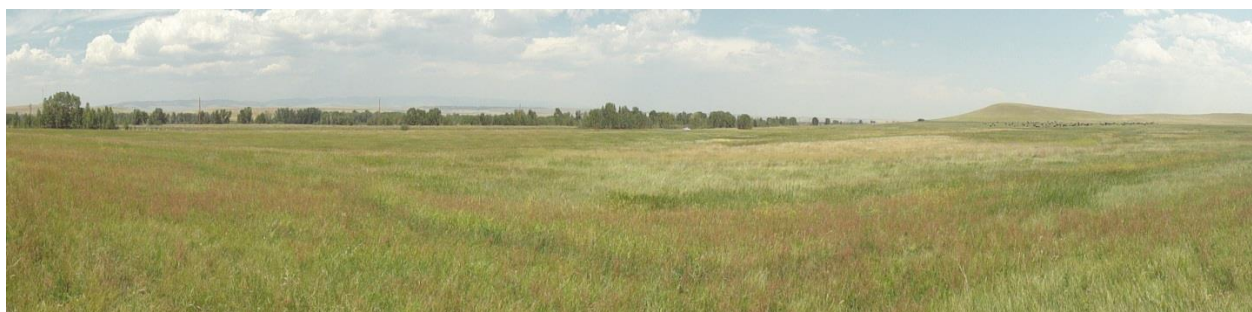
Photo Point 7 – Panorama; Location: West Fence Corner; Bearing 90 degrees; Year 2013

Photo Point 7 – Panorama; Location: West Fence Corner; Bearing 90 degrees; Year 2019

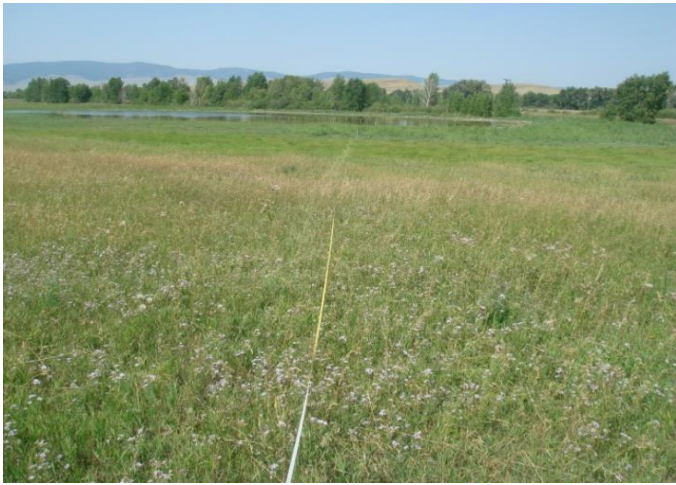
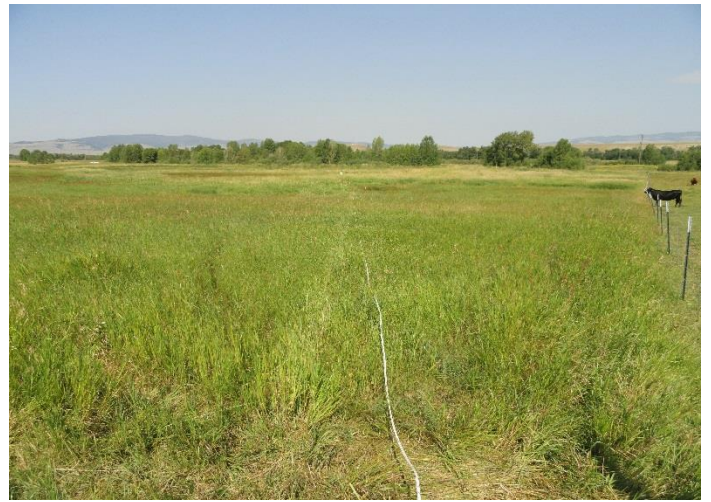
Transect 1: Start Location: NE Branch of site
 Bearing: 290 degrees Year: 2013

Transect 1: Start Location: NE Branch of site
 Bearing: 290 degrees Year: 2019

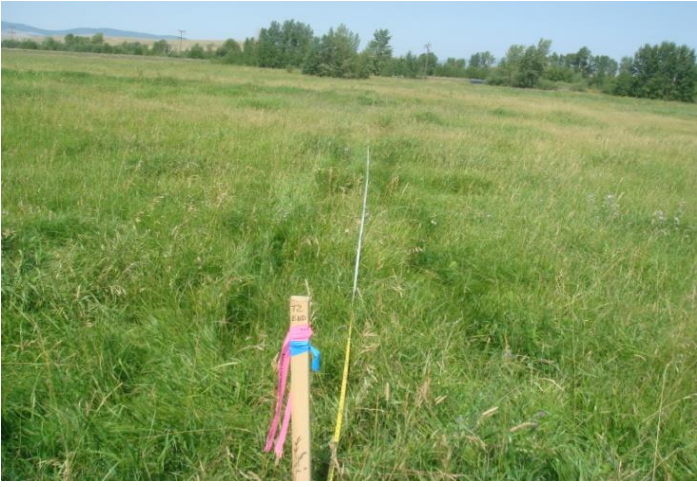
<p>A photograph showing the end of Transect 2 in 2013. A wooden stake with a pink and blue ribbon is in the foreground, and a white measuring tape extends into the tall green grass. The background shows a rolling green hill under a clear blue sky.</p>

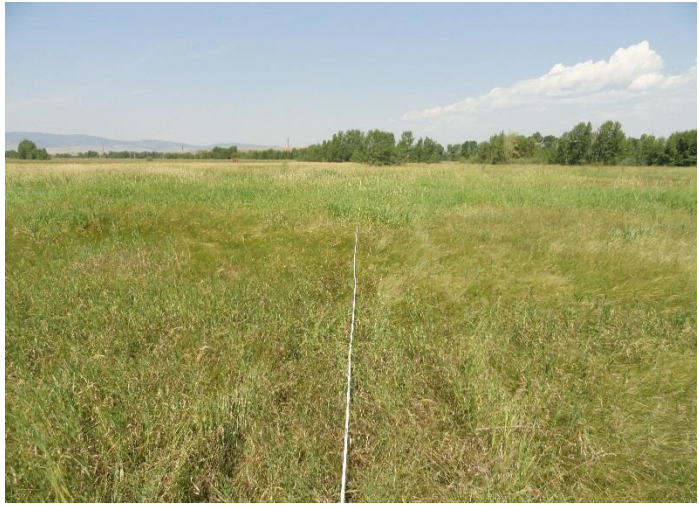
<p>A photograph showing the end of Transect 2 in 2019. A white measuring tape is visible in the tall grass. The background shows a flat field with a line of trees and distant mountains under a blue sky with some clouds.</p>		
<p>Transect 2: End Bearing: 310 degrees</p>	<p>Location: North Central Year: 2013</p>	<p>Transect 2: End Bearing: 310 degrees</p>	<p>Location: North Central Year: 2019</p>

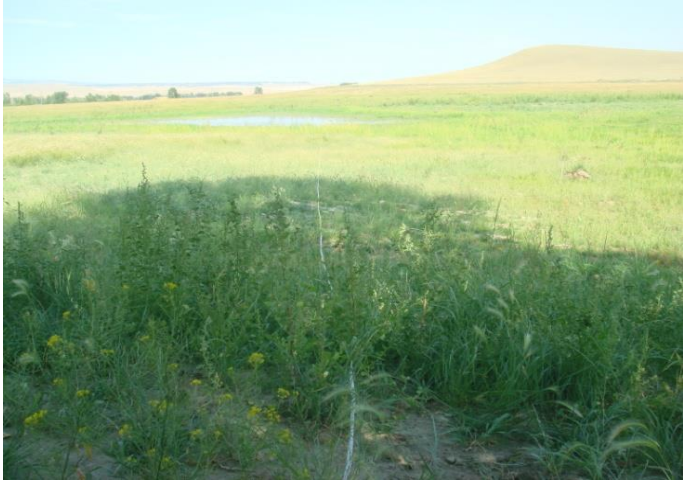
<p>A photograph showing the start of Transect 3 in 2013. A white measuring tape is in the foreground, and the background features a large, flat green field with a small pond and a distant hill under a clear sky.</p>

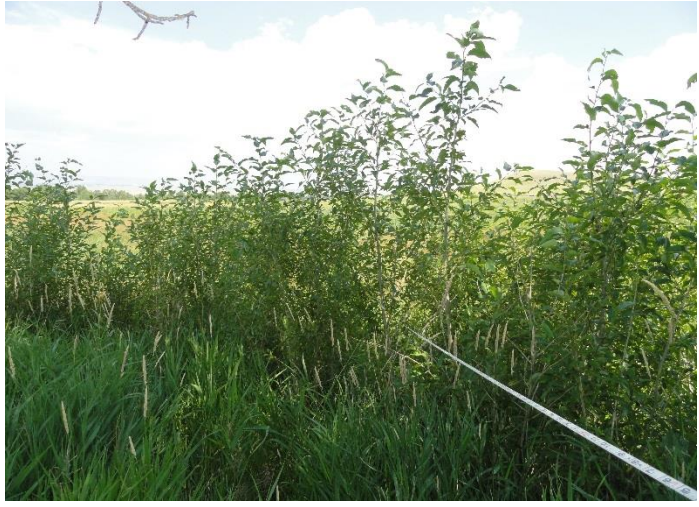
<p>A photograph showing the start of Transect 3 in 2019. A white measuring tape is in the foreground, and the background shows dense green vegetation and a clear sky.</p>

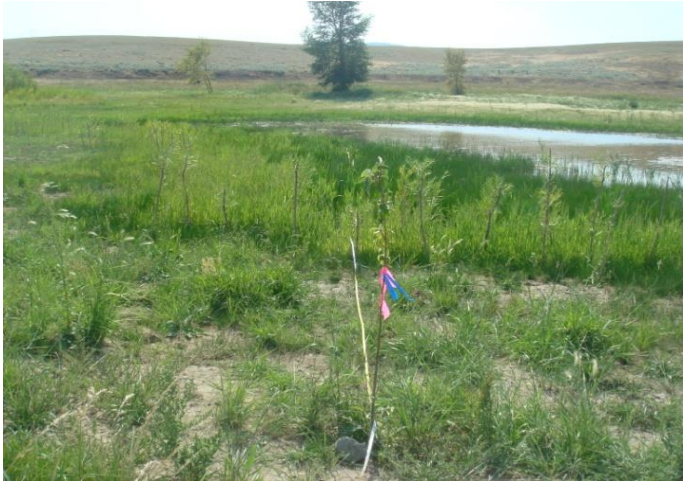
<p>A photograph showing the end of Transect 3 in 2013. A wooden stake with a pink and blue ribbon is in the foreground, and a white measuring tape extends into the grass. A pond and rolling hills are visible in the background.</p>

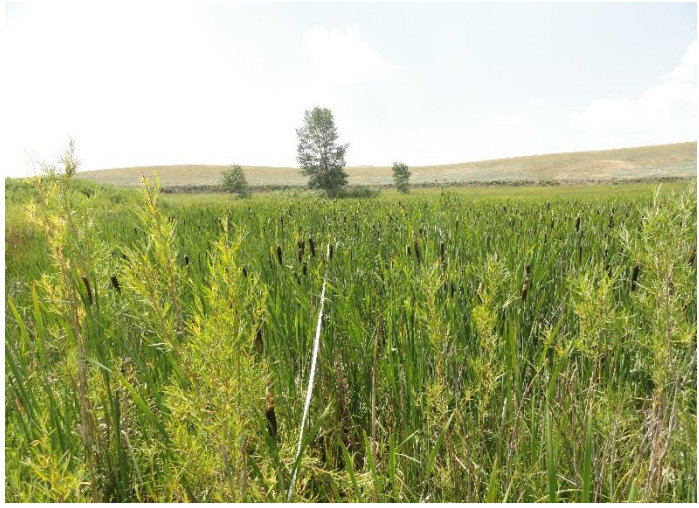
<p>A photograph showing the end of Transect 3 in 2019. A white measuring tape is in the foreground, and the background shows a field of tall green grass with a single tree and rolling hills in the distance.</p>		
<p>Transect 3: End Bearing 30: degrees</p>	<p>Location: South Portion of site Year: 2013</p>	<p>Transect 3: End Bearing 30: degrees</p>	<p>Location: South Portion of site Year: 2019</p>
