# CONCRETE-FILLED STEEL TUBE TO CONCRETE PILE CAP CONNECTIONS – FURTHER EVALUATION/IMPROVEMENT OF ANALYSIS/DESIGN METHODOLOGIES

Cash Cota, MS<sup>1</sup>; Michael Berry, PhD<sup>1</sup>; Kirsten Matteson, PhD<sup>1</sup>  
<sup>1</sup>Montana State University

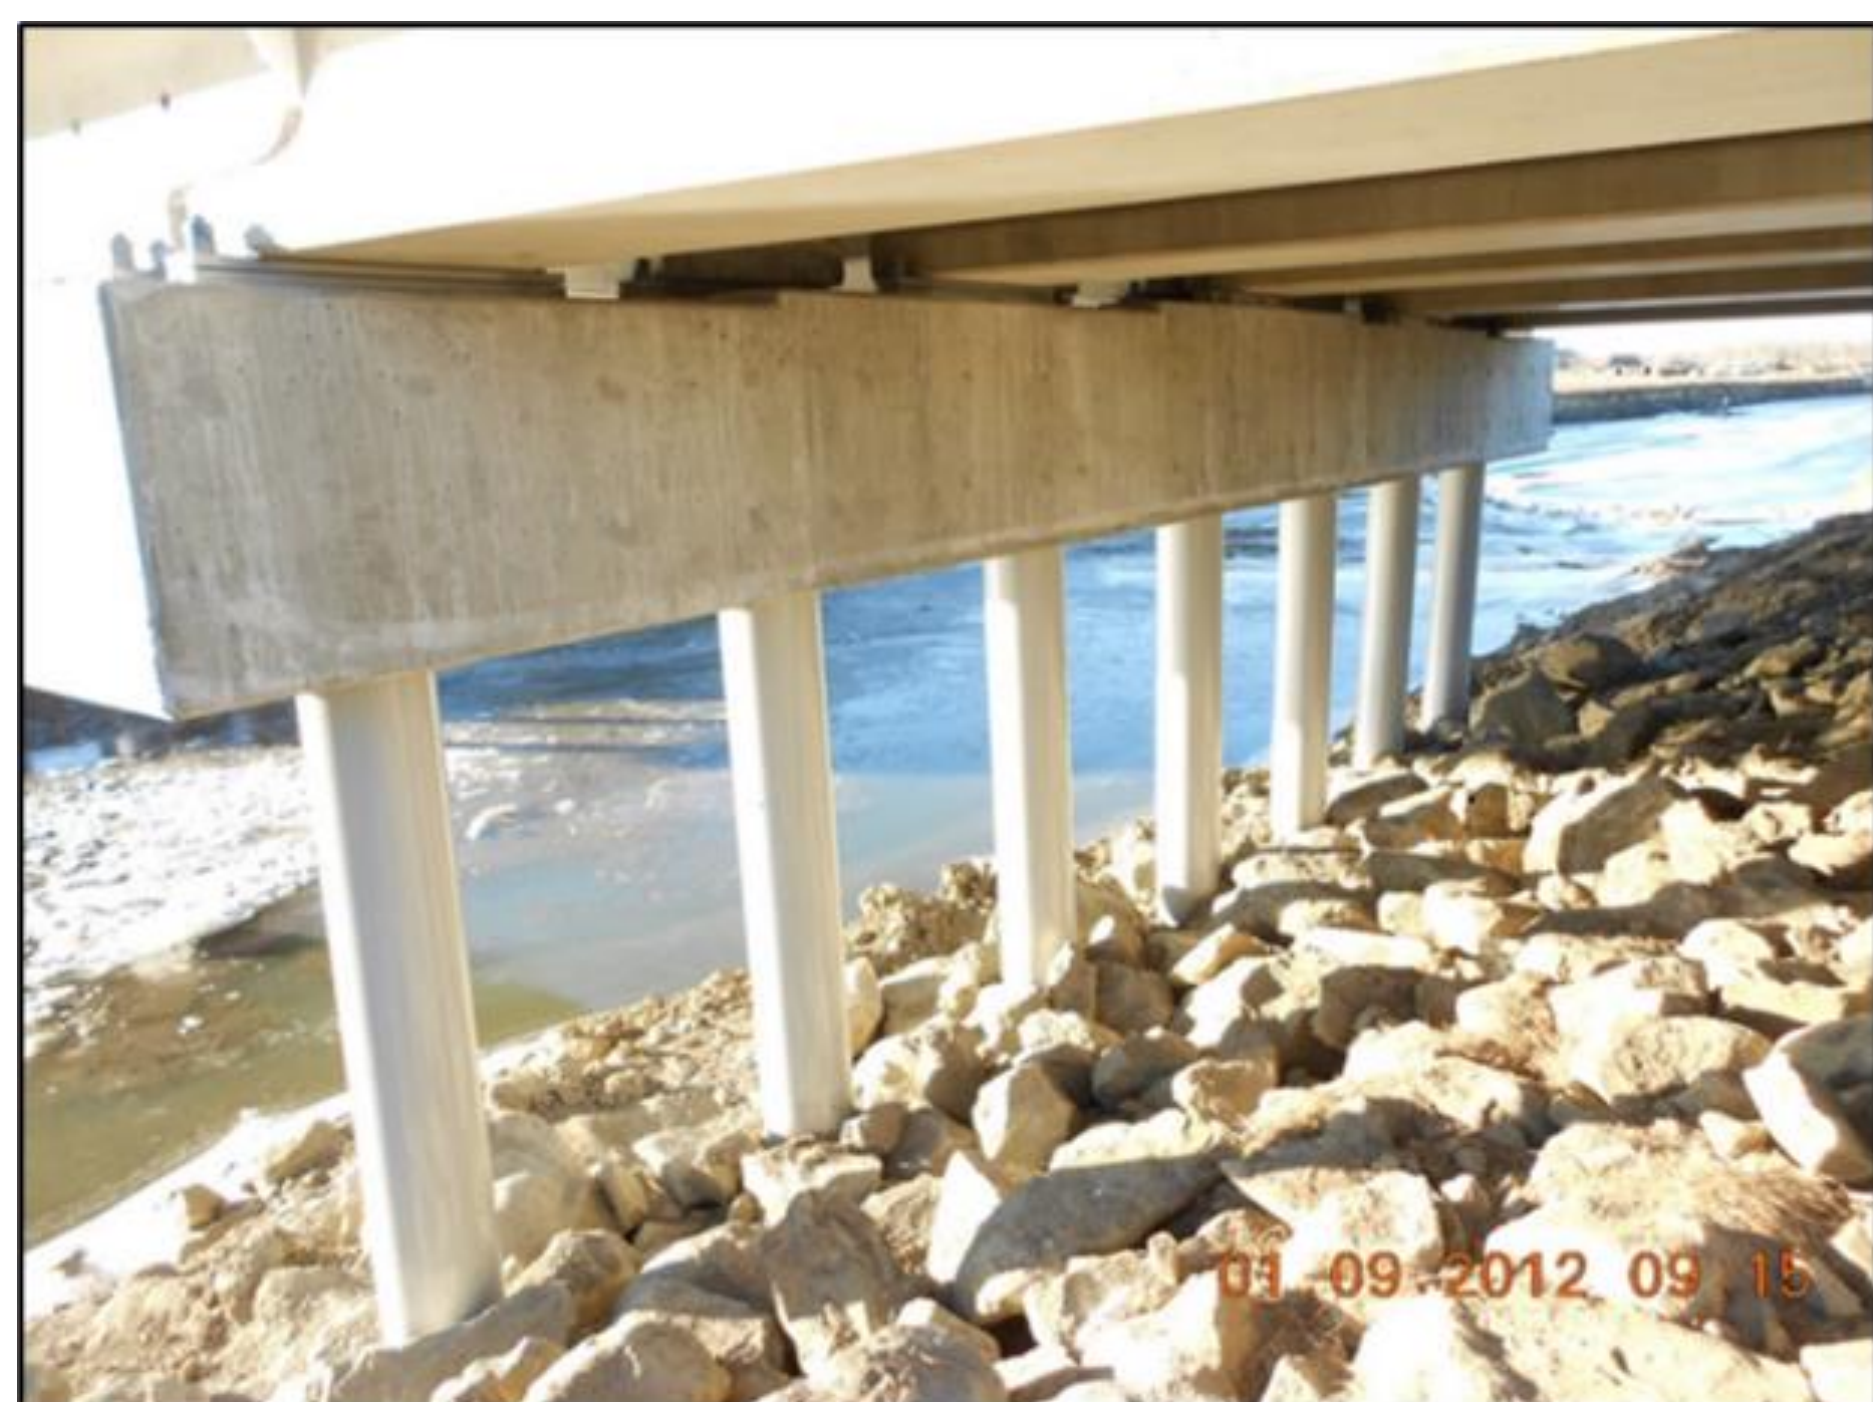
Figure 1. Typical MDT concrete-filled steel pile and concrete pile cap bridge substructure support system (Pryor Creek Bridge near Huntley, MT – courtesy of MDT (2012))

The Montana Department of Transportation (MDT) has found concrete-filled steel tube (CFST) piles connected at the top by a concrete pile cap to be a very cost-effective support system for short and medium span bridges. A typical pile cap using this system is shown in Figure 1. This type of system offers low initial cost, short construction time, low maintenance requirements, and a long service life. While the gravity load performance of these systems is well understood, their strength and ductility under extreme lateral loads (e.g., seismic events) is more difficult to reliably predict using conventional design procedures. This project aims to further develop newly established design and analysis methodologies through experimental testing to ultimately ensure bridge performance is fully consistent with design intent.

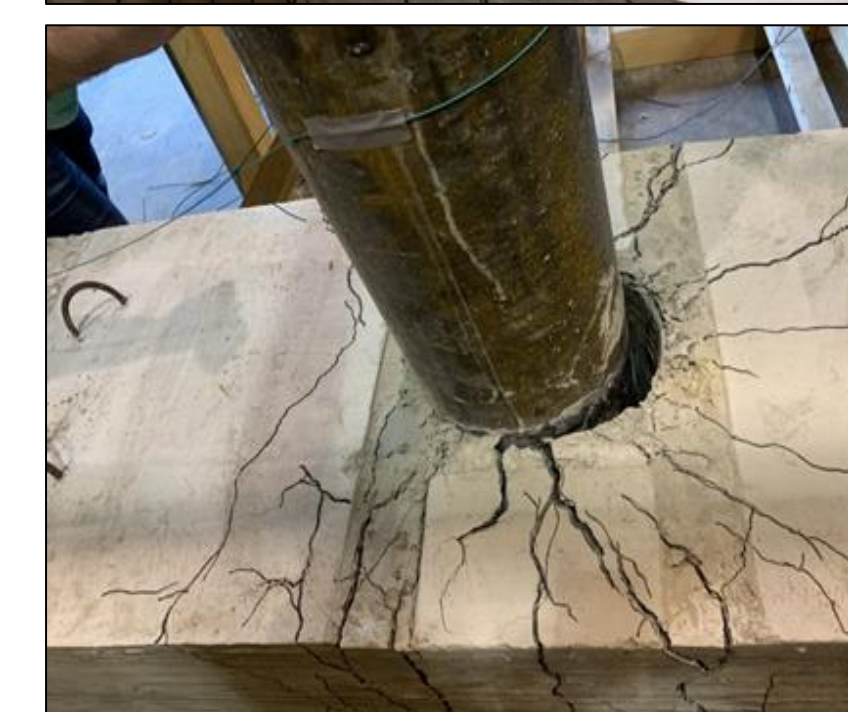
**VT2/3-6** – Failed in the pile cap due to a combination of failure mechanisms.

Figure 4. Moment-Drift Reponses Curves (Left) and photos of damage (Right) from each specimen

3. A 33% increase in concrete strength resulted in a 33% increase in the initiation of damage and ultimate load capacity of the pile indicating that the effect of concrete strength on cap performance may be 1 to 1.
