Appendix B

Existing and Projected Conditions Report

EXISTING AND PROJECTED CONDITIONS REPORT

July 2012

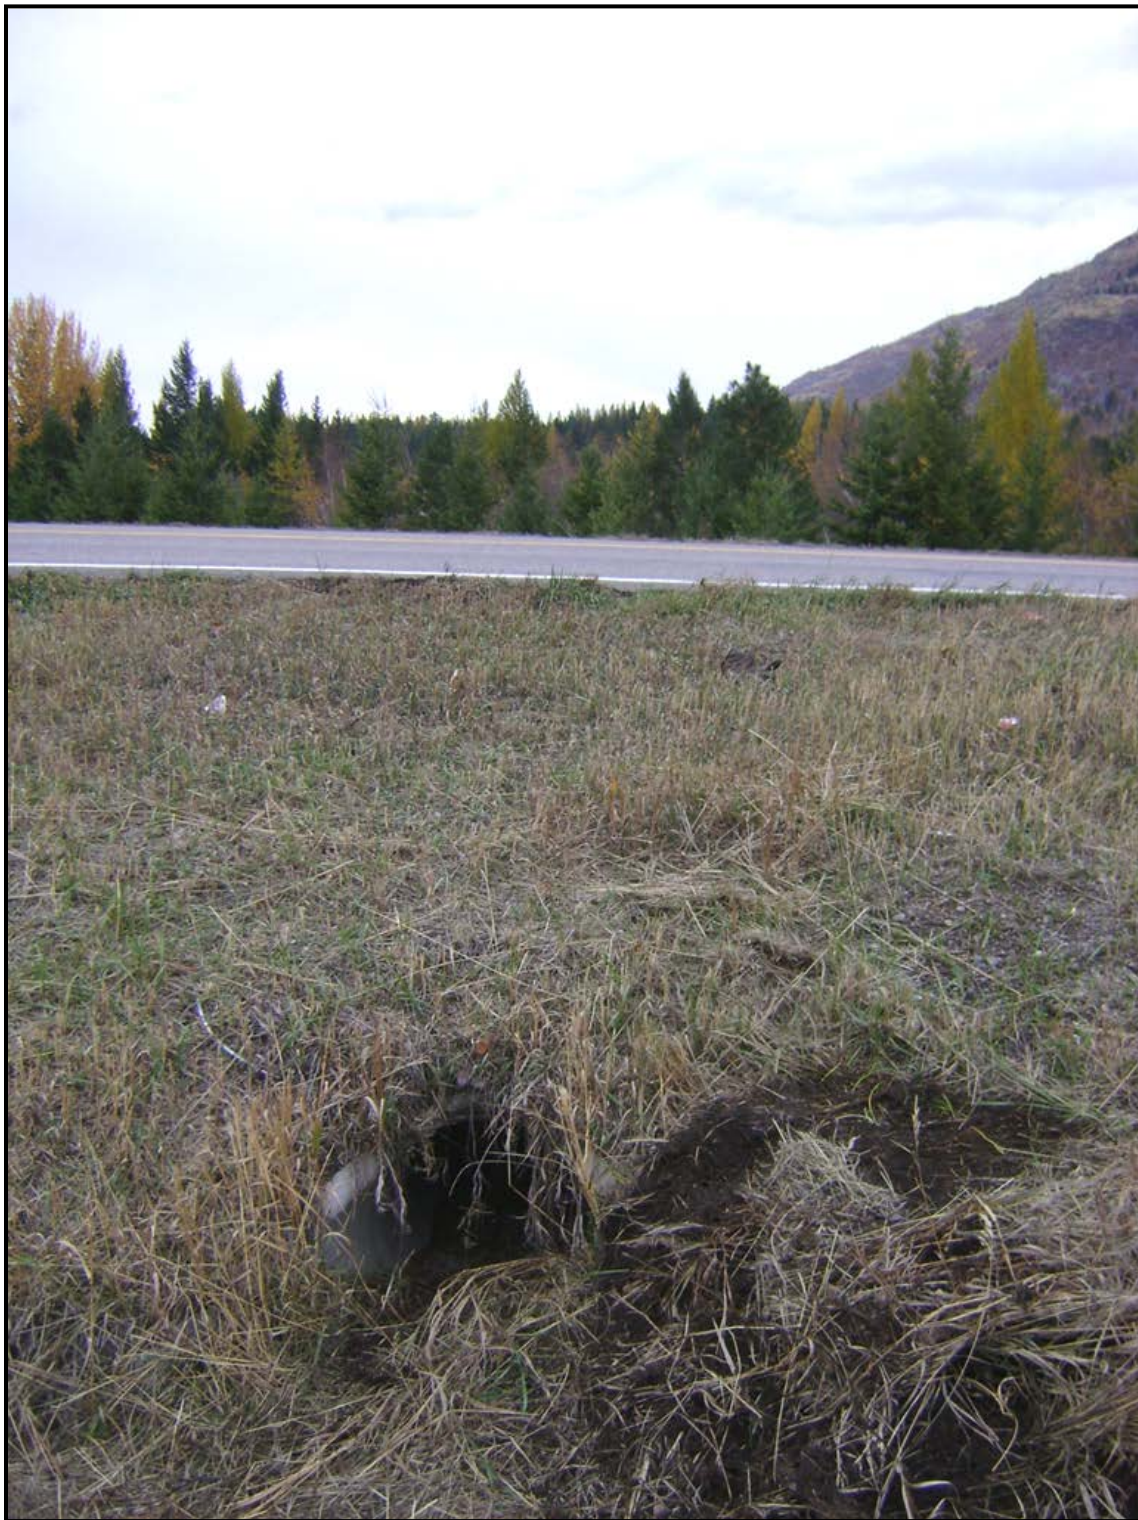
Photo 3. Single 18-inch corrugated metal pipe (CMP) on south side of US 2 at RP 140.1 (Sta. 21).

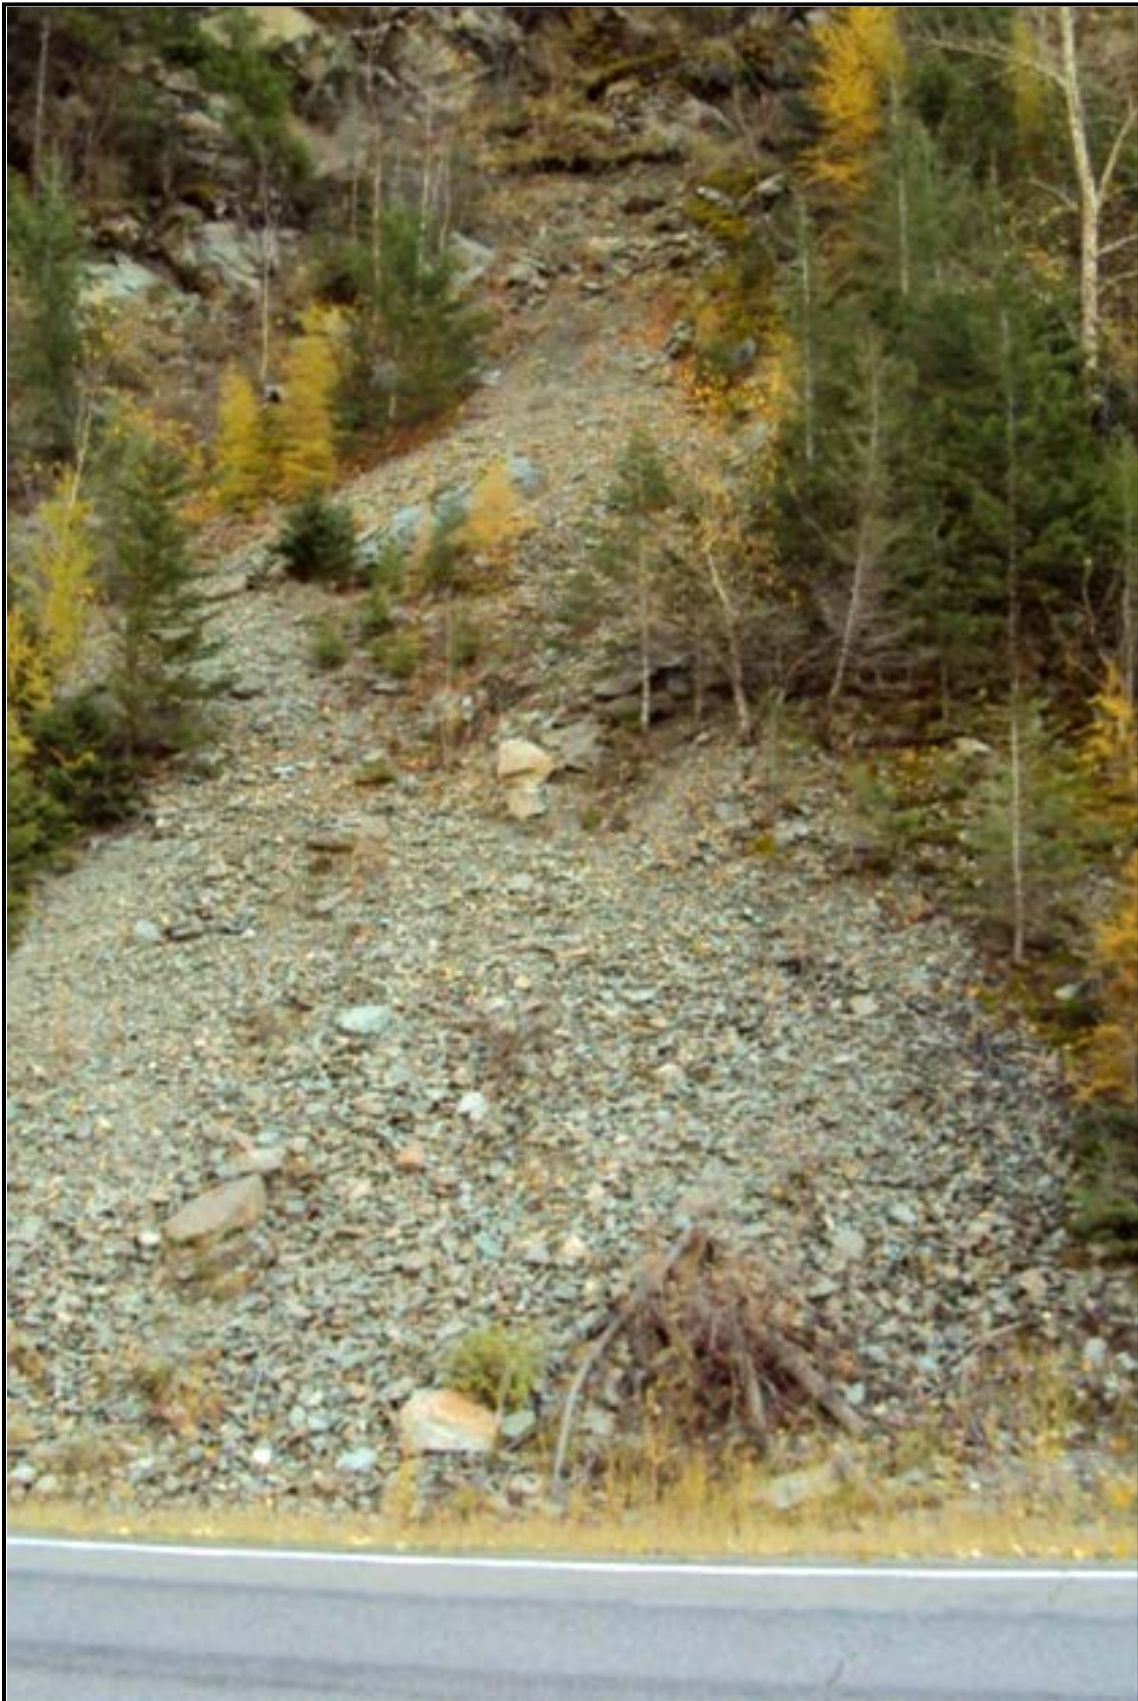
Photo 8. Unstable geologic features south of US 2. Potential for falling rock. RP 140.6 (Sta. 47).

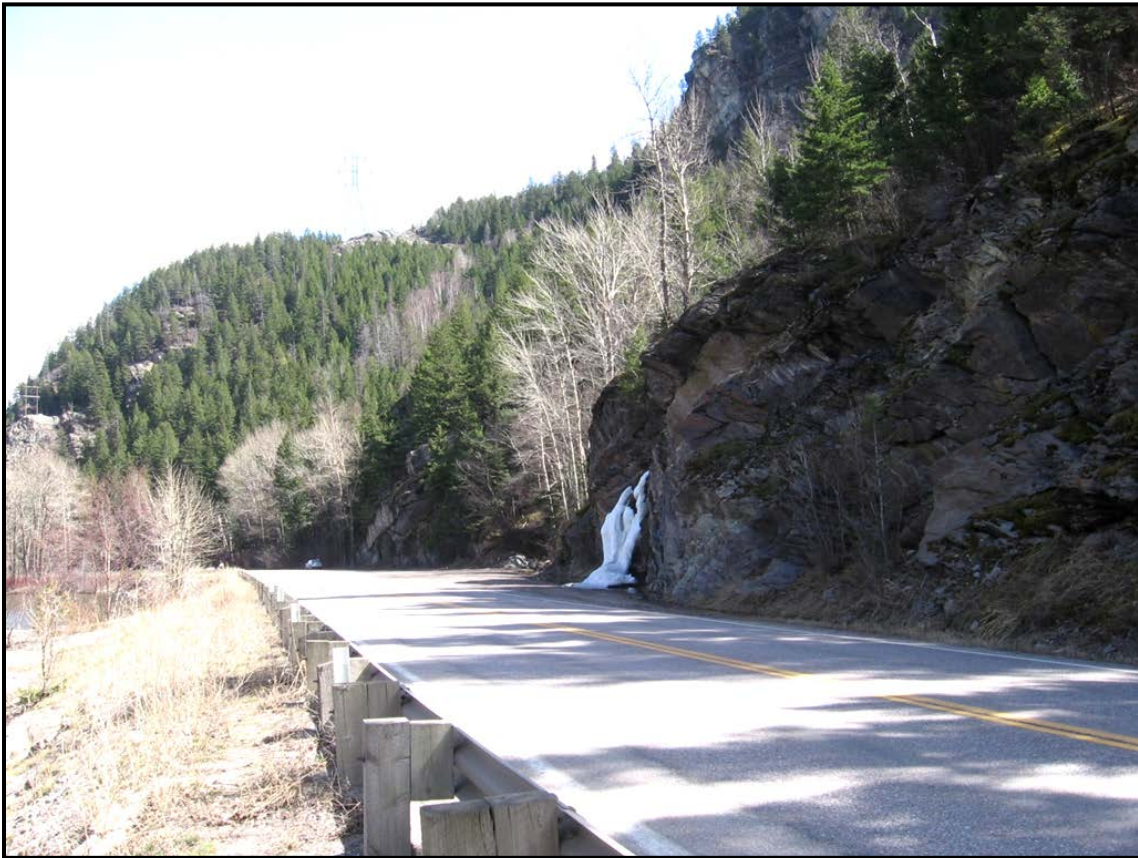
Photo 9. Looking east on the north side of US 2. Snow and ice on outcroppings to the south of US 2 may cause drainage issues. RP 140.6 (Sta. 47).

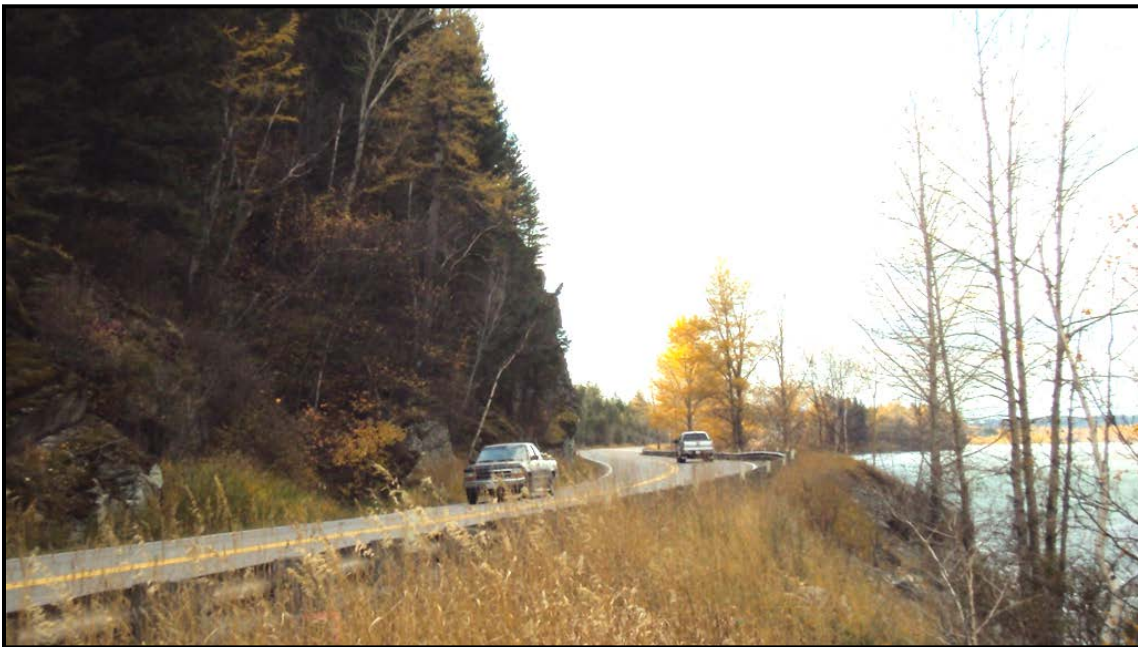
Photo 10. West outcropping along the south side of US 2, steep slope adjacent to river on the north side, and sharp horizontal curve. RP 140.7 (Sta. 50).

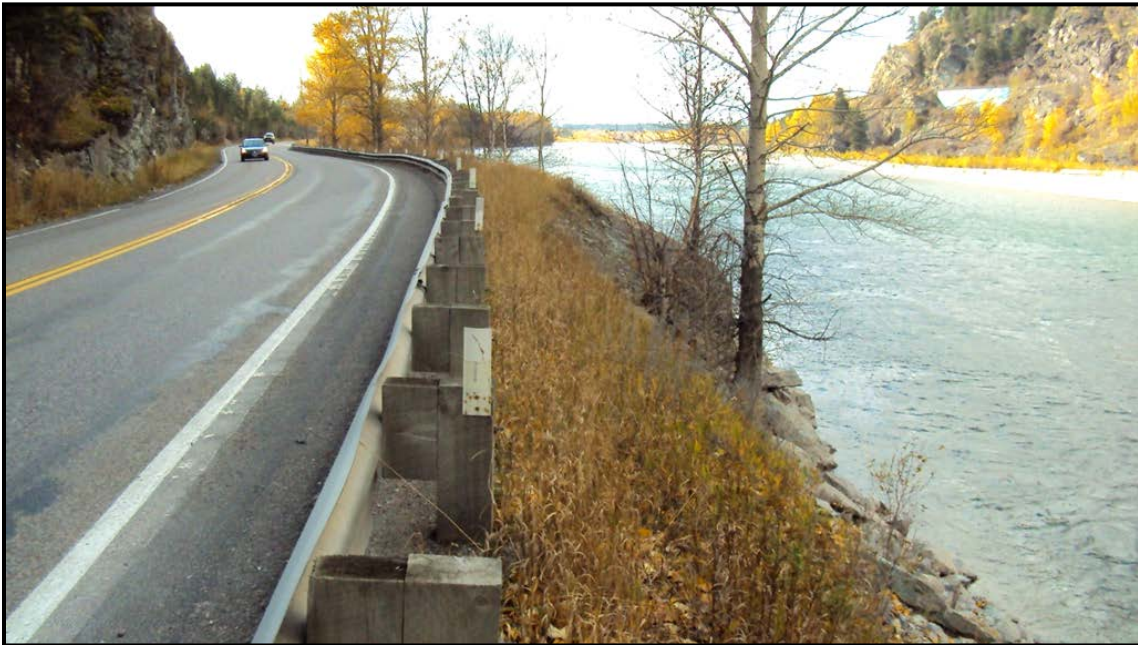
Photo 11. Steep slope adjacent to river on the north side of US 2. RP 140.7 (Sta. 50).

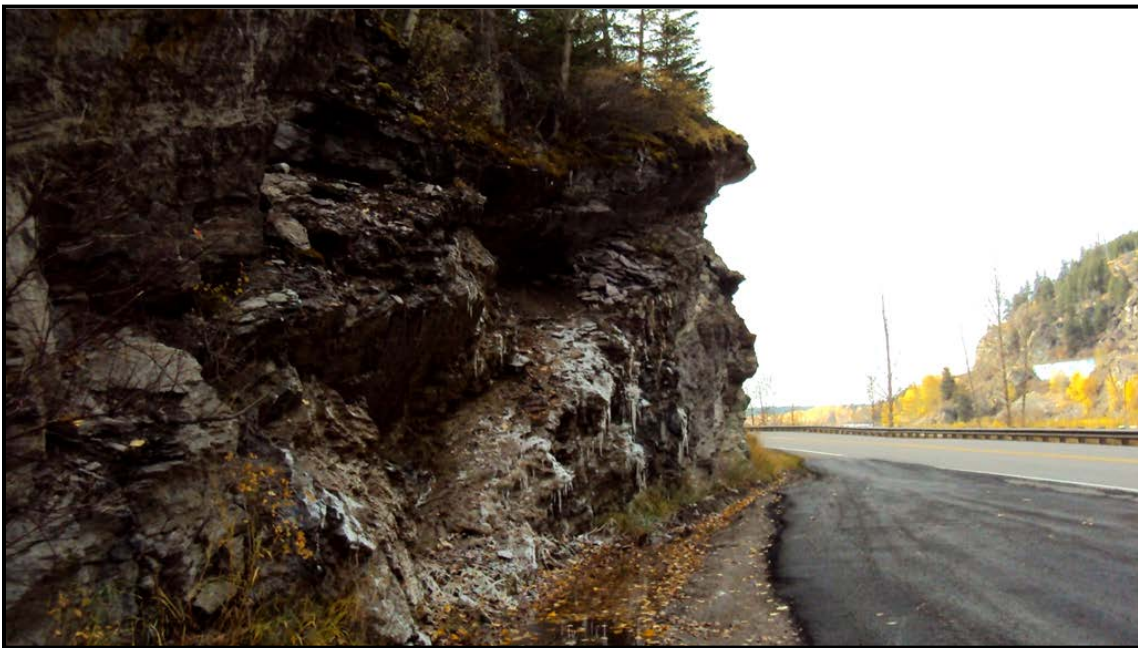
Photo 12. Icing on west outcropping on south side of US 2. RP 140.7 (Sta. 50).

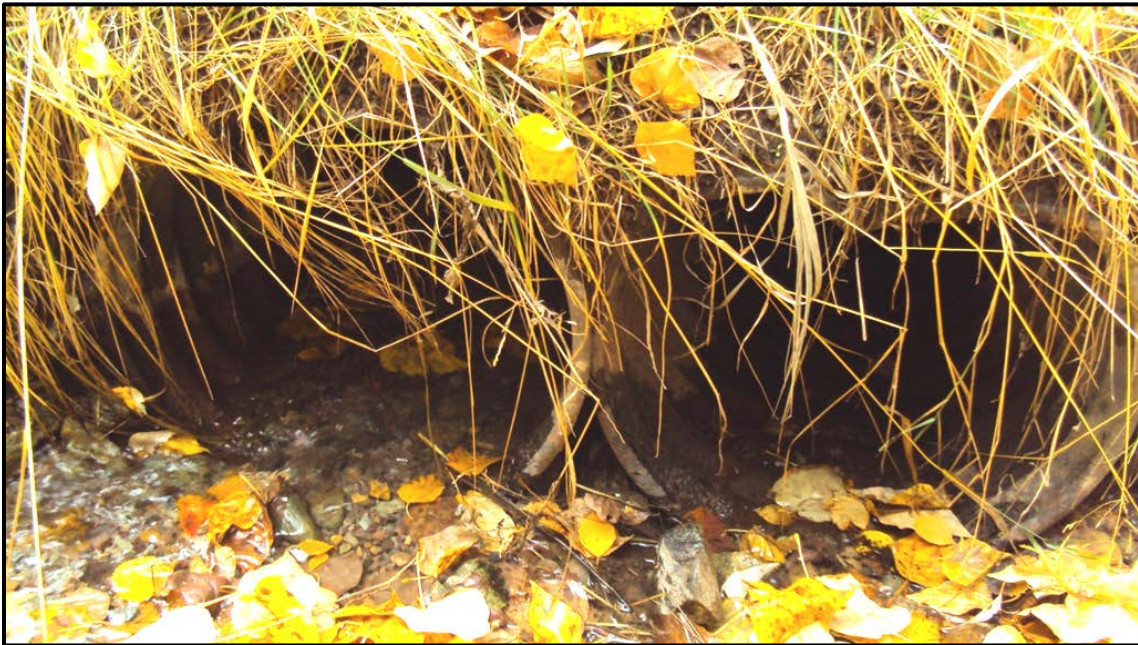
Photo 17. Two 18-inch CMP culverts south of US 2. RP 140.8 (Sta. 55).

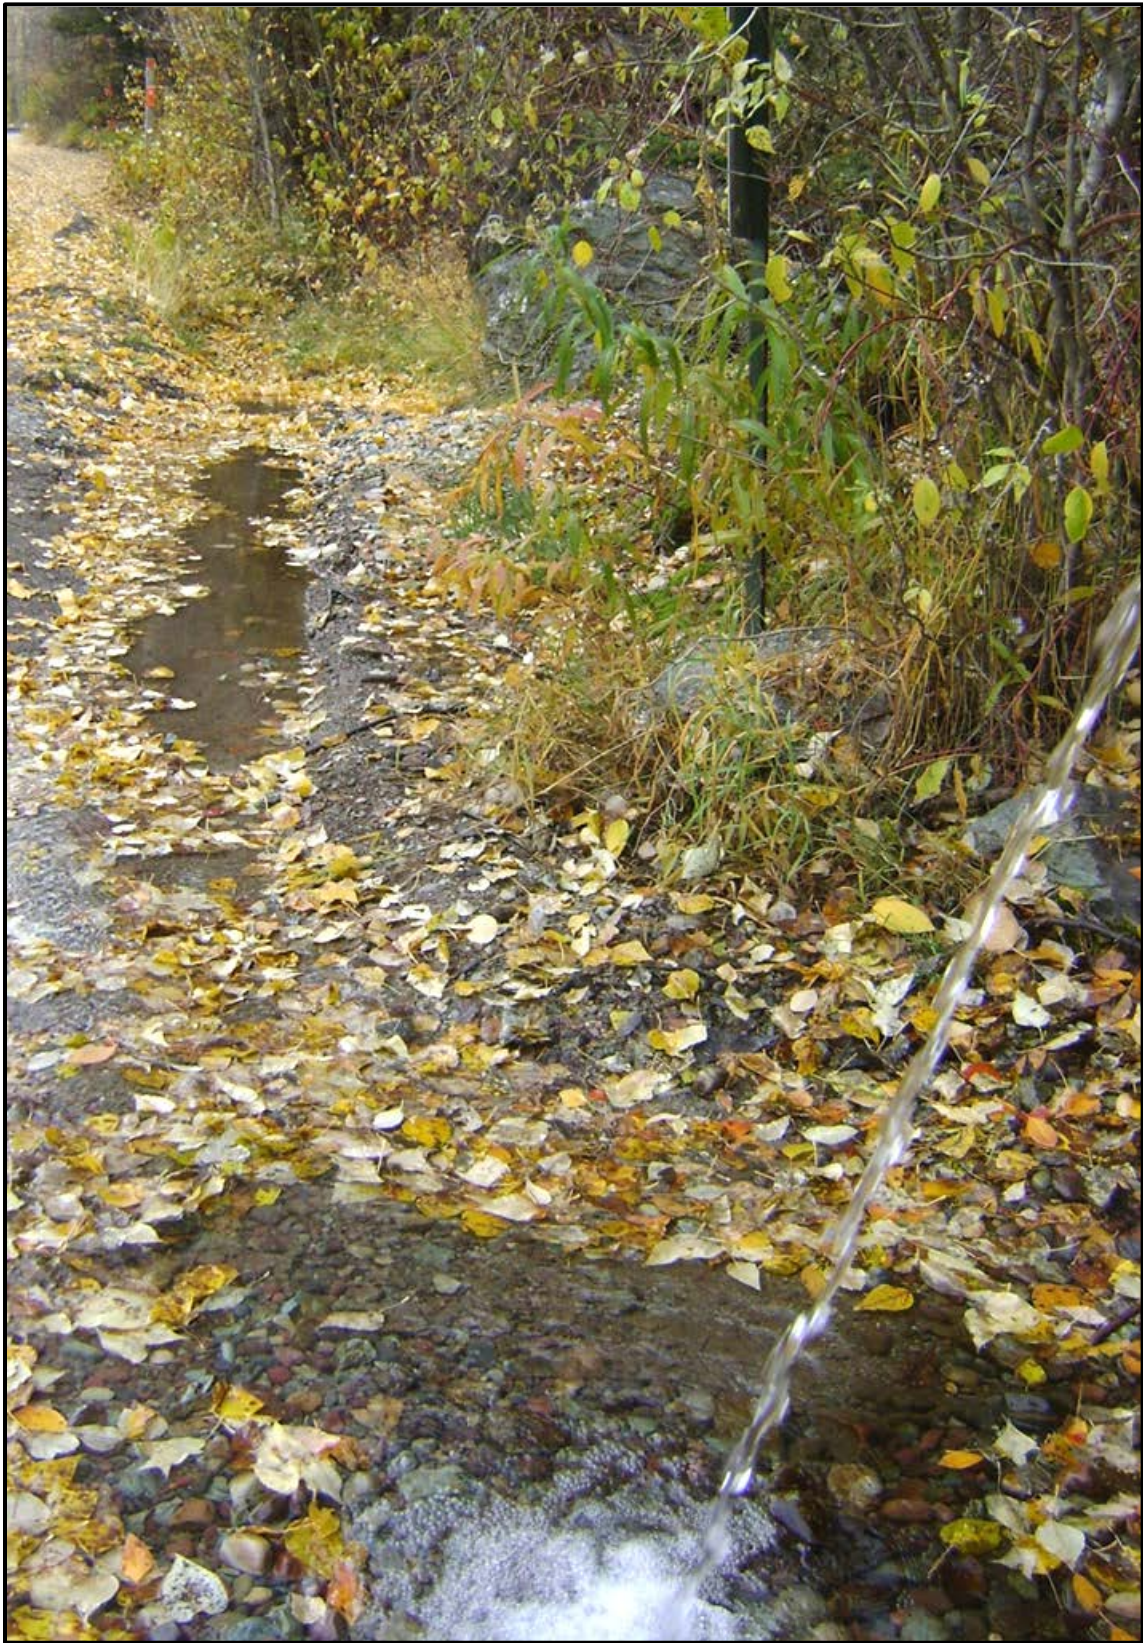
Photo 19. Drainage issues associated with Berne Memorial Park spring. RP 140.8 (Sta. 56).

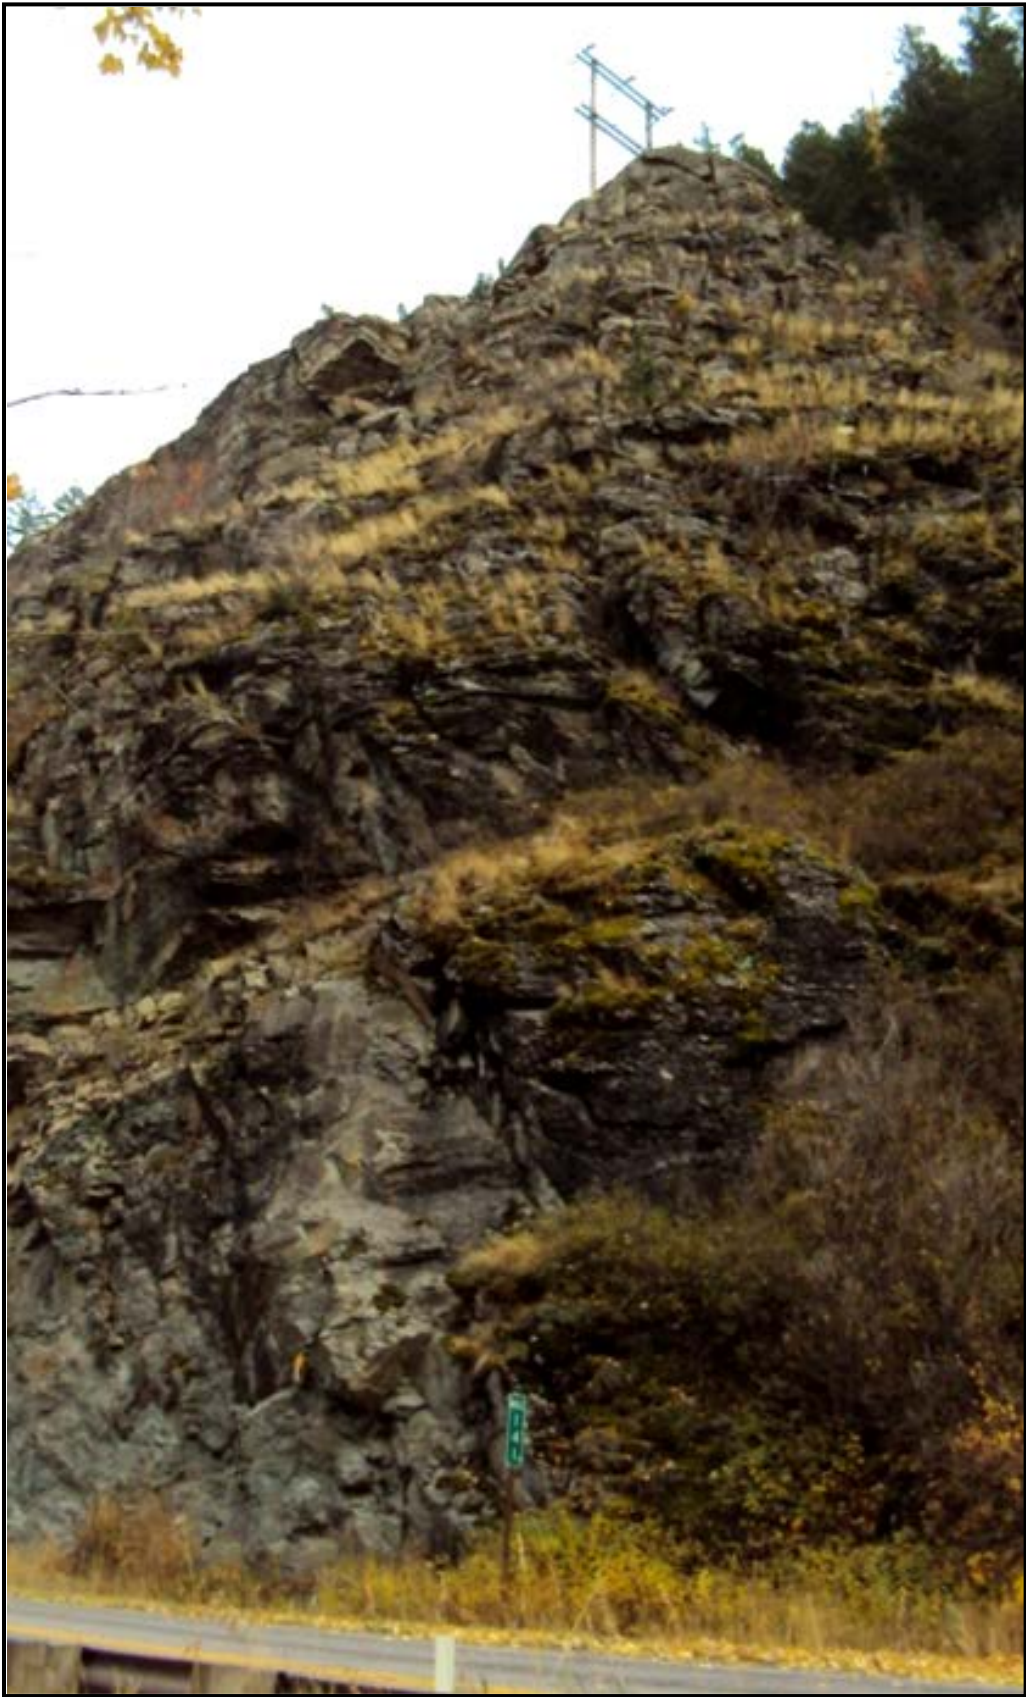
Photo 24. Reference Post 141 marker, power lines overhead, and east outcropping. Potential for falling rock. RP 141.0 (Sta. 65).

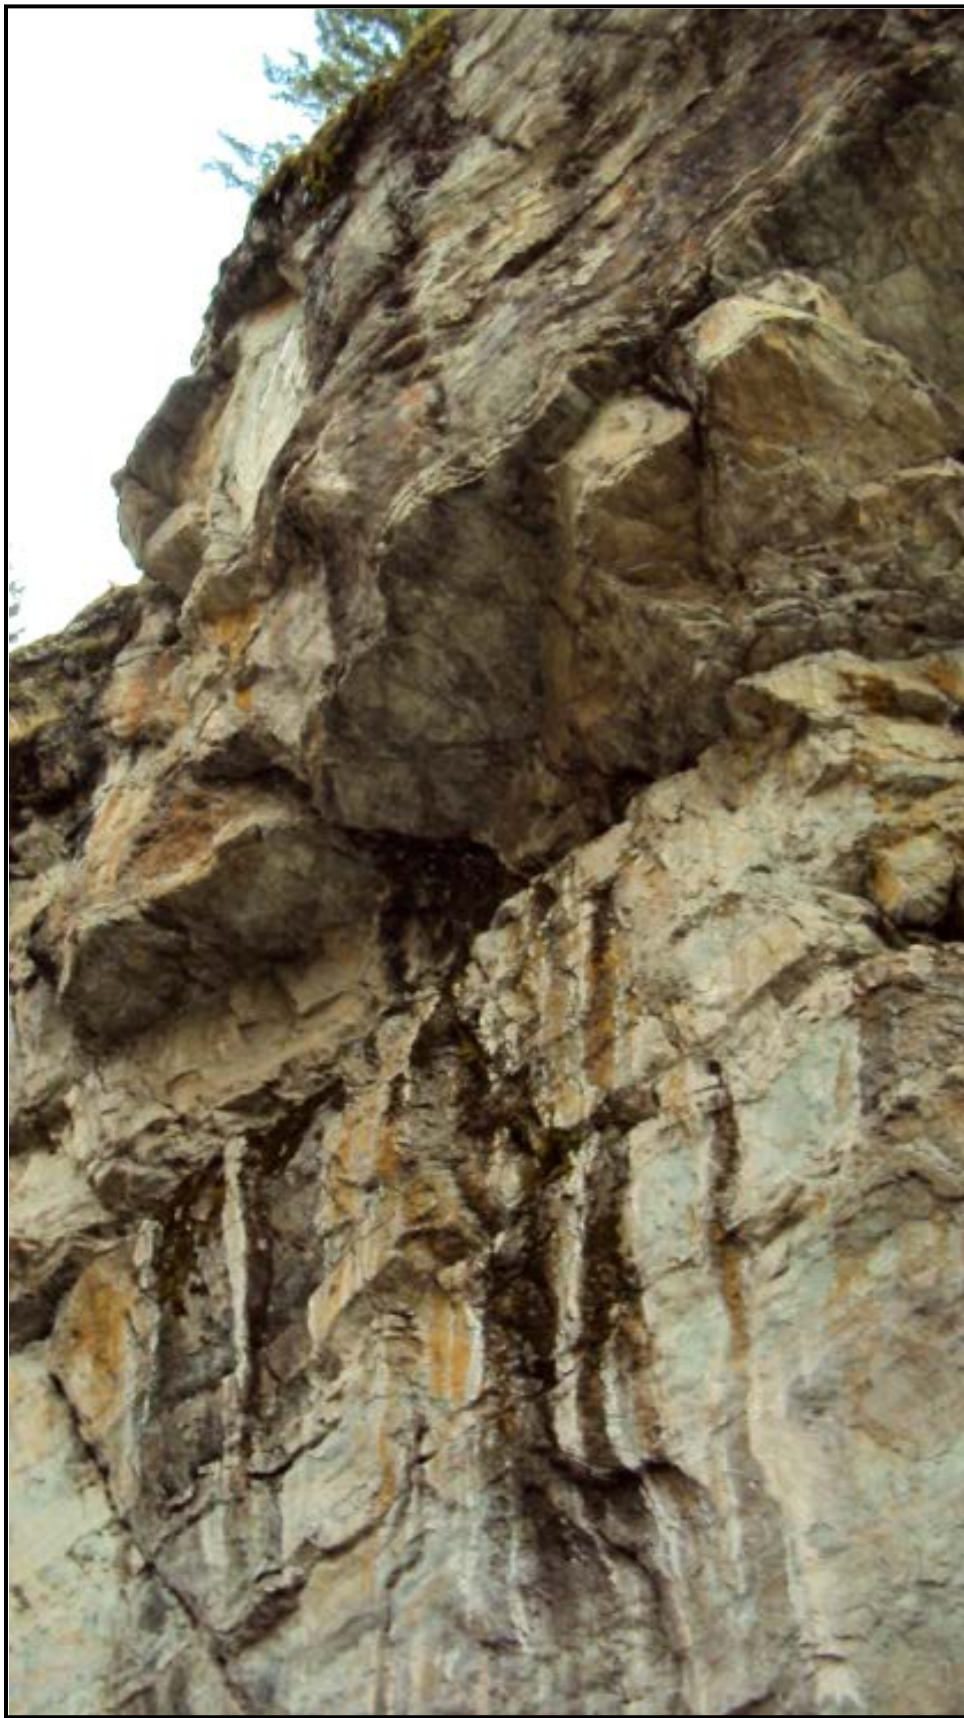
Photo 25. Evidence of water flow at east outcropping on the south side of US 2. Potential for falling rock. RP 141.1 (Sta. 67).

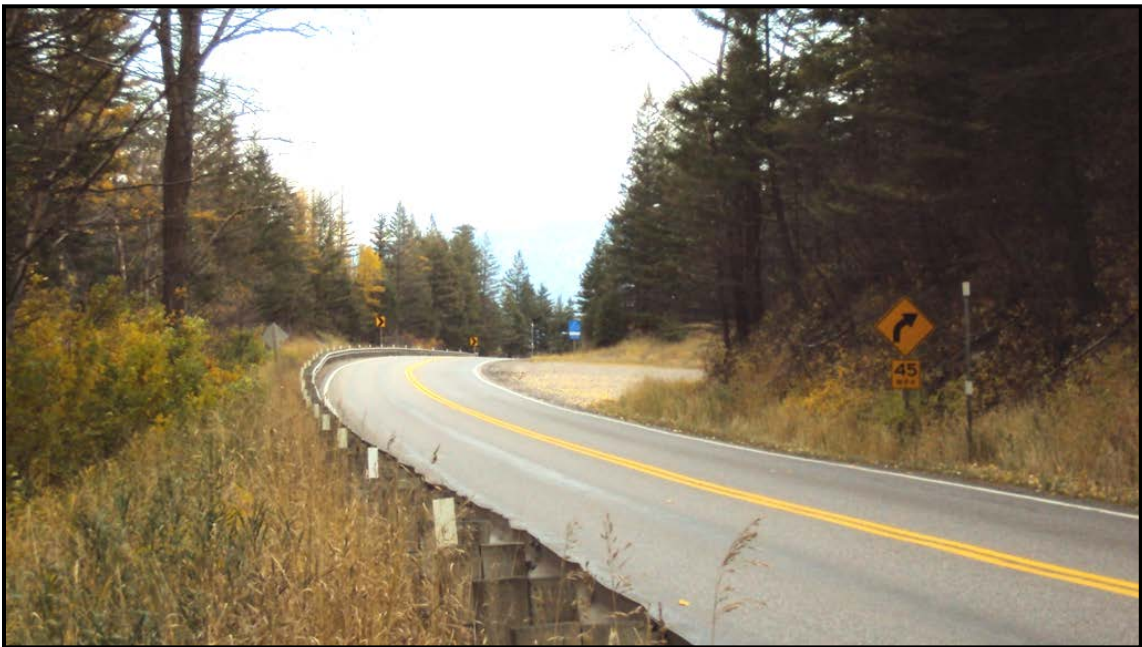
Photo 27. Looking east at a horizontal and vertical curve and a 45 mph warning sign. RP 141.2 (Sta. 70).

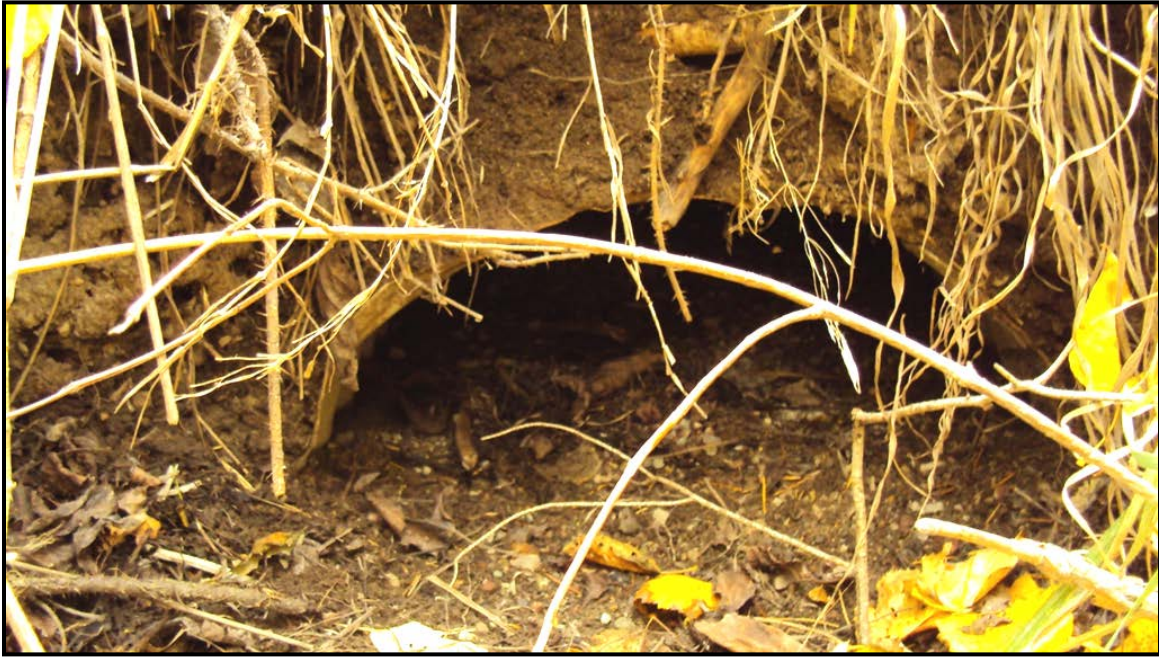
Photo 28. Single 18-inch CMP (approximately sixty percent buried) on the north side of US 2. RP 141.3 (Sta. 73).

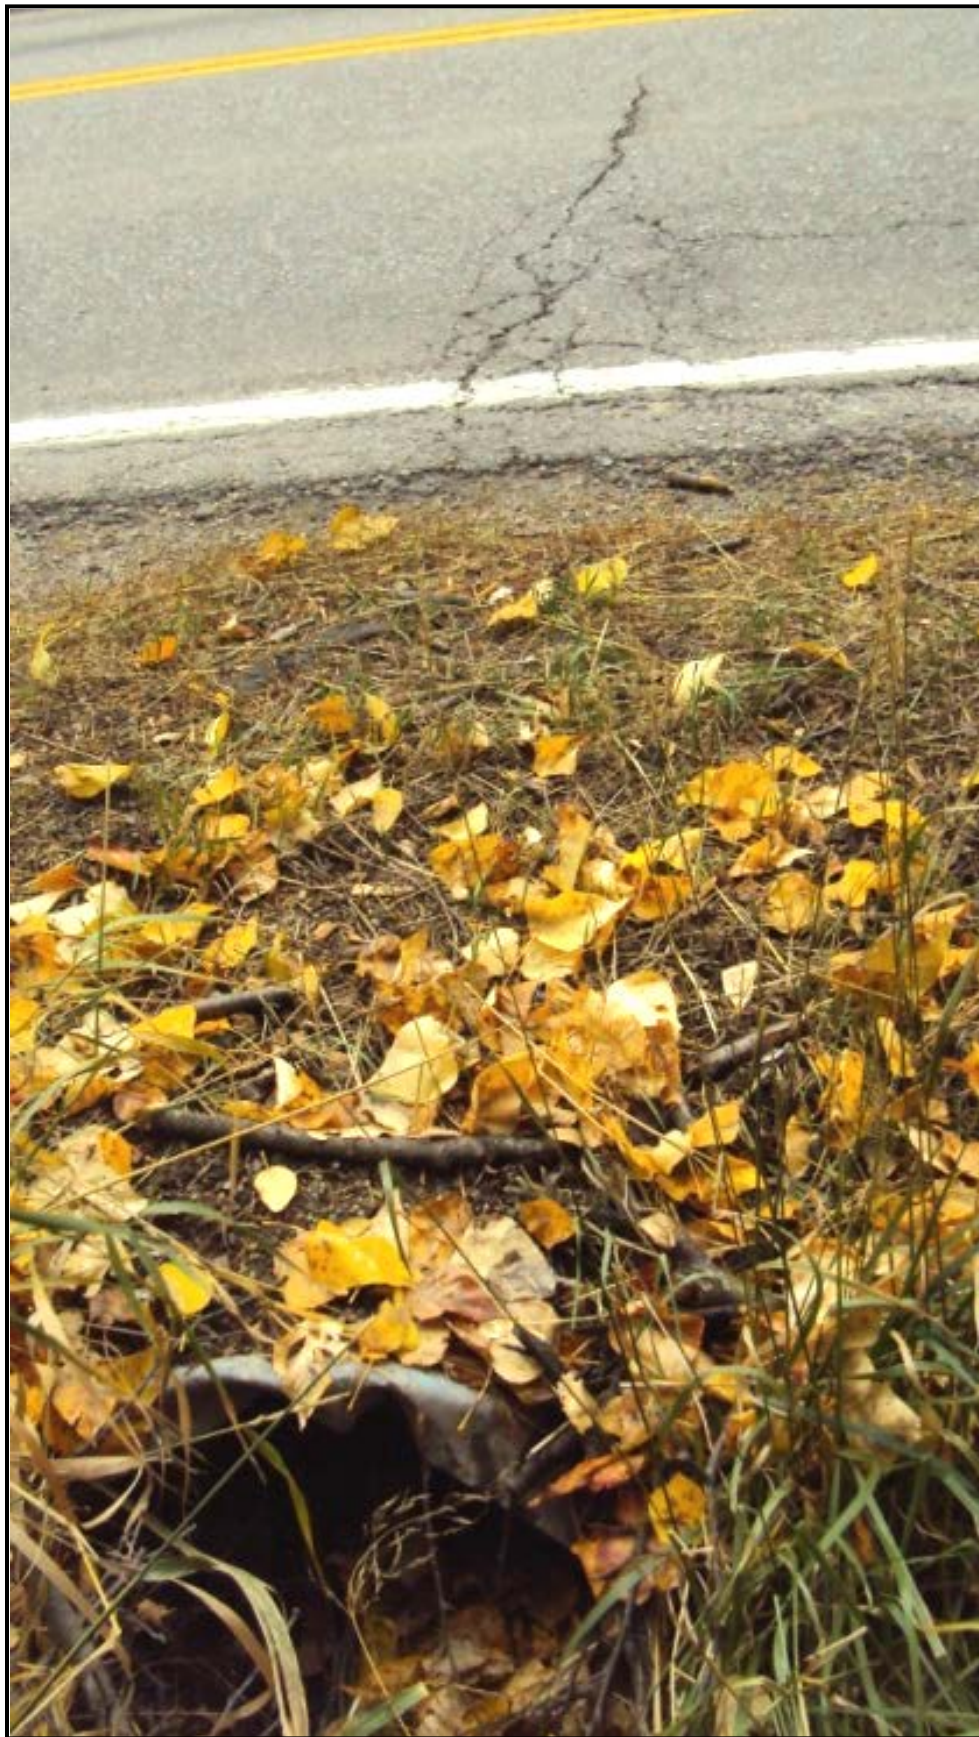
Photo 29. Single 18-inch CMP (approximately sixty percent buried) with minimal cover beneath roadbed on the south side of US 2. RP 141.3 (Sta. 73).

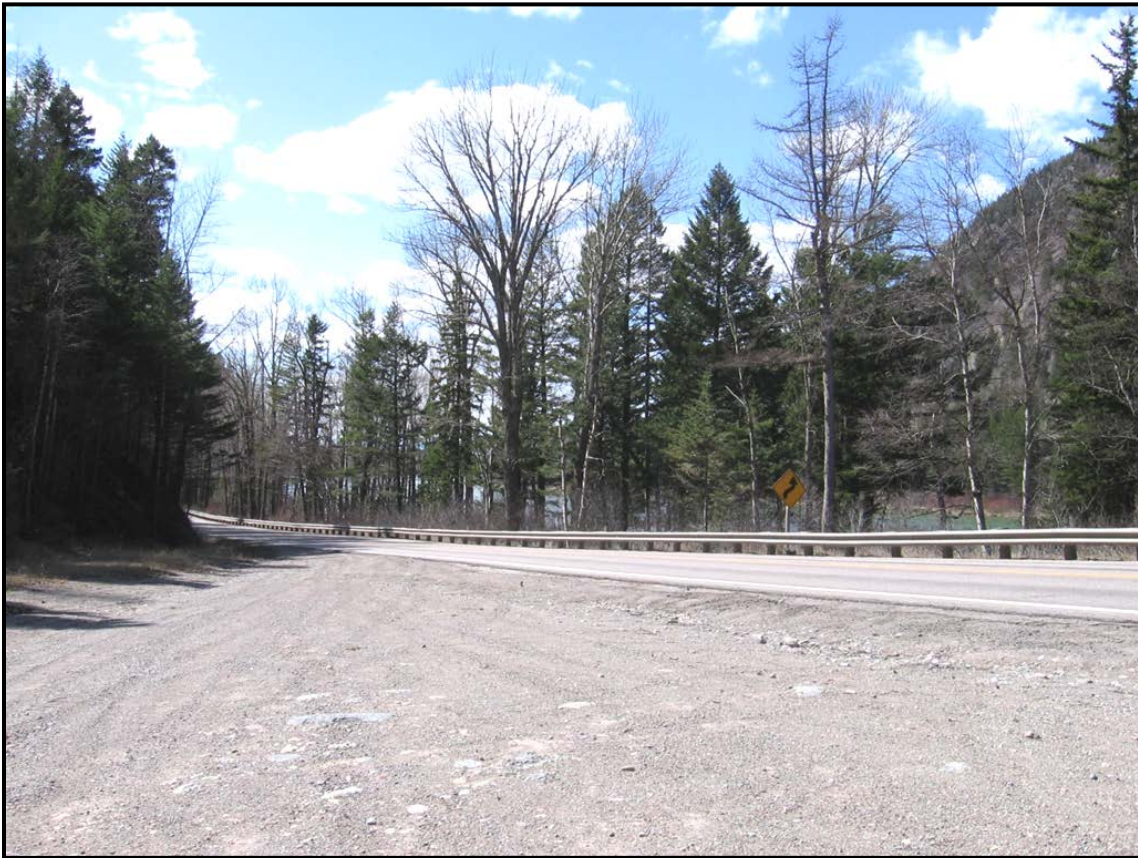
Photo 30. Looking northwest on the south side of US 2 at the east pullout. Roadside drainage issues are visible alongside the south side of the road. RP 141.3 (Sta. 75).

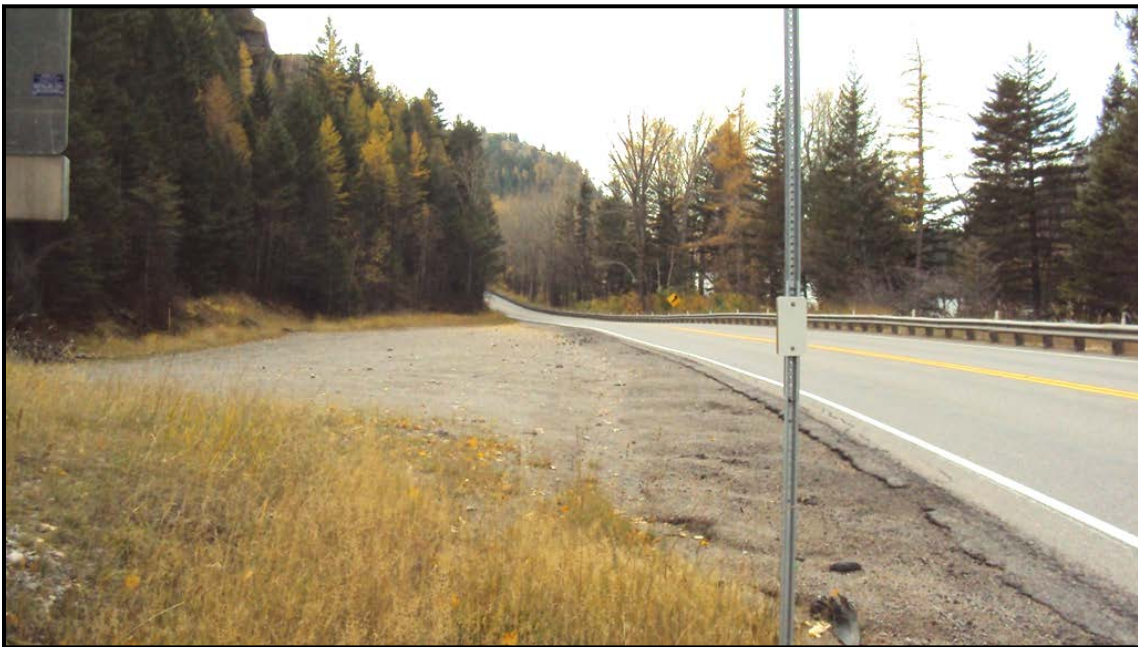
Photo 31. Roadside drainage issues along south side of US 2 looking west at the east pullout. RP 141.3 (Sta. 75).

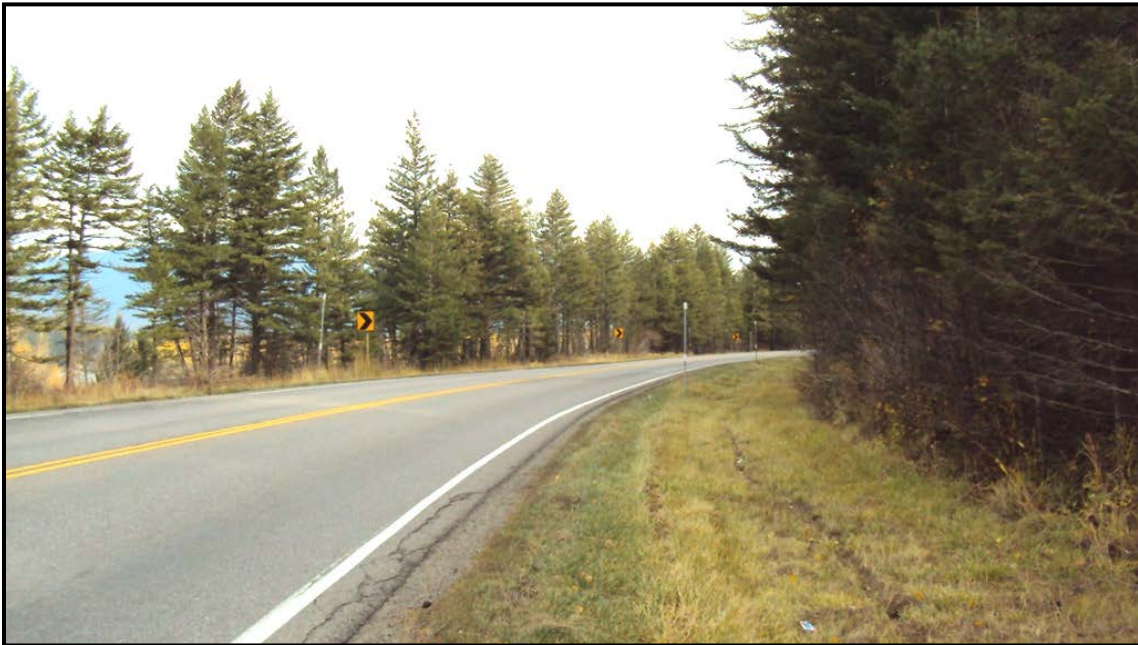
Photo 32. Horizontal curve and extended snow reflectors. RP 141.3 (Sta. 77).

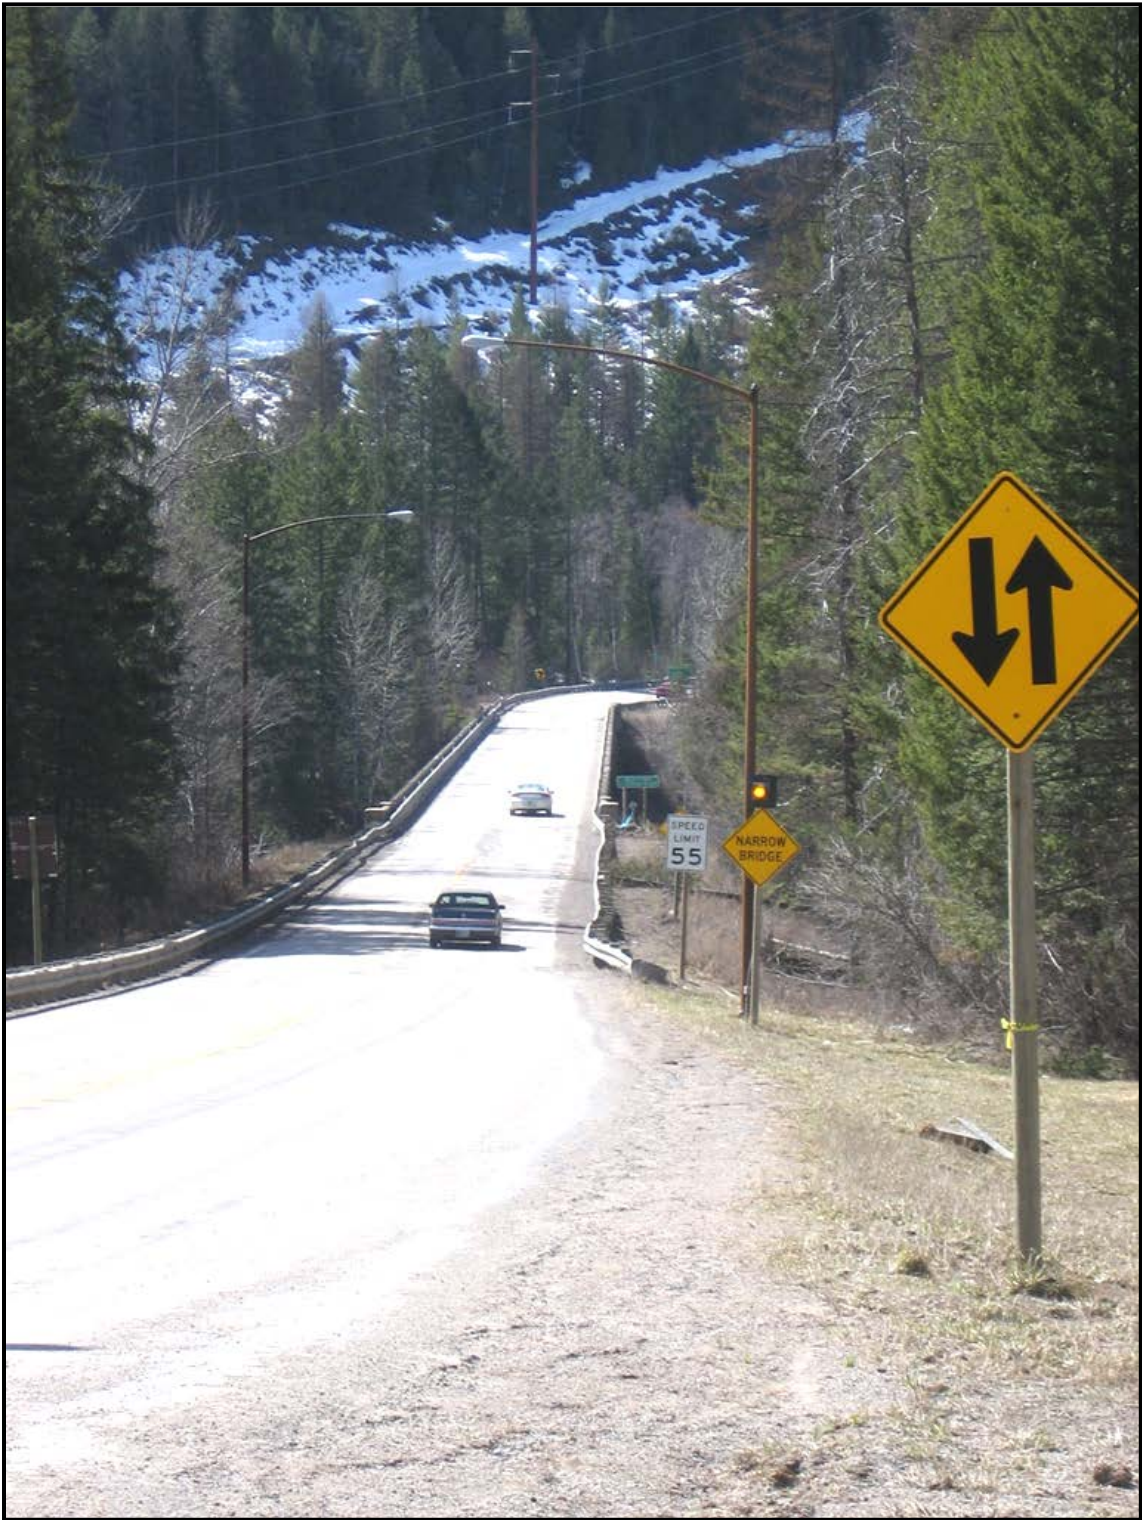
Originally constructed in 1938, the bridge has five main spans and two approach spans, with a deck width of 26 feet. Recent scheduled bridge inspections have noted some deterioration,

Photo 40. Looking west at the narrow bridge deck over the South Fork of the Flathead River. RP 142.0 (Sta. 120).

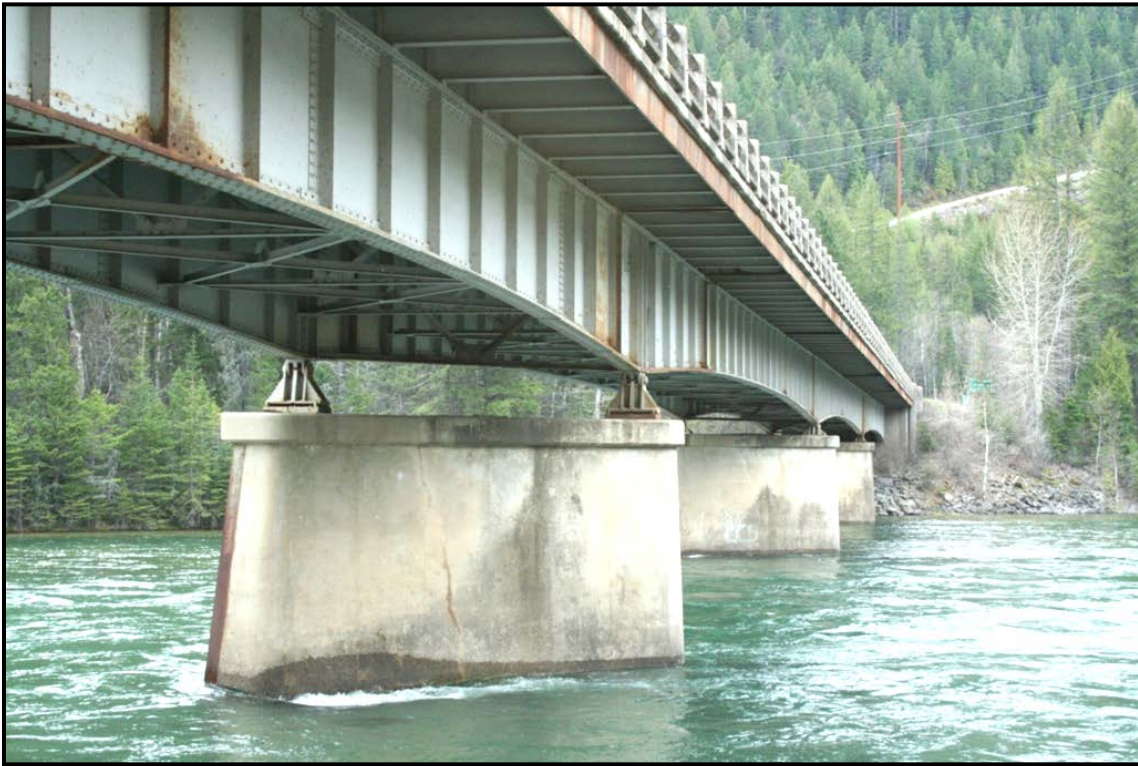
including concrete deck cracking and spalling (i.e., a depression in the surface of a concrete slab resulting from fracture), exposed reinforcing bars, and rusting of steel components. The bridge is functionally obsolete and structurally deficient.

Photo 41. Looking east under the bridge over the South Fork of the Flathead River that is showing signs of corrosion. RP 142.1 (Sta. 129).
