Biological Assessment

South Avenue Bridge Project

Bitterroot River - W of Missoula

BR 9032(65)

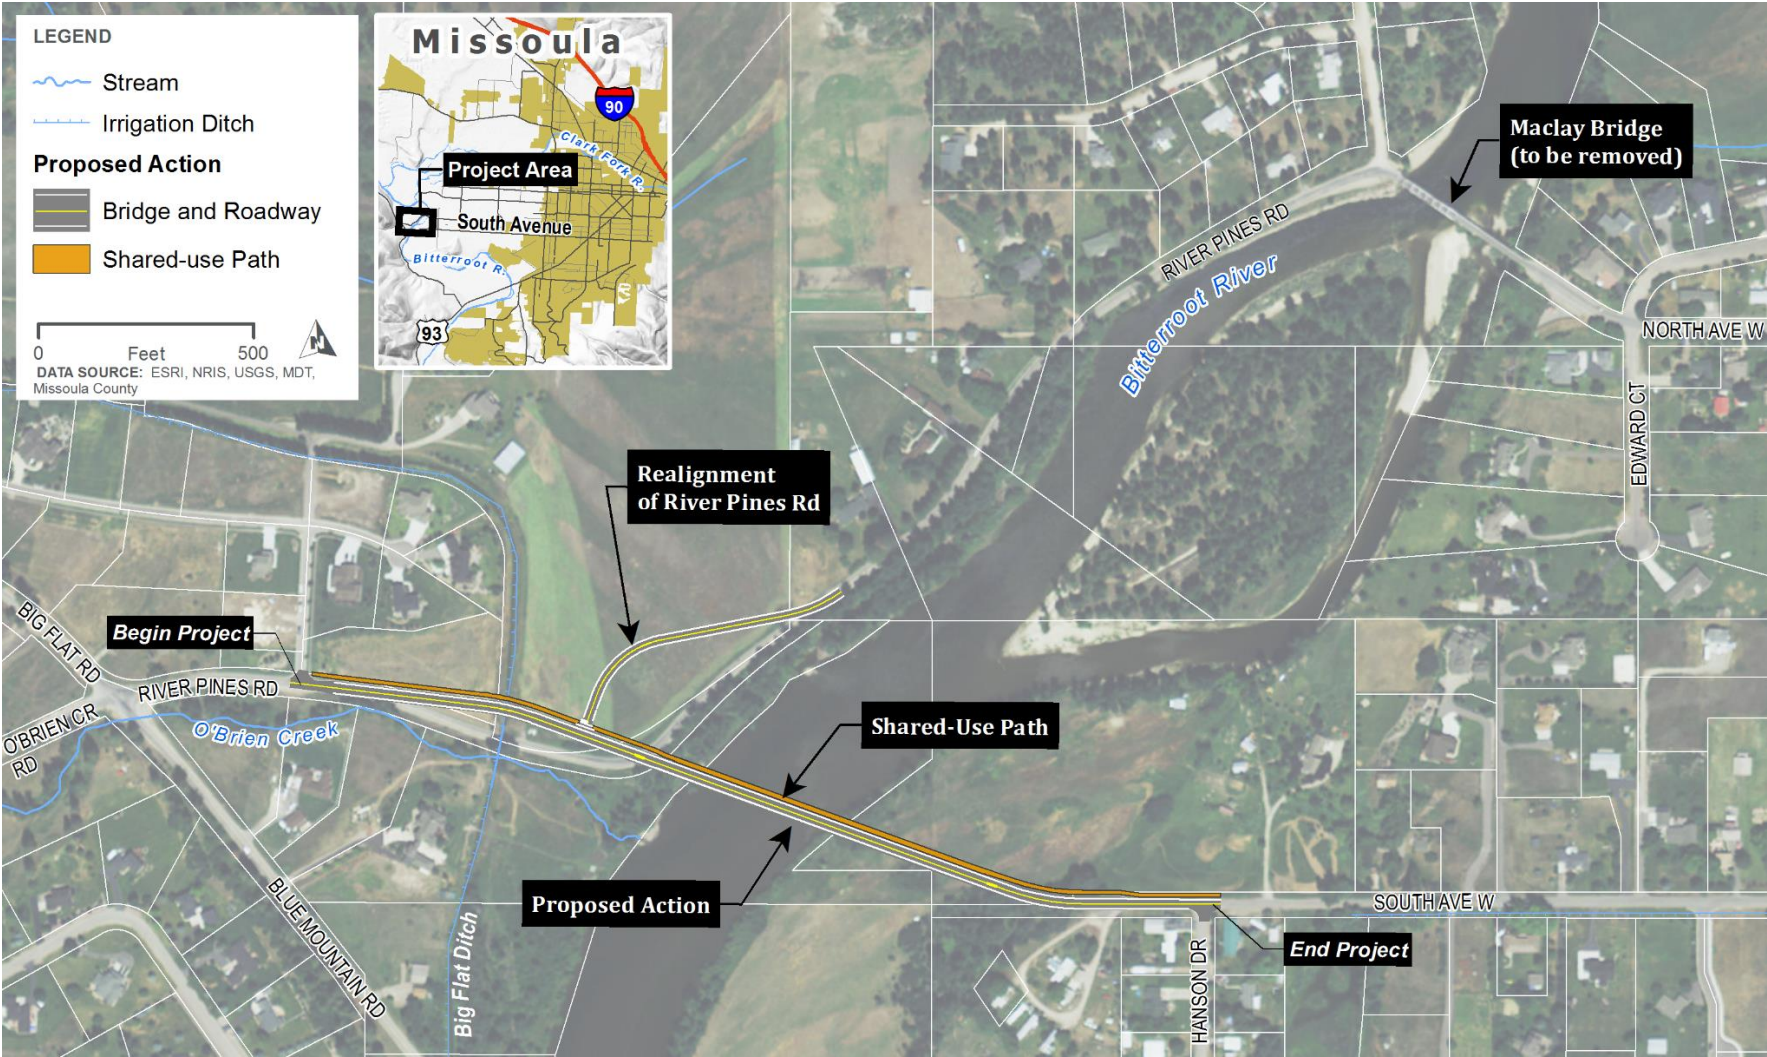
Figure 1-1. Proposed Project and Project Area

Missoula County, in cooperation with the MDT and Federal Highway Administration (FHWA), is proposing to construct a new bridge across the Bitterroot River at the western terminus of South Avenue to connect with River Pines Road immediately west of the river. The proposed South Avenue Bridge will involve construction of a new 2-lane bridge (one travel lane in each direction) that provides for bicycle/pedestrian accommodations separated from vehicular traffic. The project limits extend between the intersection of South Avenue and Hanson Drive to the east and the intersection of River Pines Road and Blue Heron Lane to the west. The proposed project includes new right-of-way (ROW) acquisition. The project includes removal of the existing single-lane Maclay Bridge on North Avenue located approximately 0.4 mile downstream of the proposed bridge. The proposed project and associated study area are shown in Figure 1-1.

Construction of the project is anticipated to occur over two seasons, with construction of the new bridge occurring in year one and removal of the Maclay Bridge in the second year. Work within the river would be scheduled to occur during the summer in-water work window (July 1 through September 30) (USFWS 2015a). The methods for constructing the new bridge and removing Maclay Bridge are currently unknown and would depend largely on contractor approach. It is likely that the extent of in-water work could include temporary work structures such as cofferdams, diversion blocks, work trestles, or other means to access and work within, or over, the Bitterroot River. To the extent possible, construction staging for the project will occur within existing ROW and limited to previously disturbed areas. Additional details specific to each major work element are further described below.

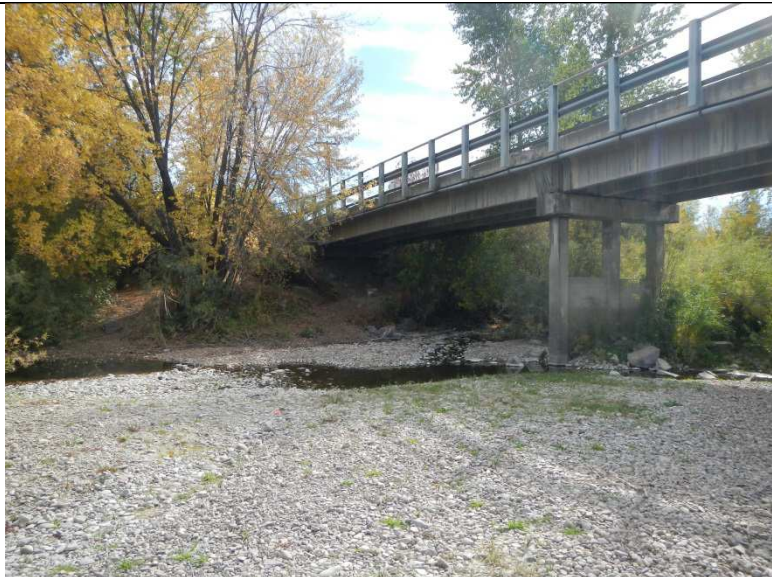
Photo 9. Maclay Bridge, looking at right bank abutments

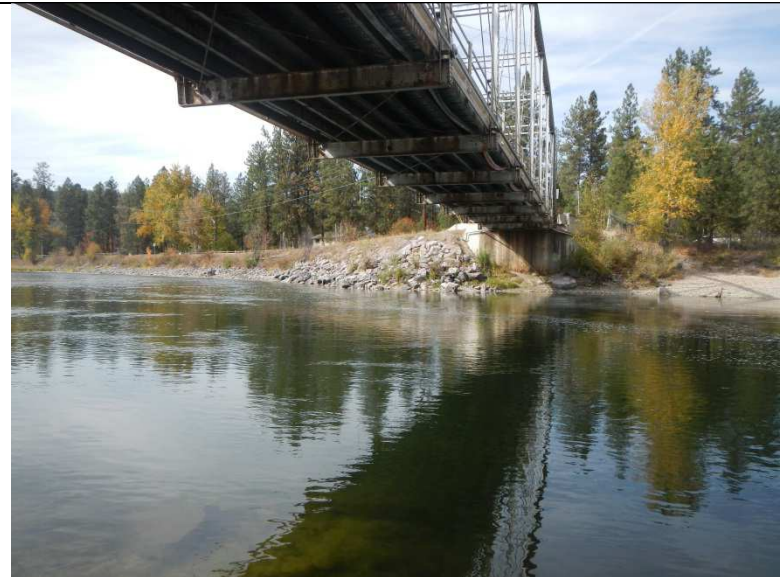
Photo 10. Maclay Bridge, looking across Bitterroot River at left bank.

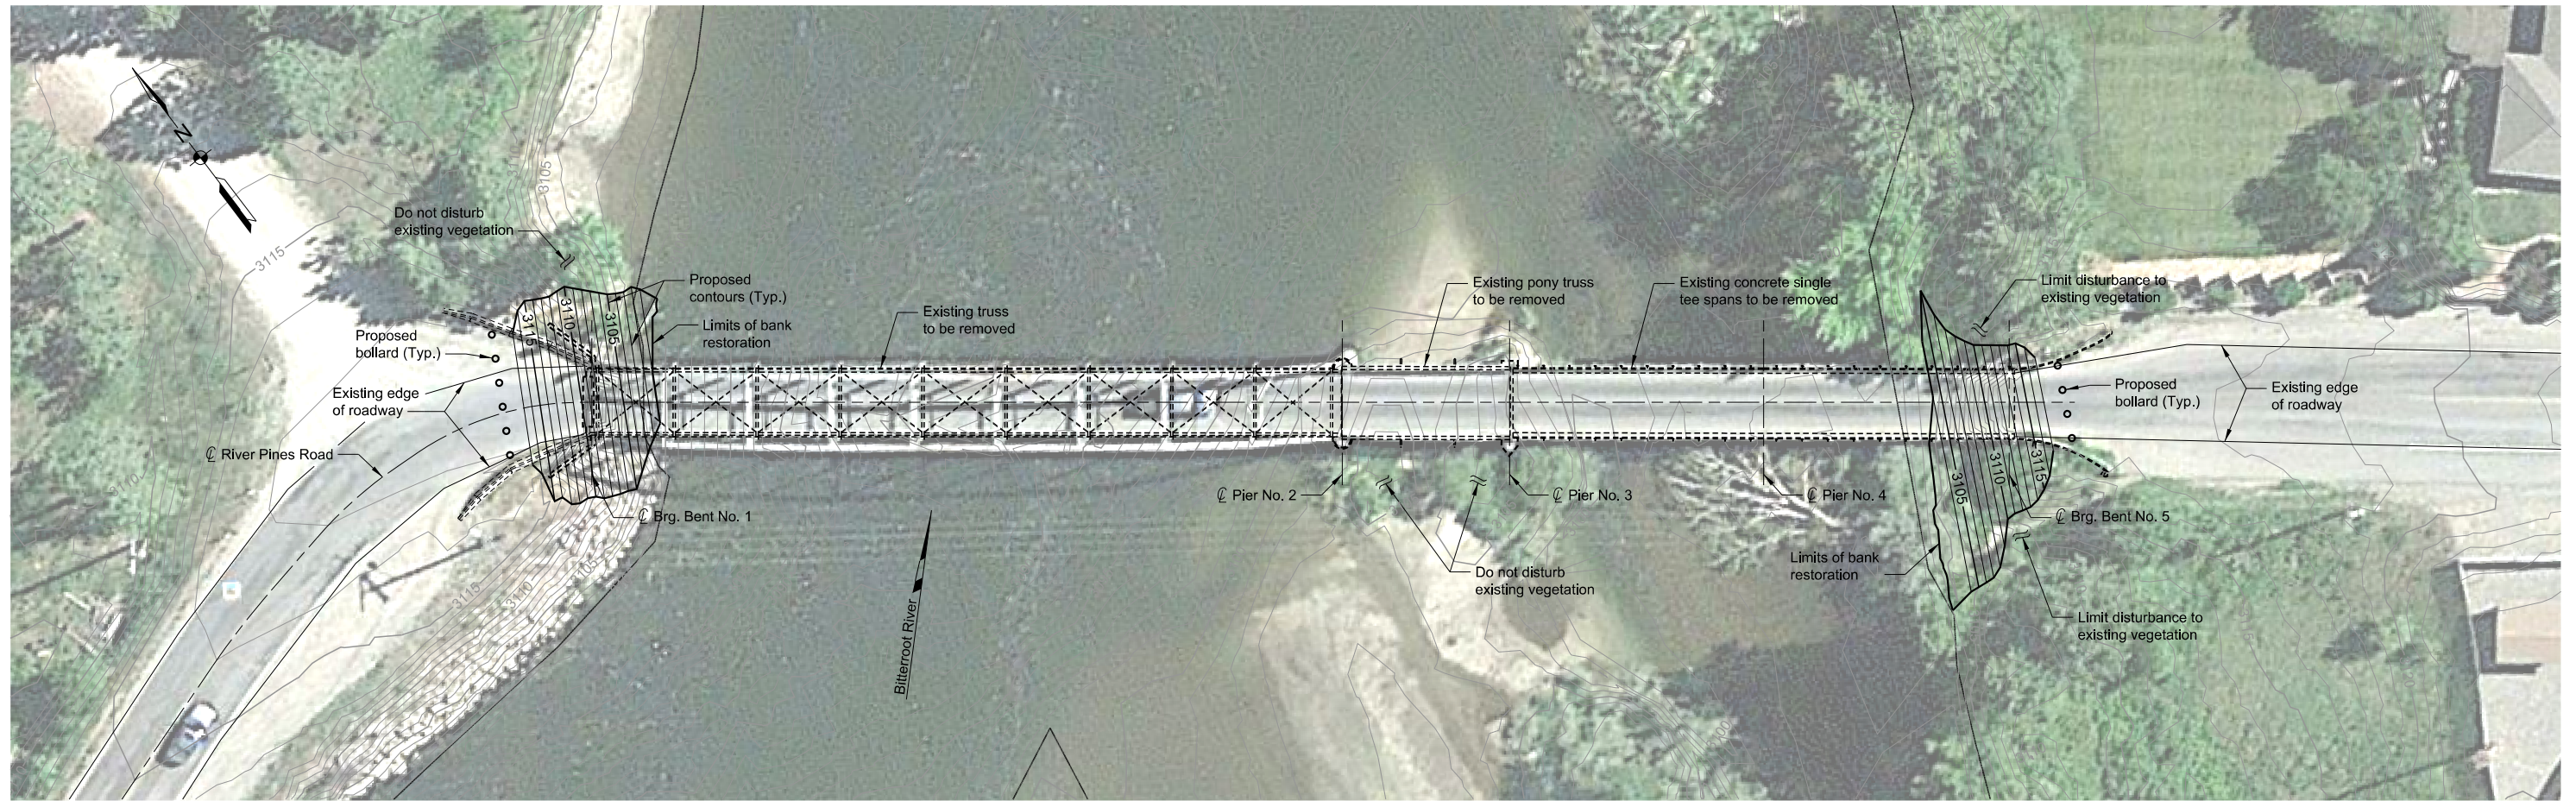
PLAN

Drift:	High
Pier Scour (Q100):	11.4'
Contraction Scour (Q100):	0.0'
Ice:	Yes
Drainage Area:	2,842 sq. mi.
2-year Stage (Q2):	3111.92
Base Flood Flow (Q100):	31,800 cfs
Base Flood Stage:	3115.51
Base Flood Velocity:	4.6 fps
Low Beam Elevation:	3118.33
