## **South Avenue Bridge**

**Public Informational Meeting #2 – Big Sky HS Cafeteria  
August 16, 2016**

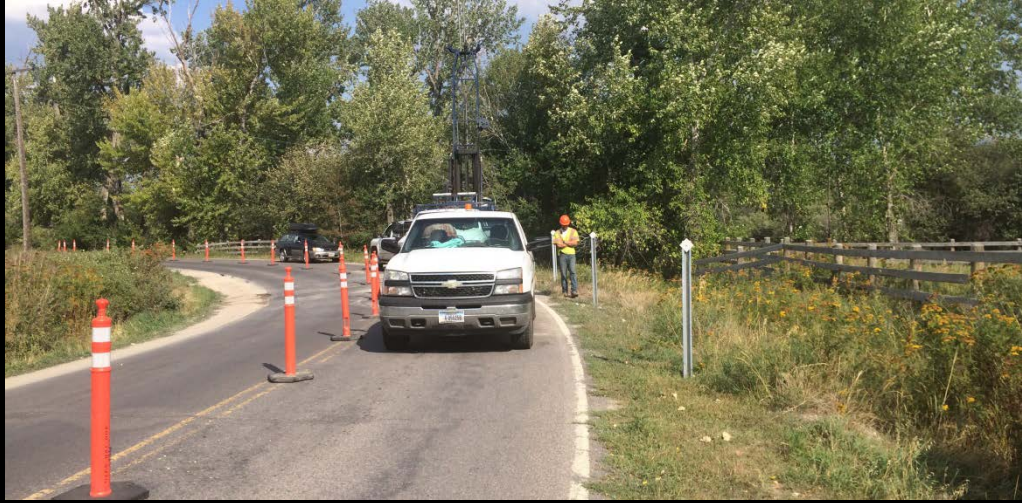
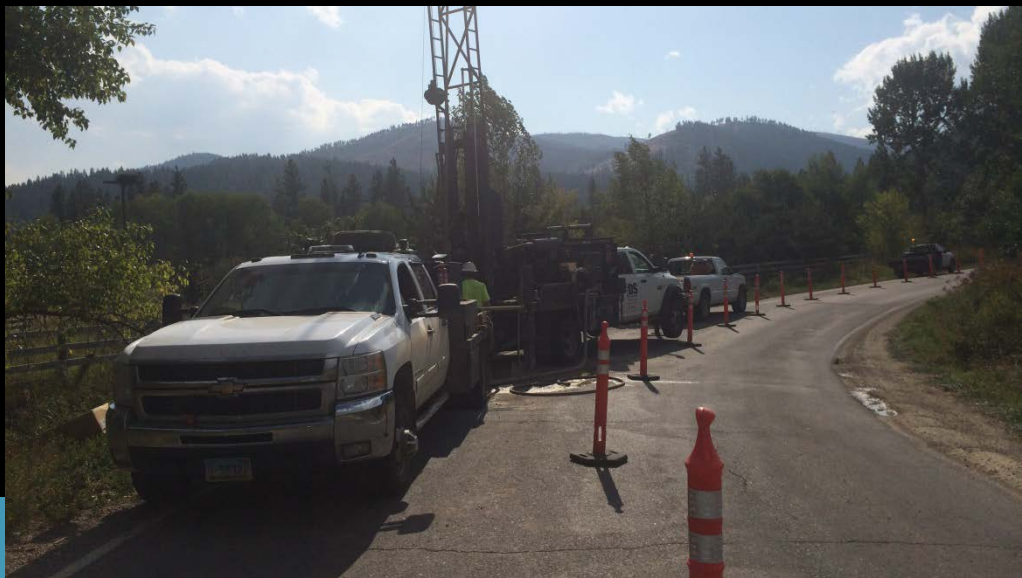
- Tetra Tech drilled two holes within legal rights-of-way
- Preliminary Geotechnical Report is complete
- Additional borings will likely be needed to provide final geotechnical recommendations
- Final report to be posted on website once review is completed

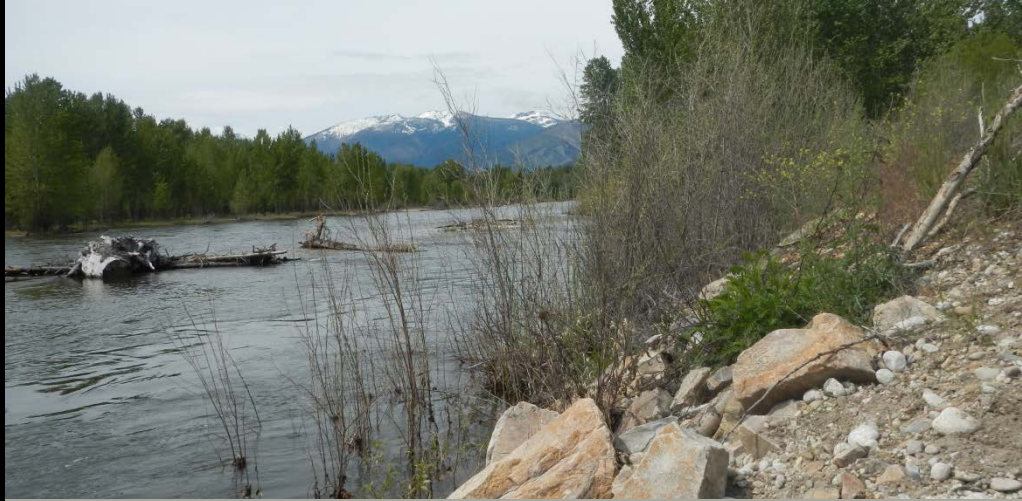
- No net rise anticipated on the Bitterroot River due to the proposed bridge
- Minor grading in the overbank and possible need for occasional low maintenance
- Preliminary report to be posted to website once review is completed

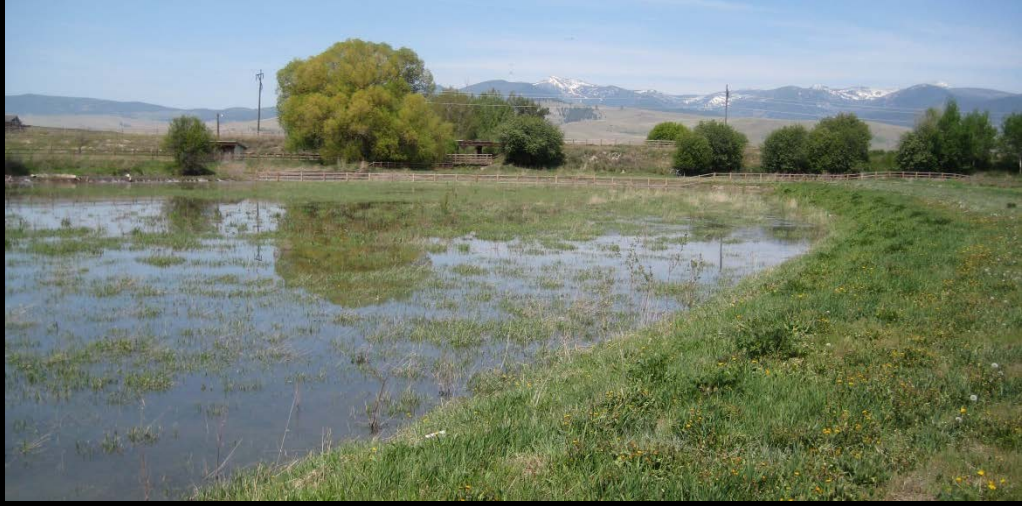
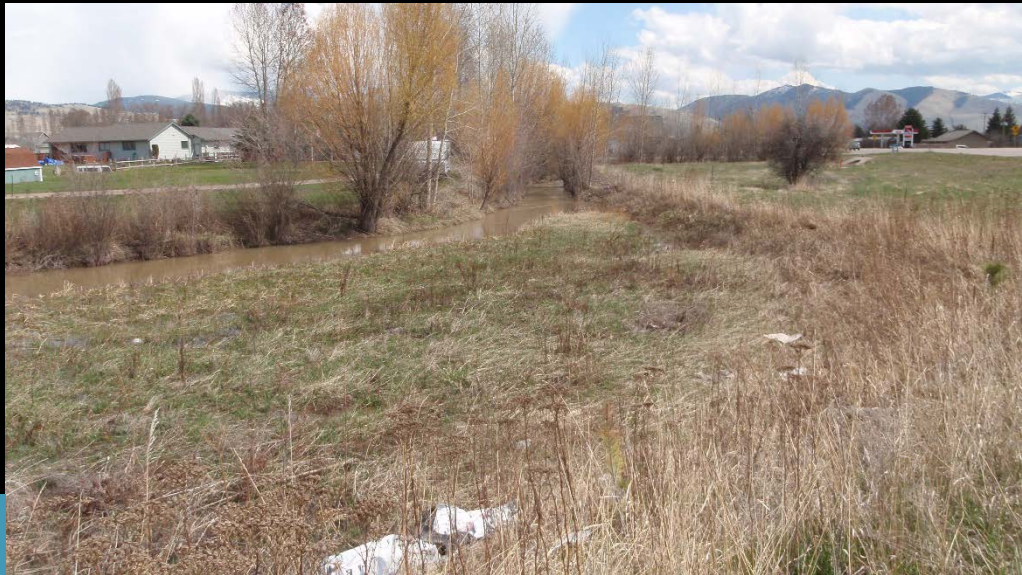
- Developing riparian area with native plantings
- Minor sediment deposition expected
- Provisions for minor maintenance activities

*(photos from completed Grant Creek Environmental Restoration and Flood Control project)*

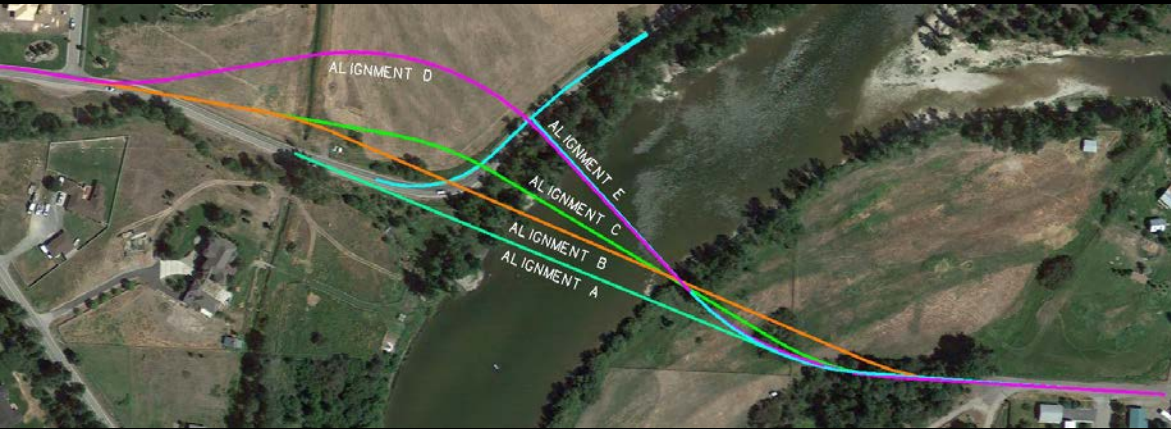
# Alignment Development

- Multiple potential alignments considered
- Alignments refined/eliminated based on:
  - Design criteria
  - Environmental impacts (avoidance of O'Brien Creek)
  - Right-of-way
  - Overall costs
  - Bridge length
  - Safety
- Alignments B and C carried forward (becoming Alignments 1 and 2, respectively)

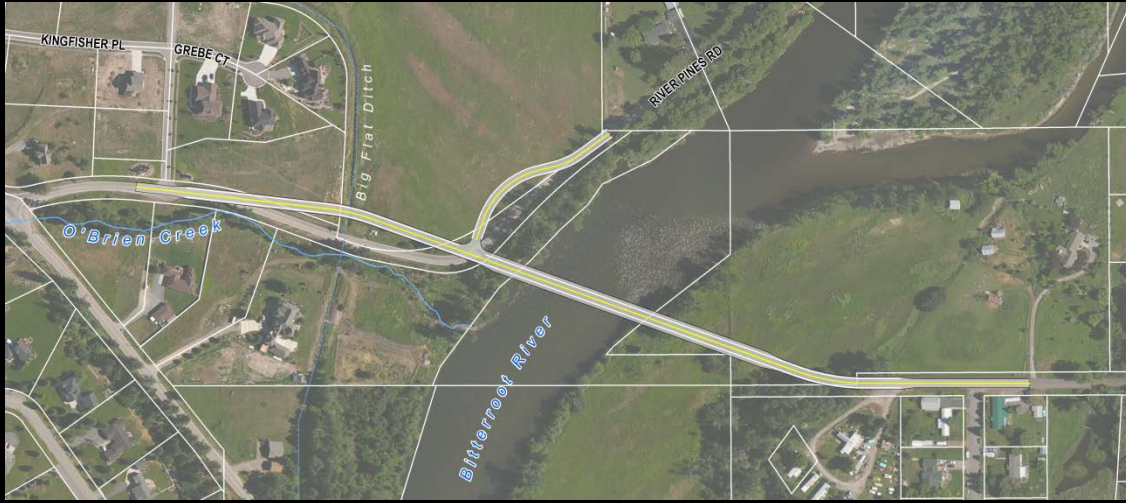
# Preferred Alternate: Alignment 1B

- Earliest availability for construction funding would be in year 2020
- Missoula County to coordinate with City to determine long-term corridor needs on South Avenue
- Future roadway improvements will be phased using County maintenance budget prior to bridge construction

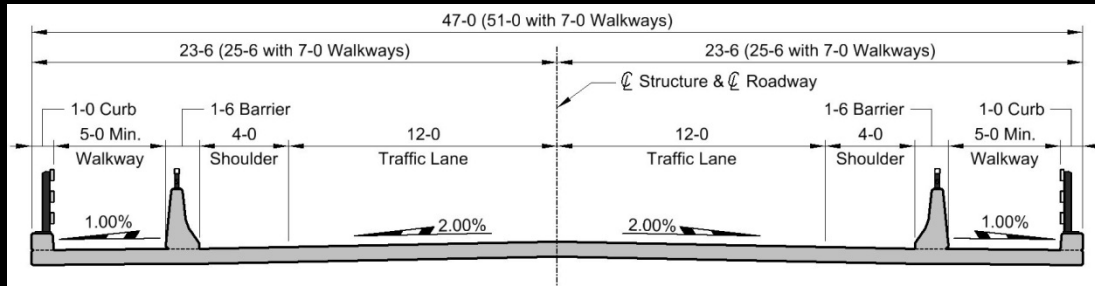
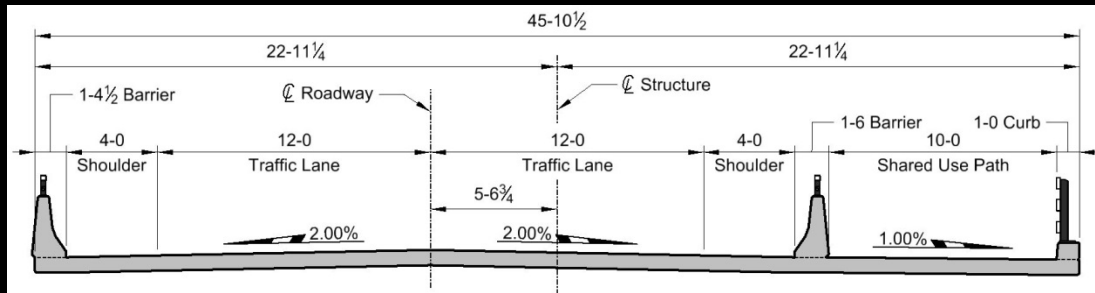
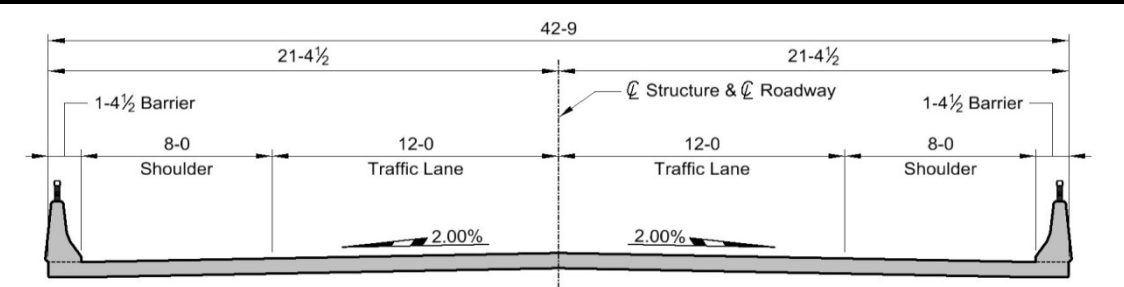
# Possible Bridge Typical Sections & Walkway Options

- Separated walkways on either side. Bikes use the shoulders
- 12-ft lanes, 4-ft shoulders
- Shared-use path for bikes and pedestrians on one side only
- 12-ft lanes and 4-ft shoulders
- No dedicated walkways. Increased shoulder widths
- 12-ft lanes, 8-ft shoulders

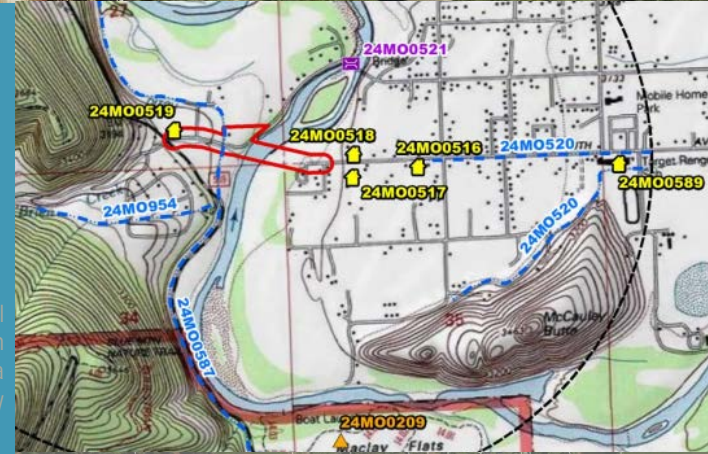
Cultural resources in project area vicinity

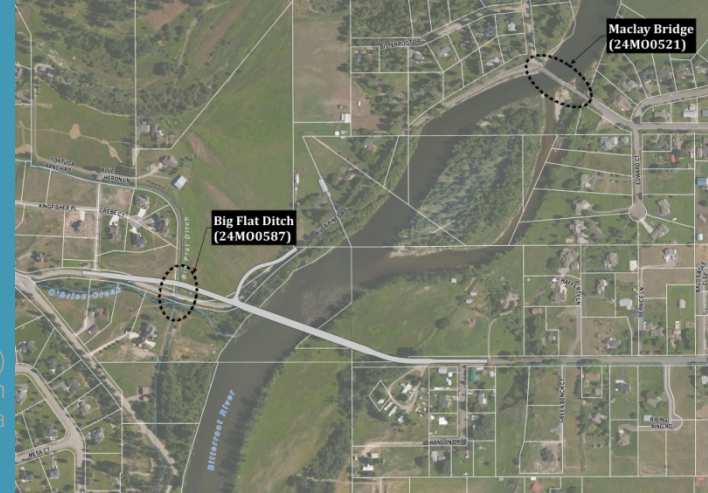
Section 4(f) resources in project area

- Protection of historic sites afforded under Section 4(f)
- Two Section 4(f) properties potentially affected:
  - Maclay Bridge (24MO0521)
  - Big Flat Ditch (24MO0587)
- Programmatic Section 4(f) Evaluations anticipated for both resources
