Running alongside the Clark Fork River, Highway 200 connects the City of Missoula and the town of Bonner, Montana.

In 2019, the Clark Fork River experienced heavy spring runoff and flooding. High water levels pushed sediment and rock downstream and away from the riverbank; compromising the stability of the highway. An erosion wall had to be constructed to save the roadway from sliding into the river.

Presented by The Montana Department of Transportation

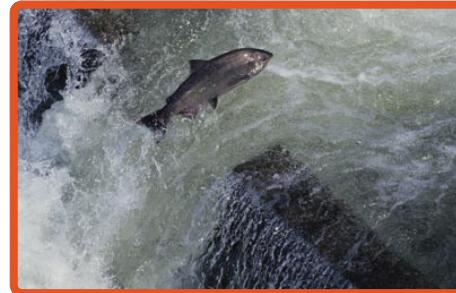
A fish ladder consists of a series of small elevated steps, or ascending pools. Fish can navigate the ladder by jumping against the current, resting in the pool and repeating the process until they have bypassed the obstacle; in this case, Highway 200.

The erosion wall was specially engineered to be built around the fish ladder and protect access for trout migrating from the Clark Fork River to Marshall Canyon Creek.

When the highway was constructed, a fish ladder was added under the roadway to maintain the connection between the creek and the river. The fish ladder allows fish to swim upstream from the river to the creek.

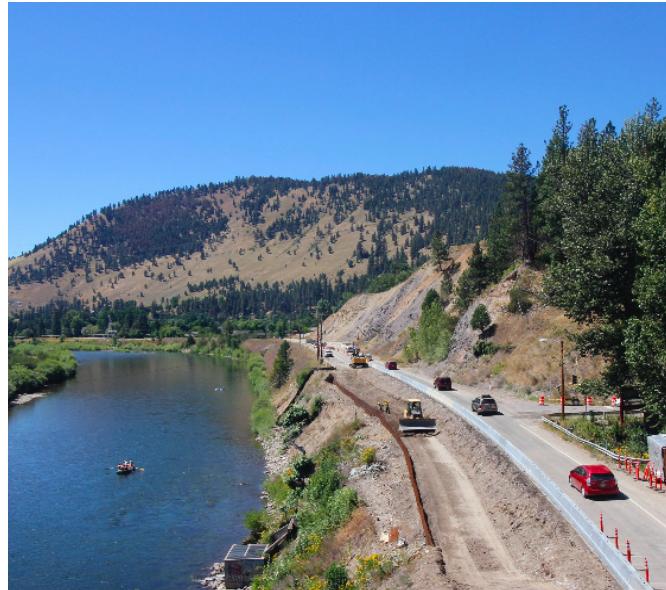
Construction on the erosion wall began with the removal of the old erosion prevention structure. Crews excavated the area and tore out the cement wall that had previously acted as an erosion prevention method.

Once the area was excavated, large steel beams, called soldier pile, were pounded deep into the ground to create the structural framework of the wall. Horizontal holes were then drilled through the steel beams and into the soil. Long braided cables were placed into holes and grout was added hold them in place and protect them from corrosion. These long cables are known as tiebacks because they tie the steel beams to the soil.

Crews added the tieback supports row by row, excavating the soil away from the wall as the work moved closer to the riverbank. The Old MT 200 erosion prevention wall consists of 55 soldier pile beams, each with four rows of tieback supports.

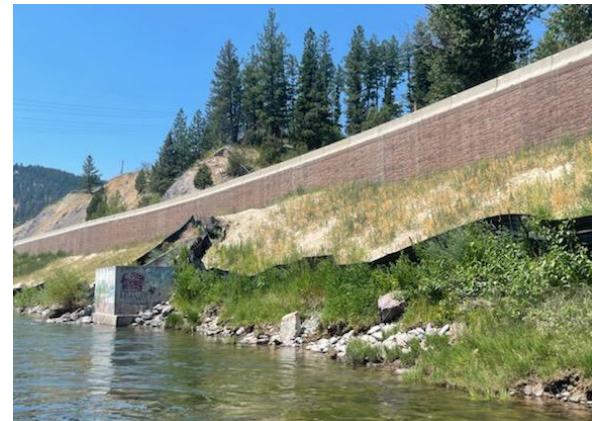
When all of the tiebacks had been drilled, installed, grouted and tensioned, the wall was covered with wooden slats and a concrete facing was poured to create a protective shell and decorative covering for the wall.

Large loose stones, called riprap, were added from midway down the wall to the bank of the river. The riprap was covered in topsoil and vegetation was planted to strengthen the riverbank against erosion and to reclaim the area for wildlife.
