PAVEMENT STRENGTH SURVEY/PAVEMENT CONDITION SURVEY

MONTANA AVIATION SYSTEM PLAN
2006 UPDATE - PAVEMENT CONDITION INDEXES

BOWMAN FIELD

ANACONDA
MONTANA

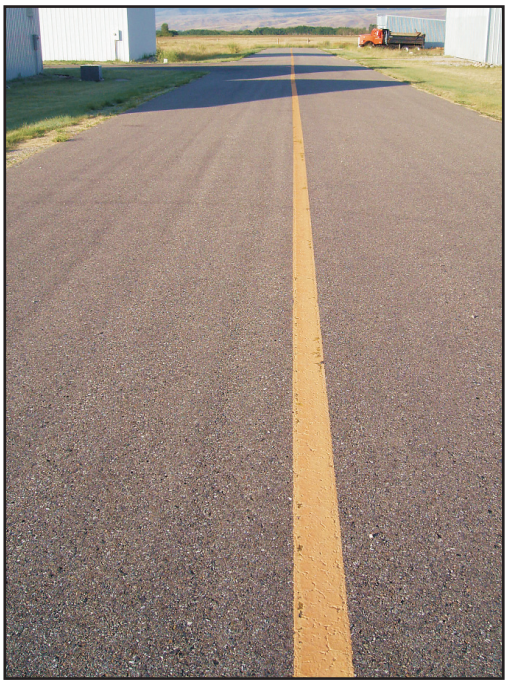
A-1, surface detail with voids

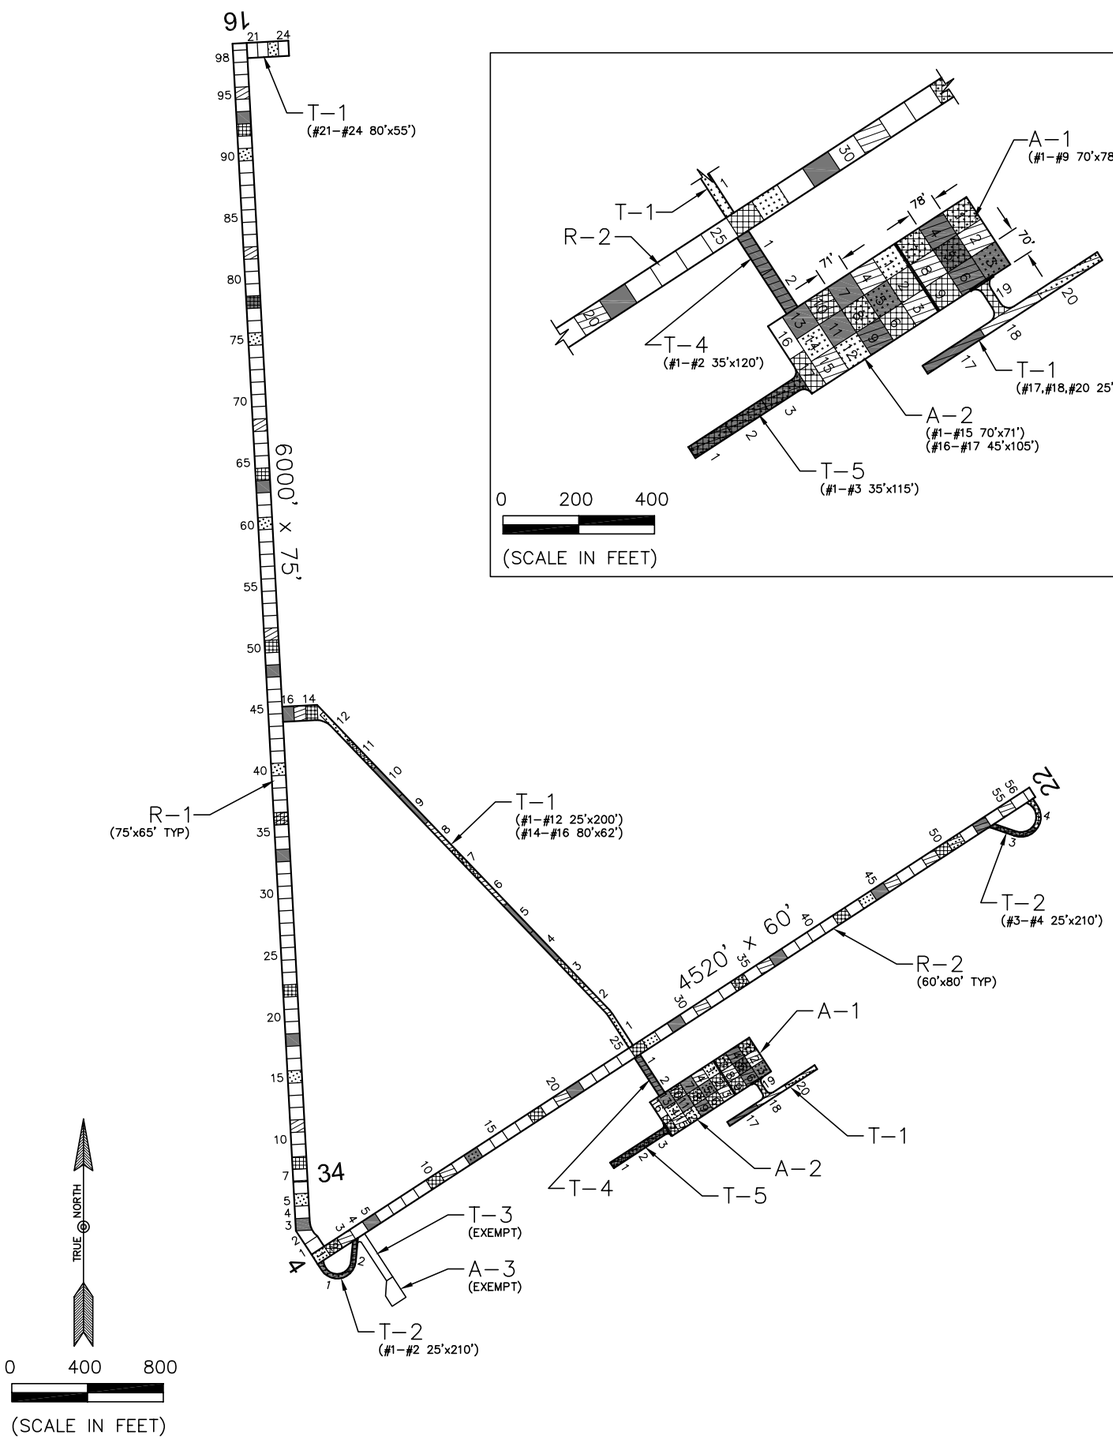
1 AIP-01, 1985, REHABILITATE RUNWAY 4-22, TURNAROUNDS, APRON, AND CONNECTING TAXIWAY.
2 AIP-02, 1992, CONSTRUCT RUNWAY 16-34, CONNECTING AND ACCESS TAXIWAYS; APRON EXPANSION.
3 AIP-03, 1993, REHABILITATE RUNWAY (R-2) AND APRON, CONSTRUCT TAXIWAY (T-5).
4 AIP-04, 2001, CRACK SEAL, FOG SEAL, AND REMARK ALL PAVEMENTS.
5 AIP-008, 2006, CRACK SEAL, FOG SEAL, AND REMARK ALL PAVEMENTS (INSPECTED PRIOR TO COMPLETION).
