Montana Department of Transportation Stream Mitigation Monitoring Report

MILL CREEK MITIGATION SITE

Monitoring Year: 2020

Monitoring Conducted By: Confluence Consulting Inc.

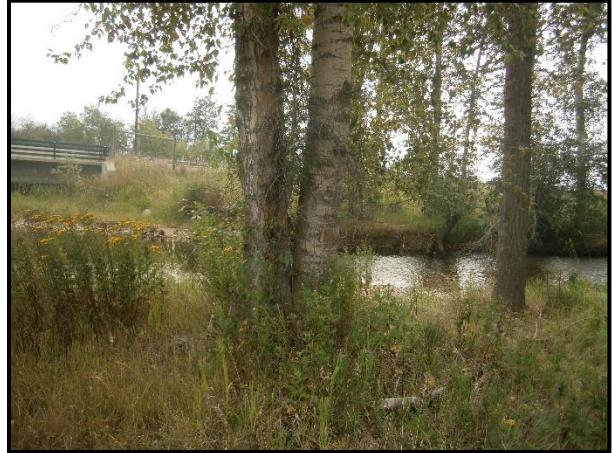
Survey Photo 26. T4 looking South downstream from T4 North bank.

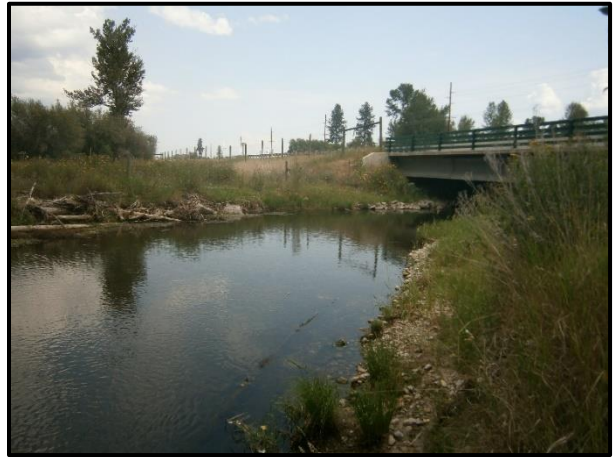
Survey Photo 28. T4 looking East downstream from South bank.

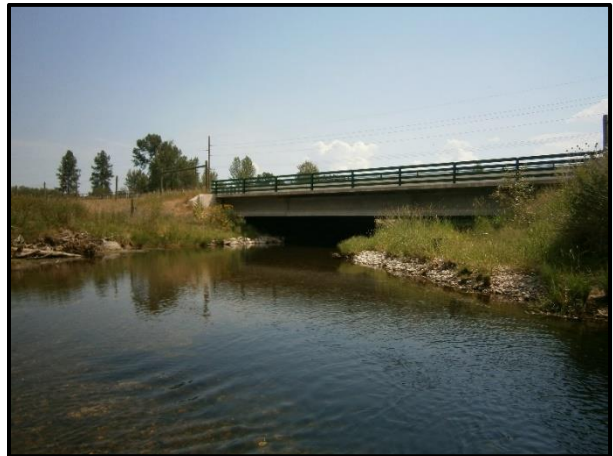
Survey Photo 30. T4 looking East downstream from middle creek.
