Montana Department of Transportation
Research Programs
April 2016

EXPERIMENTAL PROJECTS CONSTRUCTION REPORT AND ANNUAL EVALUATION

CONTECH® A-2000 POLYVINYL CHLORIDE (PVC) PLASTIC PIPE

Project Name: Checkerboard - Martinsdale (CN 4803000)

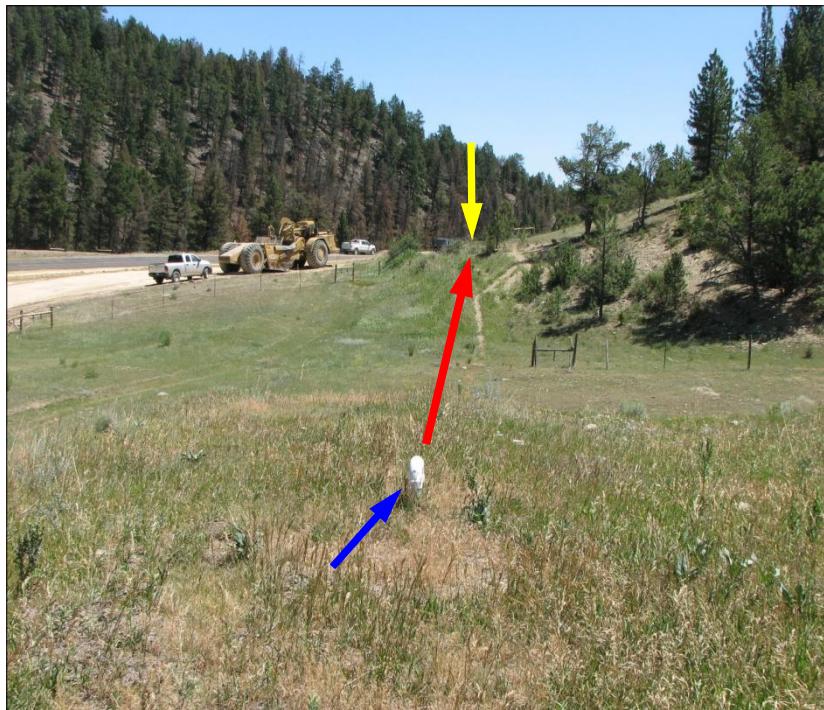
← Image shows the beginning of the 18" A-2000 installation (yellow arrow), view east. The flow runs from west to east.

The red arrow indicates the existing lay of the 15" (38 cm) PVC irrigation line (off ROW).

The white pipe in the image is the irrigation vent tube (blue arrow).

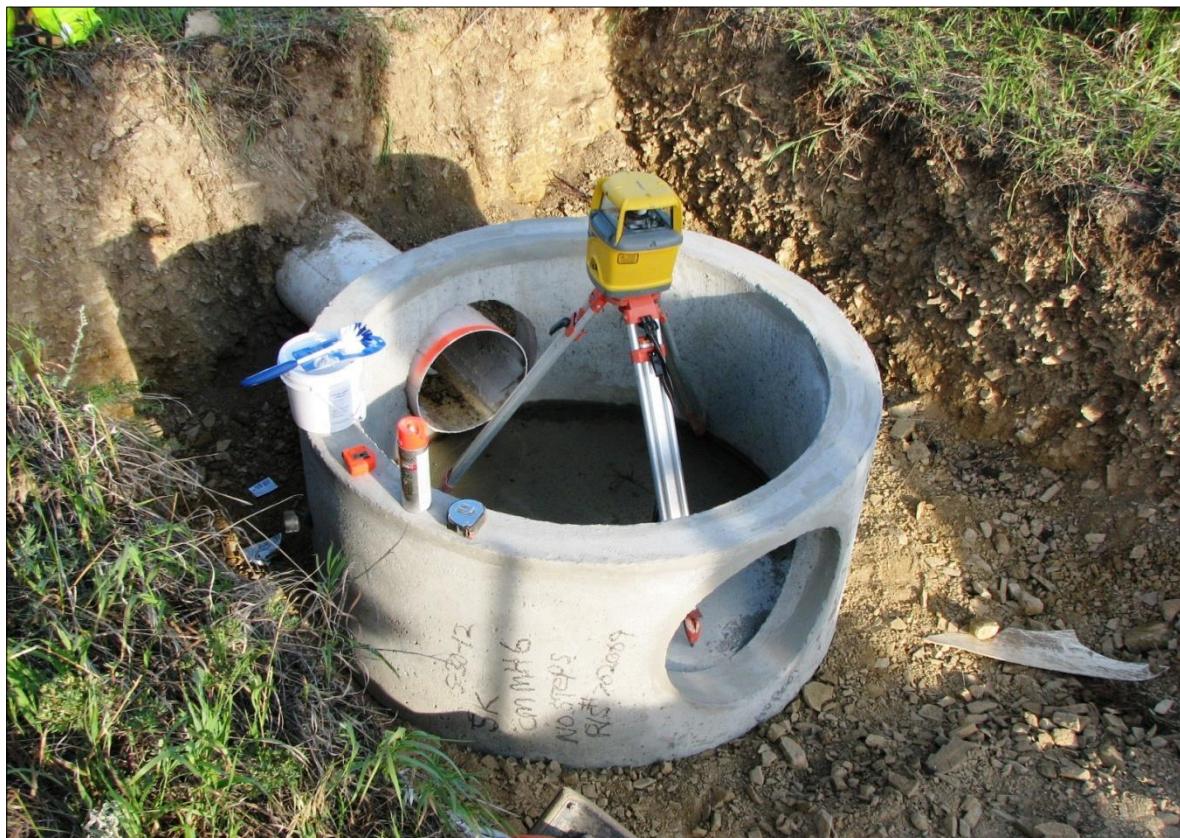
↑ Above the existing irrigation line is set within the first manhole connection. A robotic total station (RTS) is used to assure correct grade and alignment of the A-2000 pipe as it is placed.

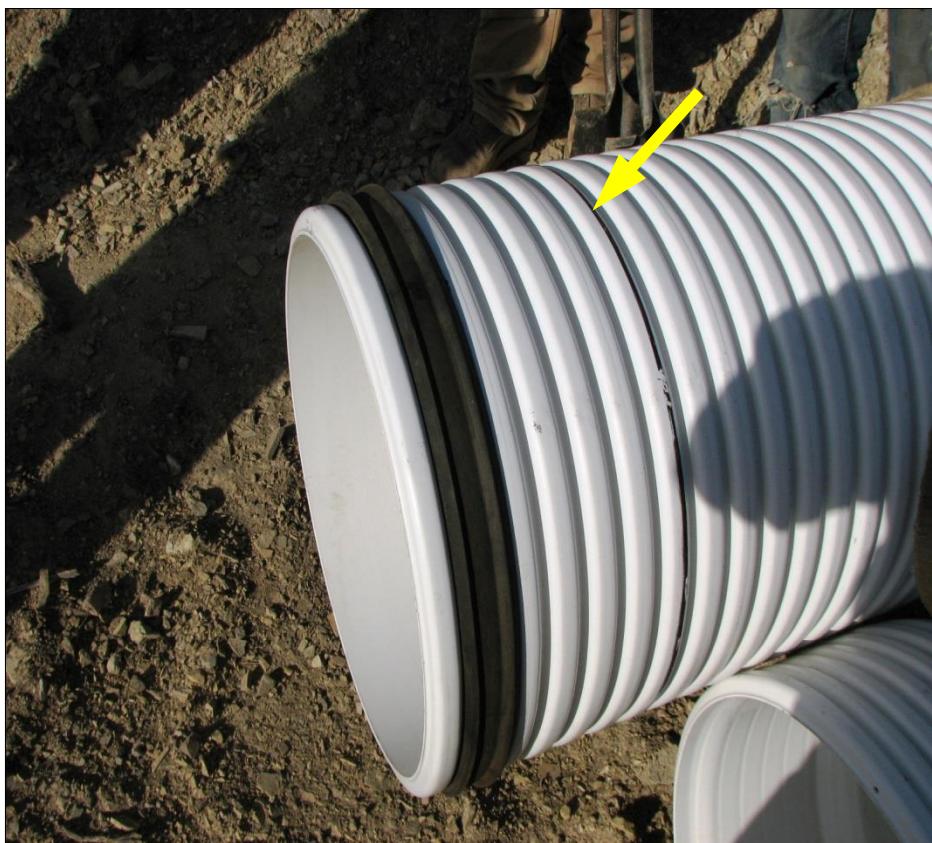
← The spigot end with the (double sealing surface) gasket is placed on the first two pipe corrugation valleys.

The gasket is shipped separately from the pipe and attached on site.

Note the black ring located approximately one foot from the spigot end (yellow arrow).

When the bell end of the pipe reaches this *home* mark within one corrugation it is seated correctly.

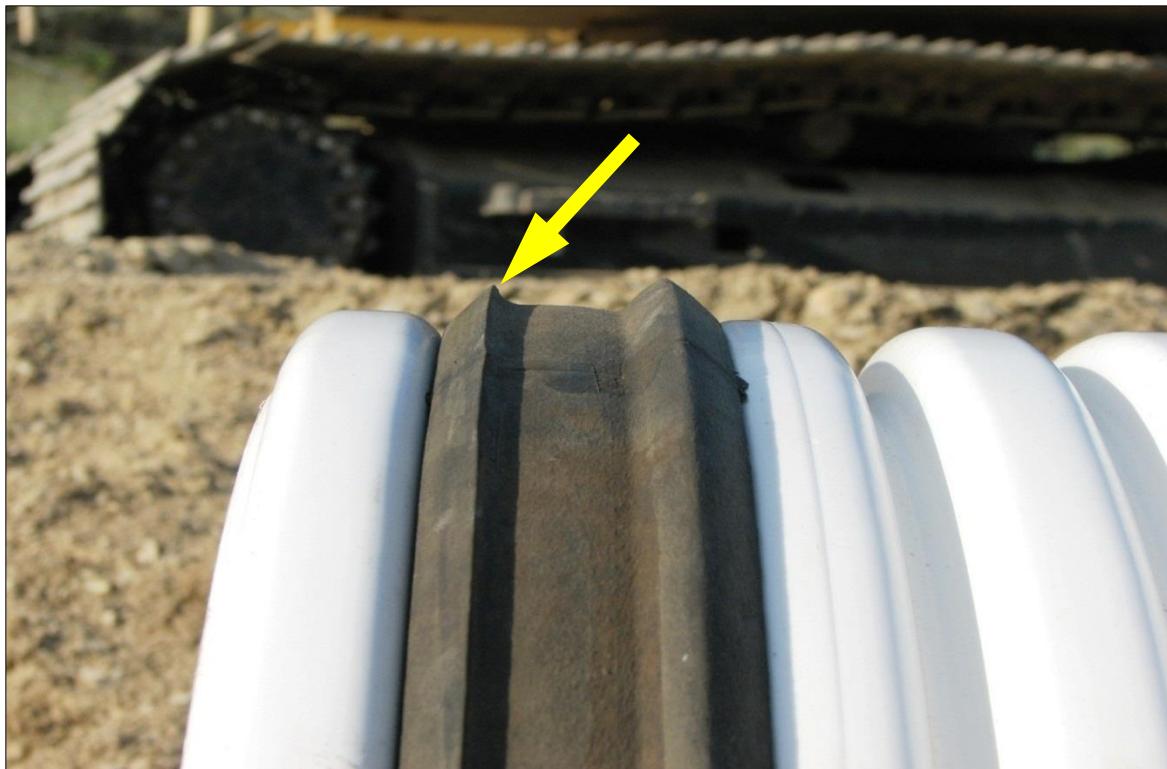
- ↑ Close-up of A-2000 gasket: The low height seal (yellow arrow) is inserted into the first corrugation. This double seal design prevents rolling of the gasket as the sections are being connected.
- ↓ Prior to the pipe connection gasket lube is liberally applied to the gasket and spigot end.

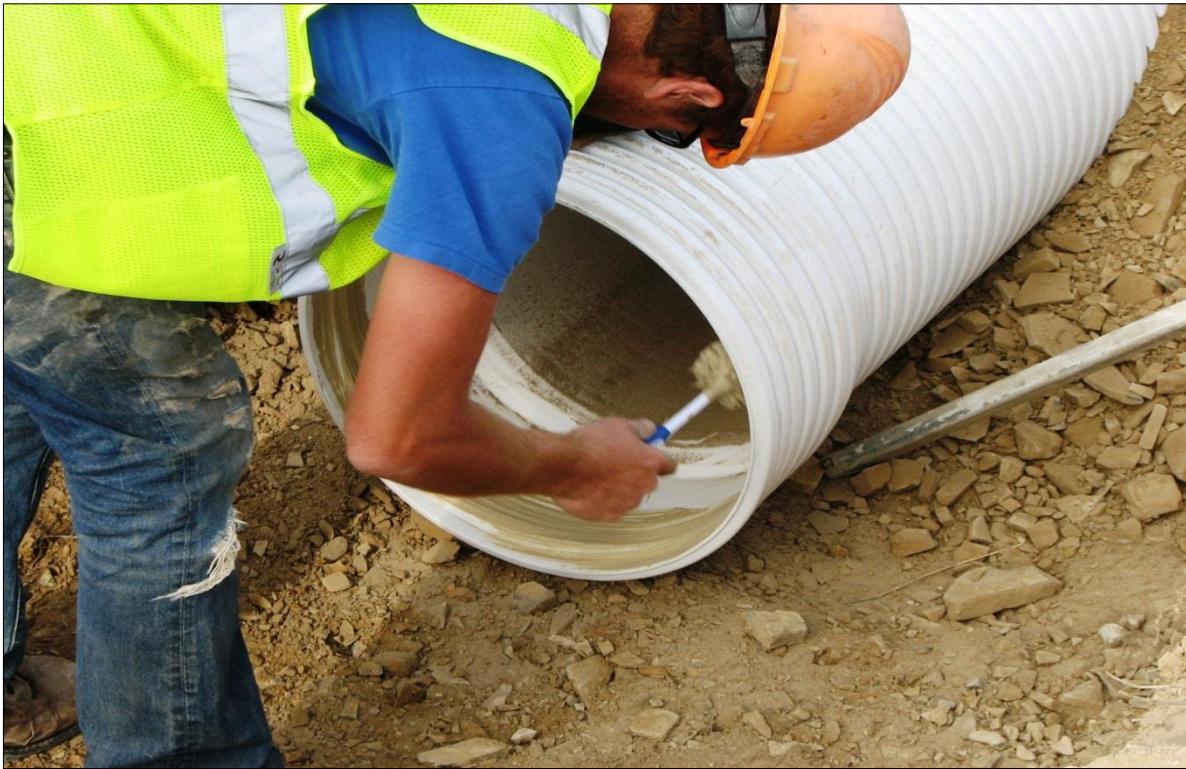
- ↑ Gasket lube is applied to the interior of the bell.
- ↓ Using an excavator, the pipe section (22'/6.7 m) is brought to the bell connection point. Also note (red arrow) the contractor is using the excavated fill from the trench to initially place and secure the pipe.

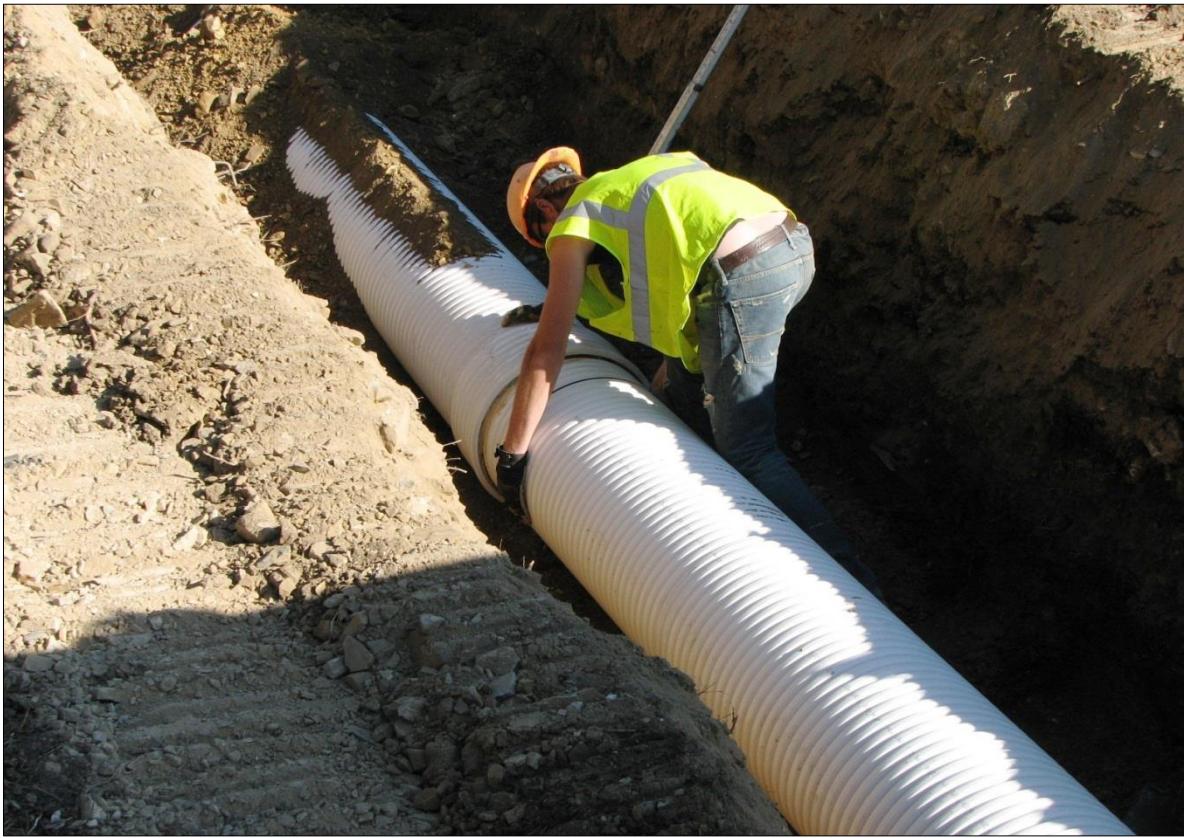
↓ Initially the contractor placed a wooden beam at the base of the pipe then used the excavator bucket to shove the connection to the proper seat.

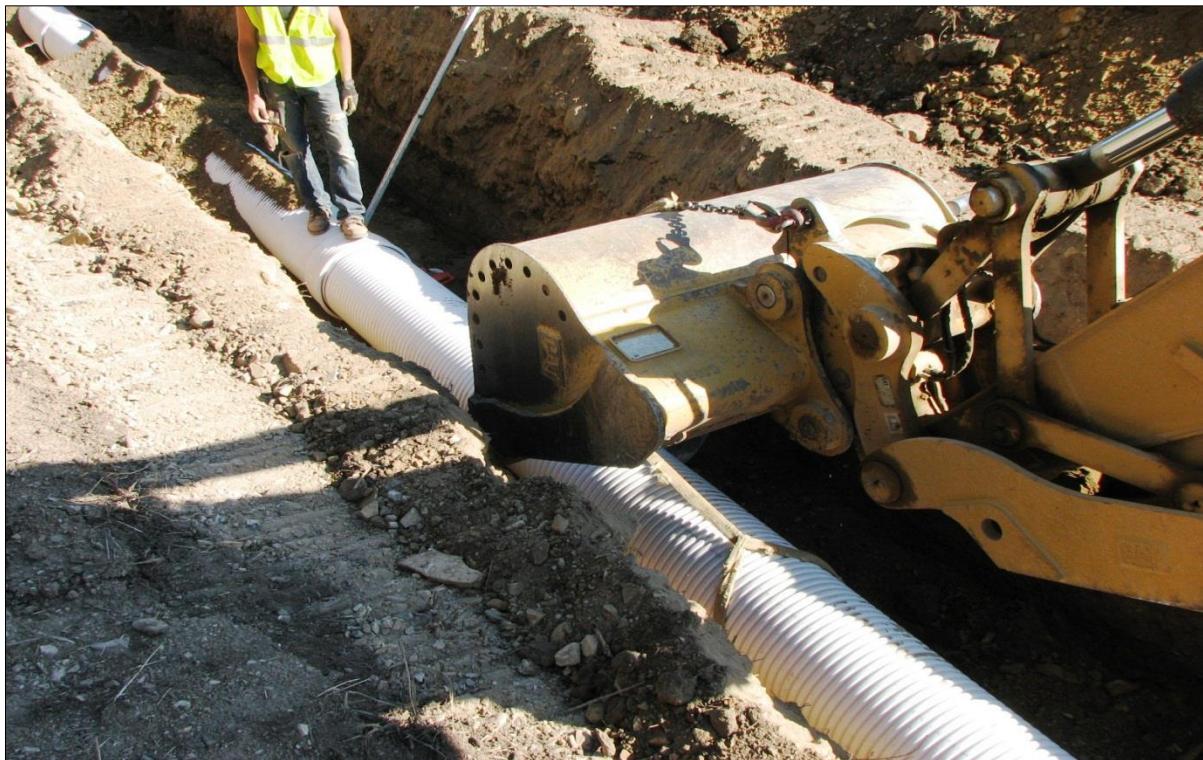
↓ Example of a properly homed bell and spigot connection.

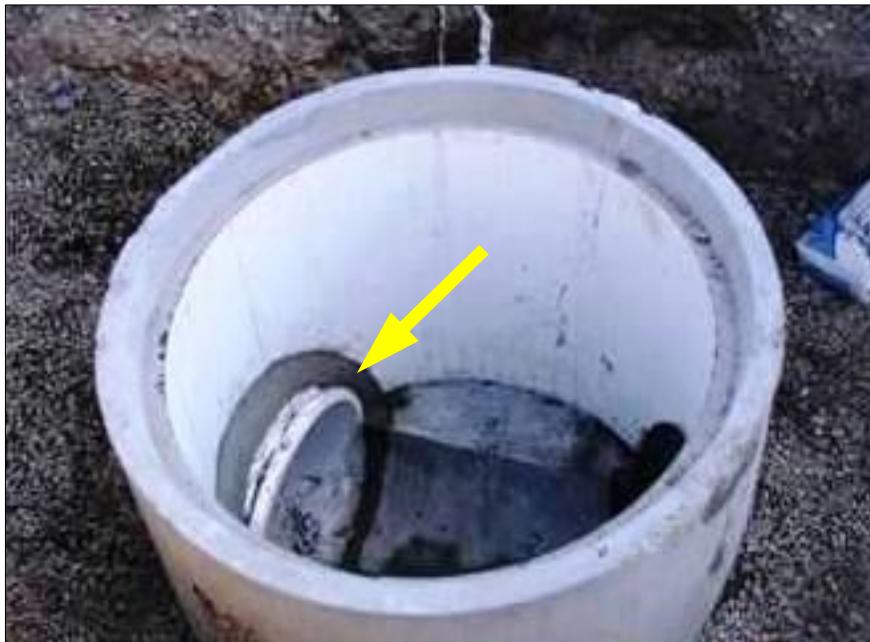
◀ Research was unable to capture the grouting procedure of the pipe to the manhole on-site.

This file photo is an example of what a completed grouting will look like (yellow arrow).

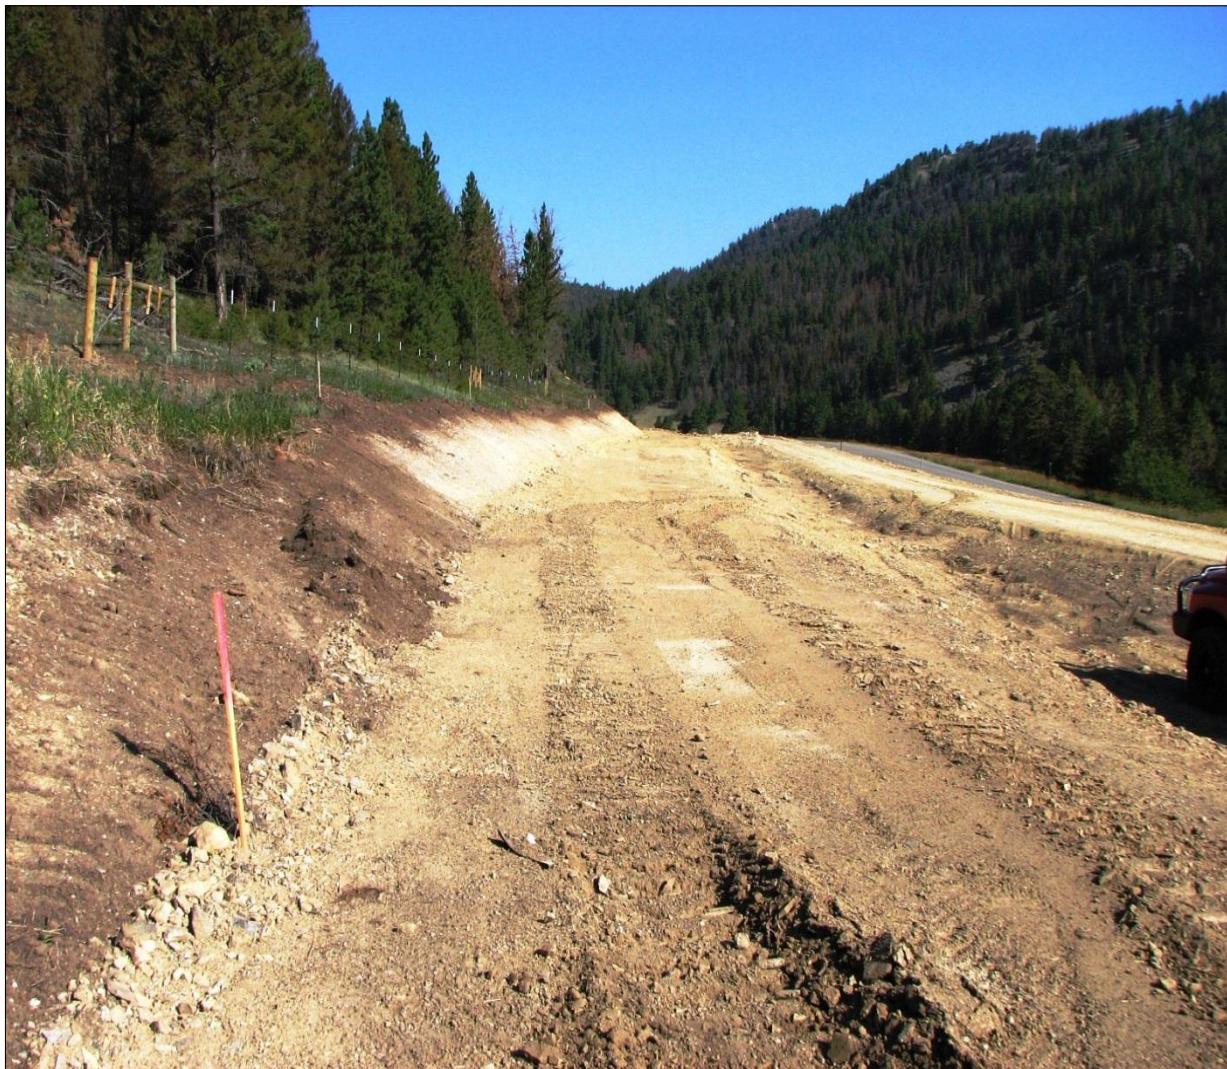
↑ Representative image of the completed A-2000 18" installation (view west).

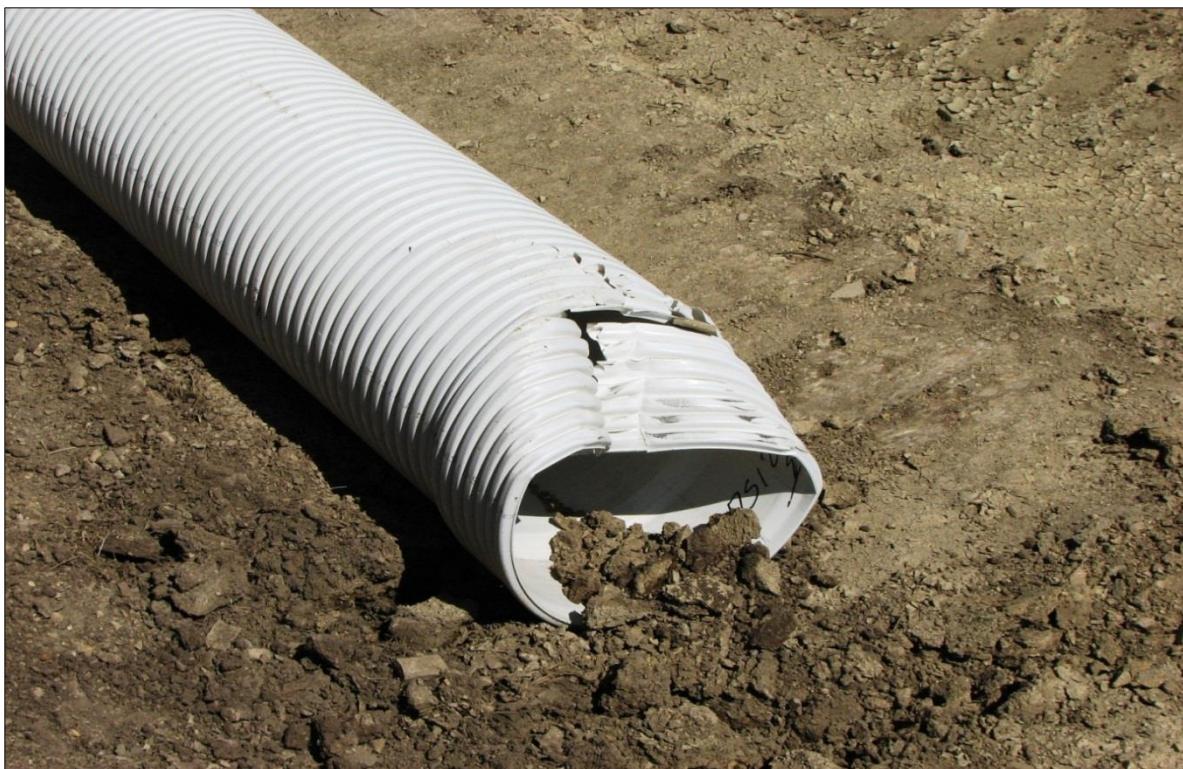
- ↑ Sample image of how pipe sections were shortened on site using a portable saw.
- ↓ Damaged pipe are saved and used when shorter sections are required during installation.

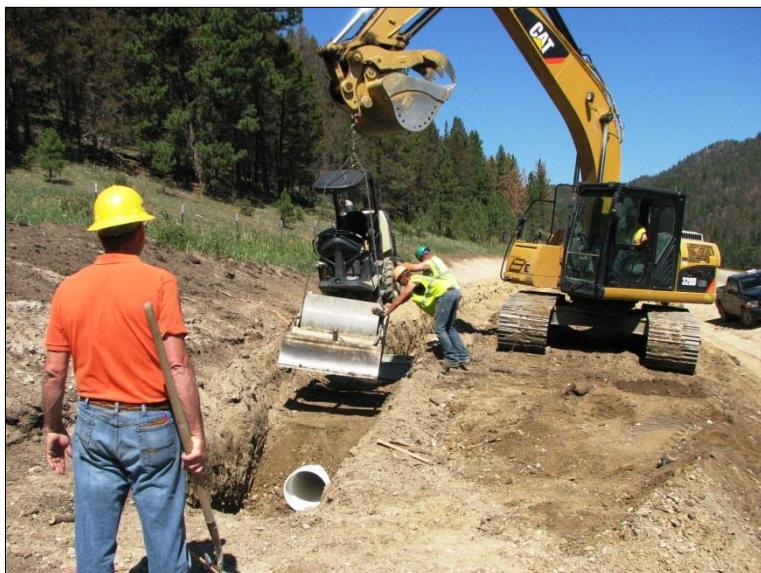
◀ The excavator is used to lower the single drum vibratory roller on top of the filled pipe section.

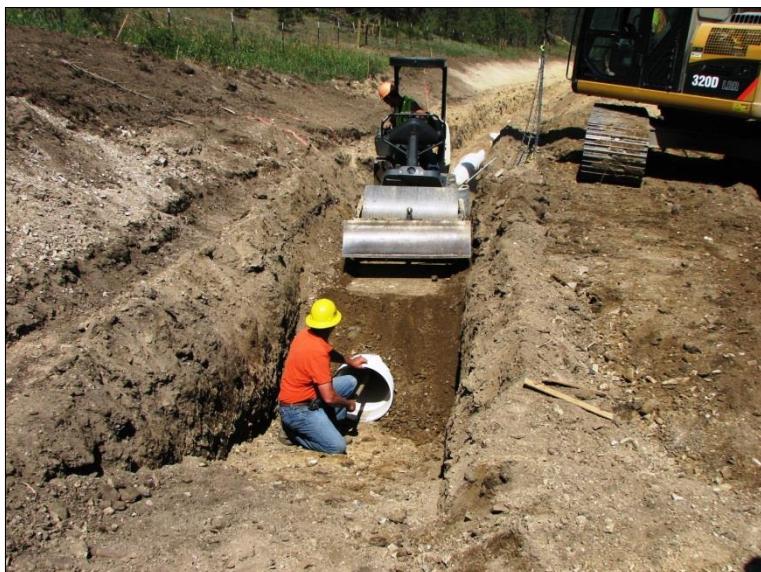
◀ The roller makes several passes using both static and dynamic modes to represent how it would be normally done throughout the project.
