**Montana Department of Transportation
Research Programs**

**EVALUATION OF CRACK-SEALING MILLED PAVEMENT IN THE EFFORT
TO REDUCE TRANSVERSE CRACKING**

Annual Report 2016

Project Number: Dutton N & S IM 15-6(35)309

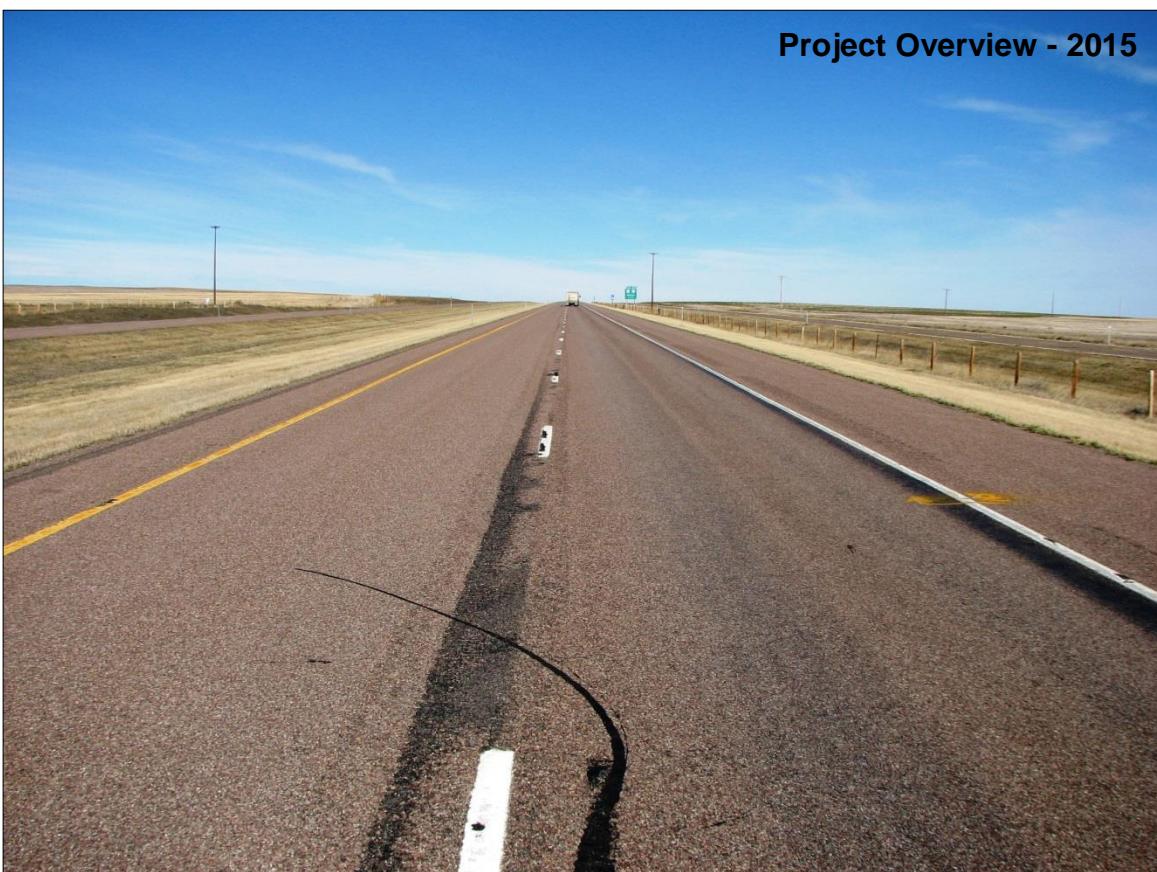
Project Overview - 2015

No additional cracking was observed since the 2014 site inspection. The graph depicts the approximate location and distance from the start of each test section, (crack locations approximate; not to scale).
