EXPERIMENTAL PROJECTS CONSTRUCTION REPORT

HIGH FRICTION SURFACE TREATMENTS (HFSTs) FOR BRIDGE DECKS

Location: •¹Kalispell-Flathead River: Highway 35
•²Roundup-Musselshell River: Highway 87
•³Big Timber-Yellowstone River: Highway 191
•⁴Bigfork-Swan River Bridge: Highway 35

Date of Inspections: March 2015/April-May 2016

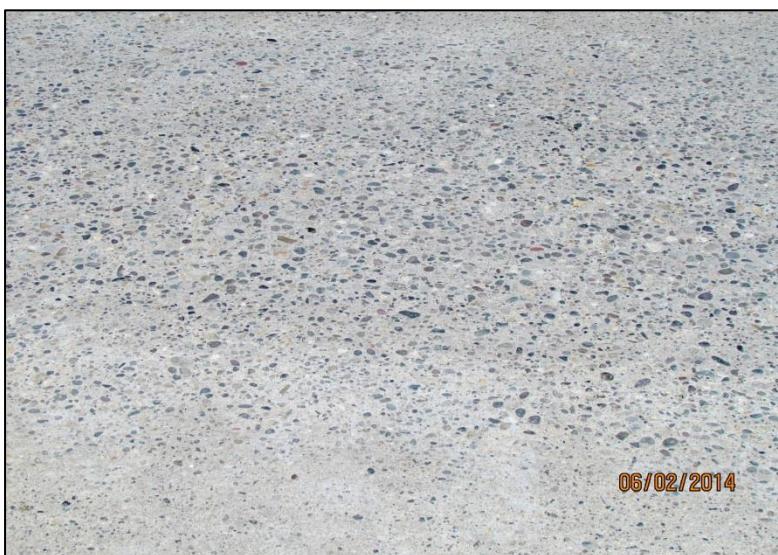
◀↓ Sample images of average deck surface condition. Most of the deck exhibited polished aggregate, minor popouts and longitudinal cracking.

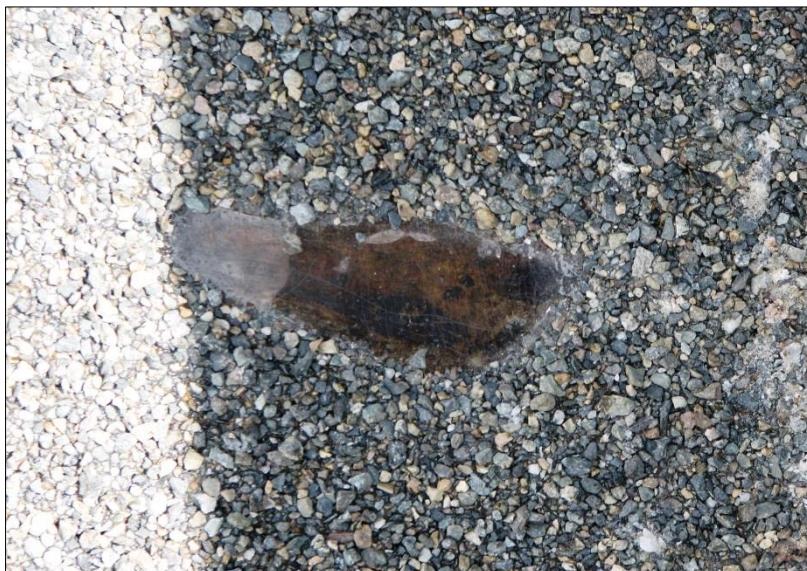
◀ After the first course had cured and cleaned, this hole (assuming a wood chip) did not have any stone embedded on the surface.

To date, no explanation can be found for this anomaly.

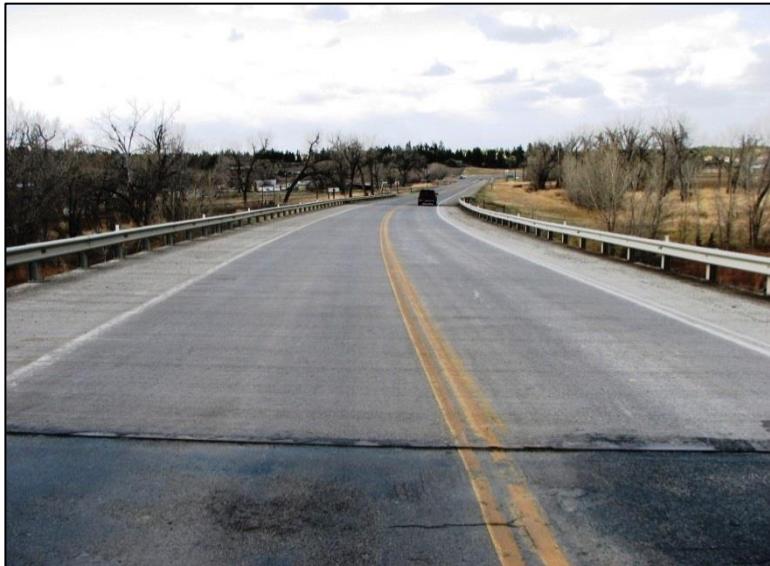
◀ Musselshell River Bridge prior to Poly-Carb treatment.

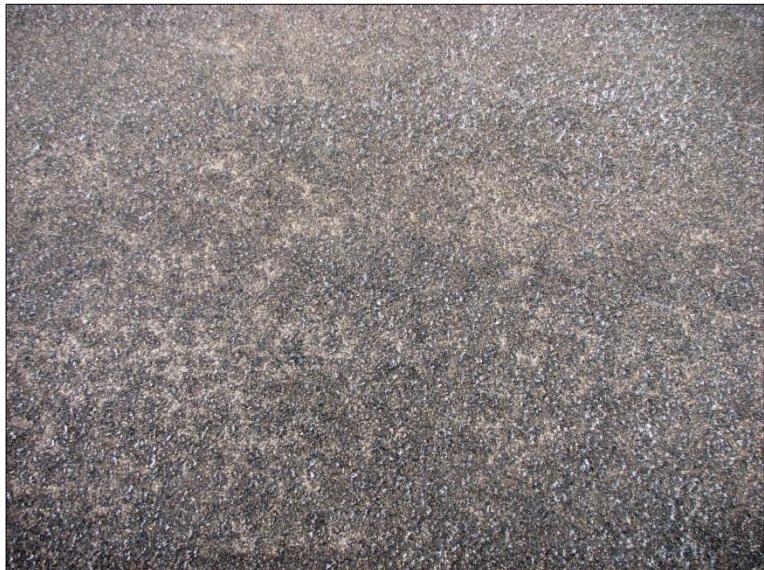
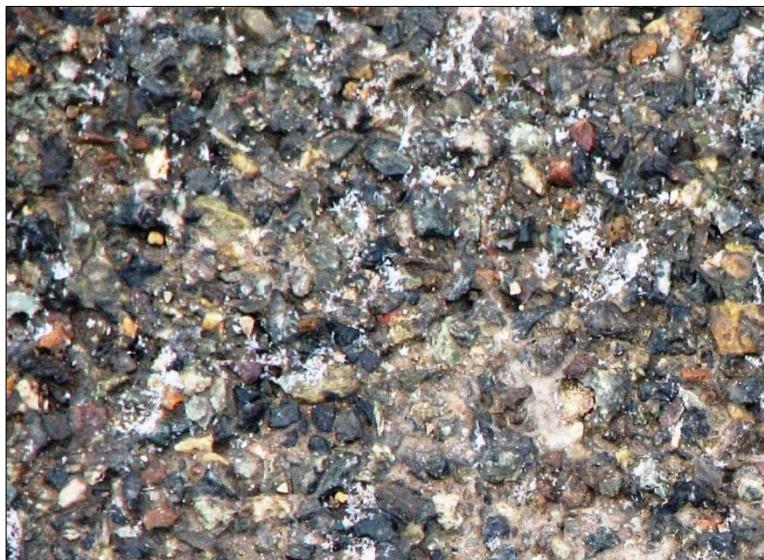
Roundup – Poly-Carb 135 Safe-T-Seal/163 Flexogrid Overlay: March 2015

◀↓ The following are images (deck overview and surface texture) depicting the general condition of the HFST (view north).

No issues to date to report; aggregate surface has uniformity in texture and appearance. No areas of delamination or debonding visible.

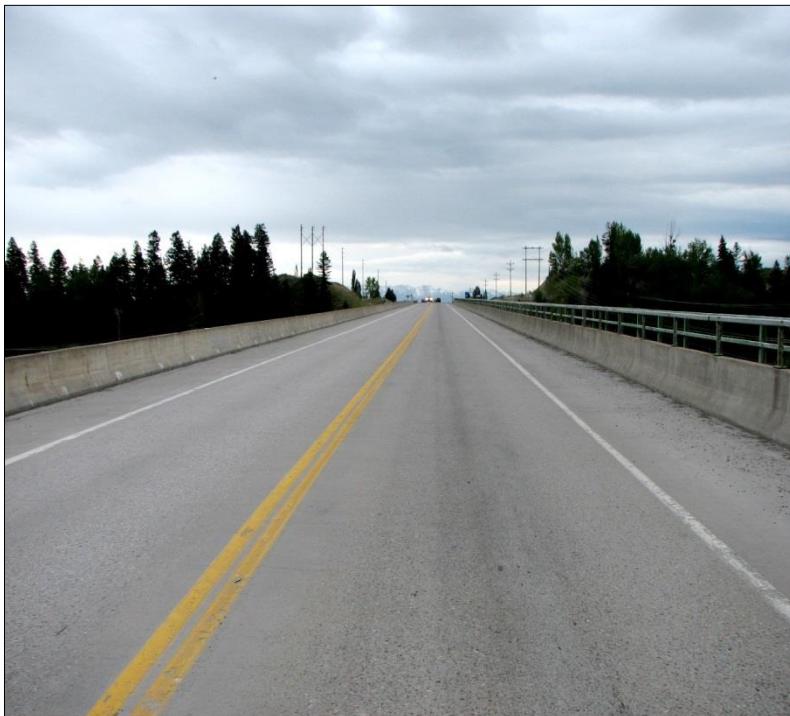
◀ Representative image of deck prior to overlay (view east).

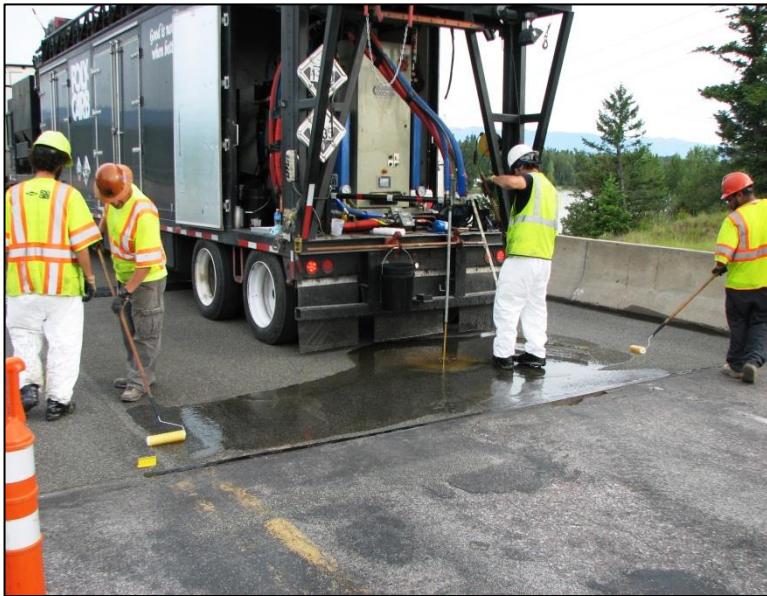
◀ The eastbound lane (left side of image) has the completed Flexogrid overlay.

The Poly-Carb Systems truck is positioned on the west bound lane to begin its second lift application.

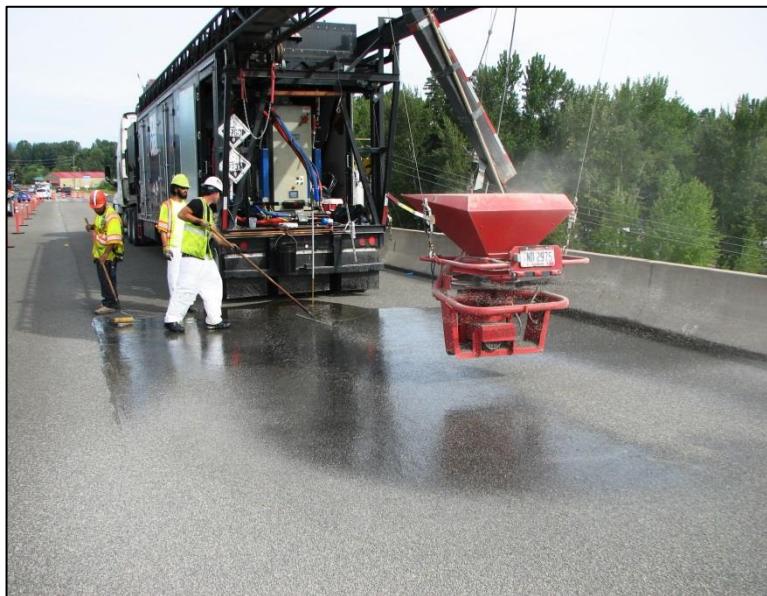
← Starting on the east end of the deck, workmen begin applying the second lift of epoxy on the west bound lane.

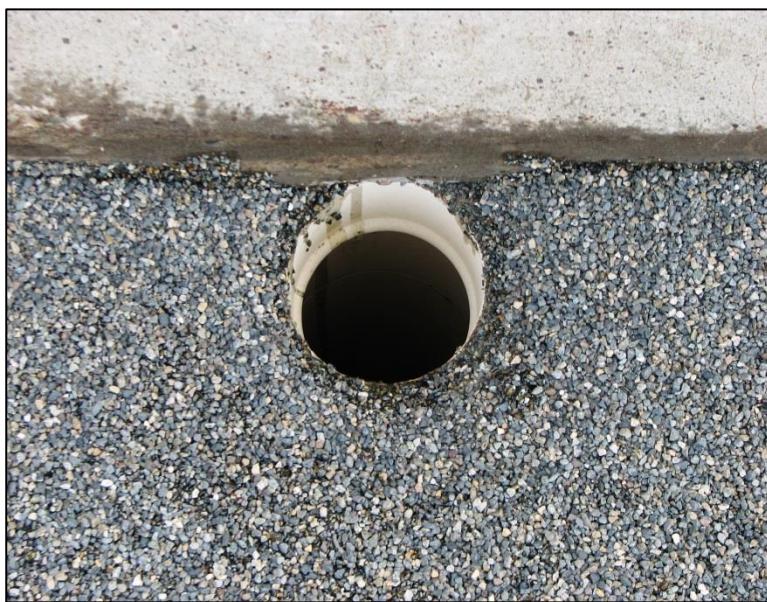
← Drainage inlets were plugged with black plastic and a conventional plastic cup was used as a stopper.

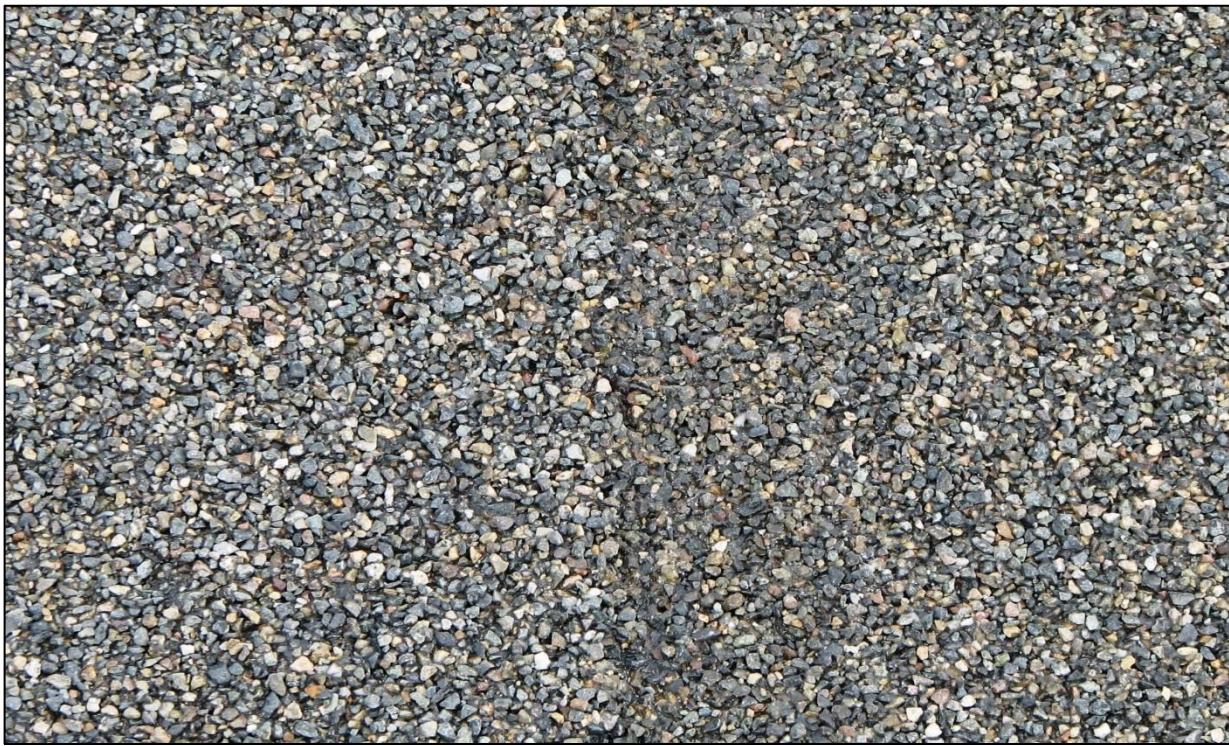
← Drain inlet with plastic block and cup removed after cured second lift.

↑ Close-up of the difference of surface texture of the first lift (right side of image) and the second lift (left side of image).

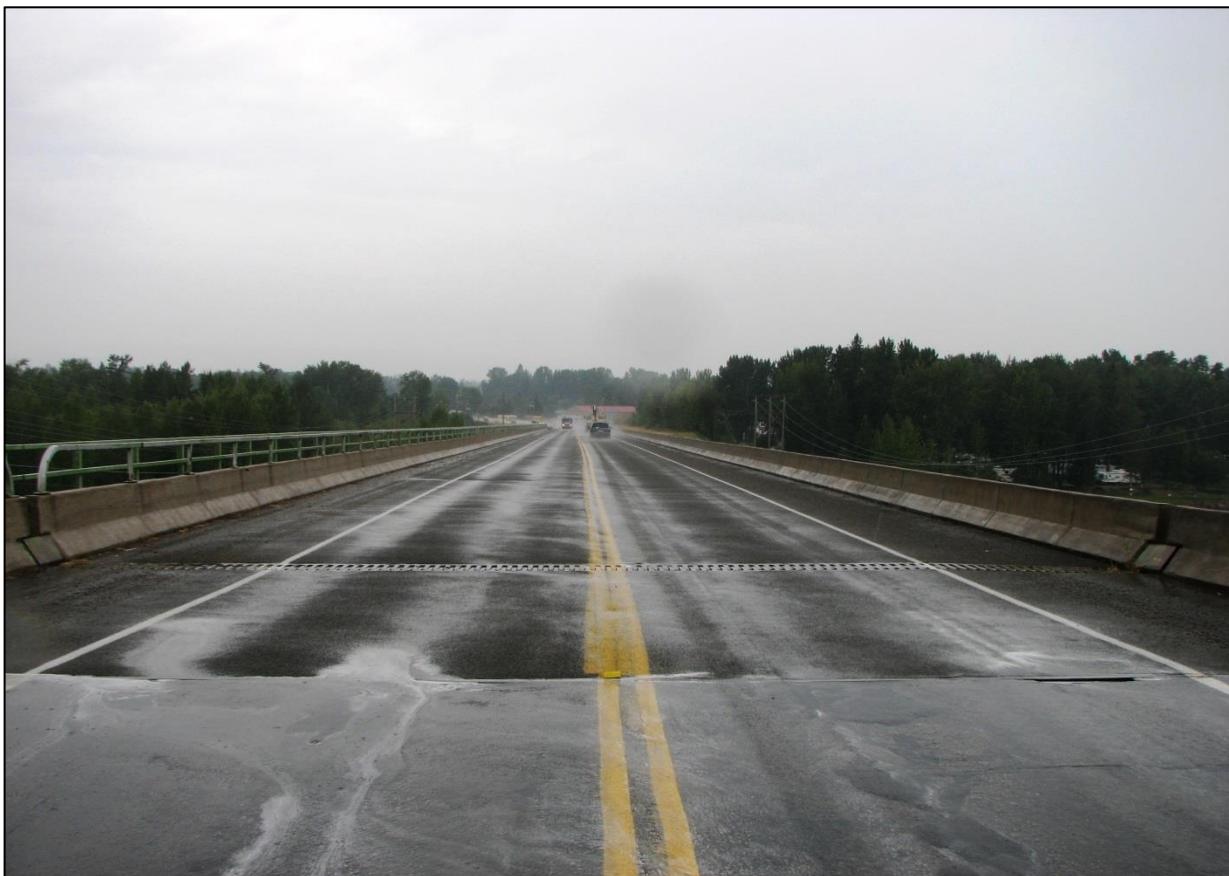
↓ Completed project, (view west). Image taken during active rain.

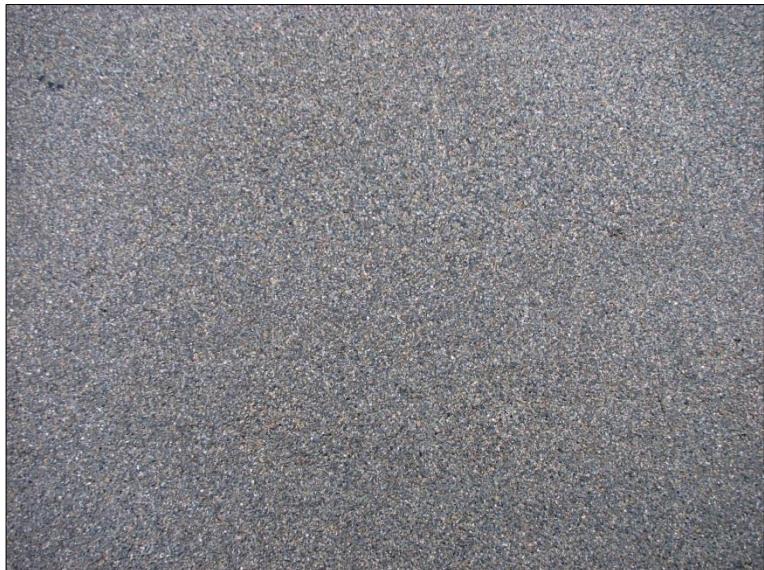
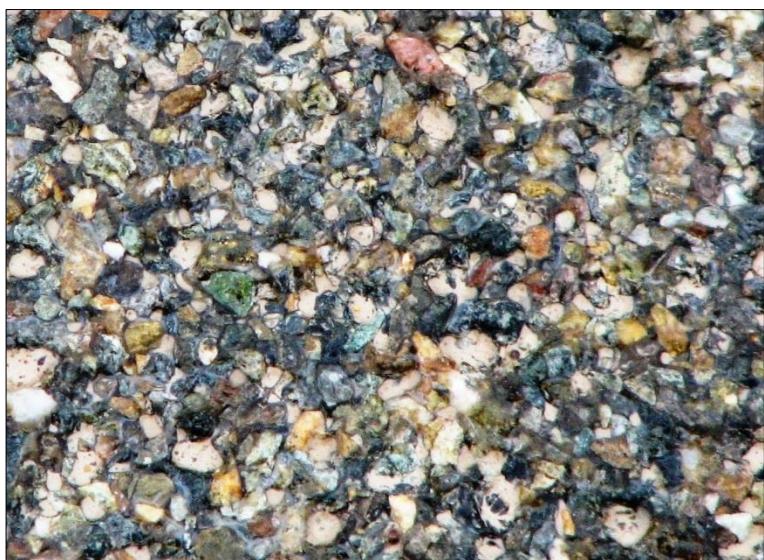
◀↓ The following are images (deck overview and surface texture) depicting the general condition of the HFST (view east).

No issues to date to report; aggregate surface has uniformity in texture and appearance. No areas of delamination or debonding visible.

The deck surface was wet during the inspection.
