Rope Access Climbing Bridge Inspection Report

Asset #: 03719

Bridge #: L32101000+01001

Location: Maclay Truss Bridge over Bitterroot River

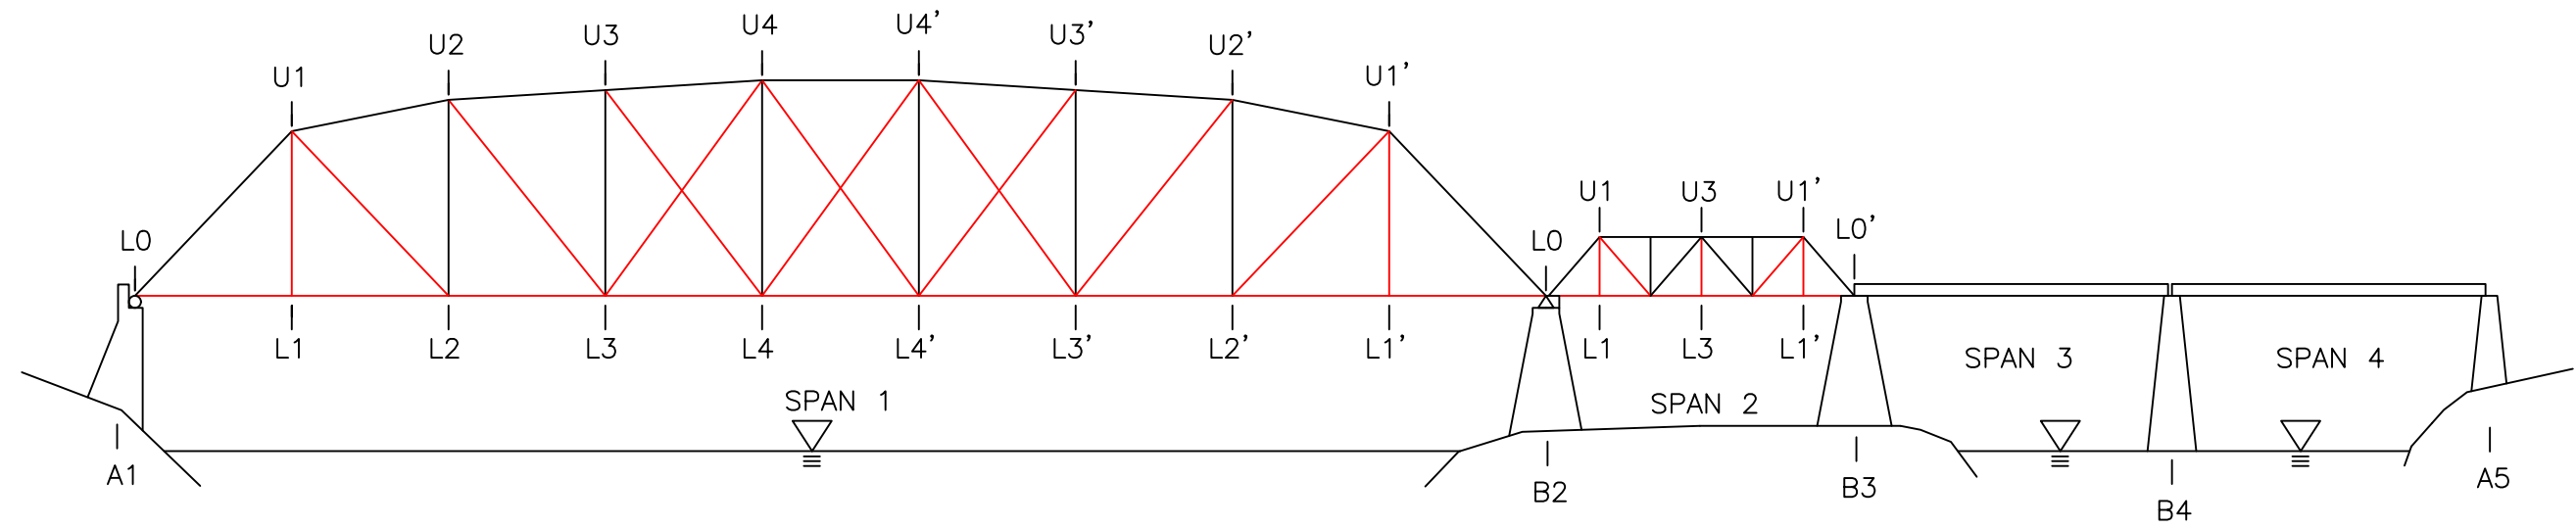
① ELEVATION LOOKING NORTH

△ — FIXED BEARING
 ○ — MOVEABLE BEARING
 MEMBERS HIGHLIGHTED IN RED ARE FRACTURE CRITICAL
 ALL (10) FLOOR BEAMS ARE ALSO FRACTURE CRITICAL

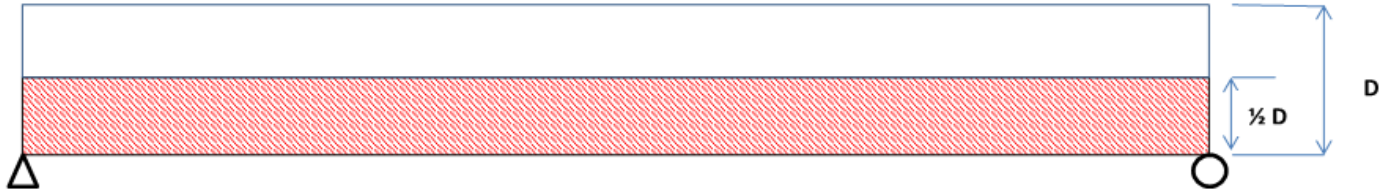
Typical Floor Beam Comments: Approximately 40 percent of the painted coating on the floor beams had failed with minor surface corrosion and negligible section loss, 40 percent had failed with exposed primer underneath, and the remaining painted coating was bubbling and peeling.
