**STRUCTURE INSPECTION REPORT**

MDT ID - 03719

Feature Intersected - BITTERROOT RIVER 010

Inspection Type - Fracture Critical

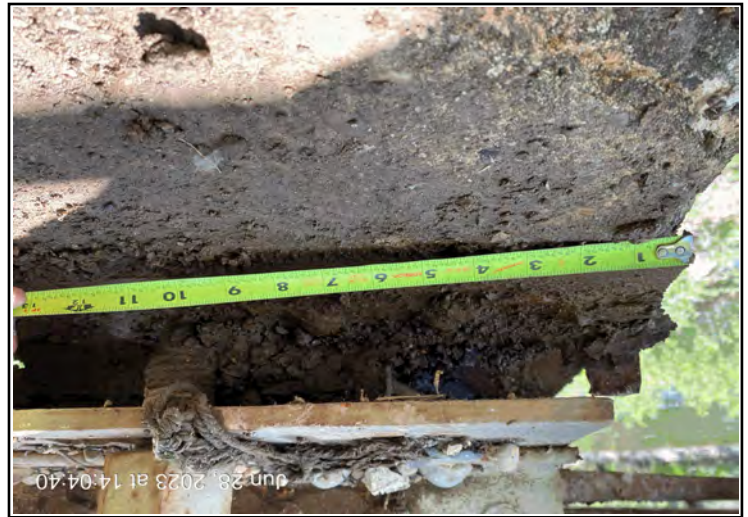
Span 1 North Moveable Bearing at Abutment 1, sole plate was displaced 2 in. to the west, in expansion, in relation to the masonry plate on a 65 degree F day.

<b>Recommended By:</b>	<b>Date Recommended</b>	<b>Type</b>	<b>Status</b>	<b>Suggested Priority</b>
	10/17/2017	Bearings	Repair Suggestion	High
<b>Comments</b>				
Both movable bearings on Abutment 1 need to be replaced/reset.

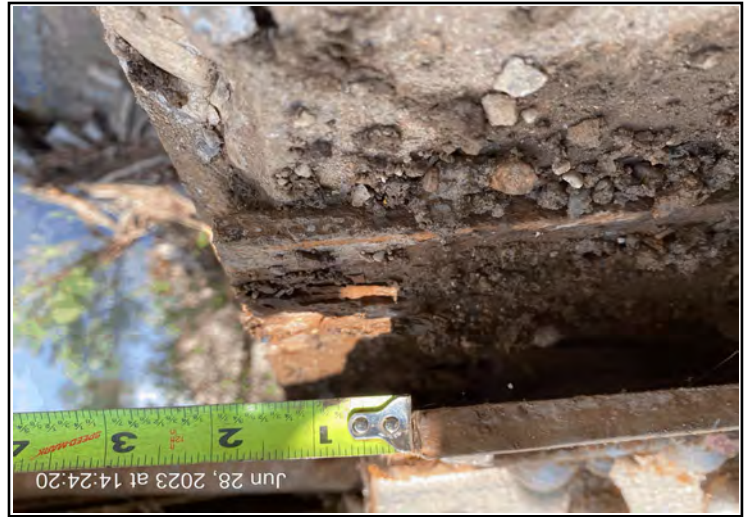
Span 1 South Moveable Bearing at Abutment 1, sole plate was displaced 1-7/8 in. to the west, in expansion, in relation to the masonry plate on a 65 degree F day.

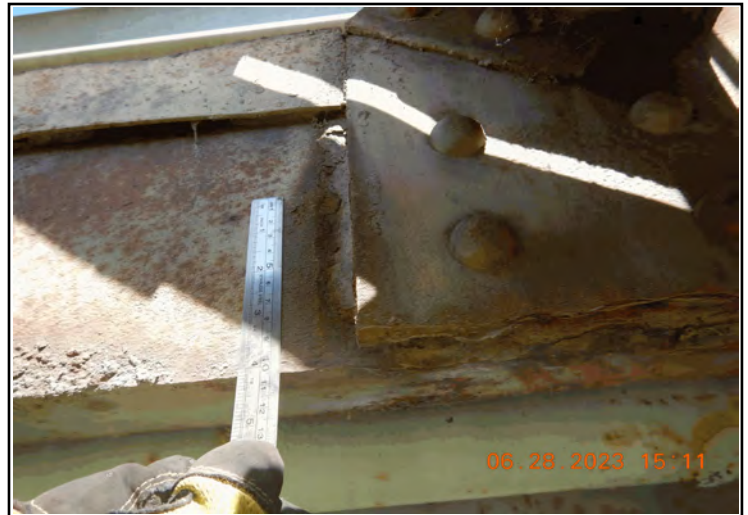
South Truss, Panel Point L2, bottom chord inboard web had pitting up to 1/8 in. deep around gusset plate.

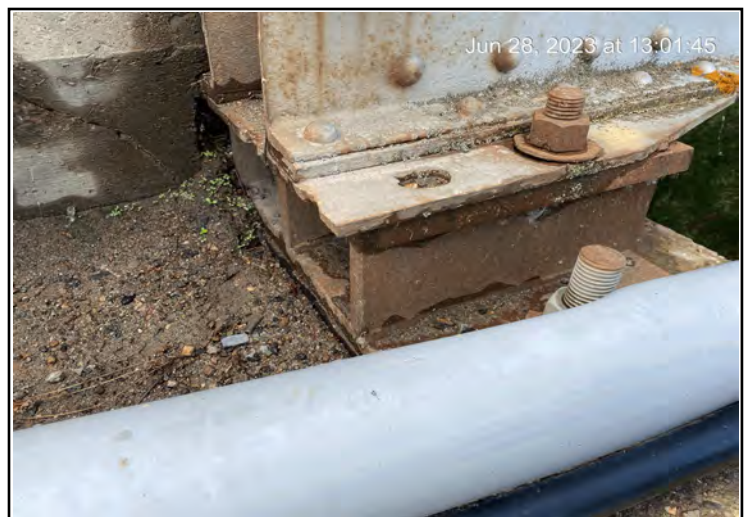
Moveable Bearings at Bent 3 were left unpainted and had moderate corrosion with pitting up to 1/16 in. deep.

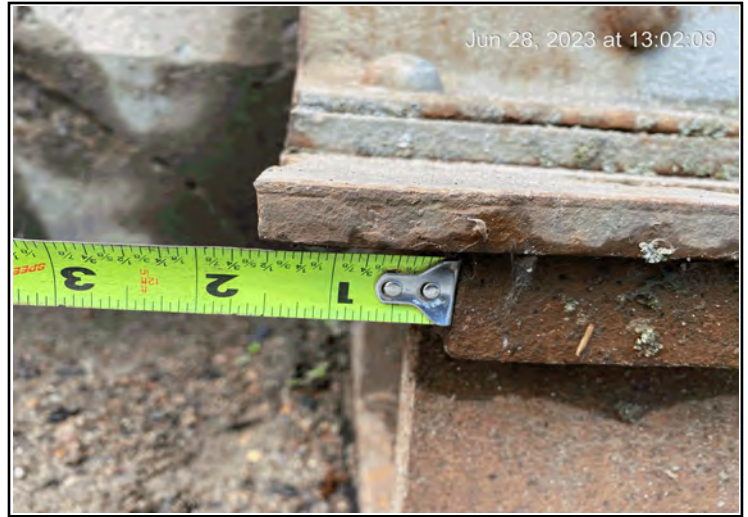
Span 2 North Moveable Bearing Alignment.JPG

North Moveable Bearing sole plate was displaced 1-1/2 in. to the east, in expansion, in relation to the upper flange of the bearing on a 65 degree F day.

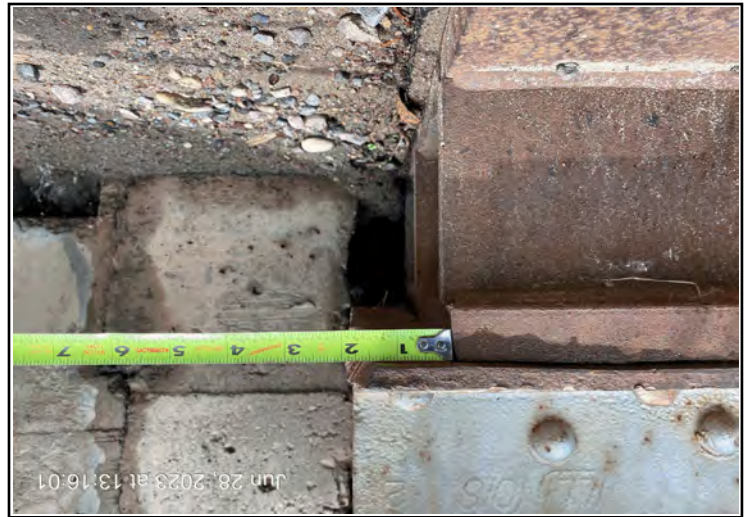
Span 2 South Moveable Bearing Alignment.JPG

South Moveable Bearing sole plate was displaced 1-7/8 in. to the east, in expansion, in relation to the upper flange of the bearing on a 65 degree F day.
