**Experimental Feature Evaluation  
 December 2022**

<b>Experimental Feature:</b>	Ace Fibers in Plant Mix Asphalt
<b>Location:</b>	Billings District, Yellowstone County, City of Billings, Division St and 6 <sup>th</sup> Ave N
<b>MDT Project Name:</b>	Division St – Billings & 6 <sup>th</sup> Ave N – 27 <sup>th</sup> to 32 <sup>nd</sup>
<b>MDT Project Number:</b>	UPPIP 1017(2)7[9003] & UPPIP 1029(4)[9004]
<b>Experimental Project Number:</b>	MT-18-03
<b>Principle Investigator:</b>	Chad DeAustin, Experimental Project Manager, (ExPM)
<b>Construction Date:</b>	July 2018
<b>Date of Inspections:</b>	April 2019, April 2020, May 2022

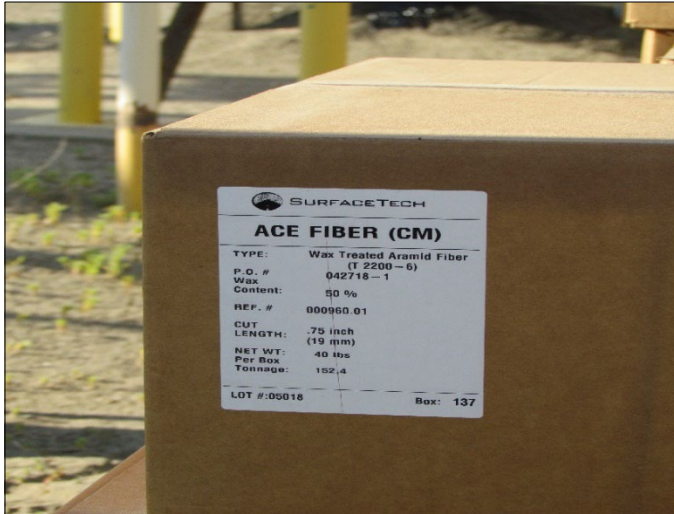
← The Ace Fiber arrive on-site at the hot plant packed in 40 lb. cardboard boxes which will produce approximately 153 tons of FRAC.

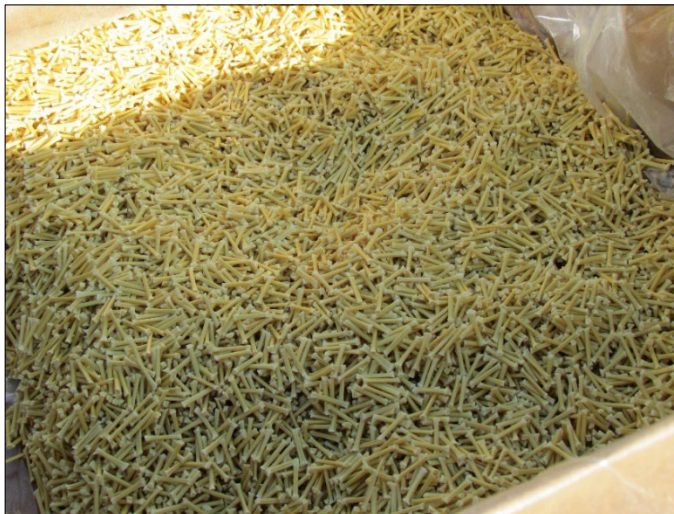
← The wax treated aramid fibers (known as clips) are approximately .75 inch (19mm) in length. With a fiber tensile strength of 400,000 psi and fiber melting temperature of 800F (427C). Each clip contains over 10,000 individual aramid fibers.

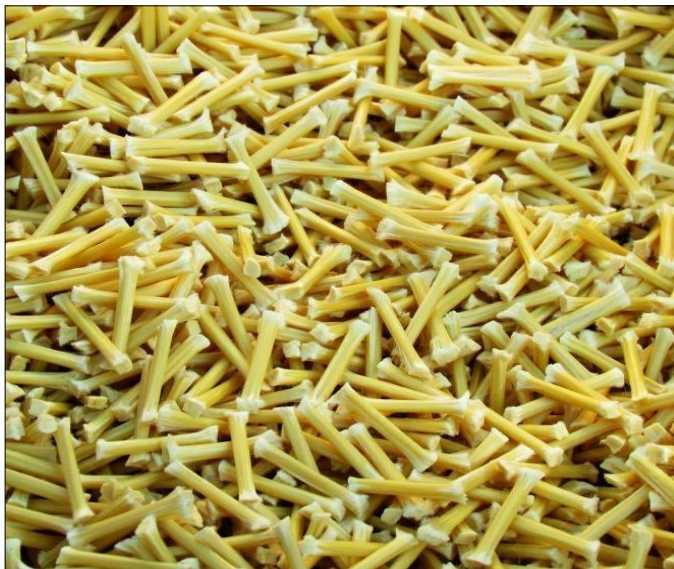
← The clips are soaked in Sasol Sasobit (a synthetic hard wax). Each clip by weight, contains 50% wax and 50% fiber, with a wax melting point of 216F (101C). The wax application gives the fiber the needed weight to adequately be distributed into the mixing drum. As the Sasobit wax melts, it allows the dry fibers to disperse evenly into the asphalt and aggregate mix.

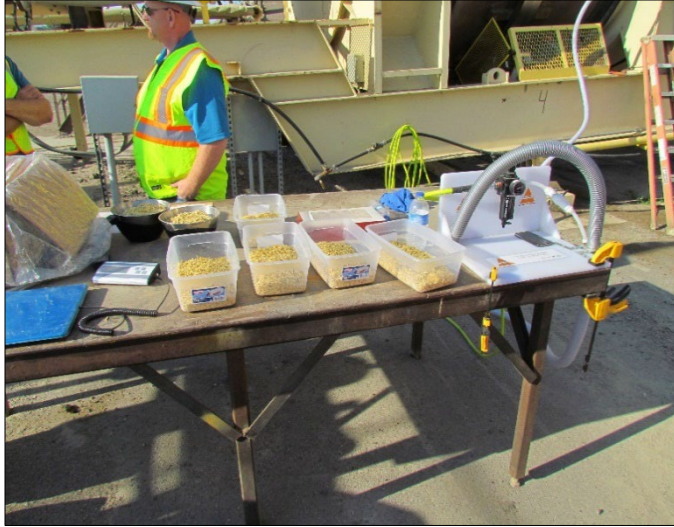
← Overview of the Ace Fiber Line-Vac Delivery System (LVDS) set-up near the hot plant mixing drum. Based on a production rate of 280 tons per hour fiber insertion (or goal) would be at an application rate of 19.6 oz. per minute (based on a 4.2 oz. per ton). Each tub would hold 19.6 oz. with four tubs on deck ready for production.

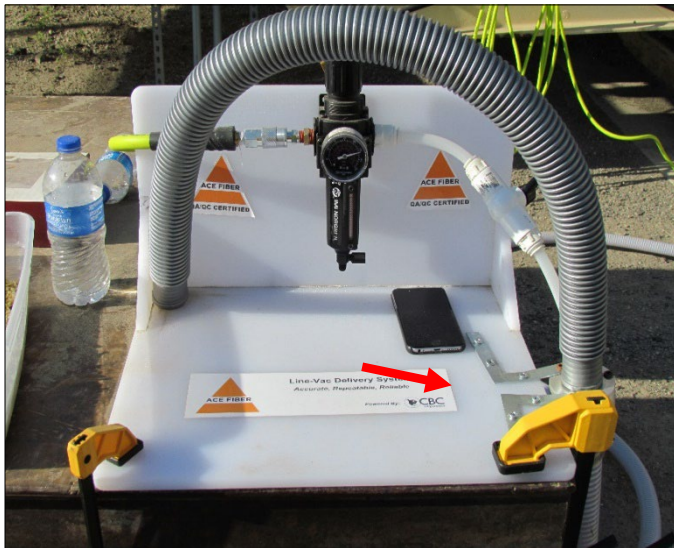
← A close-up view of the Ace Fiber LVDS set-up. The iPhone acts as the timer for the technician to ensure each tub is metered in at the one-minute per tub application rate.

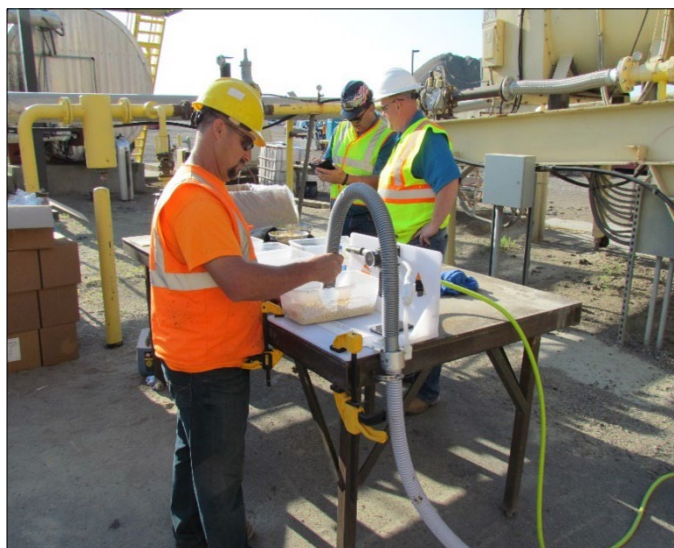
← The pilot house personnel give the technicians the go ahead to begin vacuuming the pre-weighed fibers from the tubs. Suction is generated by using an Exair compressed air powered (in-line) vacuum generator. The air pressure is regulated at 125 psi.

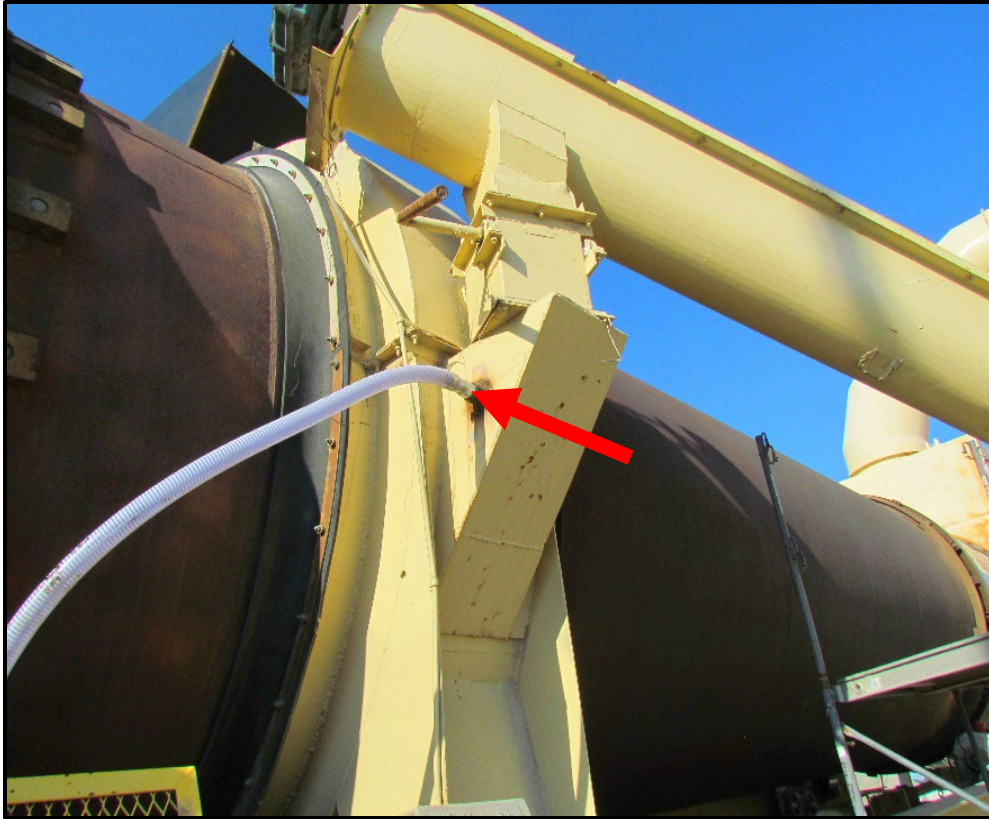
↑ Per Surface Tech's recommendation, Knife River modified their baghouse return chute with an adapter to accept the fiber vacuum hose. This added the fibers to the aggregate at the same point as the asphalt binder.

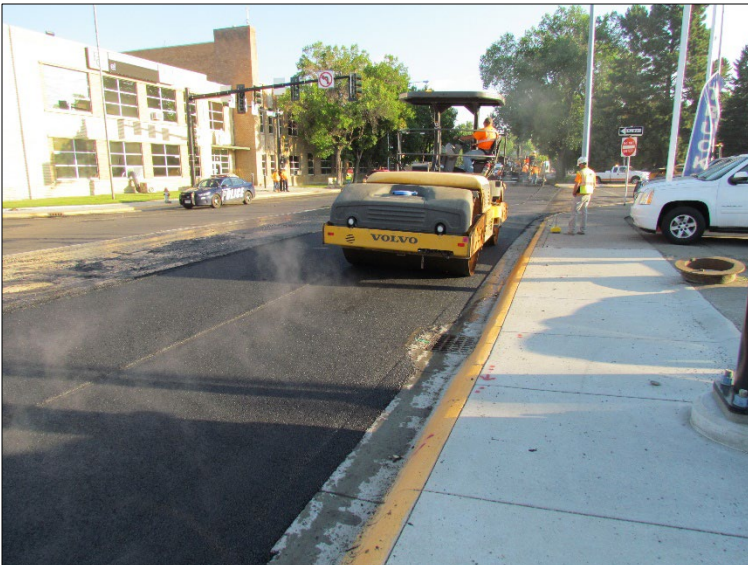
← Double steel drum rollers were used for compaction.

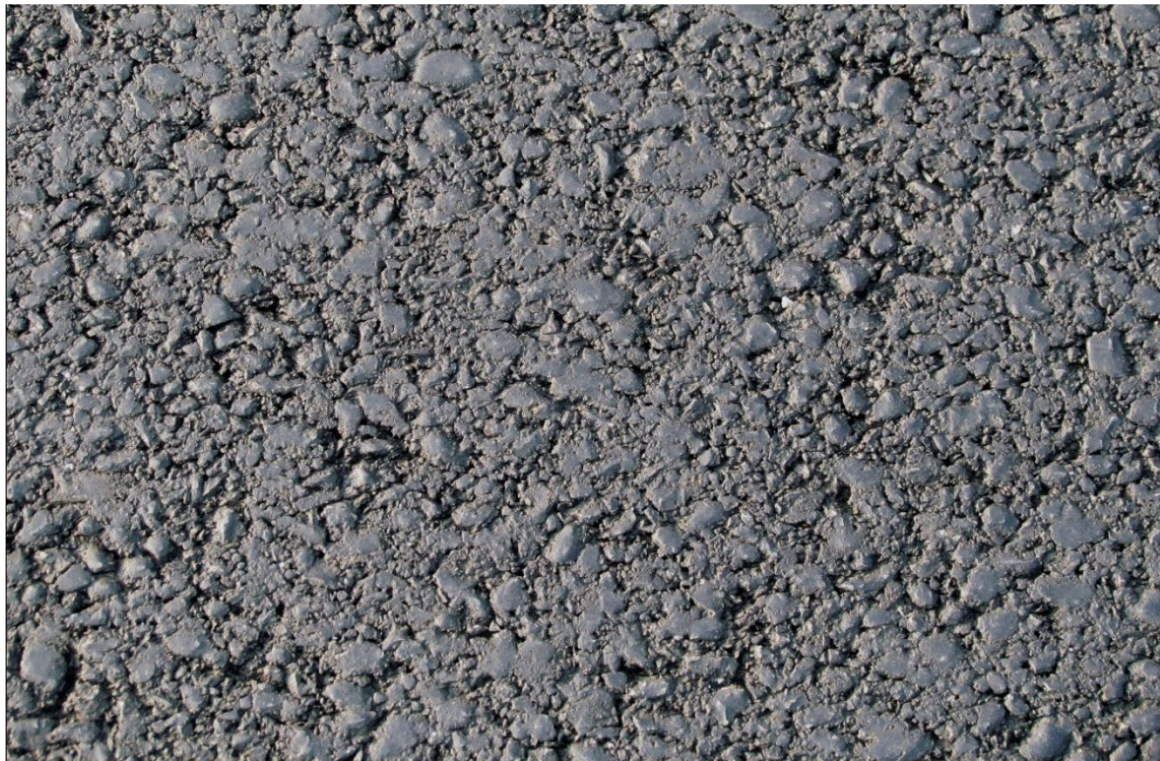
↑ Compactied FRAC.

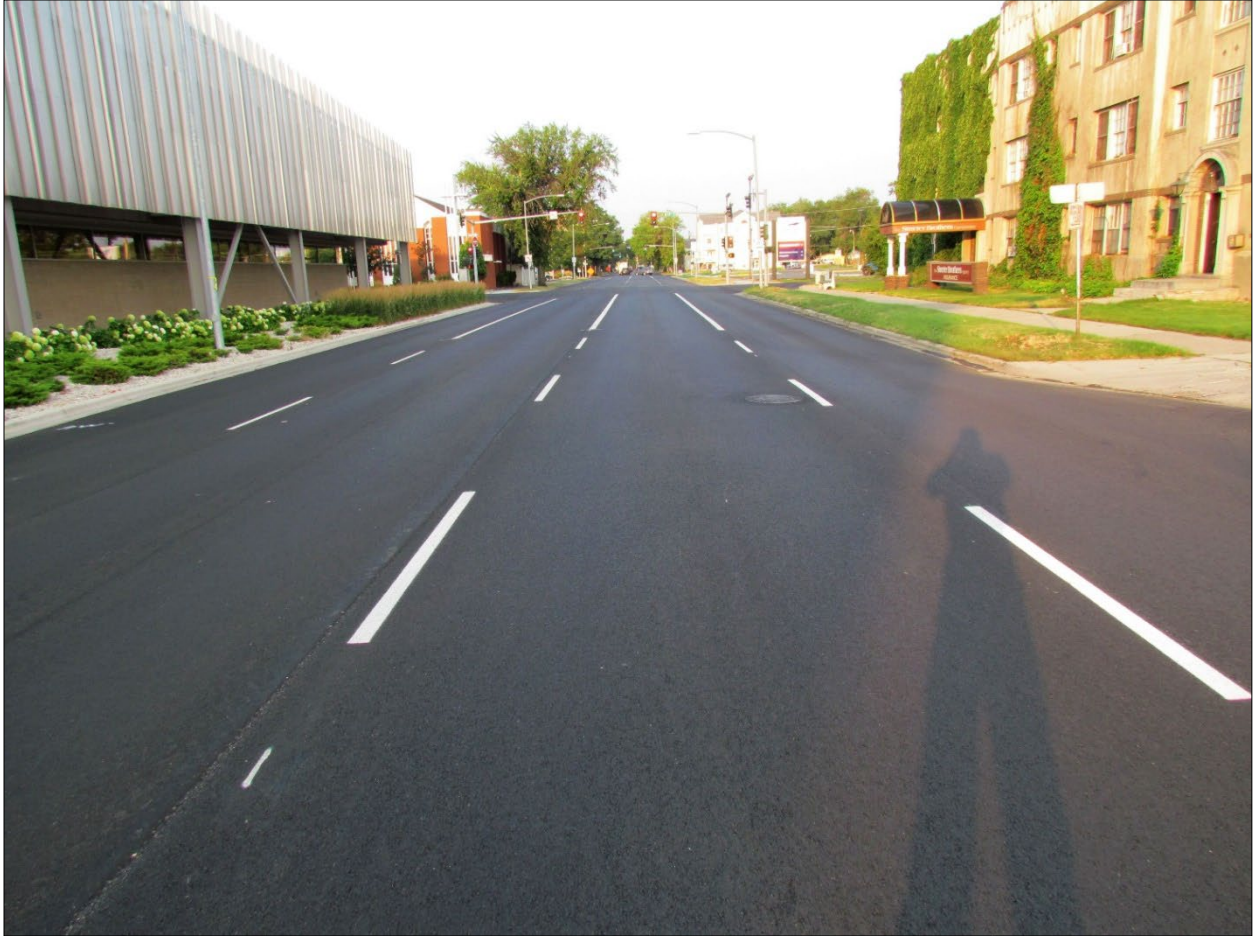
↑ Representative image of the completed project. 6<sup>th</sup> Ave N, view west.
