**Experimental Feature Evaluation
 December 2022**

Experimental Feature:	PCCP Bondbreaker
Location:	Glendive District, Richland County, Fairview, MT Hwy 200, RP 62.1 – 63.9
MDT Project Name:	MT 200 – Fairview
MDT Project Number:	NHIP 20-2(32)62[8168]
Experimental Project Number:	MT-20-05
Principle Investigator:	Chad DeAustin, Experimental Project Manager (ExPM)
Construction Date:	Spring 2020
Date of Inspections:	May 2021, September 2022

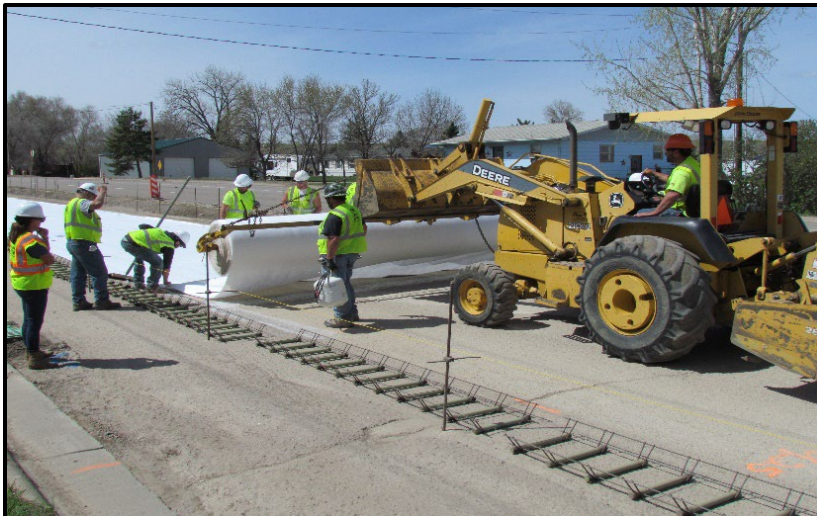
← The contractor switched to use the tractor to pull the fabric, as opposed to tractor pushing the fabric forward. The change was made to improve the lay down of fabric as the equipment was not on it.

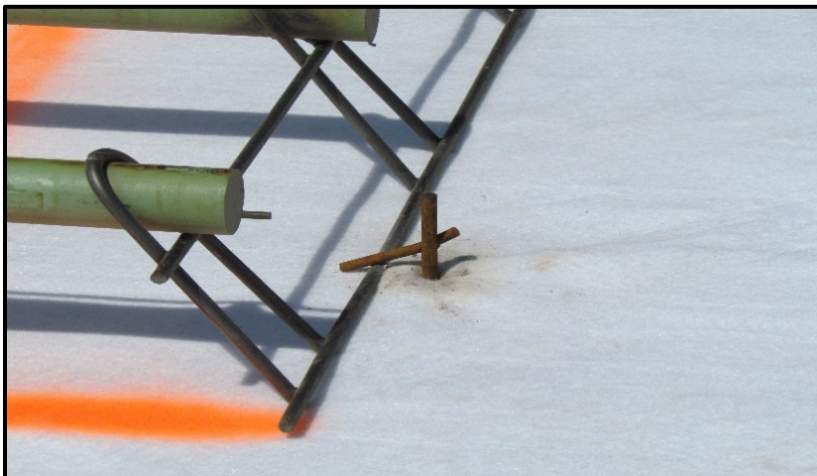
← The contractor initially anchored to the CTB. However, the contractor switched to use the anchoring system, made by Construction Materials, Inc., designed specifically for this fabric. The anchoring system anchors the baskets directly to the fabric rather than that of anchoring to the CTB.

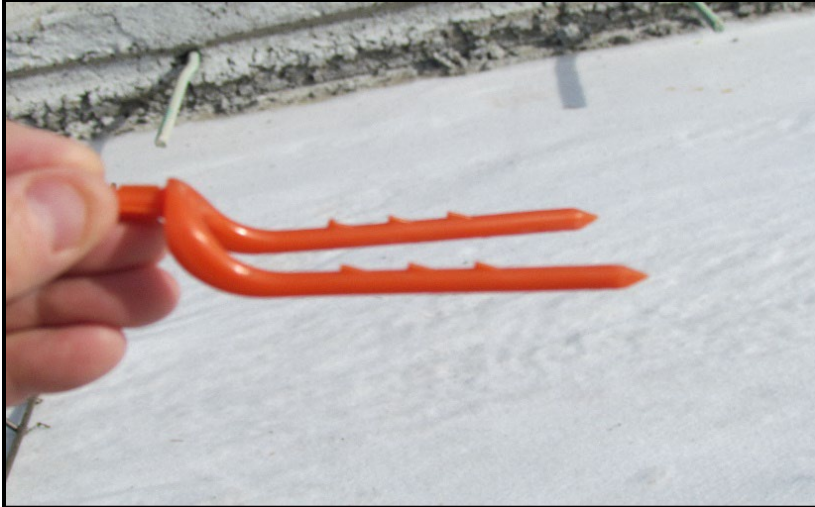
← The contractor moved to a plastic anchor system recommend by the onsite rep for the SKAPS GT116 product. The anchor is designed to be punched through the fabric rather than drilled in the CTB through the fabric.

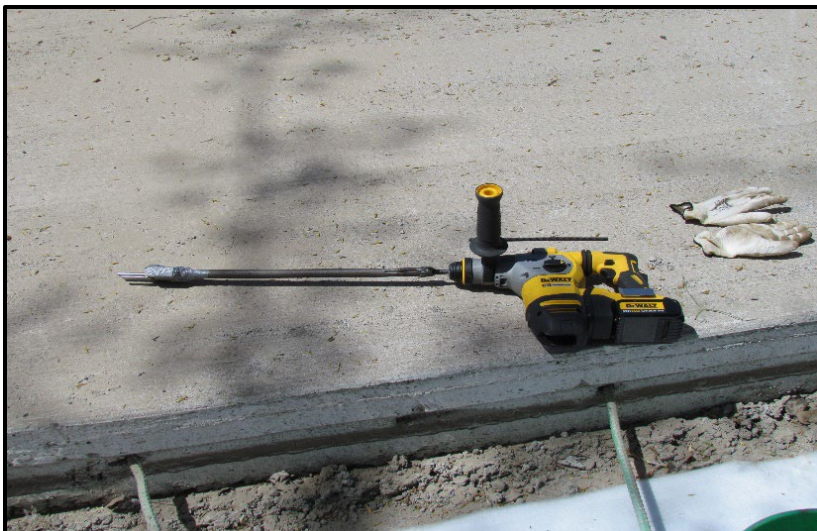
← The drill the contractor used to punch the holes in the fabric for the dowel anchor installation. The use of this anchoring method significantly reduced labor versus the pea stake installation.

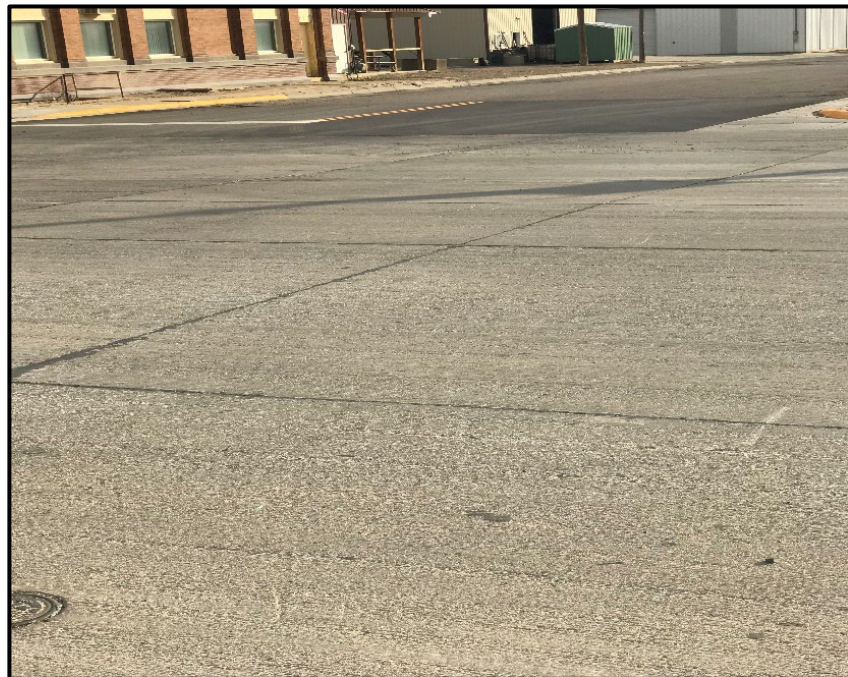
← Intersection of MT Hwy 200 and 4th St, view west. Test section.

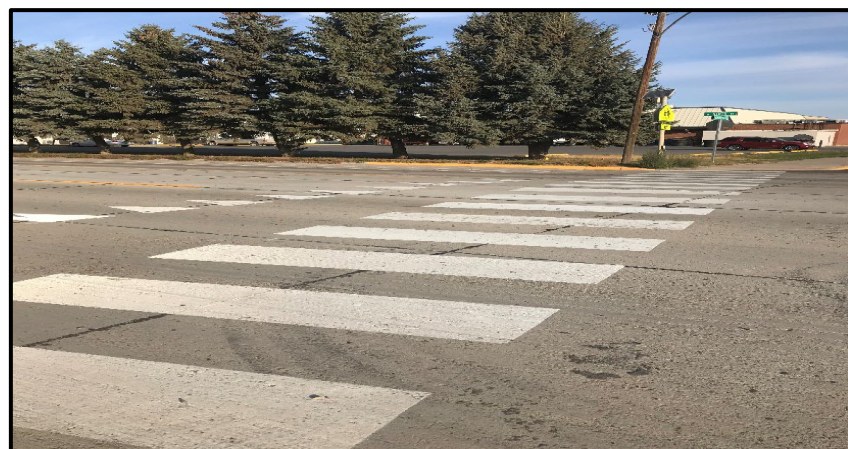
← Intersection of MT Hwy 200 and Pleasant Ave, view west. Test section.

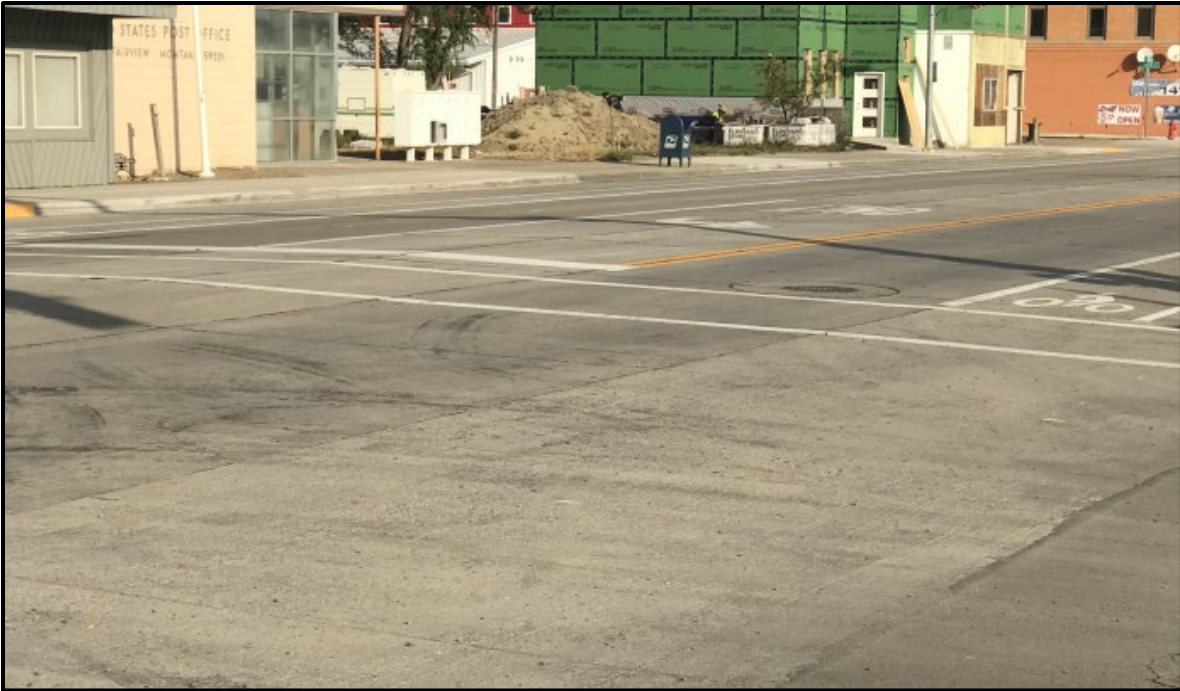
↑ Intersection of MT Hwy 200 and 6th St N, view west. Test Section.
