POST-WINTER EVALUATION REPORT

Detectable Warning Devices (Truncated Domes) for use by the Visually Impaired

Project No.: STPU 5201(11), 6th St. N. W.

Evaluation Date: April 2005

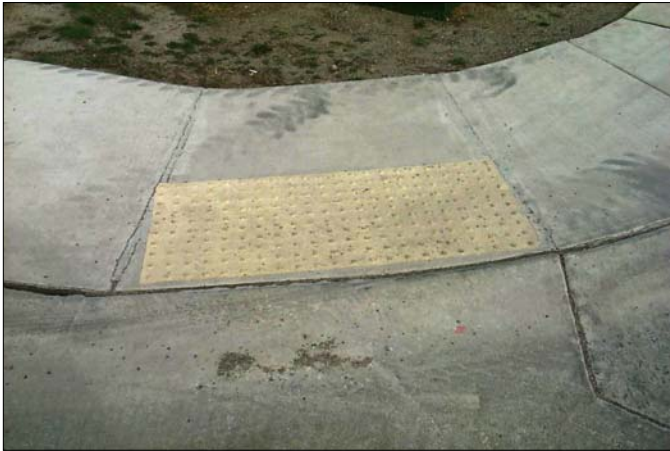
Installation 5A: located at northwest intersection of 1st Ave. N. W. and 6th St. N. W.

These installations are performing well to poor, 5 B & C has dome loss since last inspection, due to apparent blade damage. Adhesion is good. Color retention is fair.

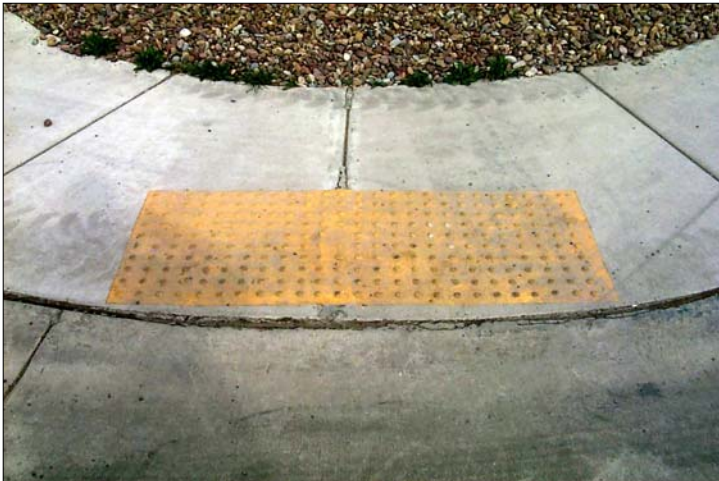
Installation 6B: located on the northwest corner of the intersection 4th Ave. N. W. and 6th St. N. W.

All installations were in poor condition at the time of inspection. Treatment 6A is continuing to lose adhesion around the edges of the mat. The anti-skid coating over the top of the rubber domes with treatment 6A & 6B is continuing to flake off. It is unclear if this is a result of blade damage, sunlight deterioration or through the action of freeze-thaw.
