Montana Department of Transportation  
Helena, Montana 59601-1001

Documentation of Great Falls Experimental Whitetopping Repair Project

Location: Great Falls, Montana; Intersection of N. W. Bypass & 3<sup>rd</sup> St. N. W.  
(U5206 & U5203). Three southbound lanes of 3<sup>rd</sup> N. W.

Repair Date: March 28 & 29, 2001

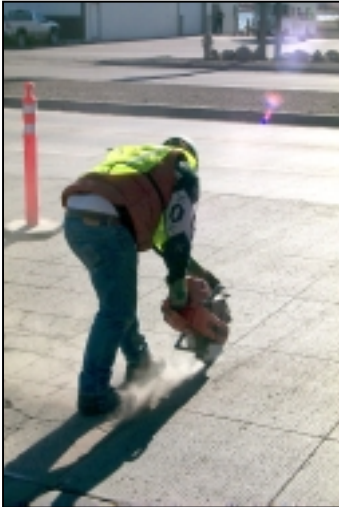
United Materials Inc., and to ascertain the plausible reason(s) of this premature failure. The image of Whitetopping above shows the area (outlined with white paint) that has deteriorated to the extent that it must be removed and replaced with full-depth PCCP. A concrete saw was used to score a deep

enough cut to break the damaged panels cleanly away from the panels not affected. Care was taken to prevent disturbing the adjacent viable panels during the removal of the cracked panels. A spud bar and picks initially were used to remove a section of panel large enough to allow a backhoe to begin removing the PCCP layer. The backhoe operator
