Montana Department of Transportation
Helena, Montana
Research Program

Experimental Whitetopping Annual Evaluation

Location: Great Falls, Montana; Northwest Quadrant of Intersection of N. W. Bypass & 3rd St. N. W. (U5206 & U5203). Three southbound lanes of 3rd St. N. W.

Evaluation Date: July 24, 2003

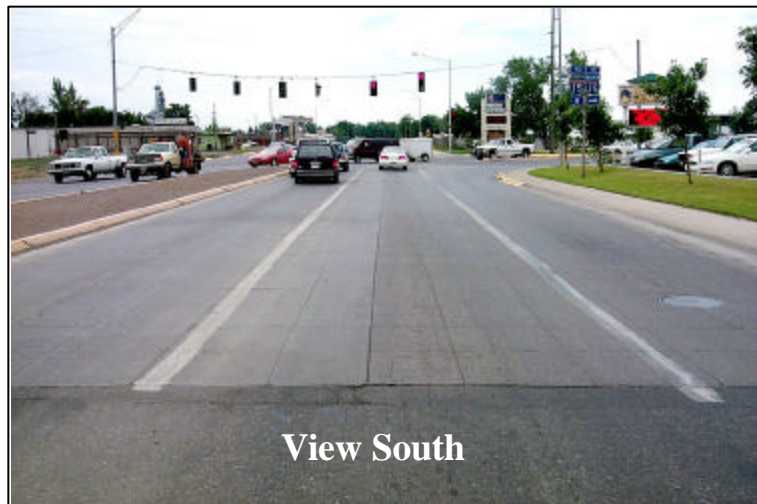
Since the 2002 evaluation, continuing panel cracking in the right-hand turn lane adjacent to the repaired area (south in the direction of travel – outlined in yellow in figure 1). This panel cracking may be an extension of the underlying AC stripping which was determined as the main factor of failure and consequential replacement of the 10' x 15' section replaced in March 2001. The moisture stripping the bottom AC layer may be attributed to the close proximity of the storm sewer line directly under the lane. Since the last evaluation, cracking has increased and approaching to severe in nature. No deflection or debonding of the individual panels was seen as traffic passed over.
