ANNUAL EXPERIMENTAL EVALUATION REPORT

Thin-Whitetopping Bonded Composite

Project No.: STPP 1-2 (93)121, East Idaho St.

FHWA No. MT 00-02

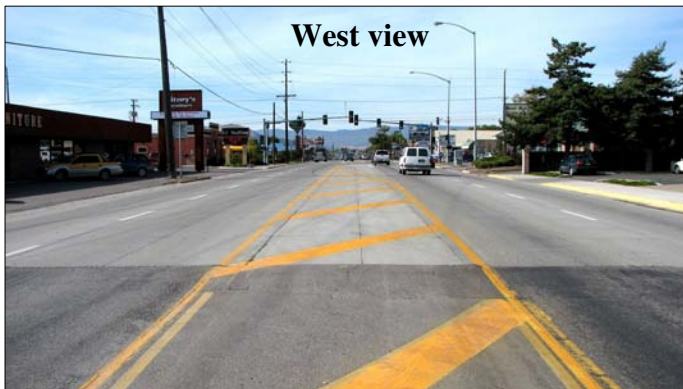
This was the seventh annual analysis of this project since construction in fall of 2000. This inspection consisted of a visual review to document any surface distress or deterioration of the whitetop/AC-bonded composite.

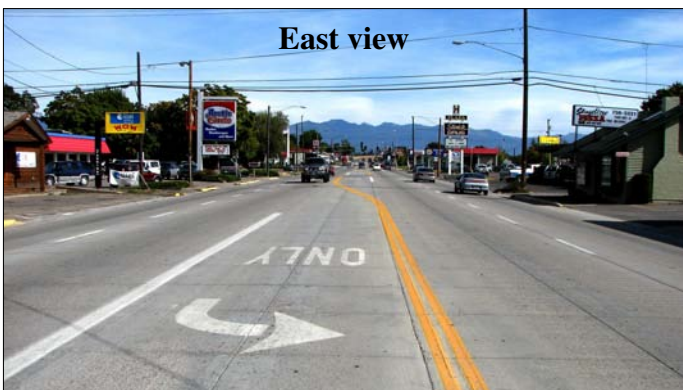
The overall appearance of the whitetopping is good. Twenty-two cracked panels were documented in the 2006 report. Nine additional panels were documented during this evaluation. All cracks are hairline in nature with no vertical displacement or debonding of the composite panels. At this time, there is no indication of a pattern or reasons for the randomness of the cracked panels; therefore, it is premature to attempt to ascertain a cause. It should be noted that the
