CONSTRUCTION REPORT – SITE EVALUATIONS

APPLICATION OF SEAL COAT ASPHALT EMULSION (OR FOG COATING) OVER EXISTING CHIP SEAL FOR IMPROVED CHIP RETENTION

Project Name: Beavertail Road Chip Seal

Project Number: MT 10-05

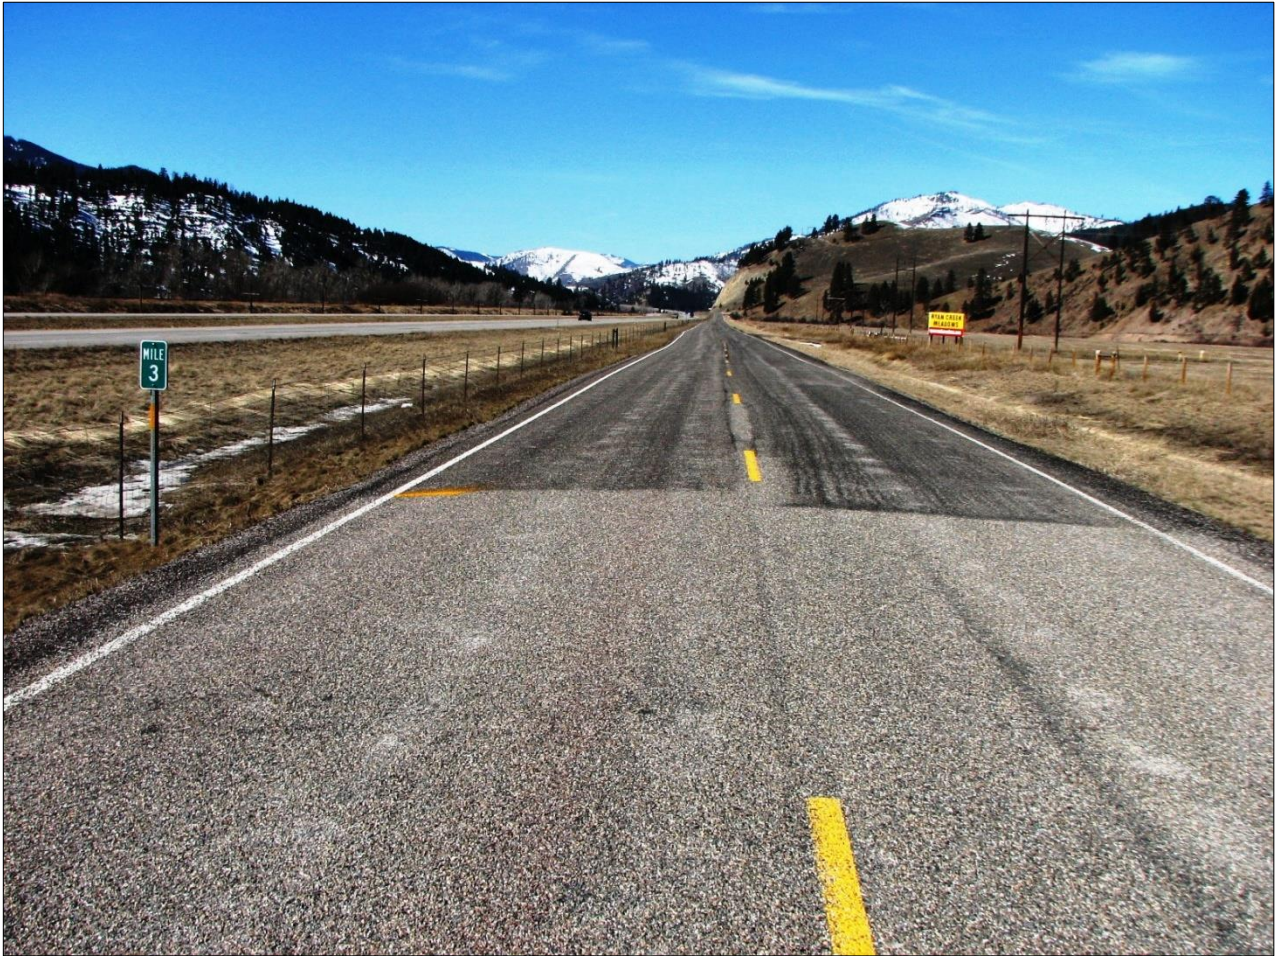
During the site visit at random spots along all three sections, a broom was used to determine if it could indicate a level of loose chips at any section. Although highly subjective; test sections 1 & 2 had about the same level of detached chips which was minimum as compared with the control section with noticeable (but minor) added chip loss. Also noted that there seemed to be very little perceptible sanding material on the pavement surface in all sections.
