EXPERIMENTAL PROJECTS CONSTRUCTION REPORT AND ANNUAL EVALUATION

Sprayroq-SprayWall Polyurethane Applied Lining for Culvert Rehabilitation

Location:	Mineral County-Missoula District: Interstate 90, Reference Point (RP) 59; Nemote Creek Crossing
Project Name:	I-90 Nemote Creek Culvert
Project Number:	IM 90-1(205)59 – Work Type 312: Structure Safety
Experimental Project:	MT-13-14
Type of Project:	Culvert Rehabilitation
Principal Investigator:	Craig Abernathy: Experimental Project Manager (ExPM)
Date of Installation:	January-February 2017
Site Inspection:	April 2017/2018, January 2019, March 2020

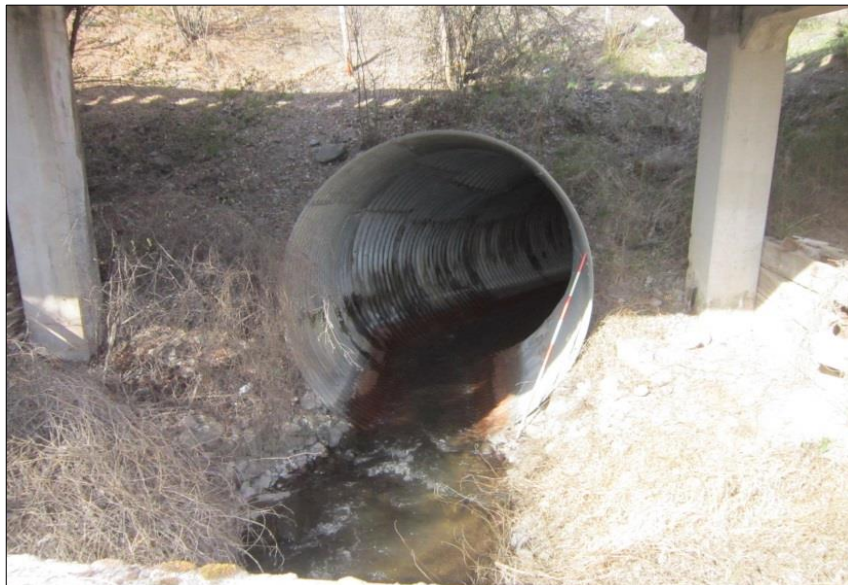
← Upstream culvert inlet view, (east end).

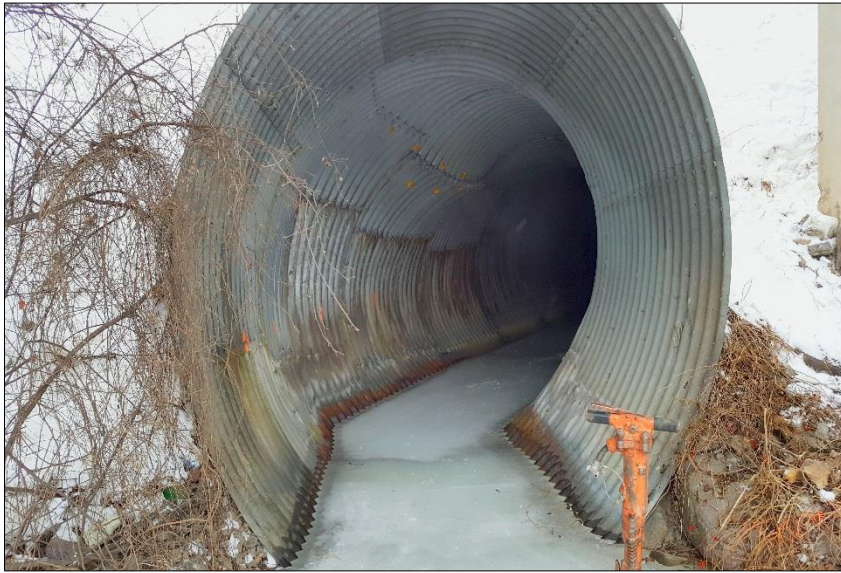
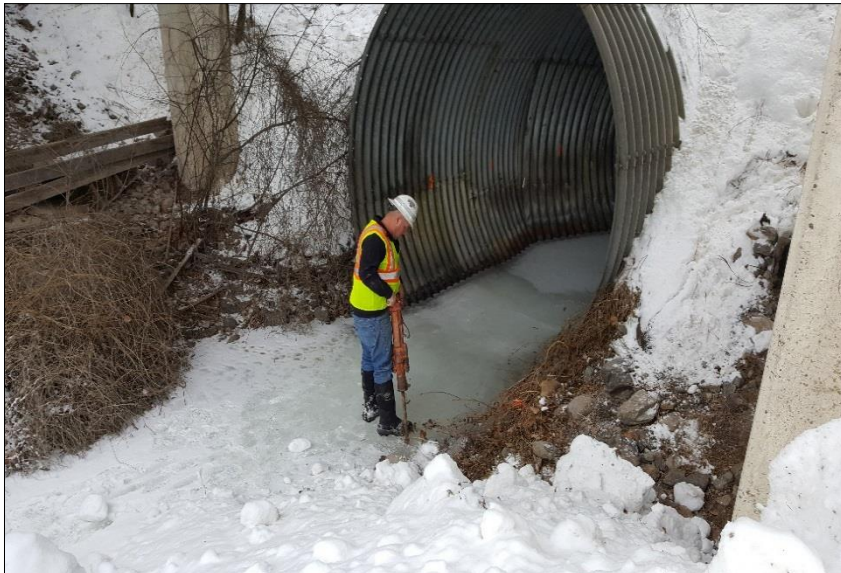
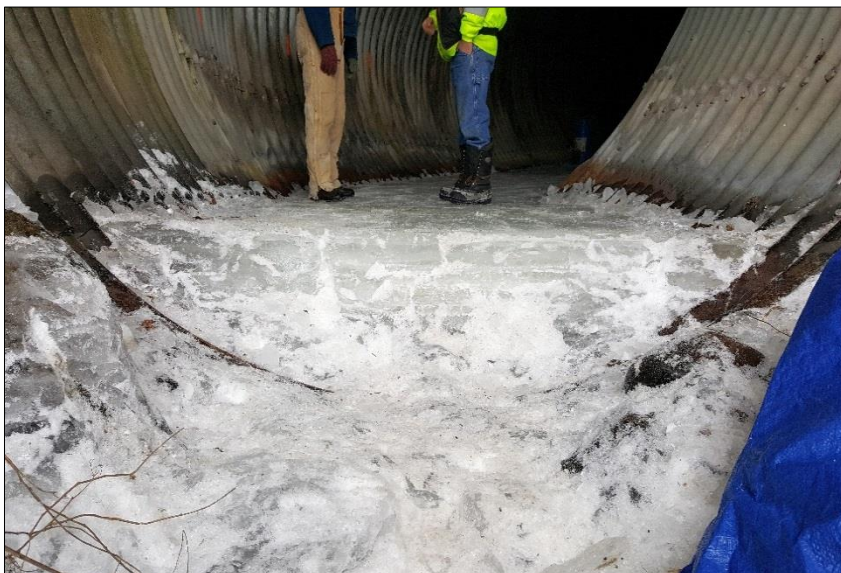
← ↓ Representative images of the process of removing ice from the culvert.

Jackhammers, shovels and picks were used to break up the nearly two feet thick ice.

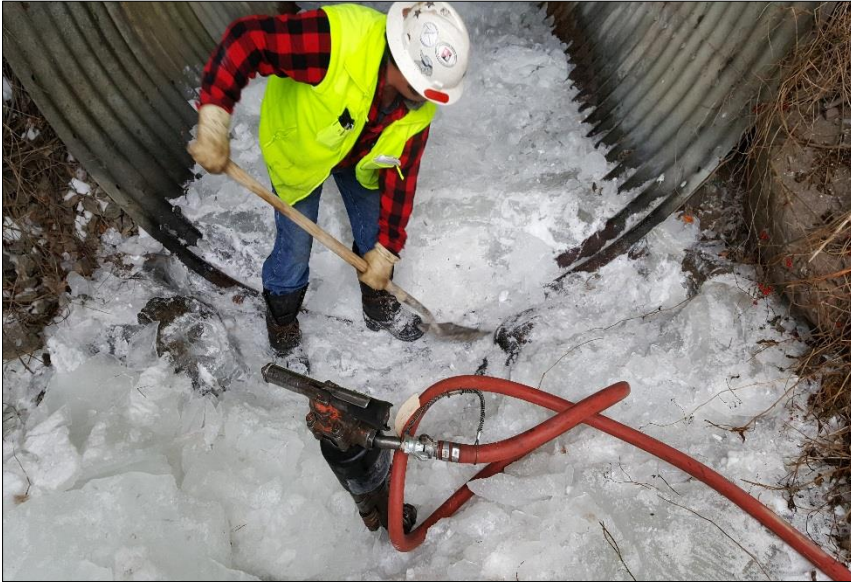
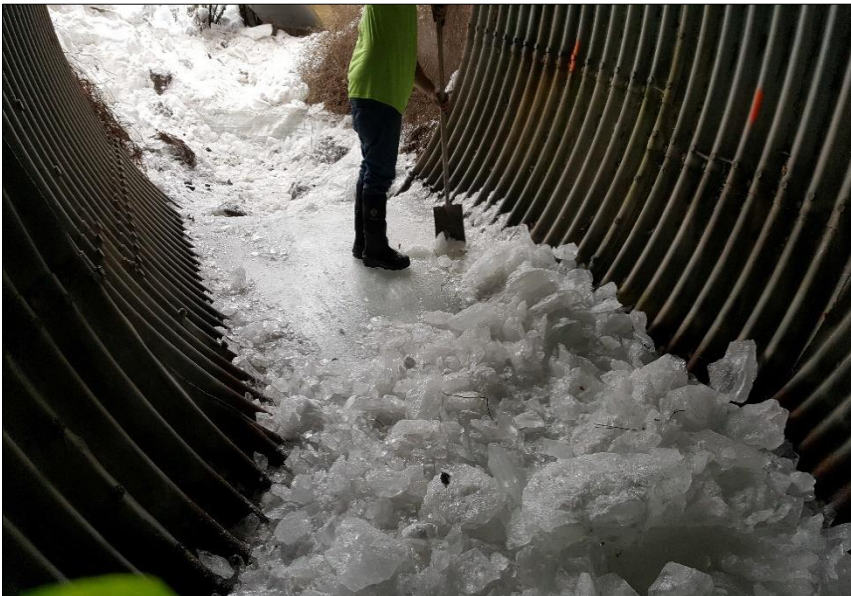
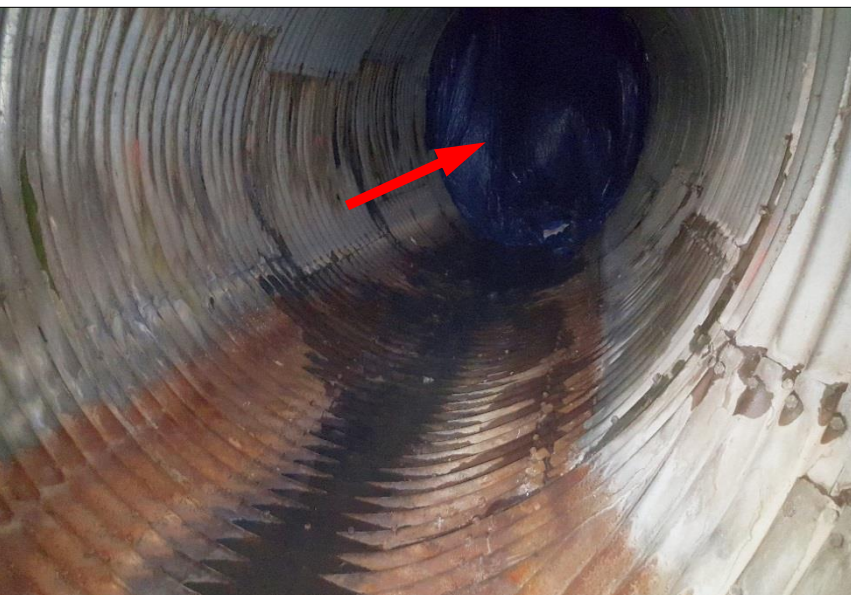
← ↓ More images of ice removal.

← Ice removal complete and culvert is now ready for preparation phase.

The red arrows show placement of tarp with sandbags past the area of rehabilitation to block air flow and meltwater from entering the cleaned-out section of pipe.

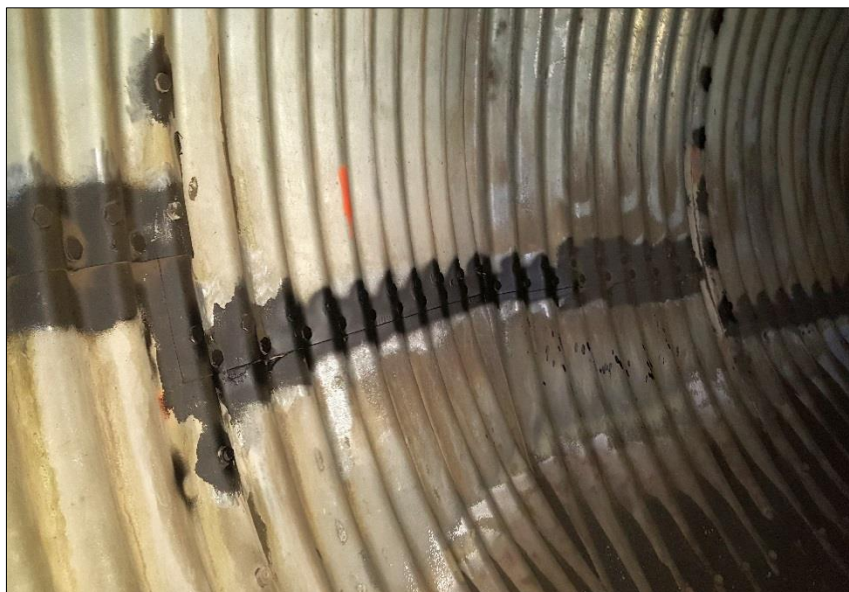
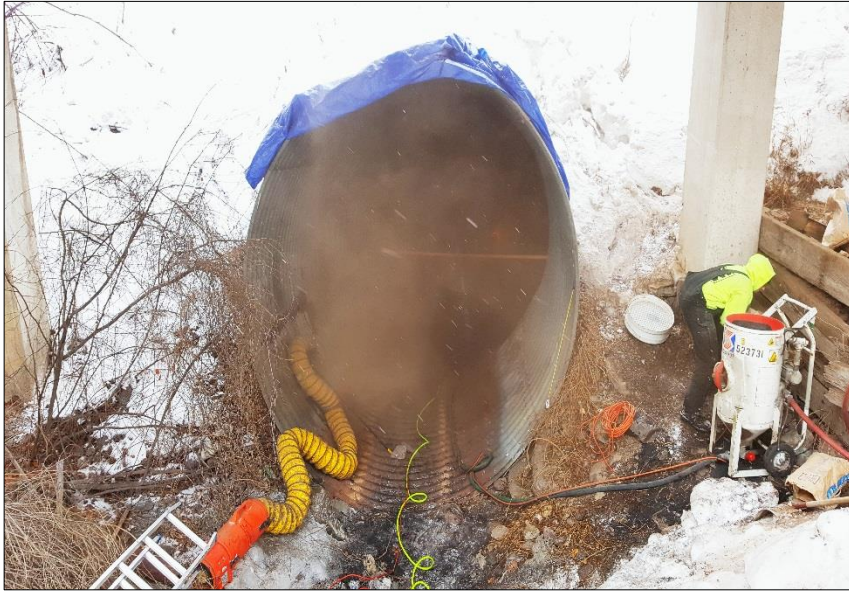
← ↓ The base of the culvert where active corrosion took place is sand blasted (Kleen Blast Abrasives) to bare metal and vacuumed clean.

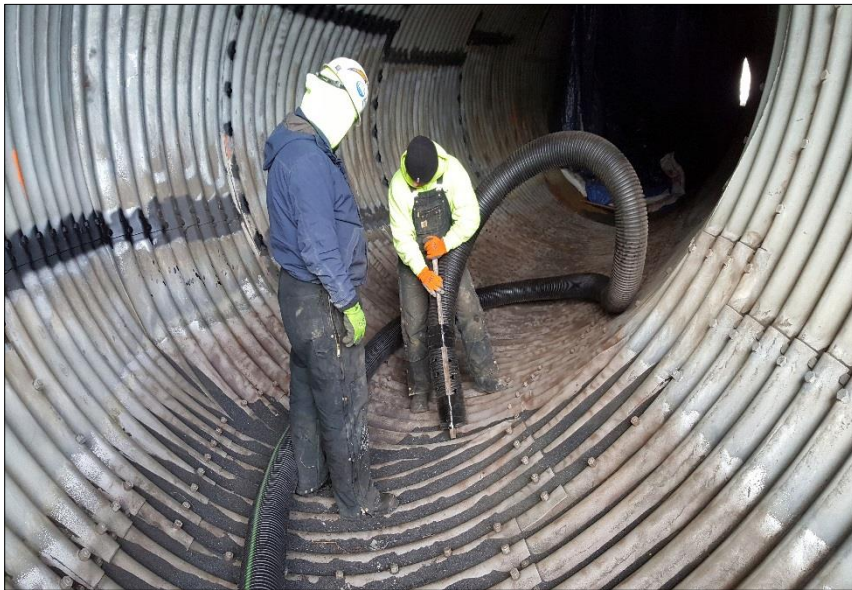
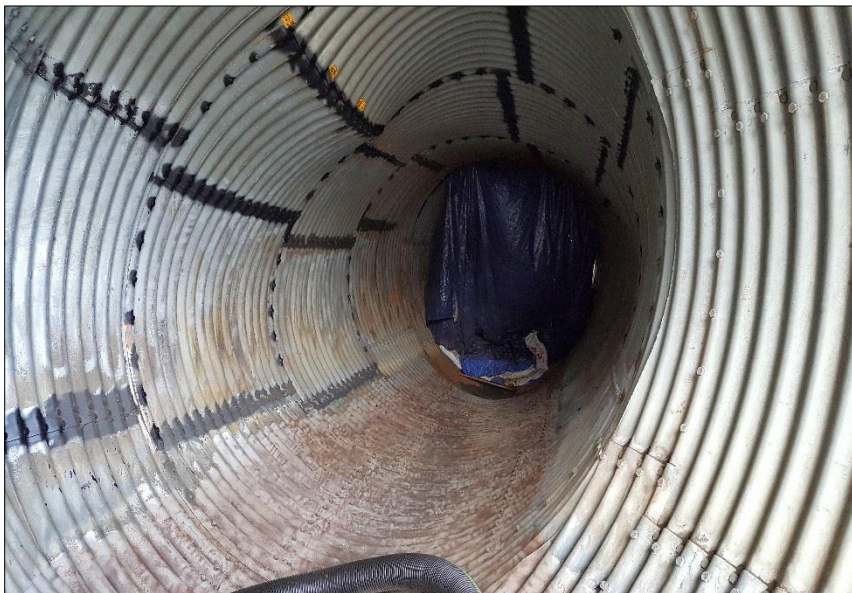
← Completed sand blasting.

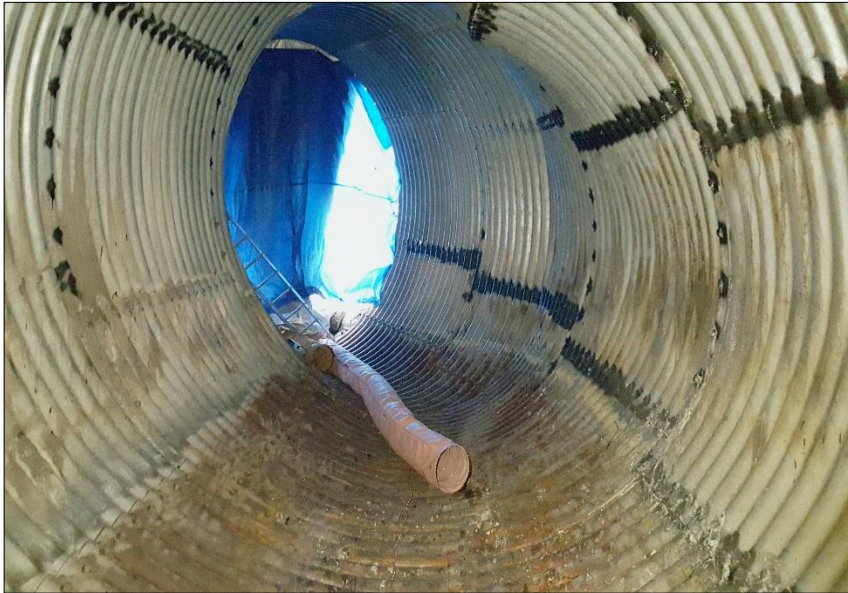
← Warm air is circulated within the prepared section of culvert.

Ambient air and surface temperature must be high enough (60°F / 16°C minimum) for adequate adhesion of the polyurethane coating.

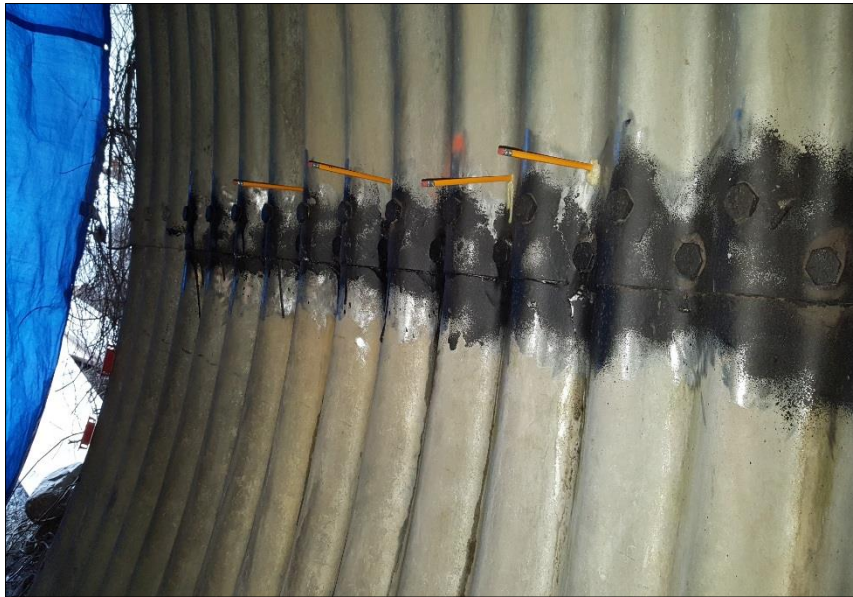
← Once the Aqua-Dam is injected, pencils (conventional No. 2 Staples brand), were used to plug the holes to prevent seepage and allow curing.

Once the cure set the pencils are cut flush to surface, and excess sealant removed prior to the SprayWall application.

MDT inspectors stated the applied sealants was not 100% effective in mitigating the moisture intrusion.

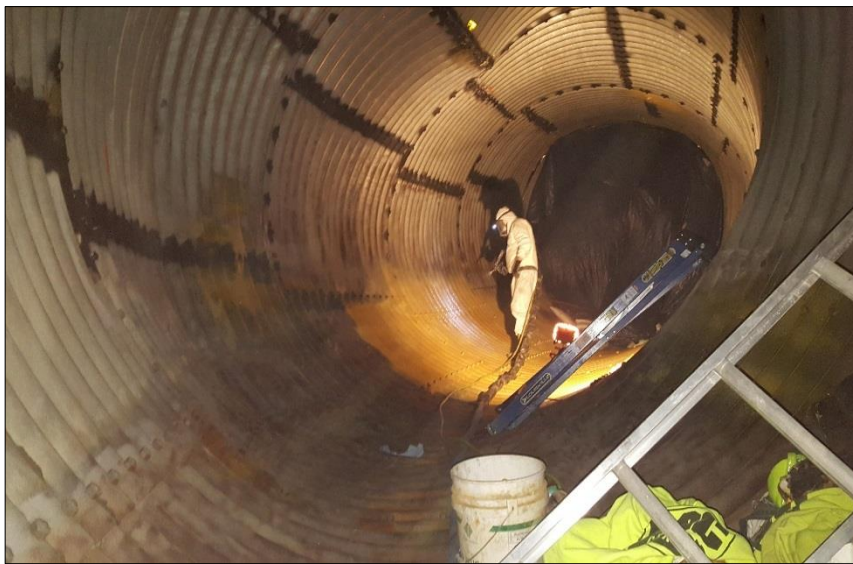
← Wearing protective clothing a worker applies the SprayWall to the bottom third of the culvert and allowed the material to cure.

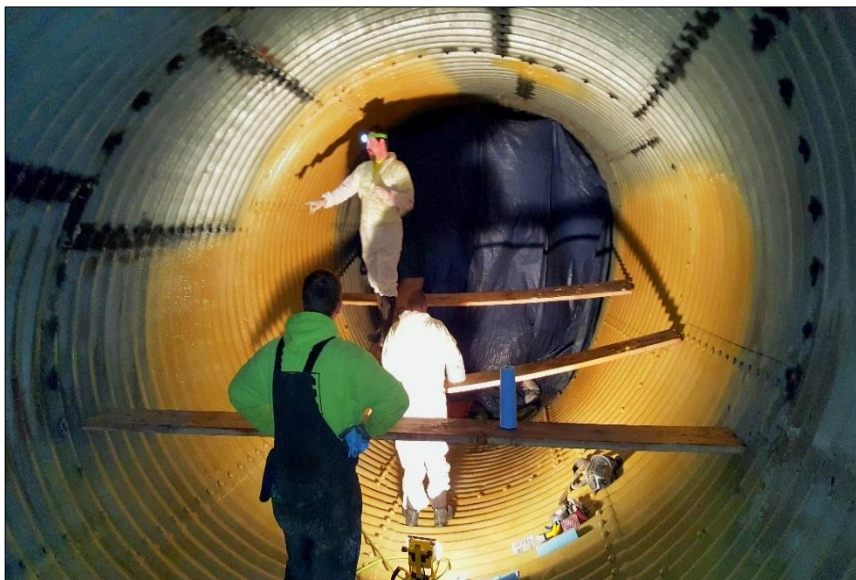
← As the spray coating proceeded up the walls of the culvert, boards were propped at the side (cured portion) to be used as stand supports for the workers to complete the treatment.

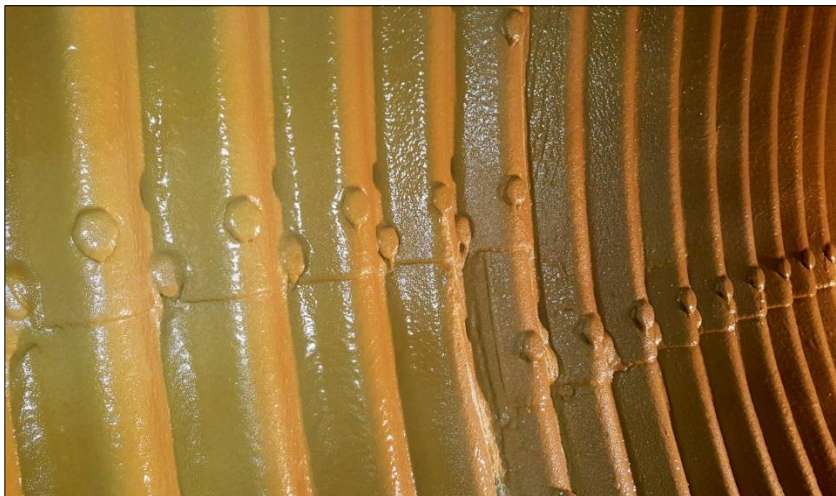
← Close-up of SprayWall texture after full cure.

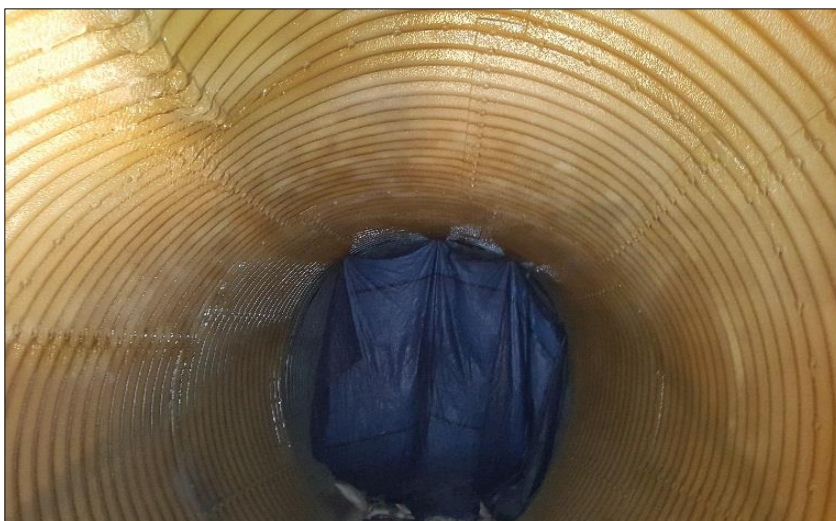
← View of SprayWall coating near end of rehab section after full cure.

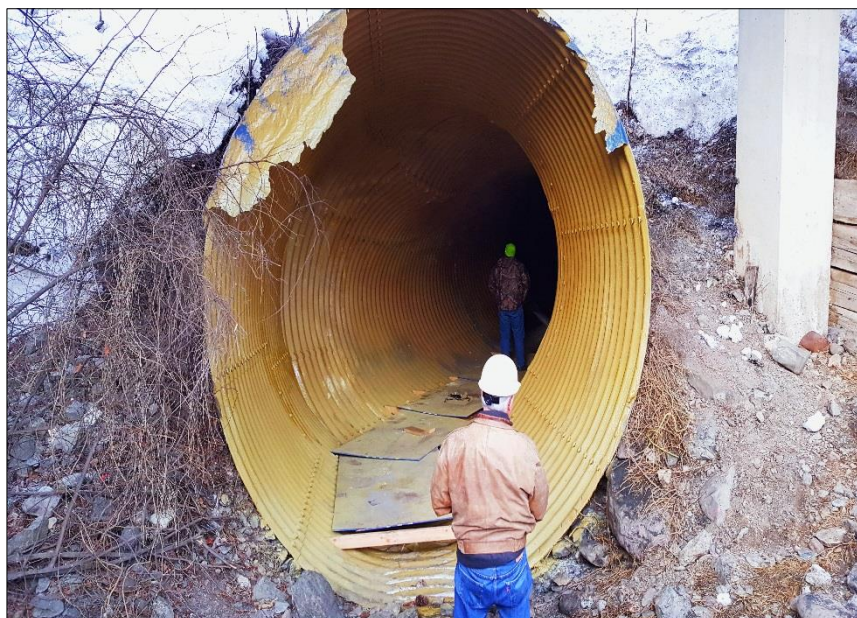
← Completed Sprayroq SprayWall installation under final inspection.

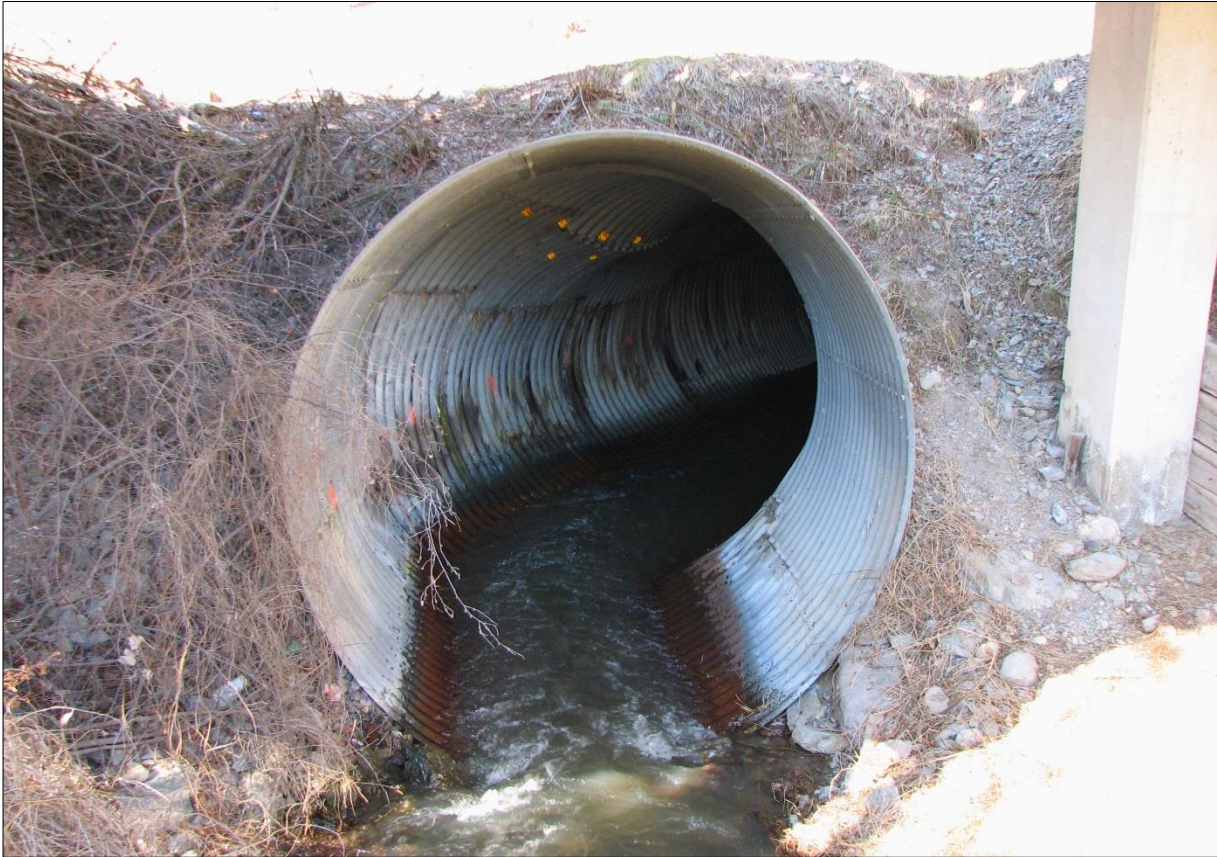
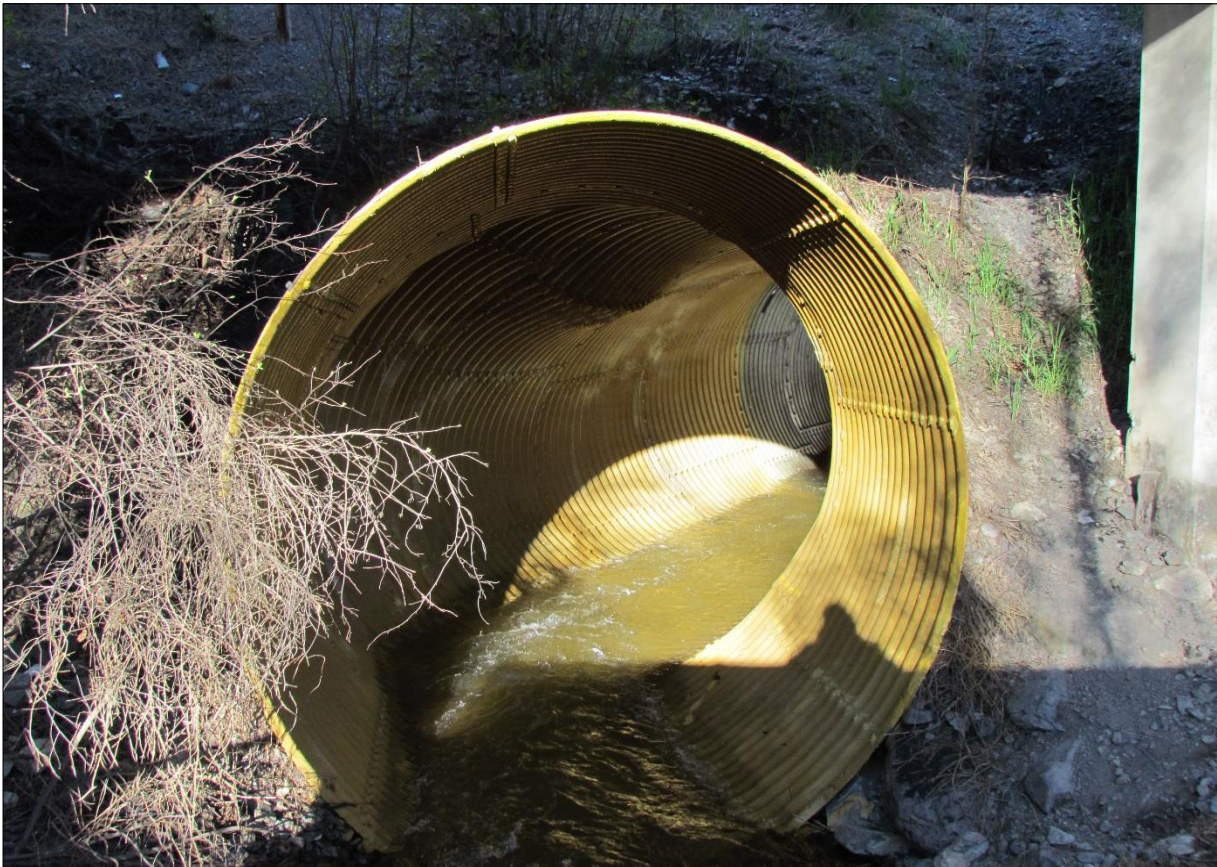
↑↓ Before culvert section rehabilitation (2016) and (lower image) completed project as seen at the **April 2017** site inspection.

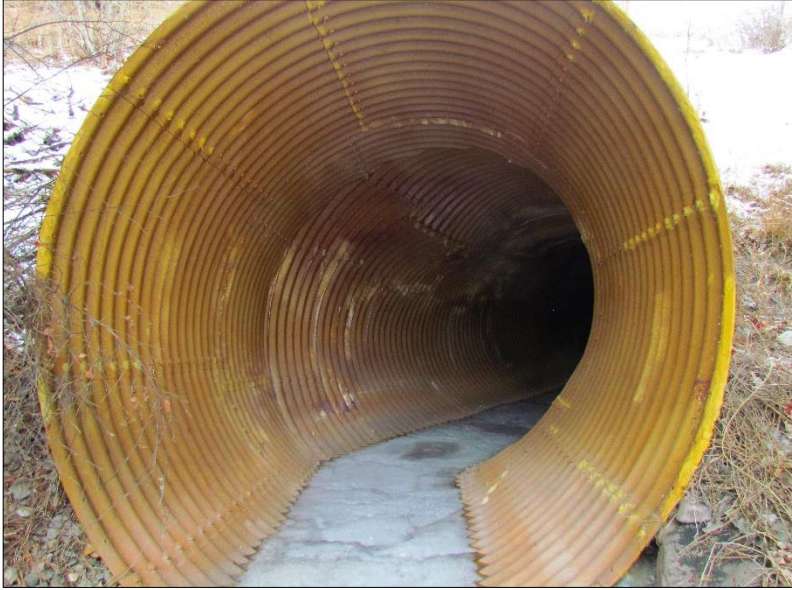
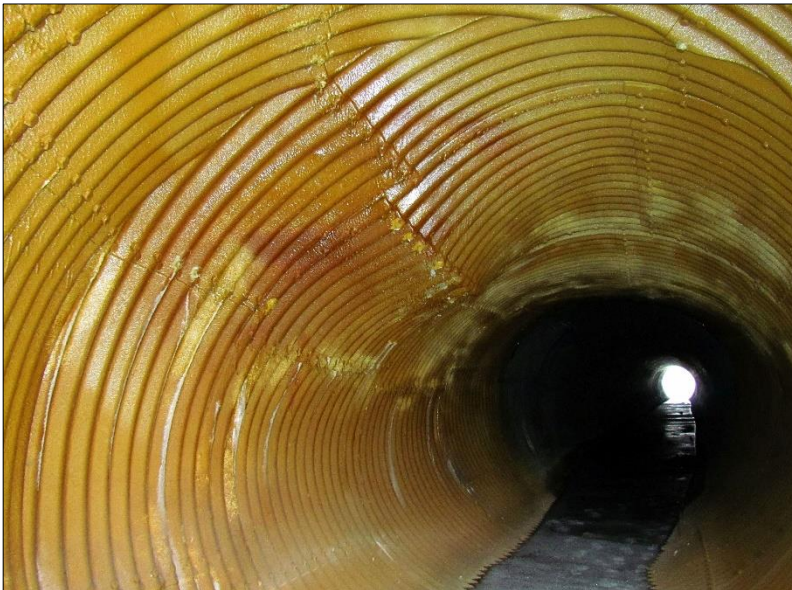
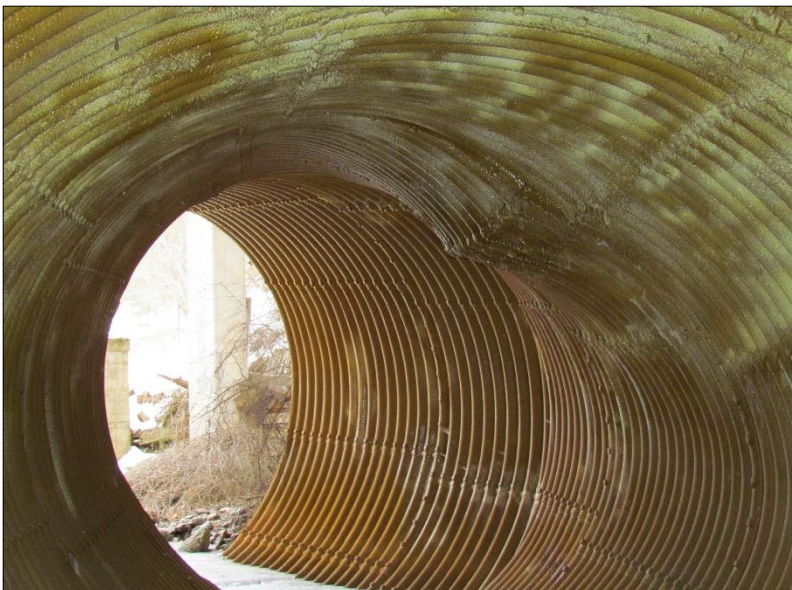
←↓ Representative images of the culvert SprayWall.

Center image is closer view of deflected panel.

Lower image is at the end of the treated culvert looking upstream.

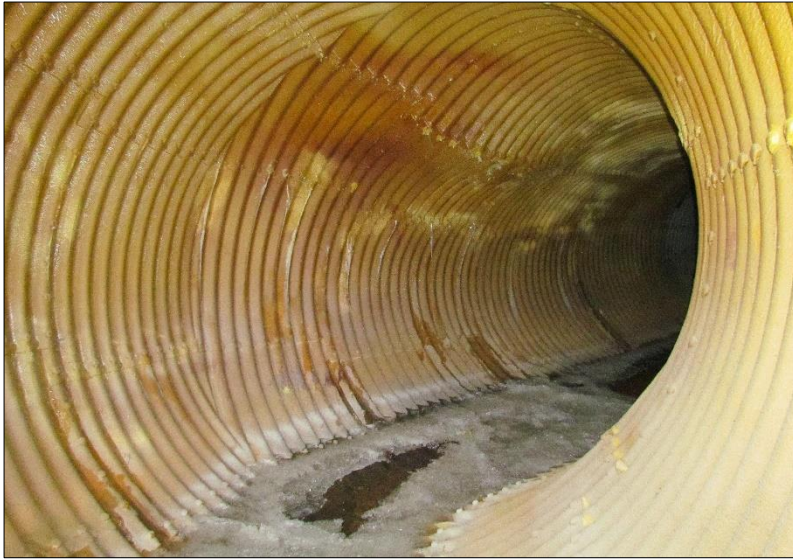
← Overview of culvert inlet.
