**Task 1 Report – Literature Review**  
**USE OF FIBER-REINFORCED POLYMER COMPOSITES**  
**FOR BRIDGE REPAIRS IN MONTANA**

Civil Engineering Department  
College of Engineering  
Montana State University – Bozeman

Prepared for the  
MONTANA DEPARTMENT OF TRANSPORTATION  
in cooperation with the  
U.S. DEPARTMENT OF TRANSPORTATION  
FEDERAL HIGHWAY ADMINISTRATION

August 2023

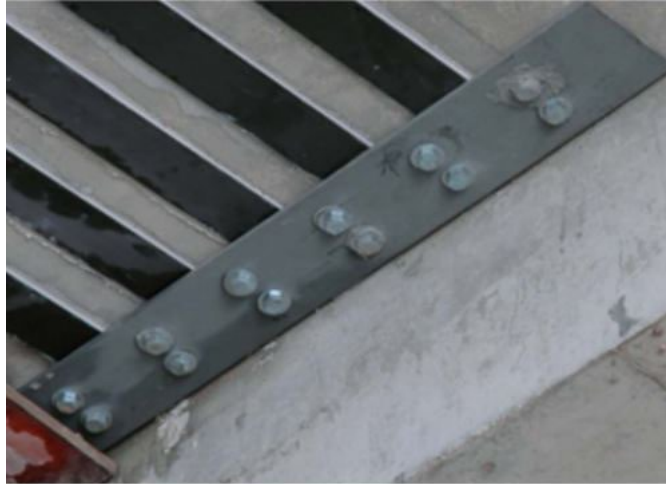
Figure 4: Example mechanical anchorage system [23].

Debonding is one of the main concerns when applying FRP techniques; however, this risk can be mitigated by providing anchorage. Examples of different anchorage systems are shown in Figure 1 – Figure 4. Kalfat [23] discussed several anchorage systems for different FRP applications techniques including U-wrap, mechanical fastener, nailed metal plates, concrete embedment, and fiber spike anchorage. Figure 1 shows an example U-wrap layout. Pham and Hao [24] showed that applying additional layering in the transverse direction can help mitigate debonding. They also described eliminating stress concentrations and thus improving the strengthening effectiveness and delaying premature debonding. Their researchers used longitudinal FRP for flexural resistance and transverse FRP for resistance to premature debonding. This same strategy was also employed in the past research at MSU previously discussed in the proposal of the current project. Lee mentioned that the angle and number of transverse wraps are two of the key parameters for mitigating longitudinal FRP debonding [25]. This study also showed that multiple 90° U-wraps provide better ductility, whereas 45° U-wraps can maximize overall capacity. Researchers also discussed the FRP spike anchorage (Figure 2), a comparatively newer anchorage system [23, 26]. This anchorage system has two parts: the anchor dowel that is inserted into a predrilled hole, and the fan that is fanned out and epoxied over the external wrapping. This technique is more flexible than U-wrapping, in that it can be easily applied on wide elements such as walls and slabs [23]. Anchorage is required at the ends of FRP NSM bar applications (Figure 3) to prevent slippage of the FRP bar. Anchorage is also necessary for prestress NSM systems to reduce the prestress loss [27]. Anchorage (bolts) is often used at various locations (primarily at the ends, Figure 4) to grip the FRP laminates [6, 28]. Al-Mahaidi and Kalfat presented two types of anchorage systems for FRP laminates to strengthen the web flange interface and combined shear and torsional strengthening [29]. To prevent the brittle failure of structures strengthened with FRP strips, several researchers recommended providing mechanical anchorage at the ends [20, 30].

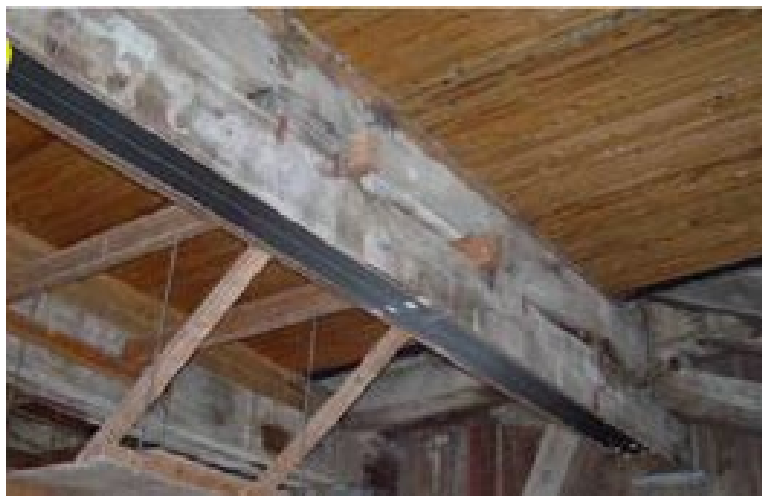
Figure 11: Post monitoring of Sins bridge, Switzerland [34].

The performance of the Sins bridge was satisfactory as of the year 2000. No significant damage was observed. Figure 11 depicts a photo of post monitoring.

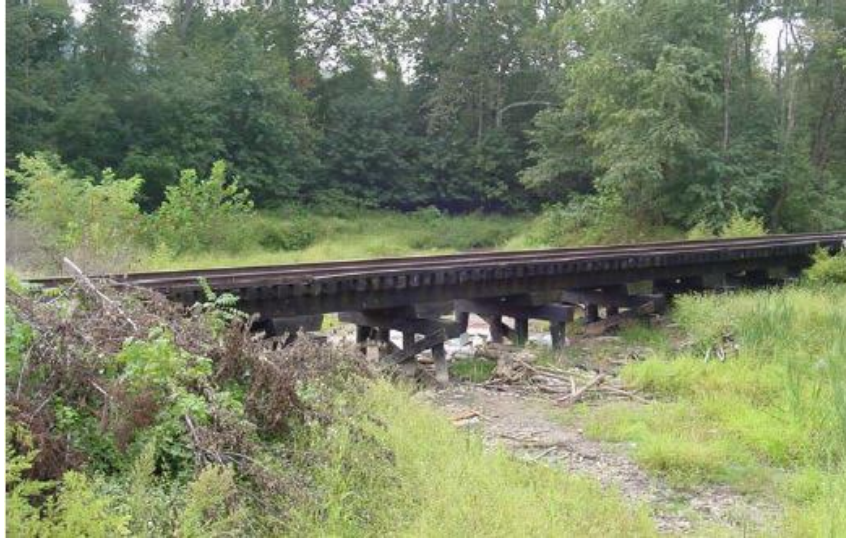
Figure 12: Photograph of timber railroad bridge in Moorefield, West Virginia [35].

West Virginia University worked on load testing and rehabilitating two 50+ year old open deck timber railroad bridges located on the South Branch Valley Railroad (SBVR), Moorefield, WV [35]. The bridge consists of seven spans on eight pile bents. Each span length is approximately 12 ft (3.6 m) center to center of the supports and contains two main chords. The chords are supported by pile bents which consist of one pile cap and four piles. Figure 12 shows a photograph of one of the bridges.

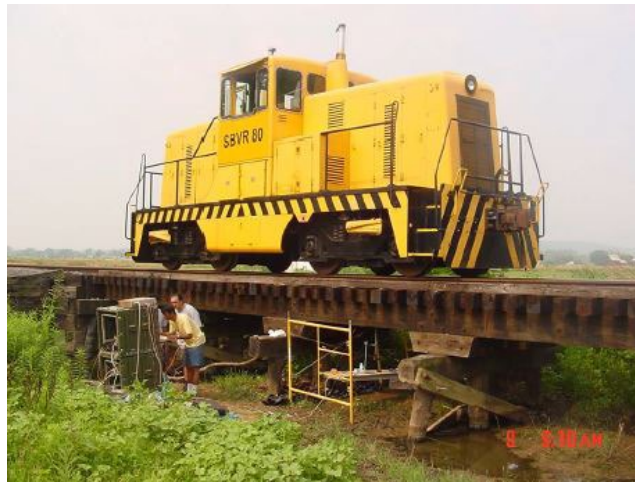
Figure 15: 80-TON SBVR Locomotive used for the Moorefield bridge field testing, West Virginia [35].

The field load testing was done before and after repairing the pile cap, stringer, and pile. The phenolic resin and formaldehyde hardener ratio used was 5:1 by weight. The pile cap and stringer repairing process involved removal of decayed material, rounding and sanding, priming the structure surface, coating of GFRP fabric with resin, and applying the GFRP wrap. The pile repairing process followed similar steps including removal of decayed material, construction of molding, placing of bulk filler, sanding, GFRP fabric application, applying pressure, and sealing. Load testing was done using a General Electric 80-ton locomotive (Figure 15) provided by SBVR. Tests were done using the locomotive at three different speeds (5, 10, and 15 mph) and dynamic responses were recorded. Static loading was performed by positioning the test locomotive at a specific place.

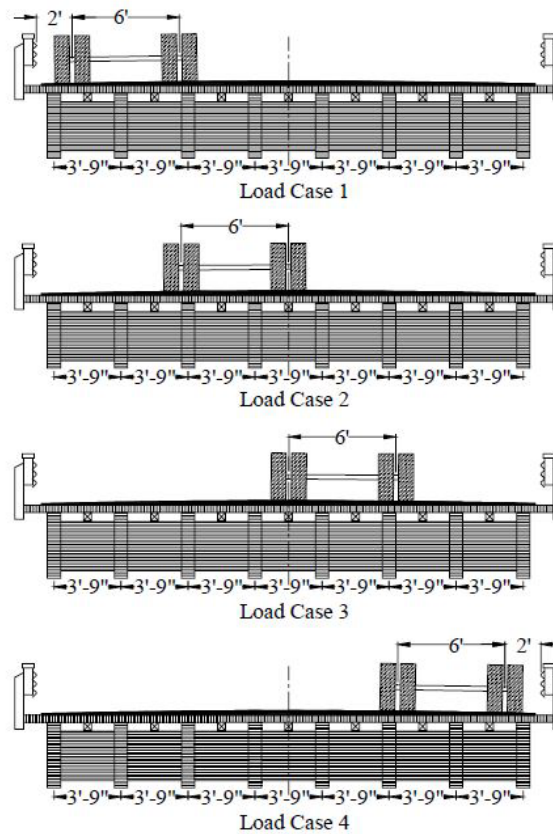
Figure 18: Load cases for Delaware county bridge [36].

The Delaware County Secondary Roads Department provided a fully loaded (51,560 lb.) tandem axle dump truck which was used for load testing. Four load cases (Figure 18) were investigated and two sets for each case were performed.

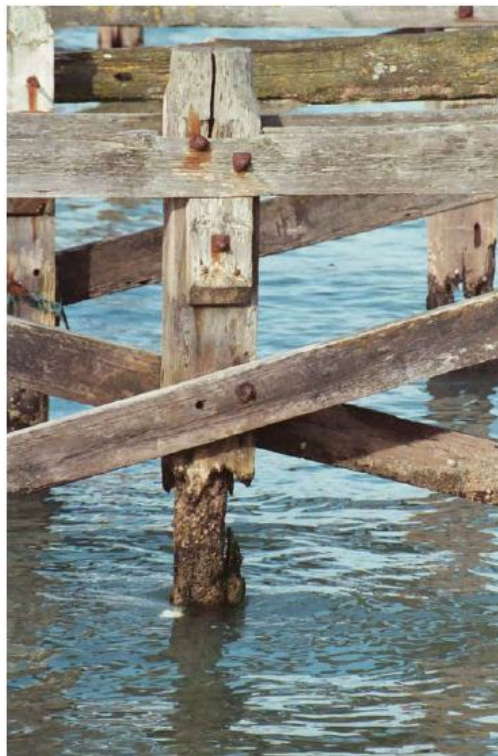
Figure 19: Biologically degraded pile [37].

The Southern Plains Transportation Center sponsored a program to evaluate the capacity of deteriorated timber piles strengthened with FRP under concentric and eccentric loads with different deterioration configurations [37]. The timber piles of Louisiana bridges are experiencing biological degradation in the wet-dry zone. An example of a biologically degraded pile is shown in Figure 19. Since complete replacement of the piles is not economically feasible, in situ repair of the piles with FRP was explored, which eliminates the need for shoring the superstructure and road closure.

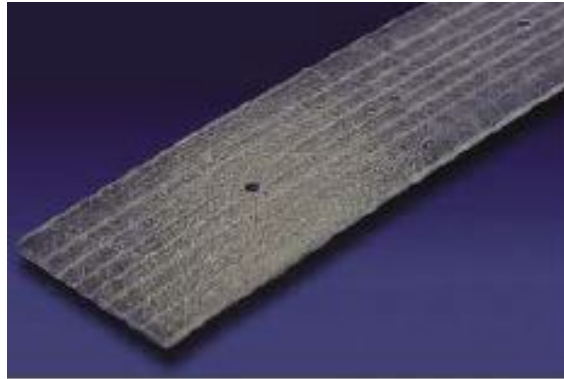
Figure 24: SAFSTRIP [22].

Douglas Fir rough sawn lumber and Douglas Fir creosote treated timber wood specimens were used in this study. The moisture contents of Douglas Fir rough sawn lumber range from 9% to 13% and their grading was Select Structural. The grade of Douglas Fir creosote treated timbers was Grade No. 1. The composite material used in this study was SAFSTRIP manufactured by Strongwell. SAFSTRIP (Figure 24) consists of carbon tows surrounded by layers of glass fiber mats, impregnated with a vinyl ester resin, and has dimensions of 4 inches (102 mm) wide and 0.13 inch (3.2 mm) thick. The design tensile strength and modulus are 92.9 ksi and 9020 ksi, respectively.

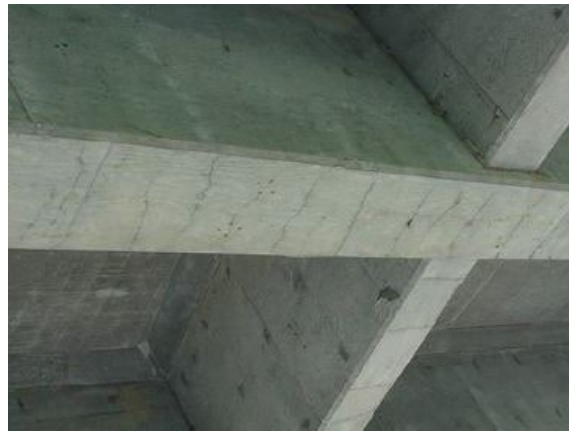
Figure 27: Cracks in Louisa Fort Gay bridge [39].

The Louisa-Fort Gay is a 12-span continuous bridge structure consisting of composite concrete deck-steel girder span and reinforced concrete middle span and is located in Lawrence County, Kentucky. Flexural cracks (Figure 27) were found in the positive bending regions of the bridge girders because of excess traffic loading that exceeded the legal weight limit specified by the American Association of State and Highway Transportation Officials (AASHTO) [39].

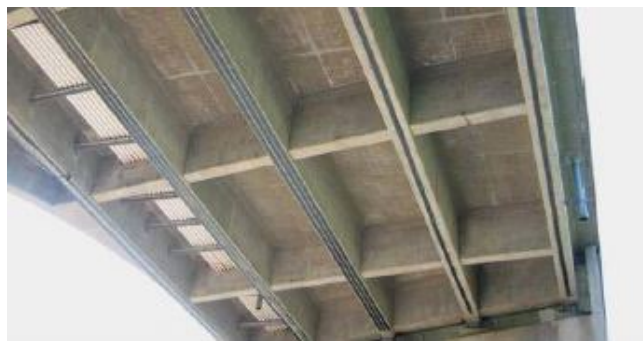
Figure 28: Repaired Louisa Fort Gay bridge girders [39].

FHWA and the Kentucky Transportation Cabinet sponsored a program to repair and strengthen the bridge. CFRP laminates were selected as the strengthening material (Figure 28). Before applying the CFRP laminates, surface preparation was performed, including cleaning, and removing loose concrete particles, debris, and other contaminants. The CFRP laminate application process included applying the epoxy on the concrete surface, placing the laminates to the structure surface, pressing the laminates, and removing excess adhesives.

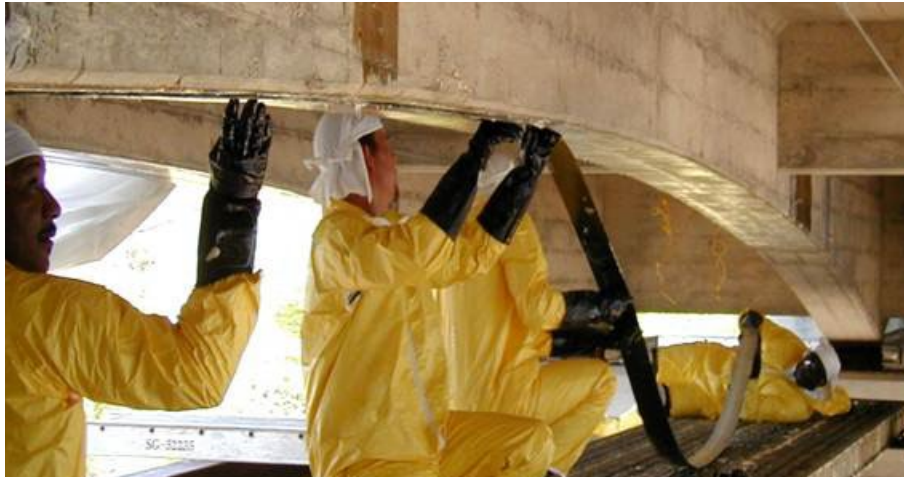
Figure 29: Application of FRP strip to the Uphapee Creek bridge girder [40].

The Tyfo UC Composite Laminate Strip System from Fyfe Company, LLC was selected as the strengthening material (Table 9). Tyfo TC epoxy was used as the adhesive, primed with Tyfo S Epoxy. The strengthening process included surface preparation, epoxy injection to the cracks, epoxy application to the structure surface, and placing the FRP to the surface (Figure 29). Figure 30 shows the strengthened girders.

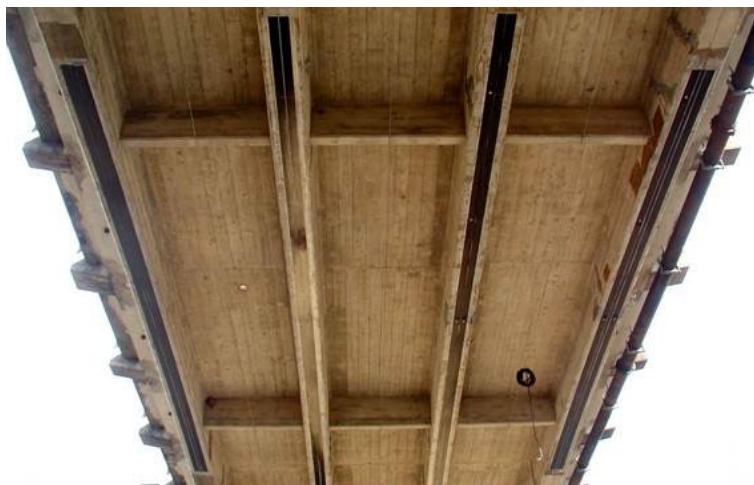
Figure 30: FRP-strengthened Uphapee Creek bridge girders [40].

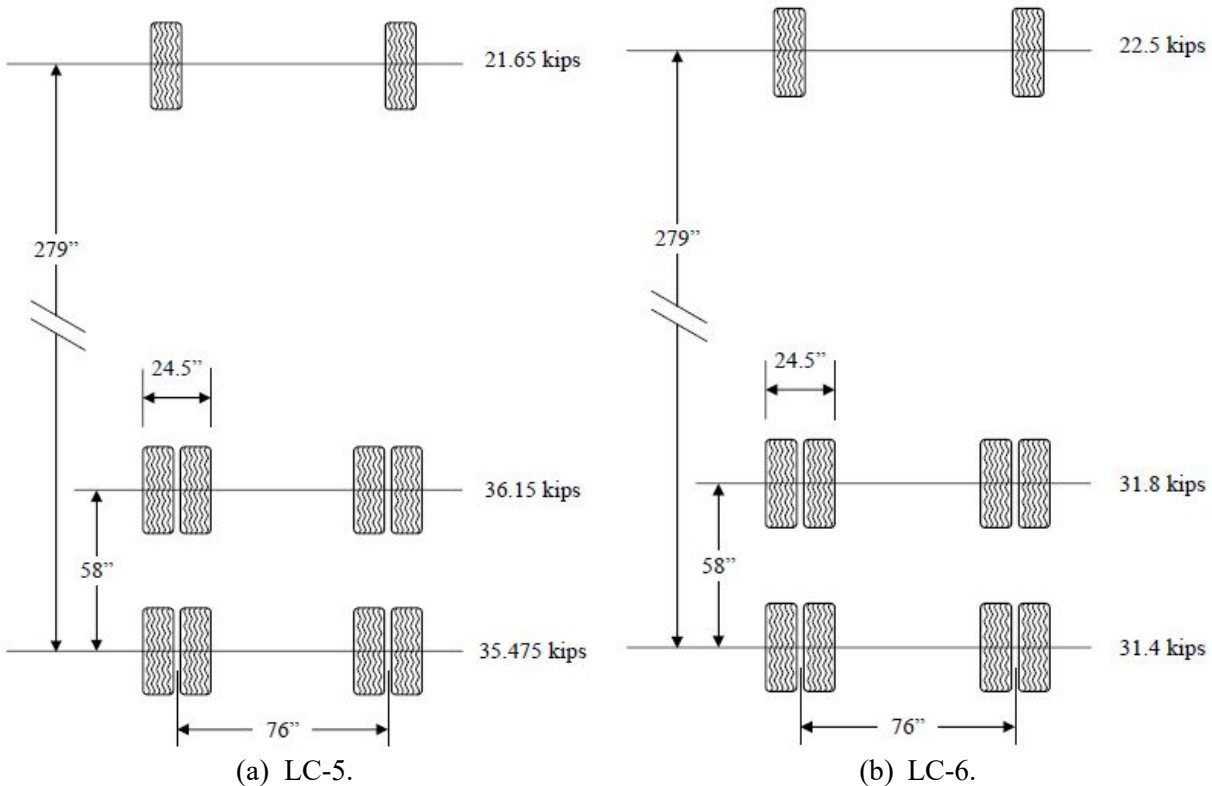
Figure 31: Truck configuration for Uphapee Creek bridge field test [40].

Static and dynamic tests were performed before and after the FRP composite installation. Field live load tests were performed with two identical load test trucks (LC-5 and LC-6, Figure 31) owned and operated by ALDOT. Electrical resistance strain gauges (ERSGs) and deflectometers were used to measure live load deflections. MEGADAC 3415AC high-speed data acquisition system, manufactured by OPTIM Electronics, was employed for data acquisition.

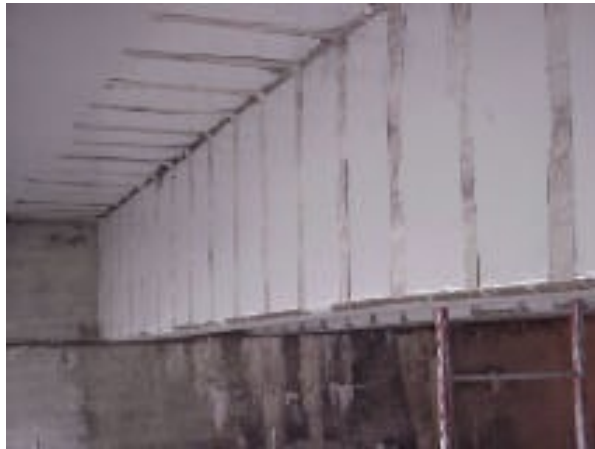
Figure 32: FRP-strengthened girder of State Route 378 bridge, New York [41].

A 40-ft (12.19 m) long bridge carries State Route 378, located in the City of South Troy, Rensselaer County, New York. During a routine inspection, freeze-thaw cracking, concrete delamination, and efflorescence were found at several locations of the bridge beams [41]. The New York State Department of Transportation (NYSDOT) decided to repair the bridge with FRP laminates. Replark 30 unidirectional carbon fiber was selected as the strengthening material, which was manufactured by Mitsubishi Chemical Corporation in Japan. The surface was cleaned, and the loose concrete was removed. Cement-based grout material was injected into the cracks, and then the surface was smoothed by sandblasting. The laminates were placed on the structure surface after applying epoxy. After drying, the structure was repainted to match the original structure (Figure 32). Load testing was done before and after strengthening the bridge girder with a 44-kip

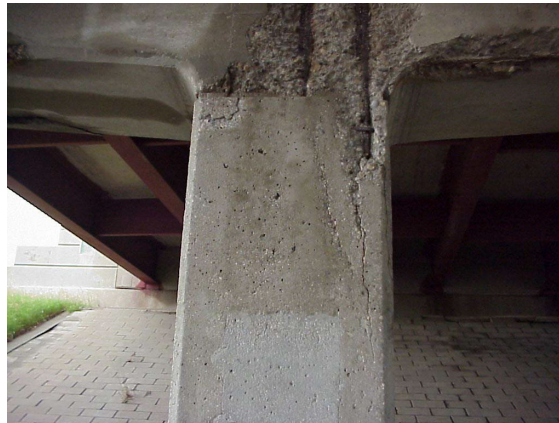
Figure 34: Deteriorated column of I-96 overpass bridge, Michigan [42].

The next phase of the program was the field application of the strengthening technique. Six columns were selected for this program which were located under the I-96 overpass, Lansing, Michigan. The columns had surface spalling and exposed rebar at several locations (Figure 34). The strengthening configurations were: two reference columns, two columns wrapped with two layers of carbon fiber, and two columns wrapped with three layers of glass fiber. Figure 35 shows one of the repaired columns.

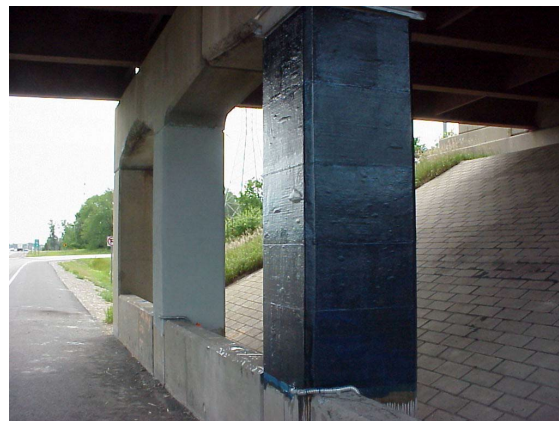
Figure 35: Repaired I-96 overpass bridge columns [42].

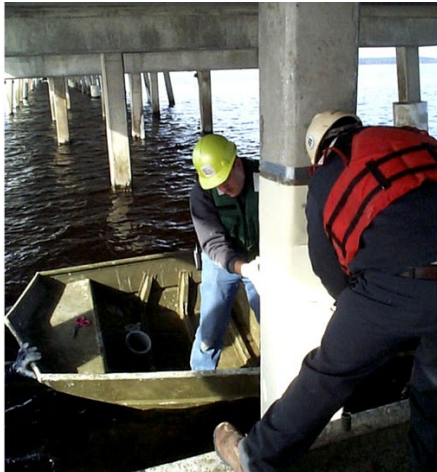
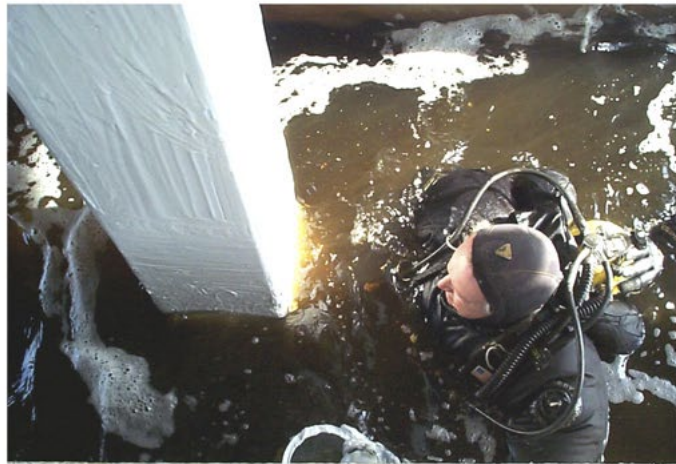
(a) Using a boat.

(b) Using divers.

Figure 36: FRP wrapping of Friendship trail bridge pile [43].

underwater concrete piles. The 2.6-mile-long Friendship trail bridge is located in Tampa Bay, Florida, and was selected for the project. Two types of FRP strengthening systems were introduced in the study: 1) Aquawrap, a uni-directional/bi-directional carbon FRP repair system with water-activated urethane resin, and 2) Tyfo SEH-51, a weave, uni-directional glass fabric with Tyfo-S underwater epoxy. A total of eight piles were selected for the study (Table 10). A pressure washer was used to remove all the dust and loose concrete from the pile surface above the water. A quick-setting hydraulic cement was injected into the cracks and any discontinuities. Four piles were wrapped following the wet lay-up process, and the other four piles were wrapped following the prepreg system. A boat was used to wrap the piles above water, and divers wrapped the piles under water, shown in Figure 36. A scaffolding system was also introduced to have easy access to the pile.

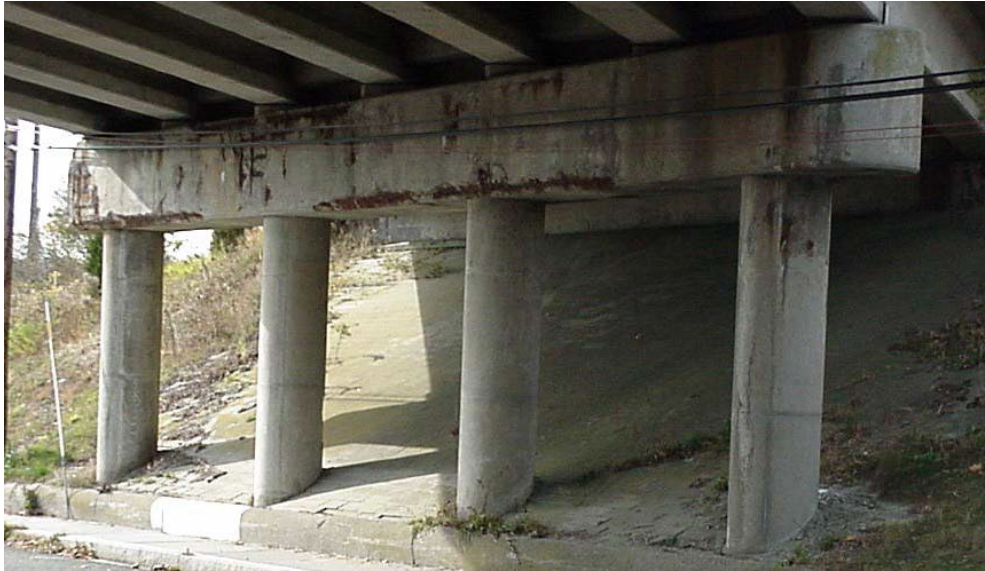
Figure 37: Deteriorated pier cap of Salt Pond Road Bridge [44].

The Rhode Island Department of Transportation sponsored a program to repair the deteriorating RC pier cap of the Salt Pond Road bridge in South Kingstown, Rhode Island. The pier caps showed severe spalling and cracking, and the reinforcements were exposed at several locations [44] (Figure 37). The bridge is located near the ocean, and the constant exposure to contaminated water flowing over the pier caps was identified as the cause of the severe deterioration.

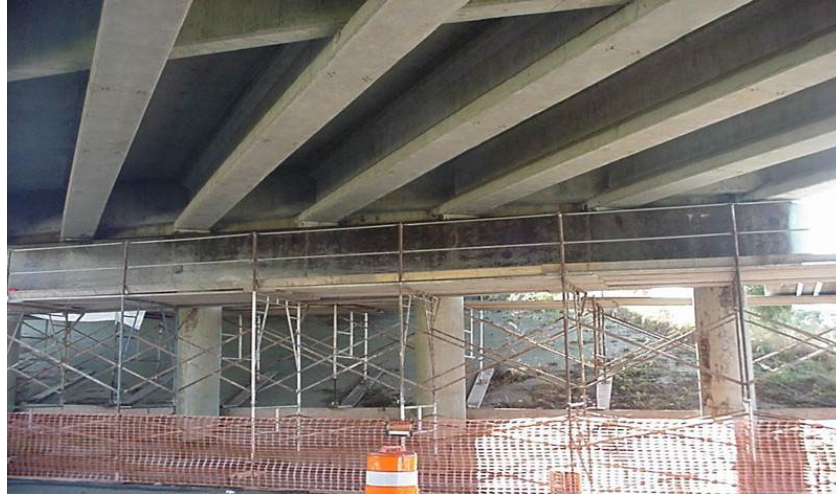
Figure 38: Scaffolding and safety measures for repairing the Salt Pond Road Bridge [44].

The faculty and students at Rutgers University and the University of Rhode Island carried out the field application with the help of professional staff. Scaffolding and surface preparation were complete before the actual application (Figure 38). E-glass fabric with Sikadur Hex 300 resin was selected as the strengthening material for field application. After the concrete surface was completely dry, the FRP composite was placed. The vacuum bagging process (Figure 39) began after 16 hours of placing the FRP.

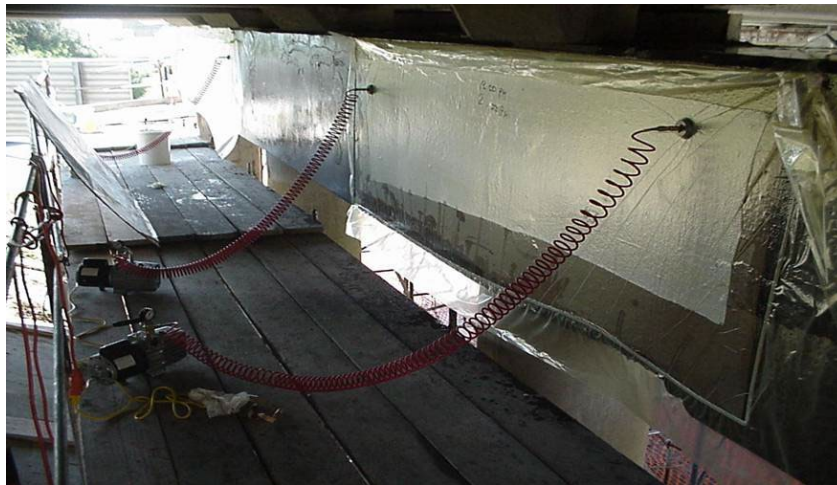
Figure 39: Vacuum bagging system adopted in repairing the Salt Pond Road Bridge [44].

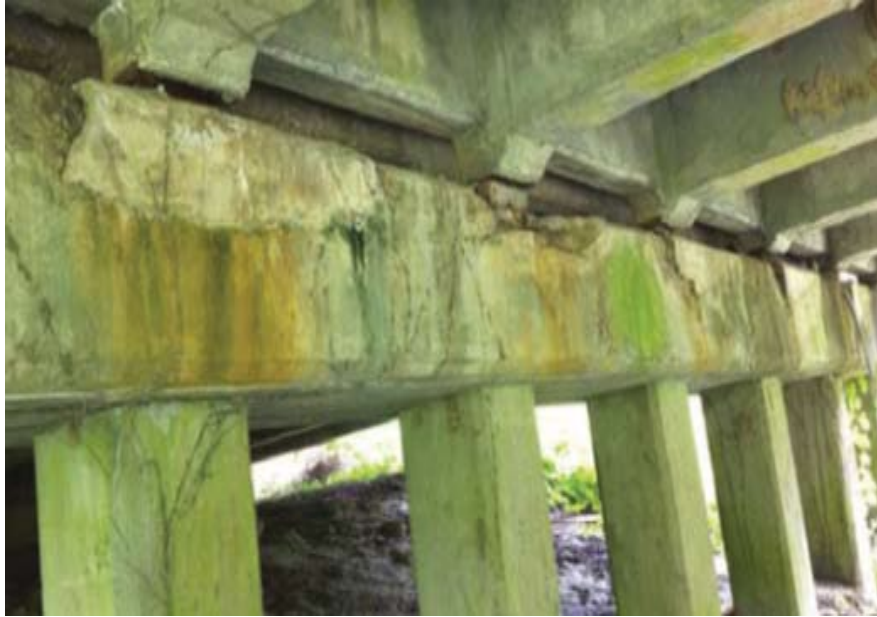
Figure 40: Delamination under the bearing plate of the Morganza Spillway bridge, Louisiana [45].

The pile cap of the Morganza Spillway bridge in Louisiana needed repairing, as the previous repair method of patching the damaged area with structural grade high-adhesive material epoxy concrete was ineffective and resulted in delamination (Figure 40) [45]. The Louisiana Department of Transportation and Development sponsored a program to repair the damaged pile cap and Louisiana State University conducted the project. CFRP was used as the strengthening material, with Young's modulus of 90 million psi. After placing the FRP on the concrete surface, the bent surface was coated with an inorganic polymer coating reinforced with short carbon fiber (Figure 41). The coating formulation, originally developed for use in aircraft structures, was used to prevent deterioration and provide UV-protection, and had self-cleaning properties.

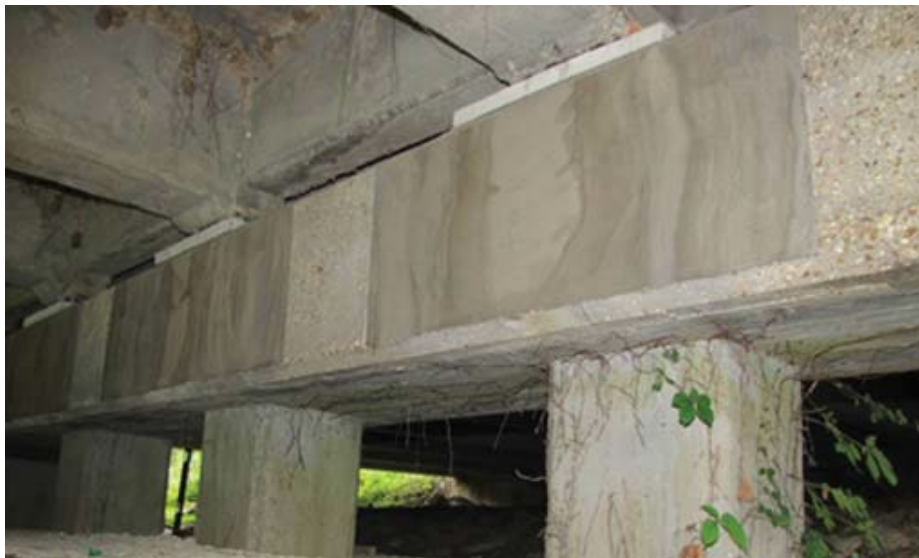
Figure 41: Repaired pile cap of the Morganza Spillway bridge, Louisiana [45].
