Montana Department of Transportation

MEMORANDUM

Subject: Interim Guidance for Quantifying Sister Girders on Timber Bridges

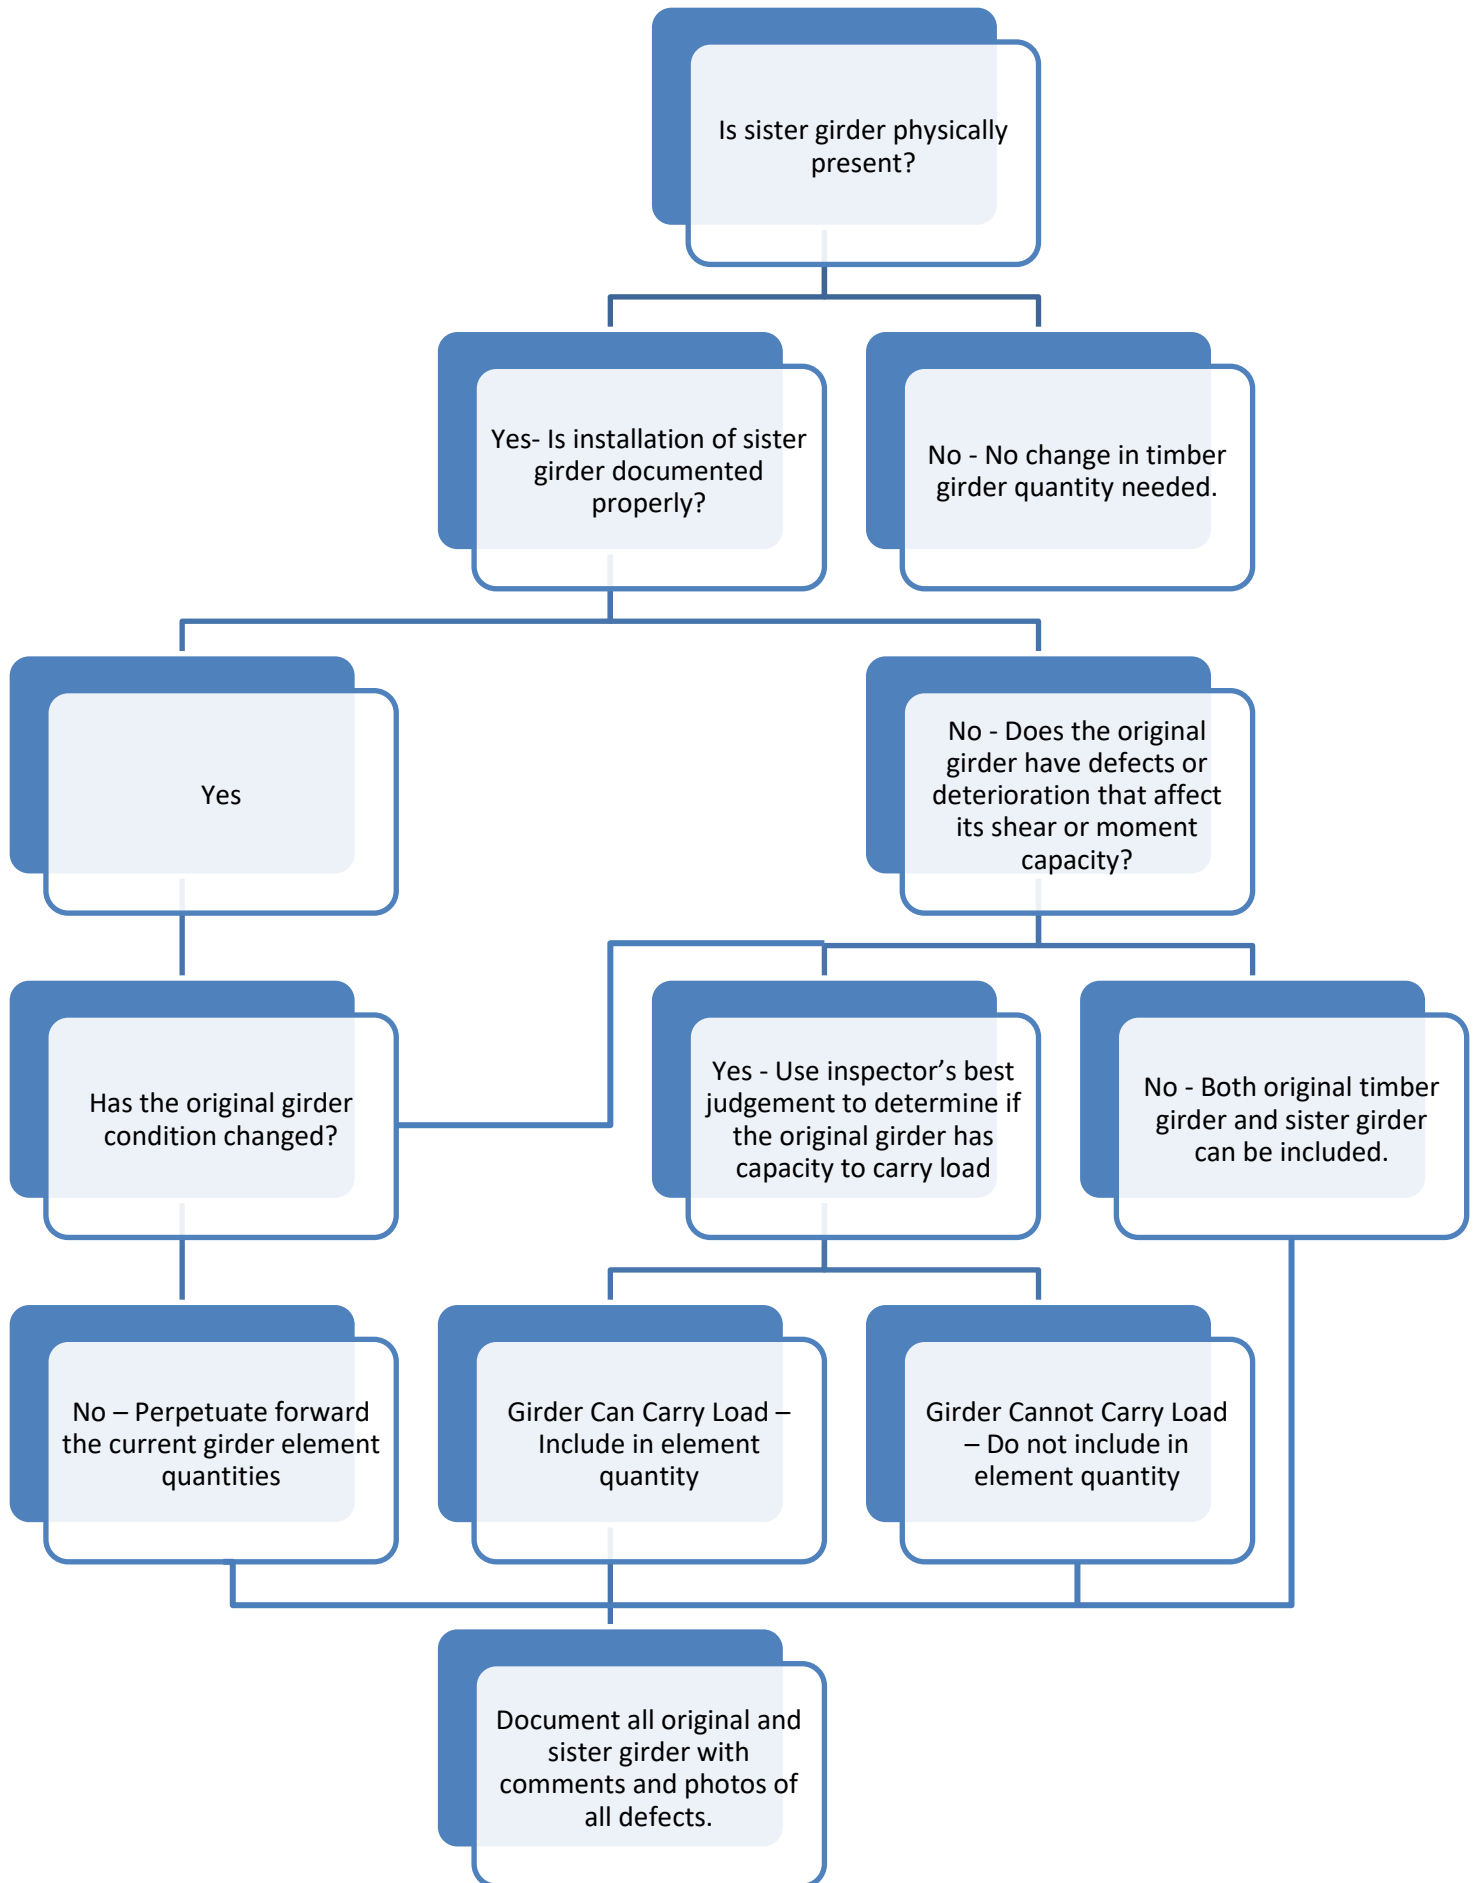
- See *Documentation of Girders Not Included In Element Quantity*
- Photos
 - Always include photos to show where a sister girder is relative to the other girders in the span.

- When documenting with photos physically mark the girder (paint pen, spray paint, chalk, etc...) with its number (Sp2-G4L, Sp1-G7, etc....) prior to taking photo, when possible.

Girders with sister girders have a different naming convention than what has been done in the past. Use the following naming convention to number bridge girders with sister girders. The original girder number should always remain the same, however, the sister girder will have a name corresponding to the original girder number and what side (right or left) the sister girder is on. For example, if the original girder 7 has a sister girder on the right the sister girder would have the name G7R. The sister girder will have this name regardless of the condition of the original timber girder and whether the original girder is included in the element quantities. Right and left denotations are determined when looking in the direction of the bridge inventory direction. See [Bridge Inventory and Nomenclature Memo](#) for more information on bridge inventory direction and how to determine the direction.
