# TIMBER BRIDGE INSPECTION GUIDE

**MONTANA**  
**MDT** ★  
**DEPARTMENT OF TRANSPORTATION**

## **Understanding Timber**

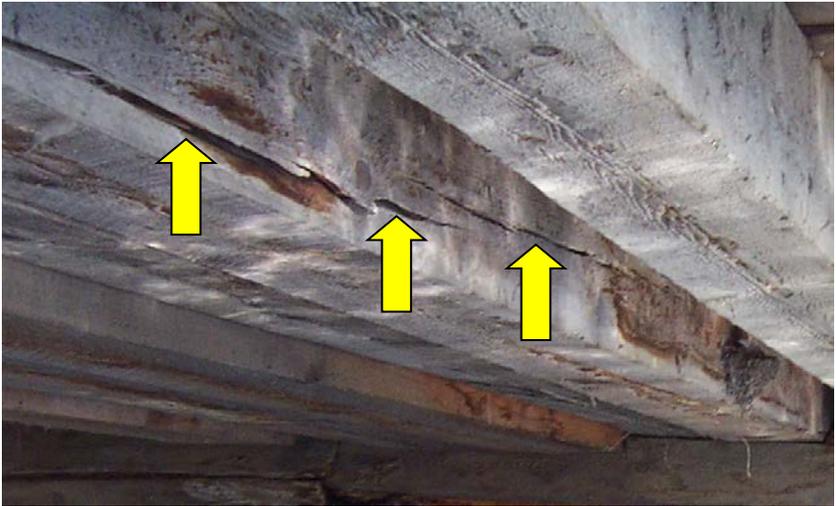
Checks are caused by the drying out or “seasoning” of timber. As timber dries, or seasons, the outer fibers in a member dry faster than the interior fibers. As the wood fibers lose moisture, they shrink. If the interior fibers have more moisture content than the exterior fibers, they shrink at different rates. This differential shrinkage causes stress between these fibers of different moisture contents, resulting in a separation of the fibers that we see as checks. The thicker the member and/or the faster the drying rate, the more likely and pronounced the checks become.

*Checks*

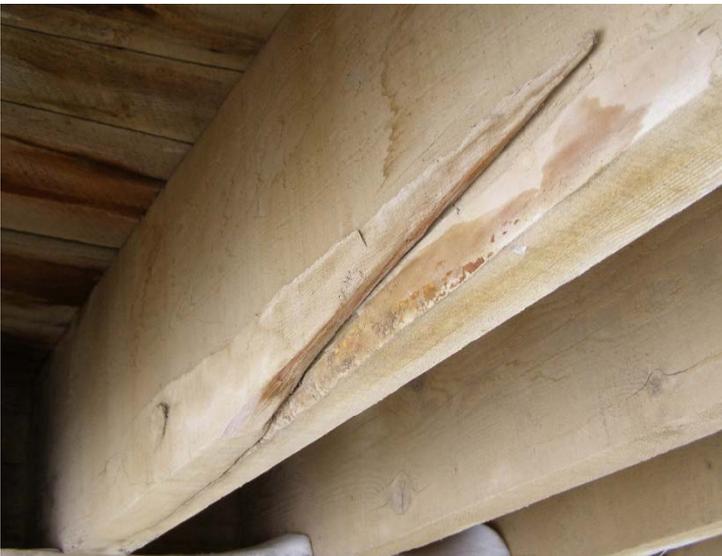
A shake is a separation or plane of weakness between growth rings and can be found throughout a timber member. Shakes are usually caused by external forces acting on the wood before it is milled. This can be caused by wind on a standing tree, during the cutting and felling of the tree, or during the handling and transport of the tree.

*Shake*

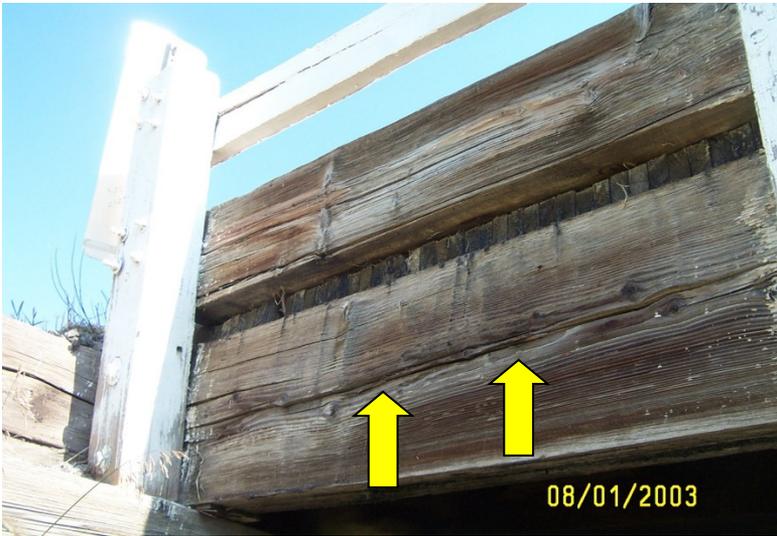
A split is essentially a check that extends completely through a member from face to face. It will usually follow the grain of the wood, does not propagate through the top or bottom of the member (i.e. it is more or less parallel to the top and bottom face) and typically starts at the ends of a member. They are usually caused by seasoning of the wood, but can be caused by a notch in a beam acting as a stress riser.

*Split*

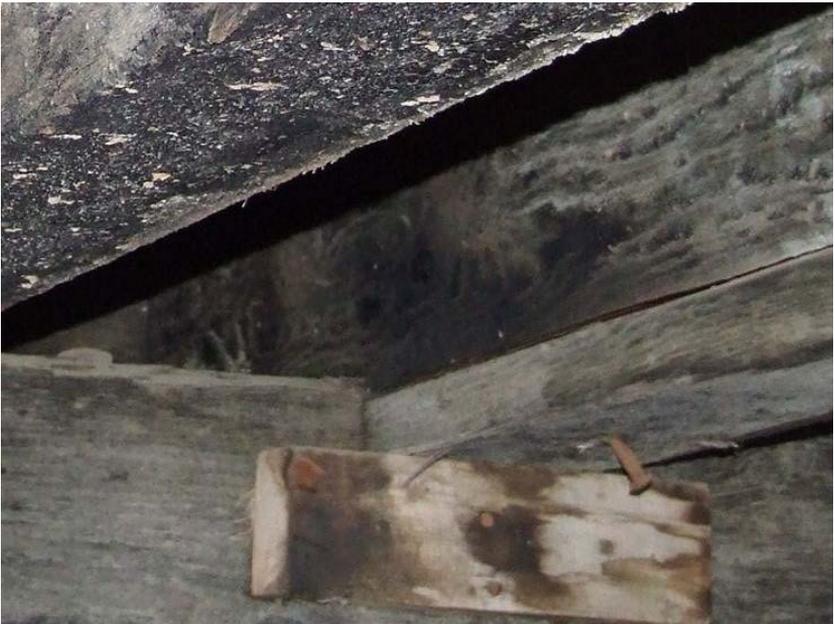
*Split propagating from a notch*

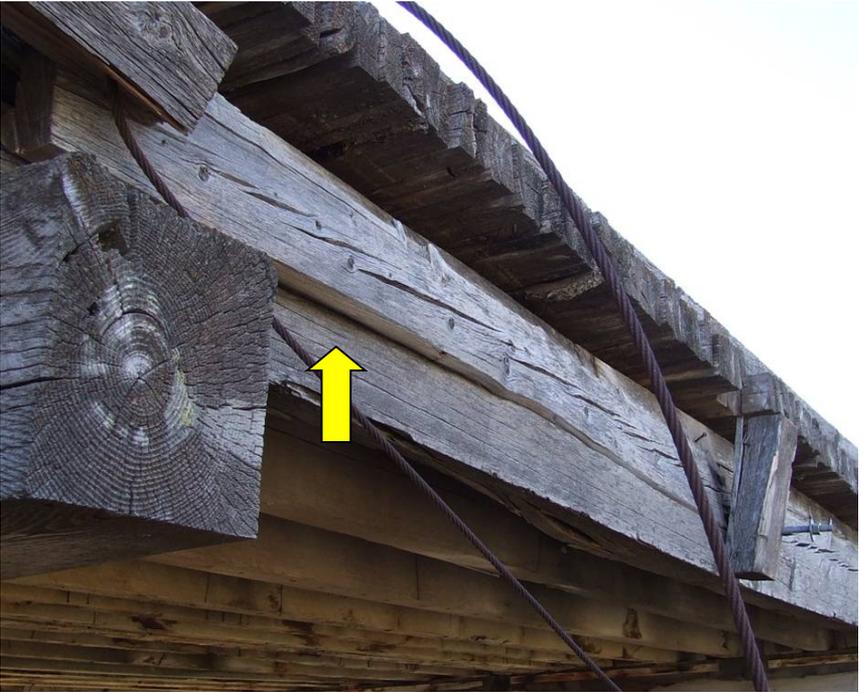
*Split with lateral displacement between sections*

Generally, splits will have no effect on the bending capacity of a member. However, in rare cases the load raters may reduce the capacity of a timber member if they deem a split to be severe enough. Severe may be defined as a split longer than 25% of the member length, the faces of the split are offset, or multiple splits. For this reason, moderate or severe splits should be noted and documented.

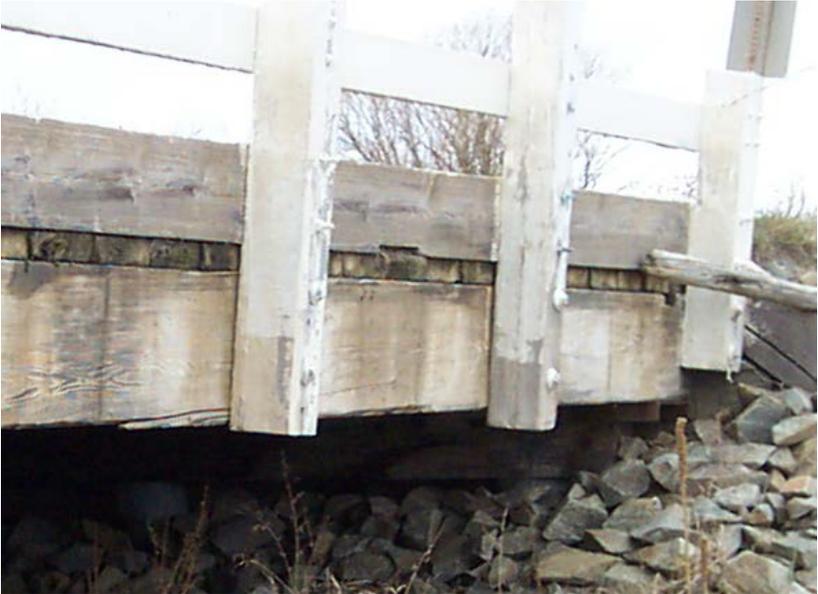
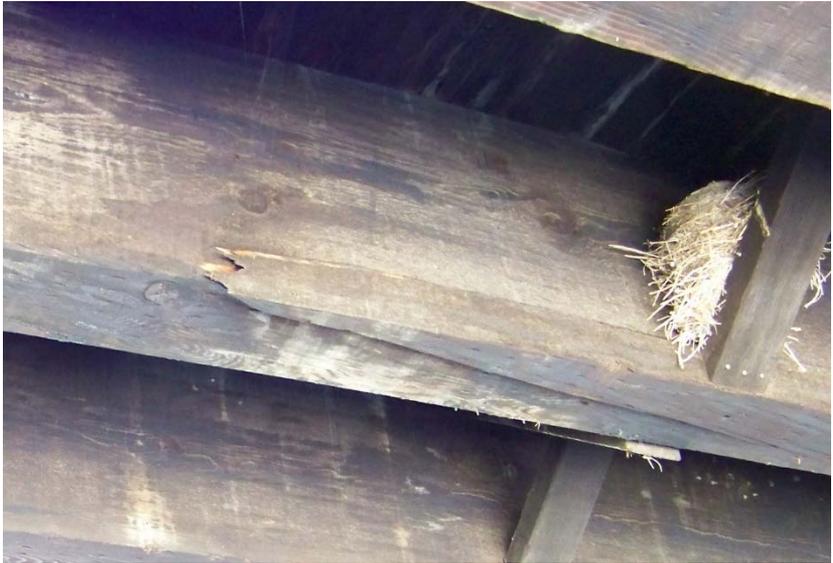
*Moderate Crack*

Cracks have a direct effect on the load carrying capacity of a beam. Any crack that has extended up more than 10% of the depth of the girder would be considered moderate to severe and would need a rating analysis. Because of this and their potential to quickly propagate, all cracks that are found should be documented in detail and photographed, especially any moderate or severe cracks.

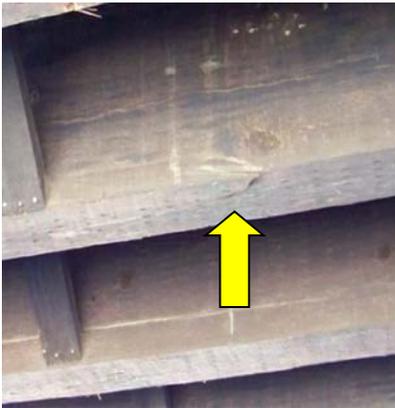
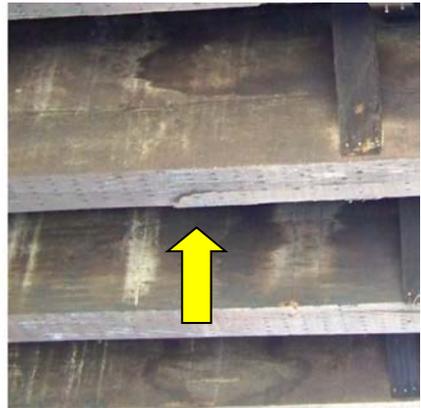
*Minor Crack (both photos are of same crack)*

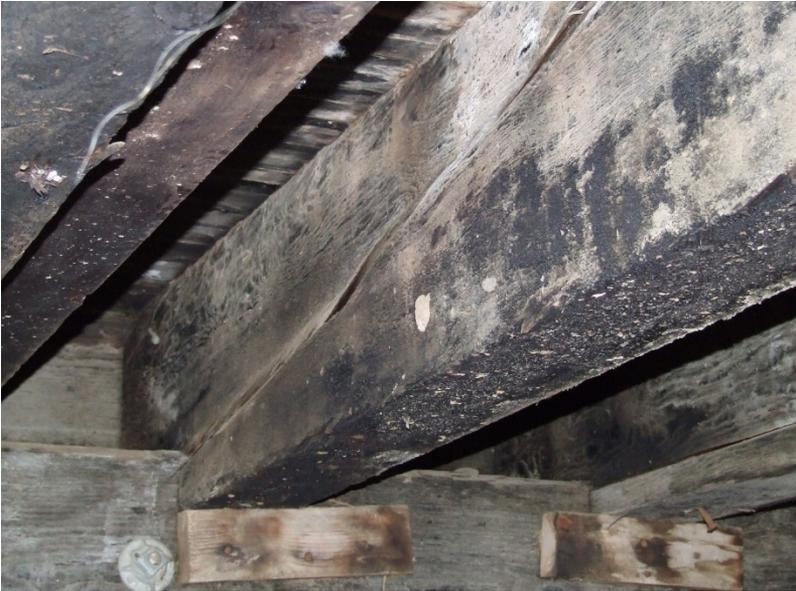
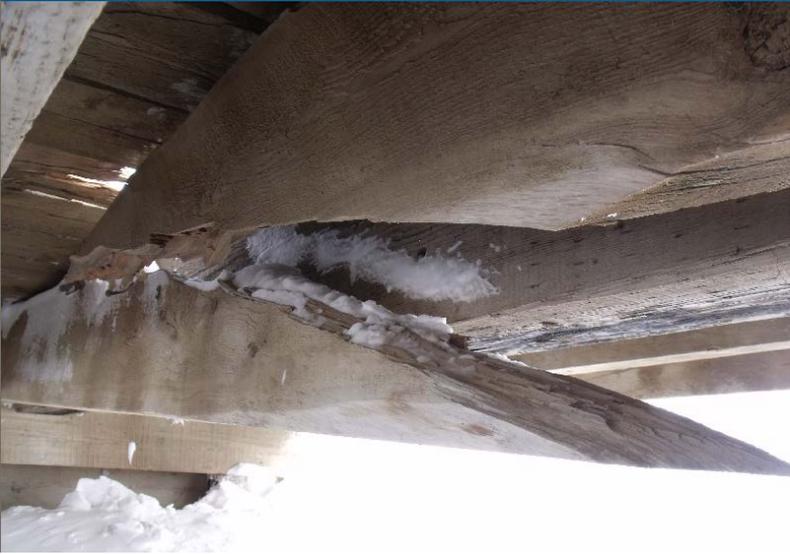
*Complete Break*

A complete break is the loss of all strength in a member. Complete breaks extend across the entire member, usually diagonally, and propagate from the bottom of the member completely to the top. Complete breaks will open significantly under live load, and will sometimes hang open under dead load.

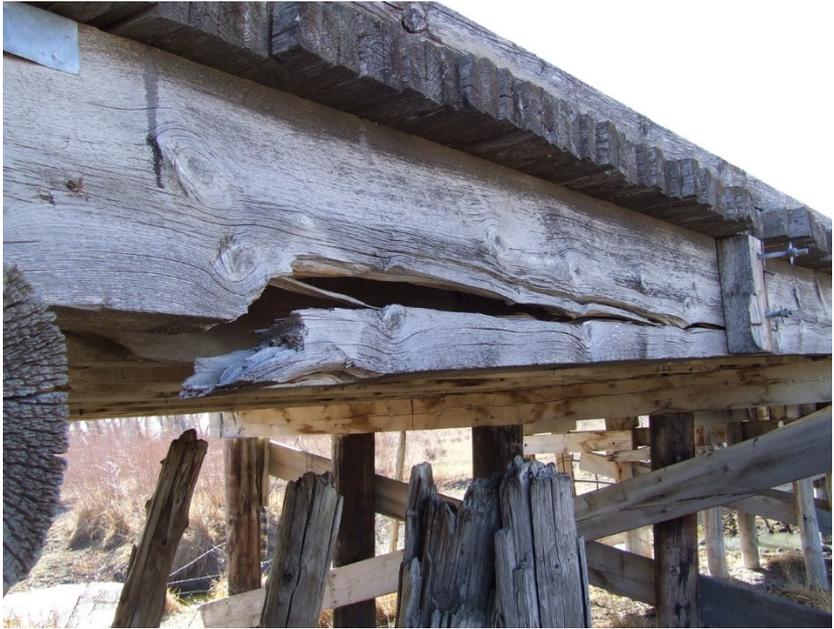
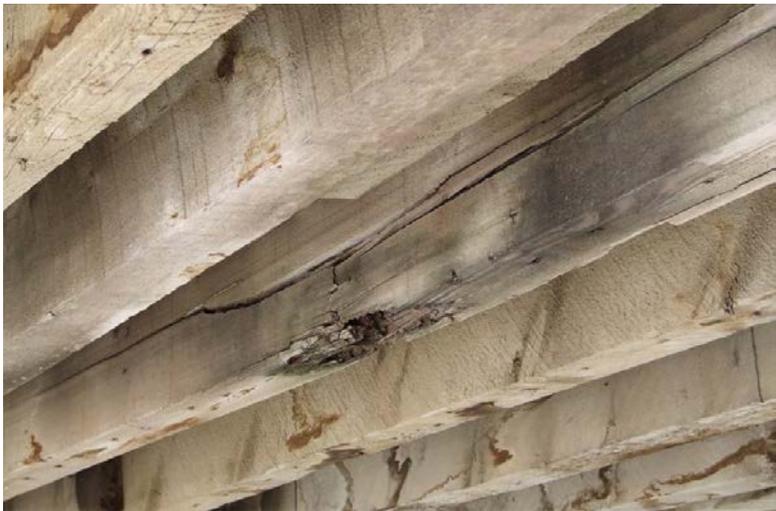
*Partial Break*

A partial break is the loss of all strength in a portion of the member's cross-section. Partial breaks typically occur where a split meets a knot near the bottom of a girder. Partial breaks are likely to hang open under dead load, but will sometimes only open under live load. When describing a partial break, it is important to note how much of the member's cross-section is intact.

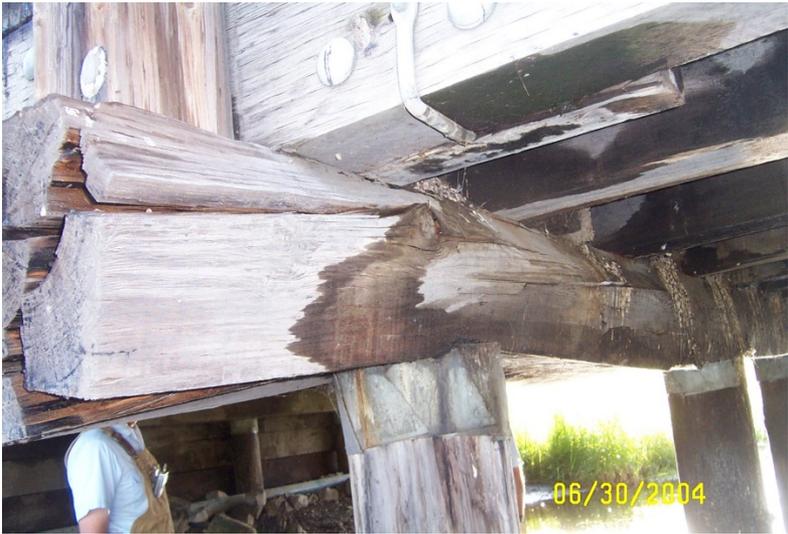
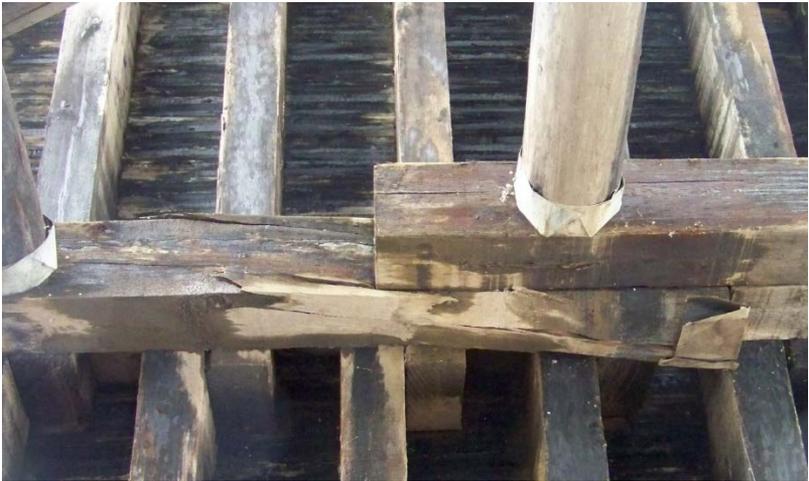
*Severe crushing due to decay*

Even after crushing is noted, it is still important to find out how much of the member’s cross-section is sound. The Bridge Management Section can then re-rate the bridge or recommend replacement of the member. Eventually, almost complete failure can occur, a condition in which there is not enough cross-section remaining in the member for it to have any significant strength, such as in the following photographs on pages 26-28.

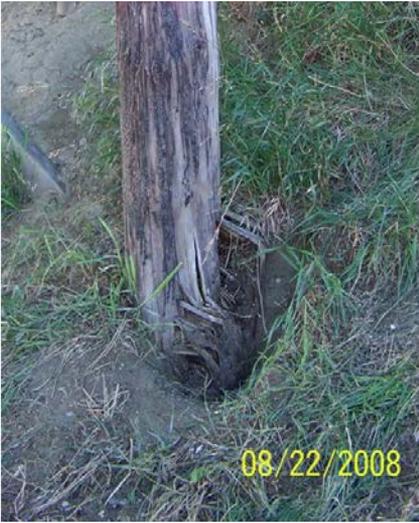
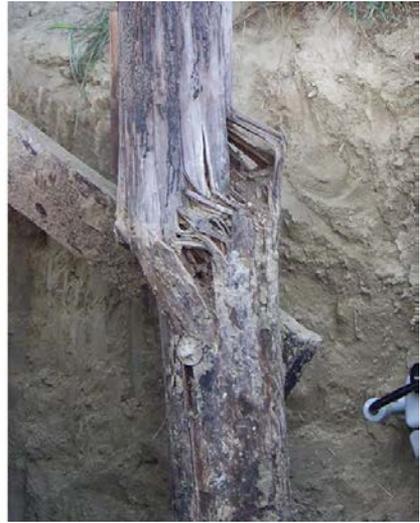
*Failed timber pile due to decay*

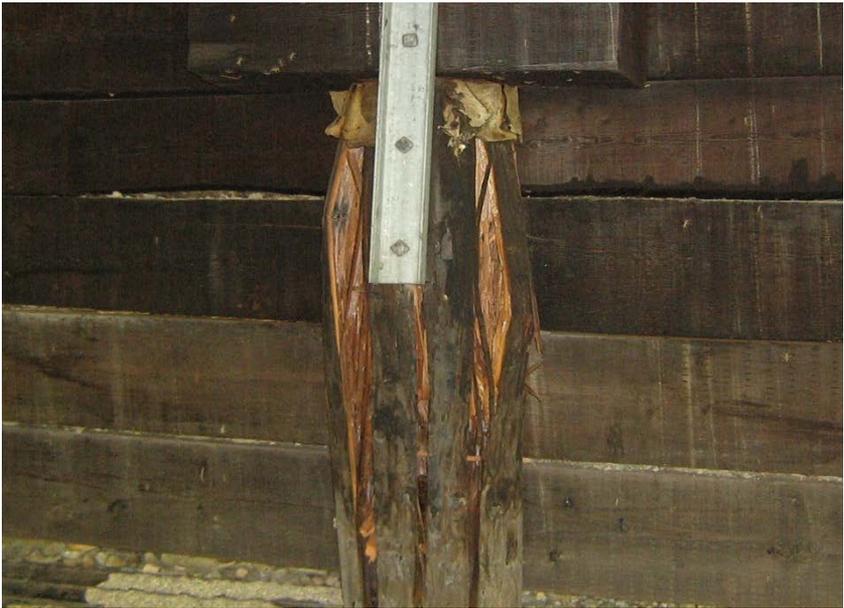
*Failed timber pile*

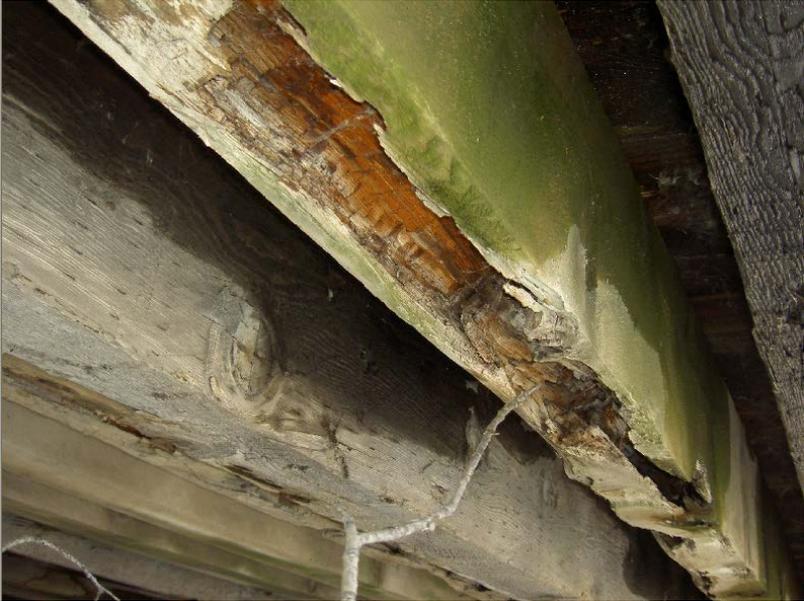
*Severe decay in a girder*

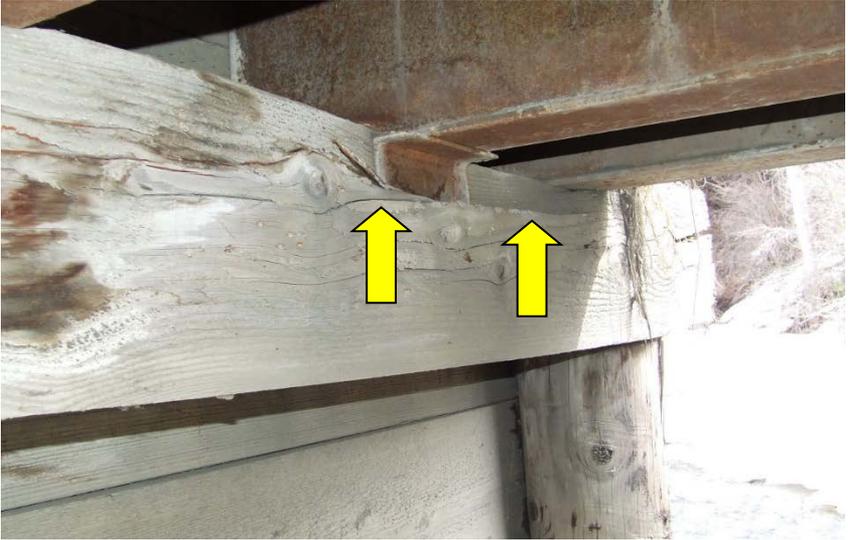
*Crushing due to decay*

In the case of the following photos (page 29) however, the member has only partially or locally failed, and could have some strength left in the cross-section.

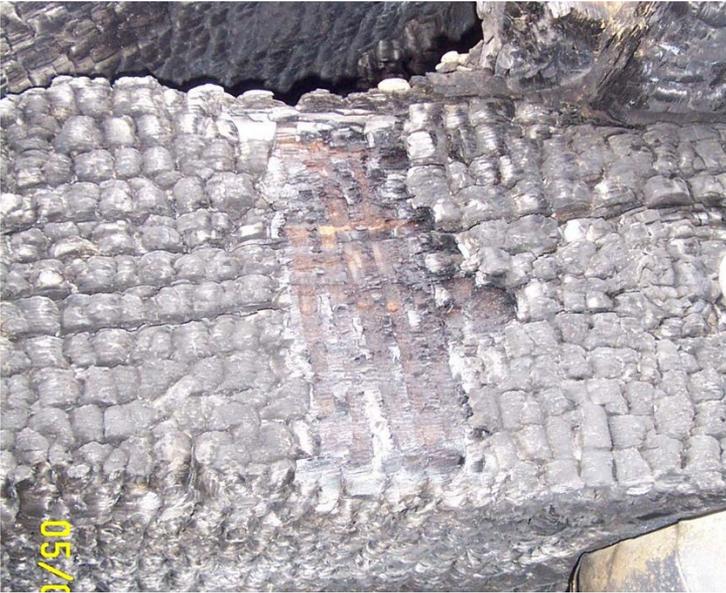
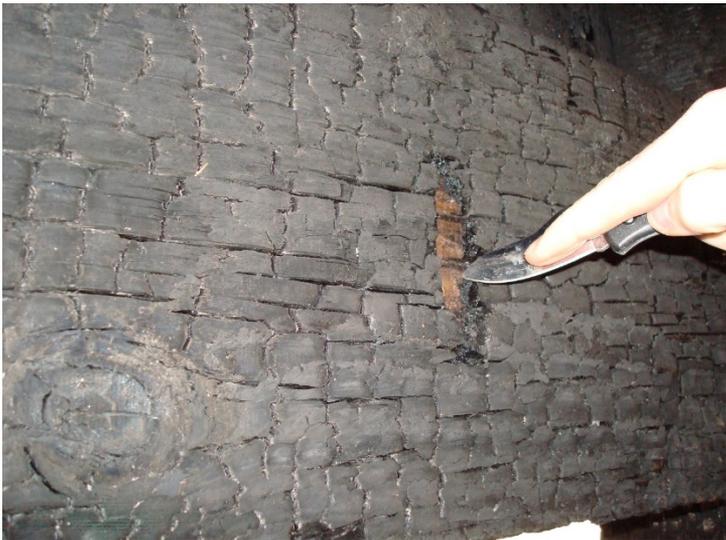
If the duration of the fire is limited, many timber bridges will survive the fire with only a small amount of section loss. After a timber bridge has been through a fire, the inspector needs to give it a thorough inspection. The char layer should be scraped off in random locations and in areas of likely maximum section loss, then the measurements of the intact cross-section of all members should be recorded. The Bridge Management Section can then re-rate the bridge with these measurements.

*Burned timber members with the char layer scraped off*

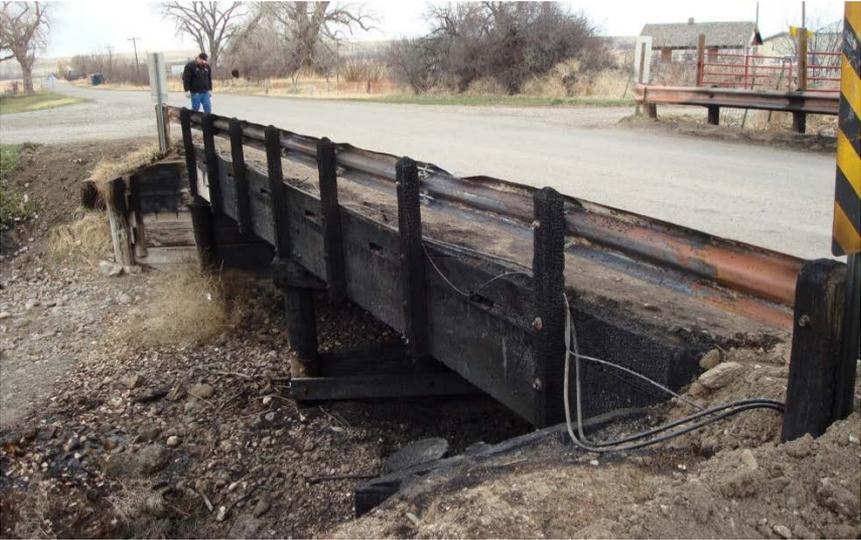
*Timber bridge after a fire*

In some cases, timber can perform well in a fire. This statement is true if the duration of the fire is limited, it is not fueled by an external source, and the members are “thick” – which is typical of bridge members. Also, as timber burns, a char layer forms which insulates the inner layers of the member from the fire.

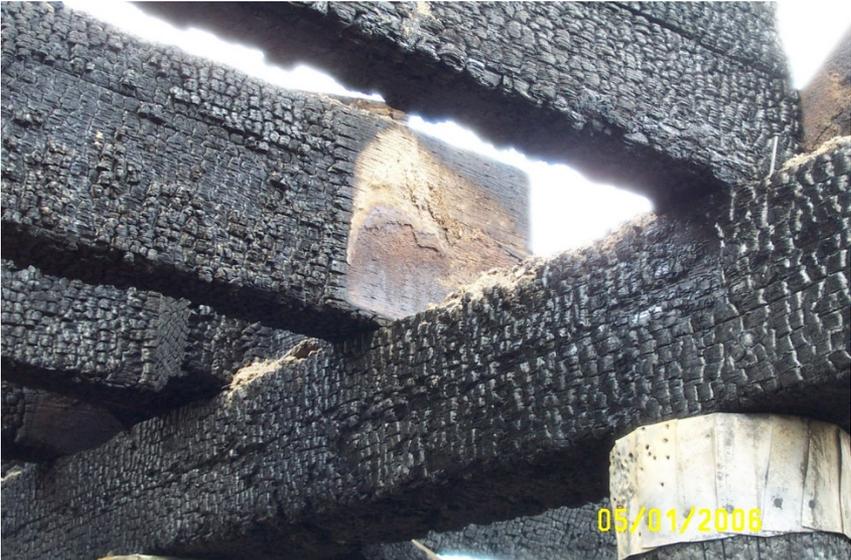
*Considerable section is left on members under the char layer*

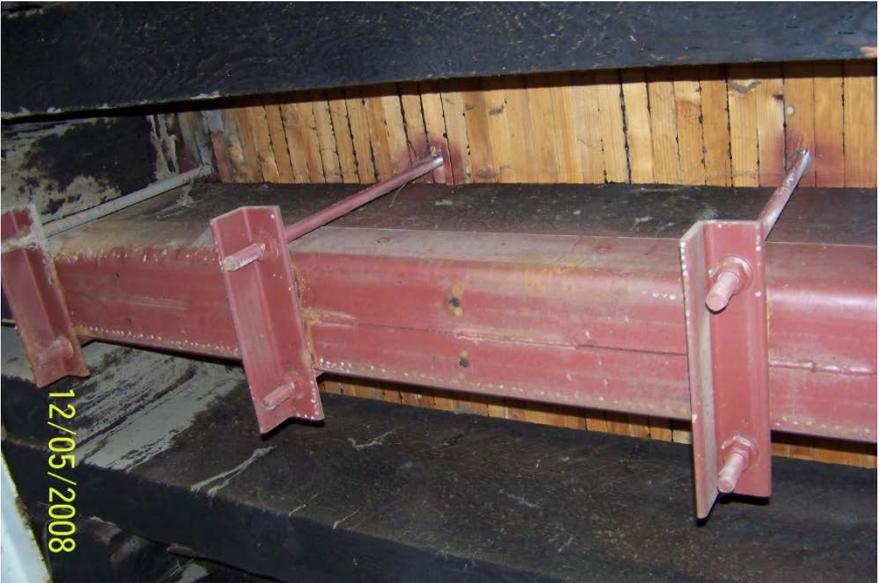
*Steel hanger girder repair – through deck hangers with bottom plates*

There are many types of timber member repairs out there. The most common type is the hanger clamp on timber girders along with the occasional steel splice plate girder repair. Unfortunately, these types of timber girder repairs do not restore the member to its full capacity. Most of the time, they can arrest any additional crack propagation and may even add back some of the lost capacity. However, quantifying any additional capacity that a specific hanger clamp repair will add is not practically possible because of all the different types of hanger repairs that are done throughout the state.

Because of the uncertain additional capacity that the hanger or splice plate repair adds, girders repaired with these types of repairs should be in condition state 4 if the hanger was to repair a moderate or severely cracked or broken girder. The girder can be in condition state 3 only if the hanger is to repair a minor crack or was used as a preventative repair on a split girder. It can only be in a condition state 1 or 2 if it is a preventative or unnecessary hanger repair *and* it was in condition state 1 or 2 before the repair.

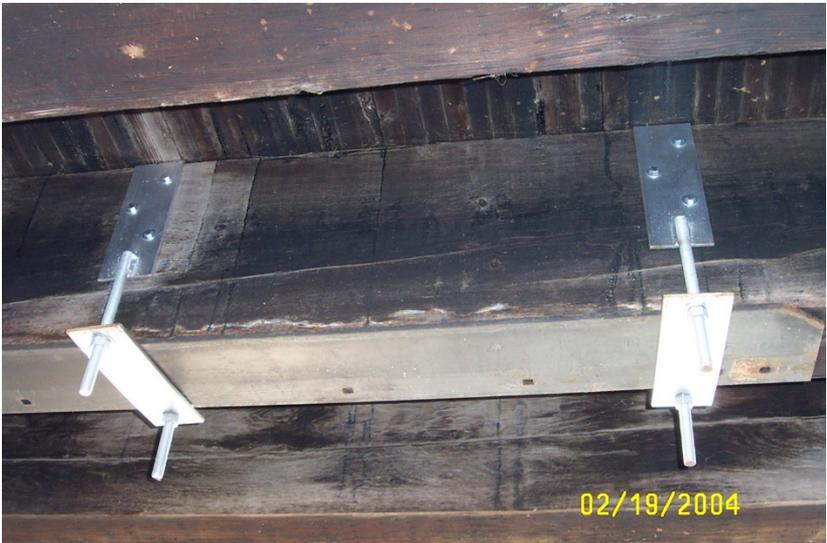
*Steel hanger girder repair with multiple bolts*

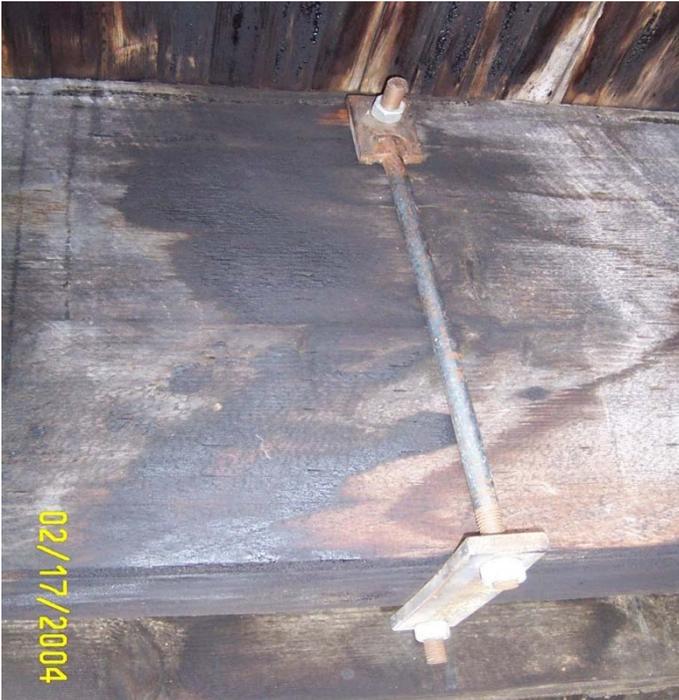
*Steel hanger girder repair - single bolt and no bottom plate*

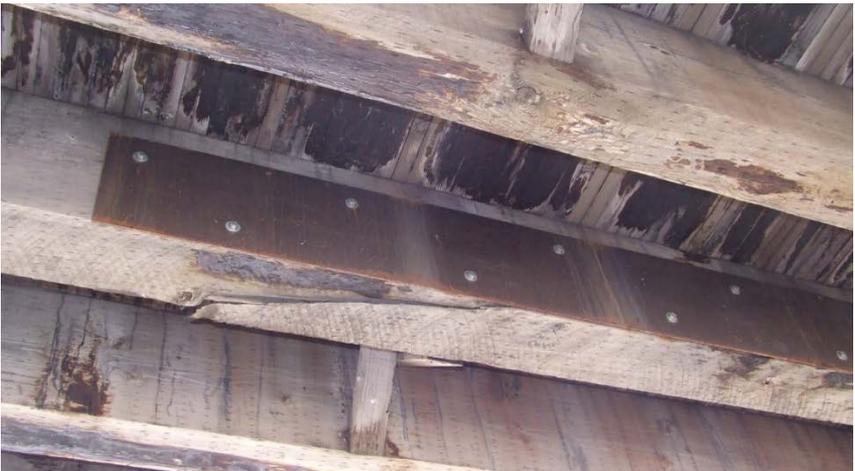
*Steel plate girder repair*
