6.1 Improvement Options

MT 78 Corridor Study

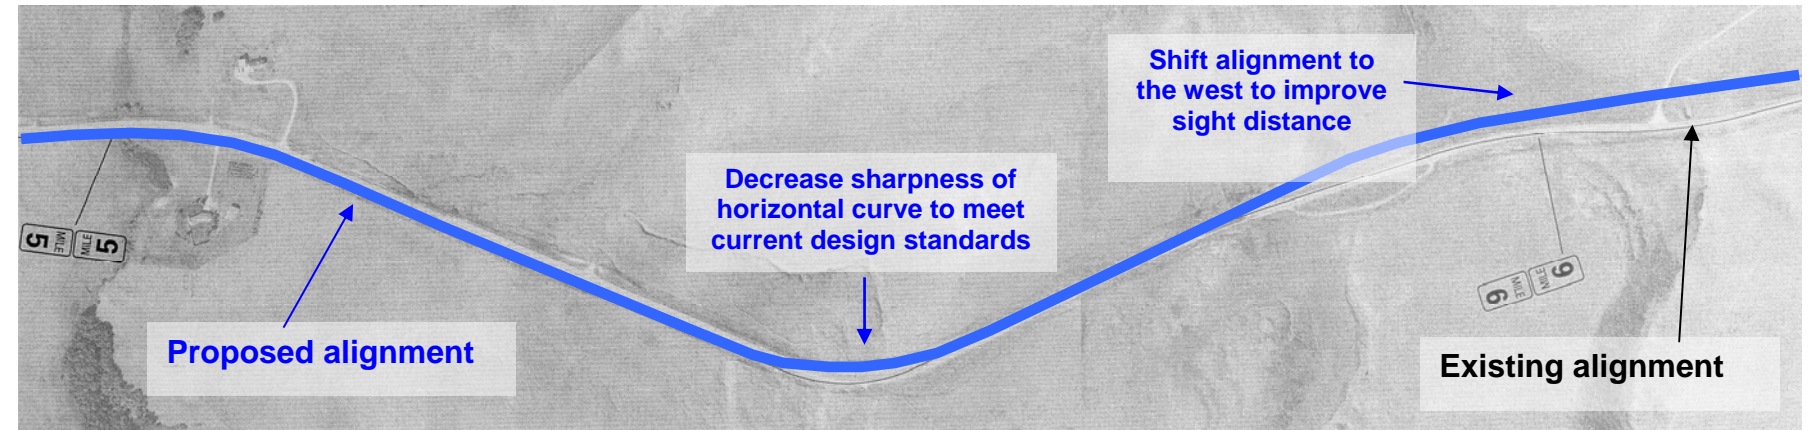
At MP 5.5±, there is a sharp horizontal curve. As noted in Figure 4.2, this curve is rated “poor” due to its inadequate curve radius.

As shown in Figure 6.1, it is proposed that the roadway be shifted to the west in this location to decrease the sharpness of this curve. The alignment was shifted only far enough to ensure that the curve meets current design standards.

Beginning at MP 5.8±, it is proposed that the roadway be shifted to the west again in order to improve sight distance.

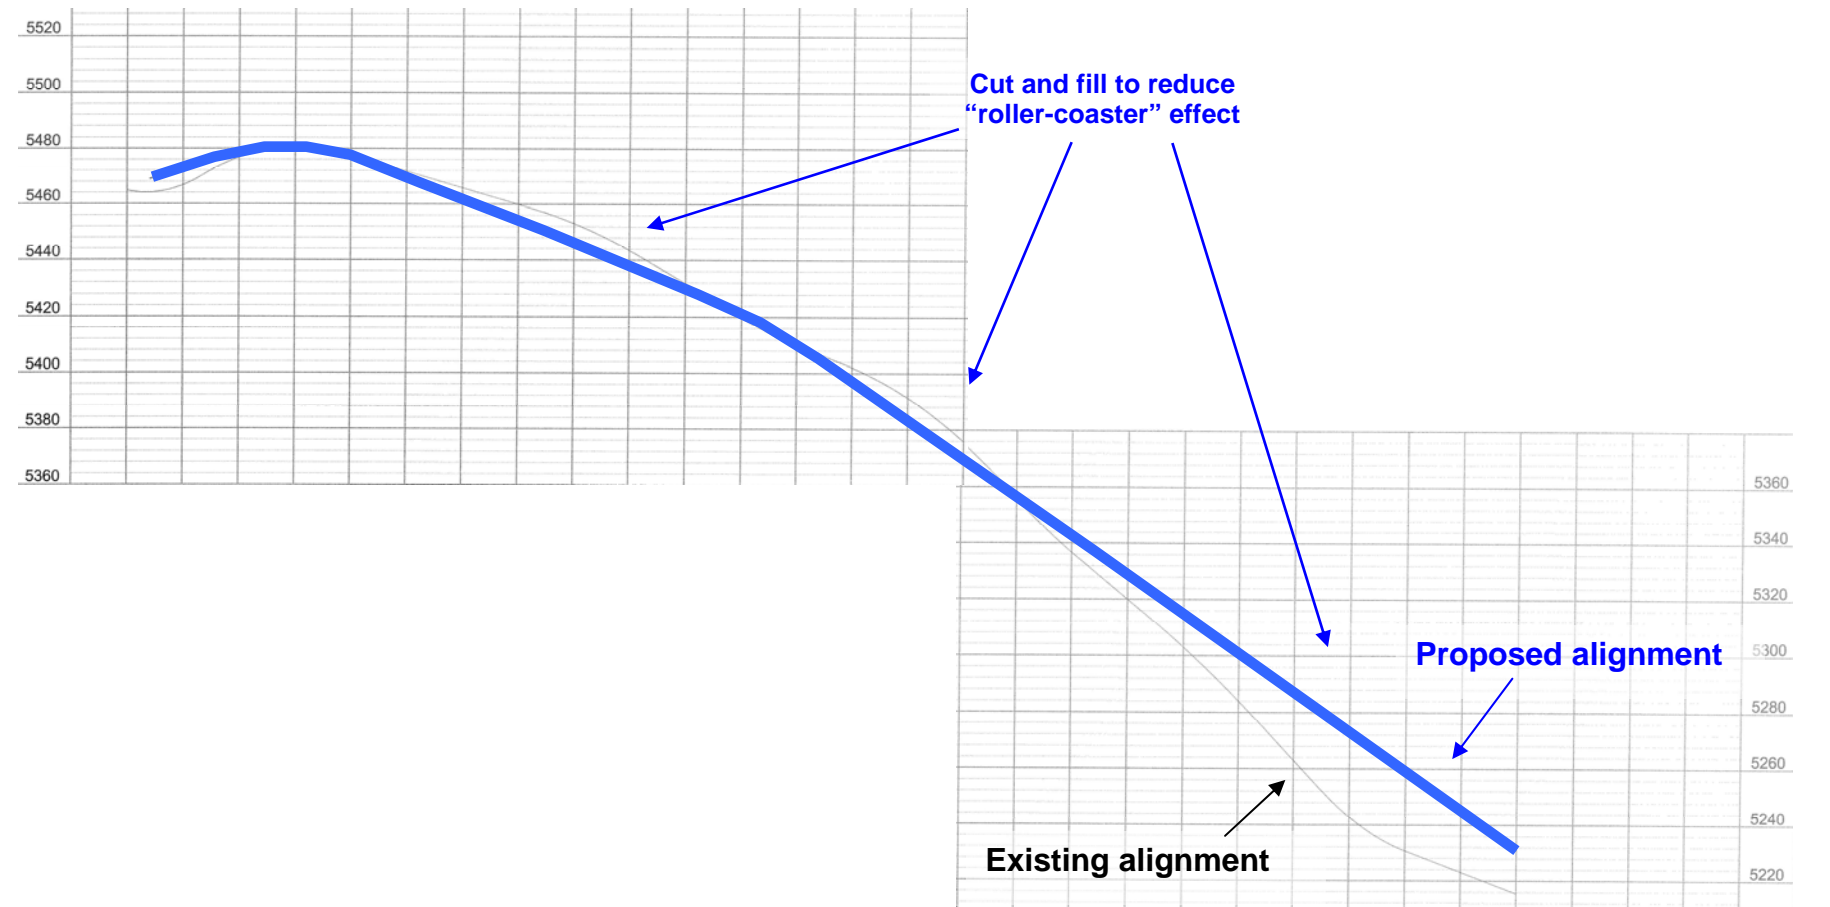
Between MP 5± and 6±, there are several sag and crest curves in the vertical alignment, creating a “roller-coaster” effect. Grades exceeding the maximum recommended grade within this portion of MT 78 range from approximately eight to 11 percent. As noted in Figure 4.2, these curves are rated “fair” and “poor,” due to their steep grades. It is proposed that cut and fill be used to reduce this effect and create a more uniform grade. This action would bring the curve up to current design standards.

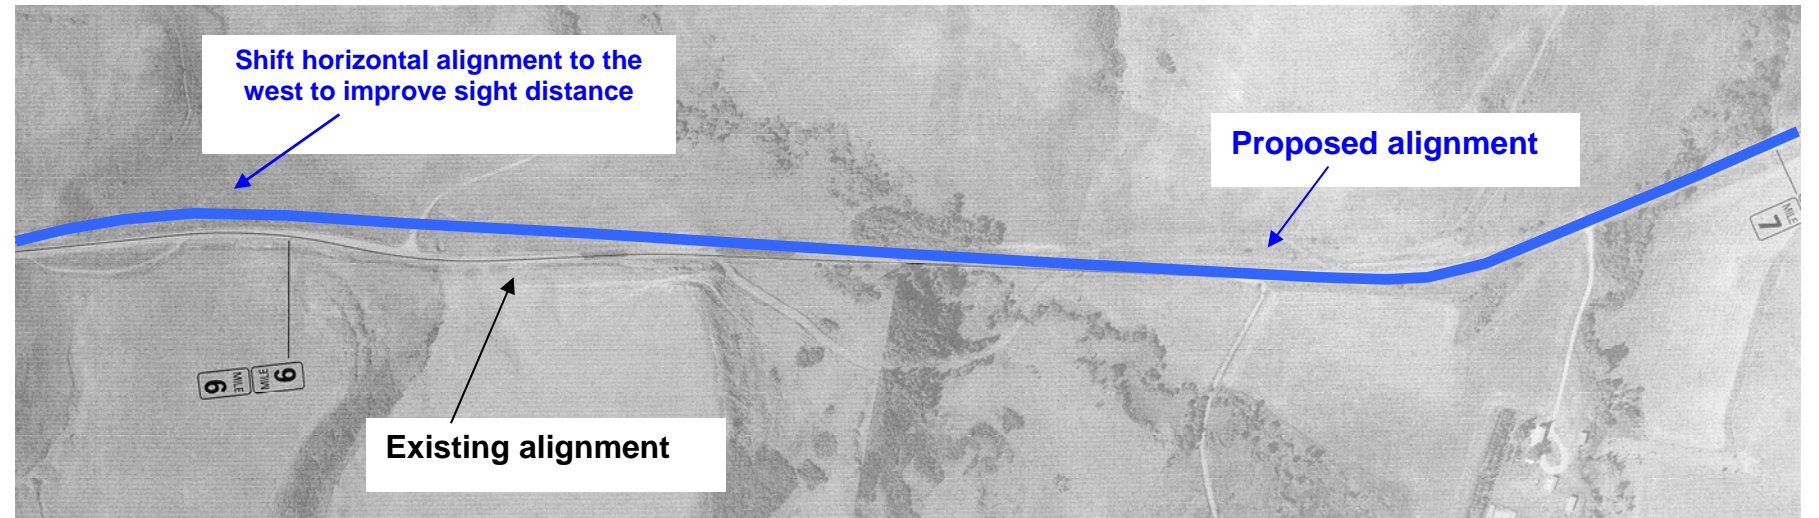
Near MP 6±, it is proposed that the roadway be shifted to the west in order to improve sight distance.

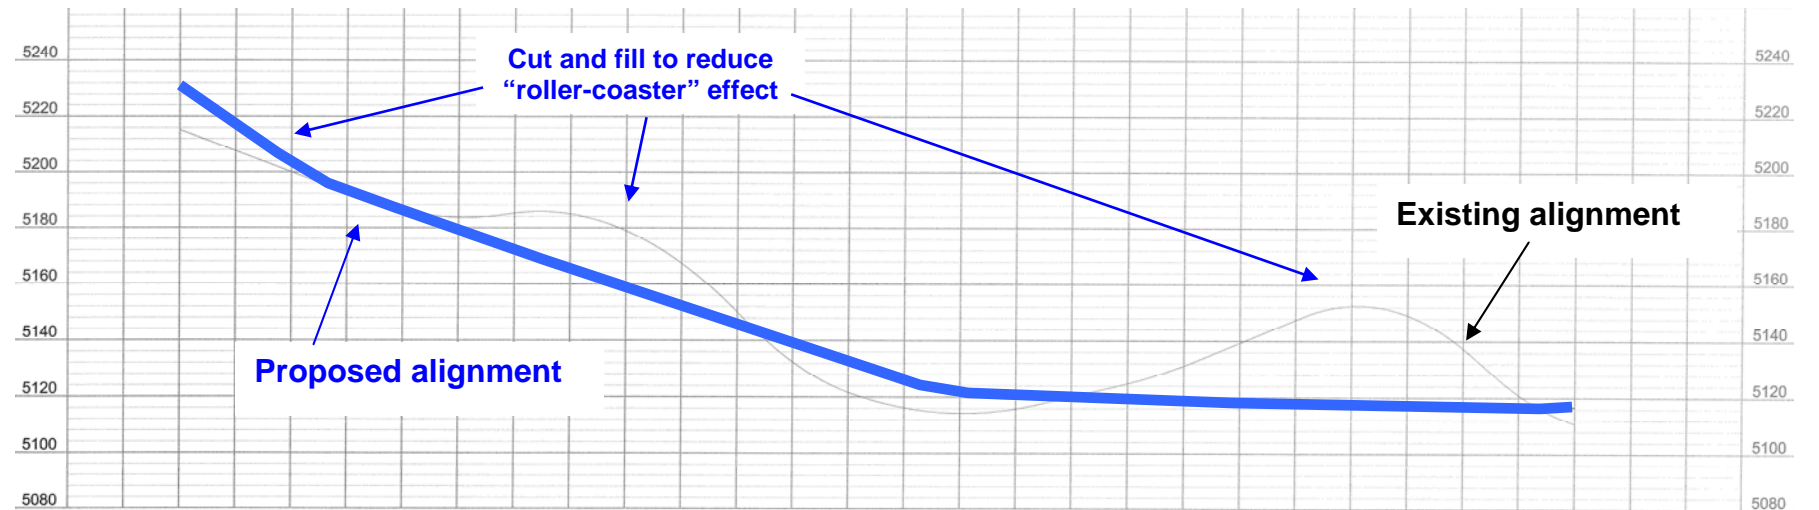
Between MP 6± and 7±, there are several sag and crest curves in the vertical alignment, creating a “roller-coaster” effect. Grades exceeding the maximum recommended grade within this portion of MT 78 range from approximately nine to ten percent. It is proposed that cut and fill be used to reduce this effect and create a more uniform grade.

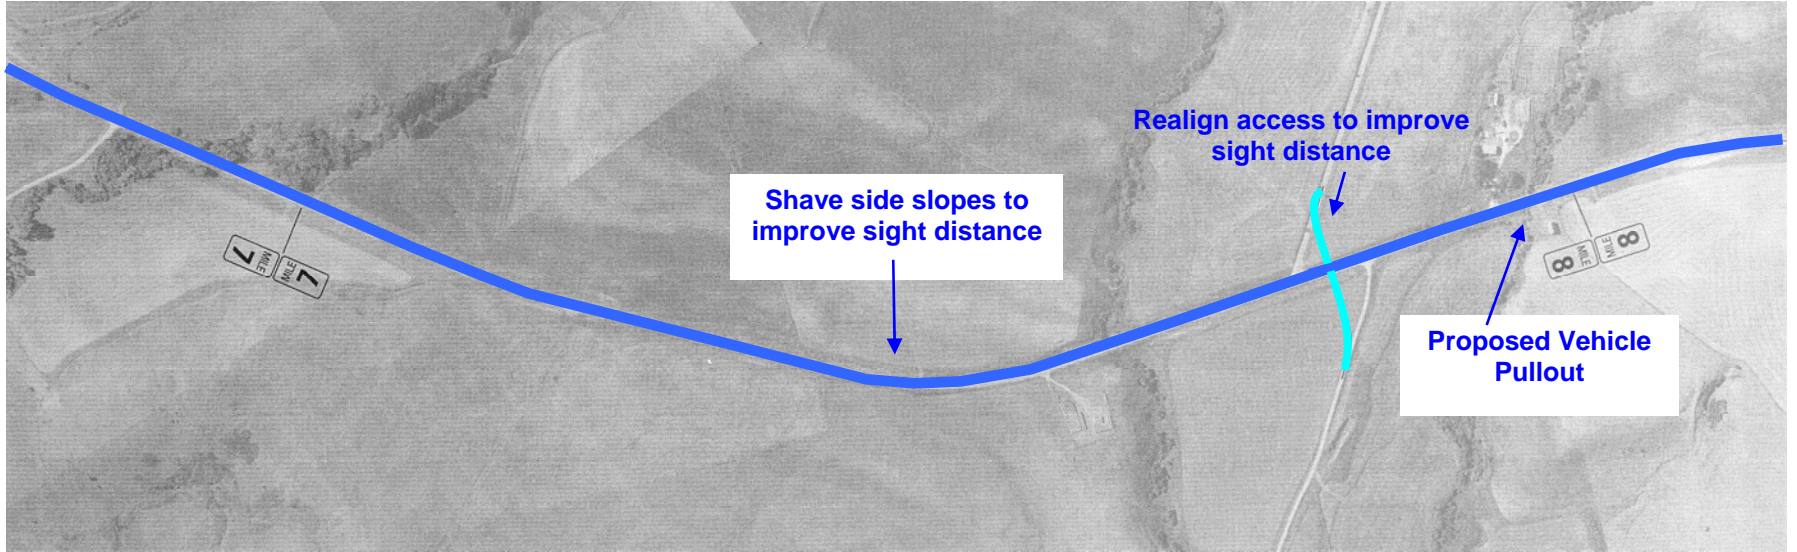
Between MP 7± and MP 8±, it is proposed that the side slopes be shaved to improve sight distance. At MP 7.8±, it is proposed that the access points be realigned to improve sight distance. At MP 7.9±, a vehicle pullout is proposed.

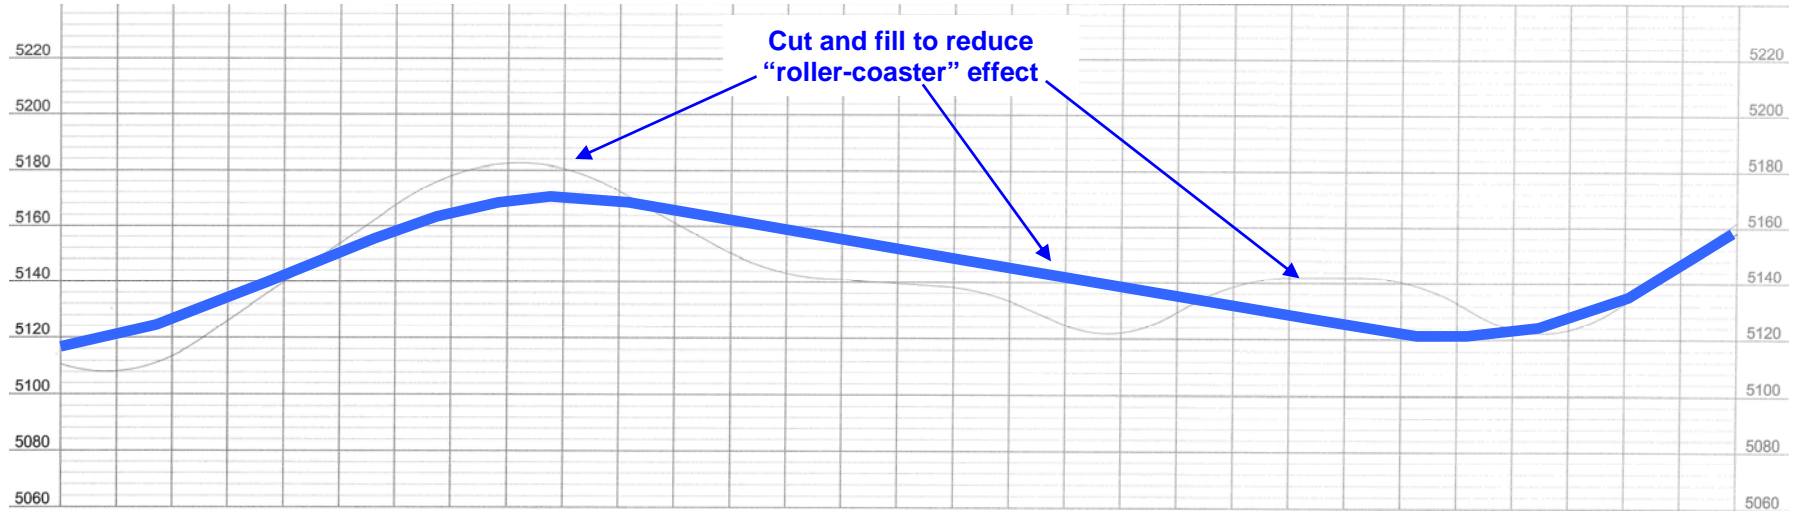
Between MP 7± and MP 8±, there are several sag and crest curves in the vertical alignment, creating a “roller-coaster” effect. Grades exceeding the maximum recommended grade within this portion of MT 78 range from approximately seven to nine percent. It is proposed that cut and fill be used to reduce this effect and create a more uniform grade.

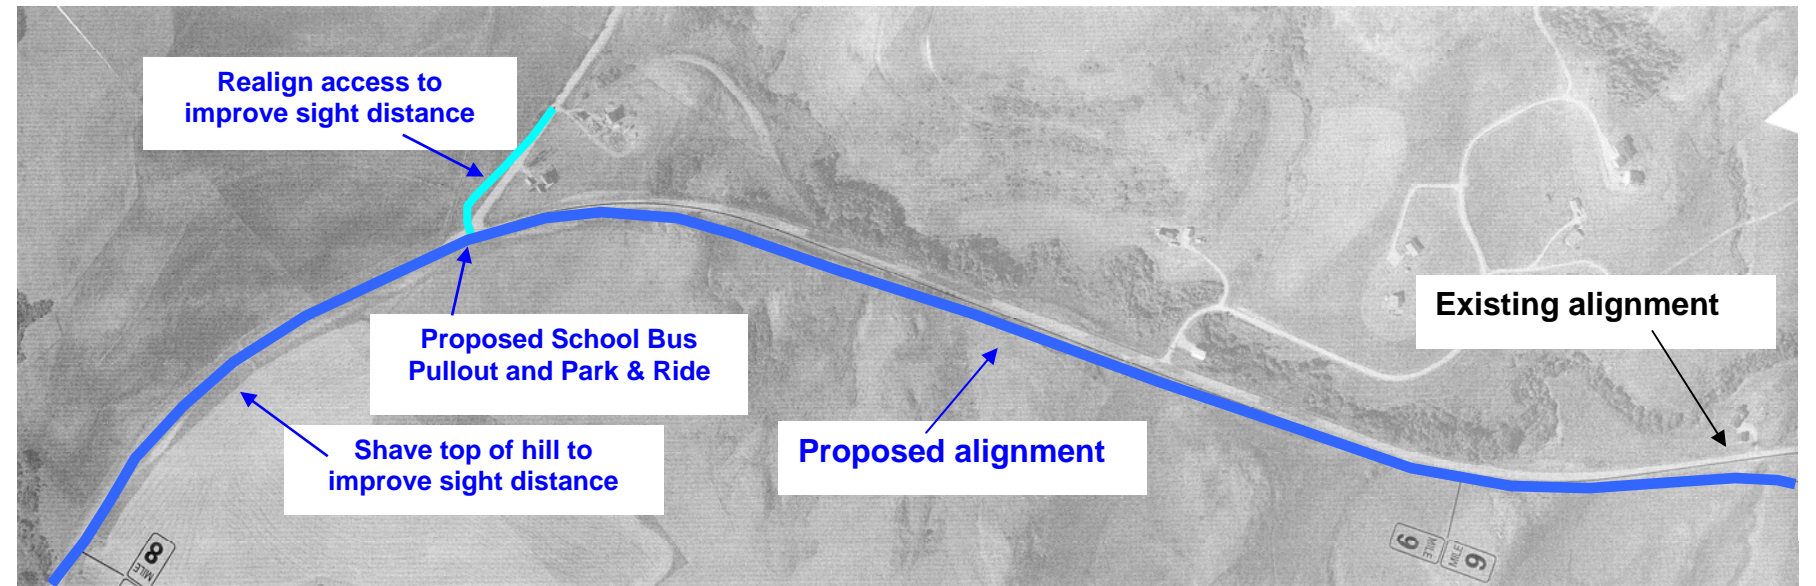
Between MP 8± and MP 9±, it is proposed that the top of the hill be shaved to improve sight distance. At MP 8.2±, it is proposed that Upper Luther Road be realigned to improve sight distance. Additionally, a school bus pullout and park & ride facilities are proposed at this location.

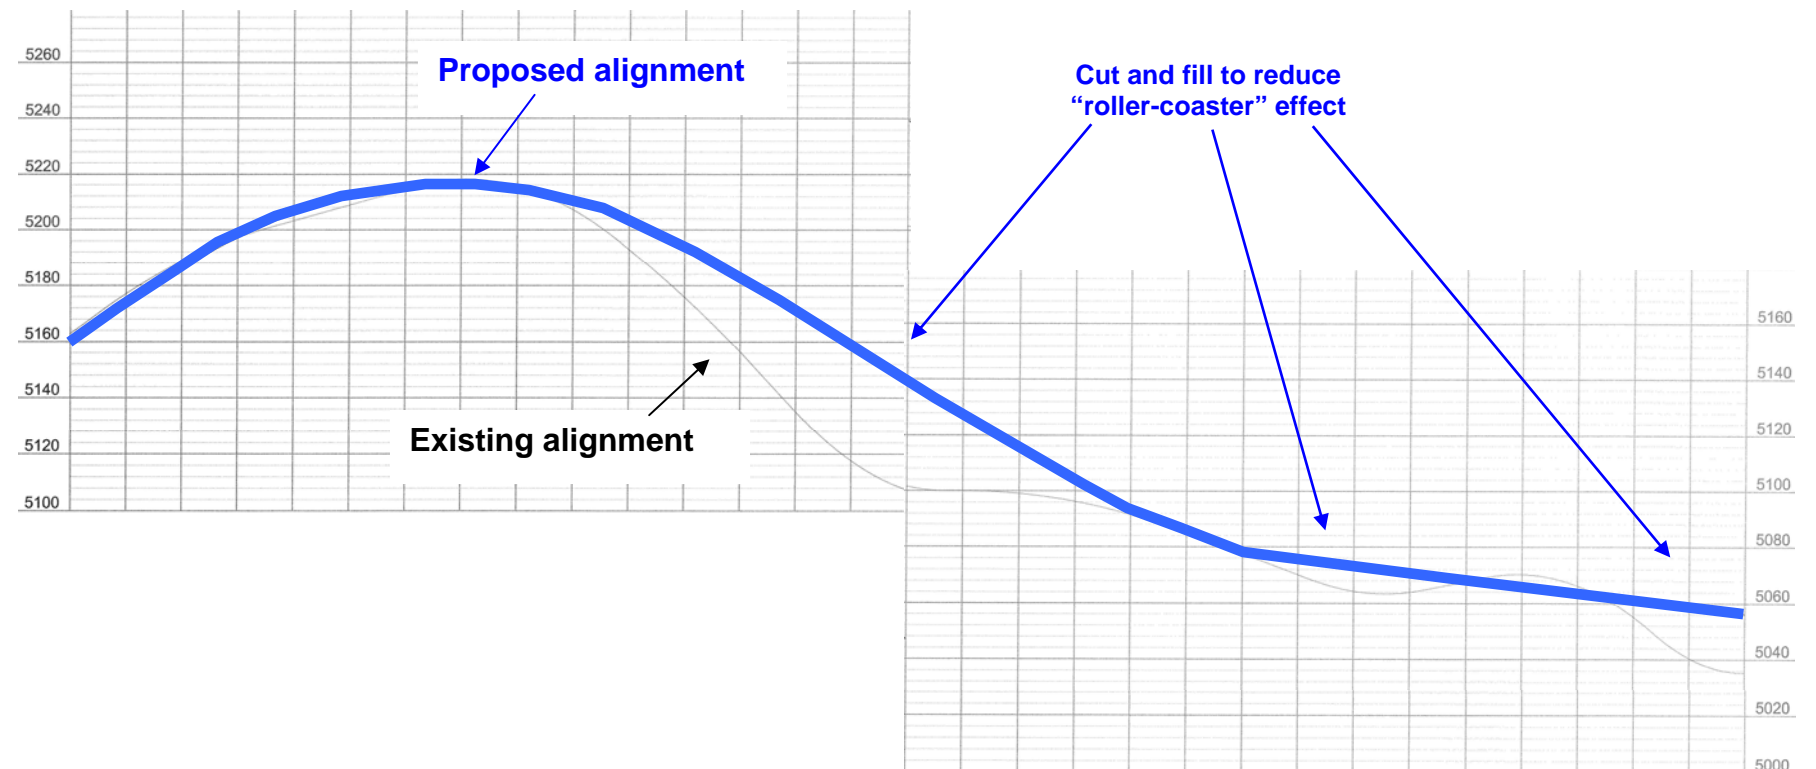
Between MP 8± and MP 9±, there are several sag and crest curves in the vertical alignment, creating a “roller-coaster” effect. Grades exceeding the maximum recommended grade within this portion of MT 78 range from approximately seven to 11 percent. It is proposed that cut and fill be used to reduce this effect and create a more uniform grade.

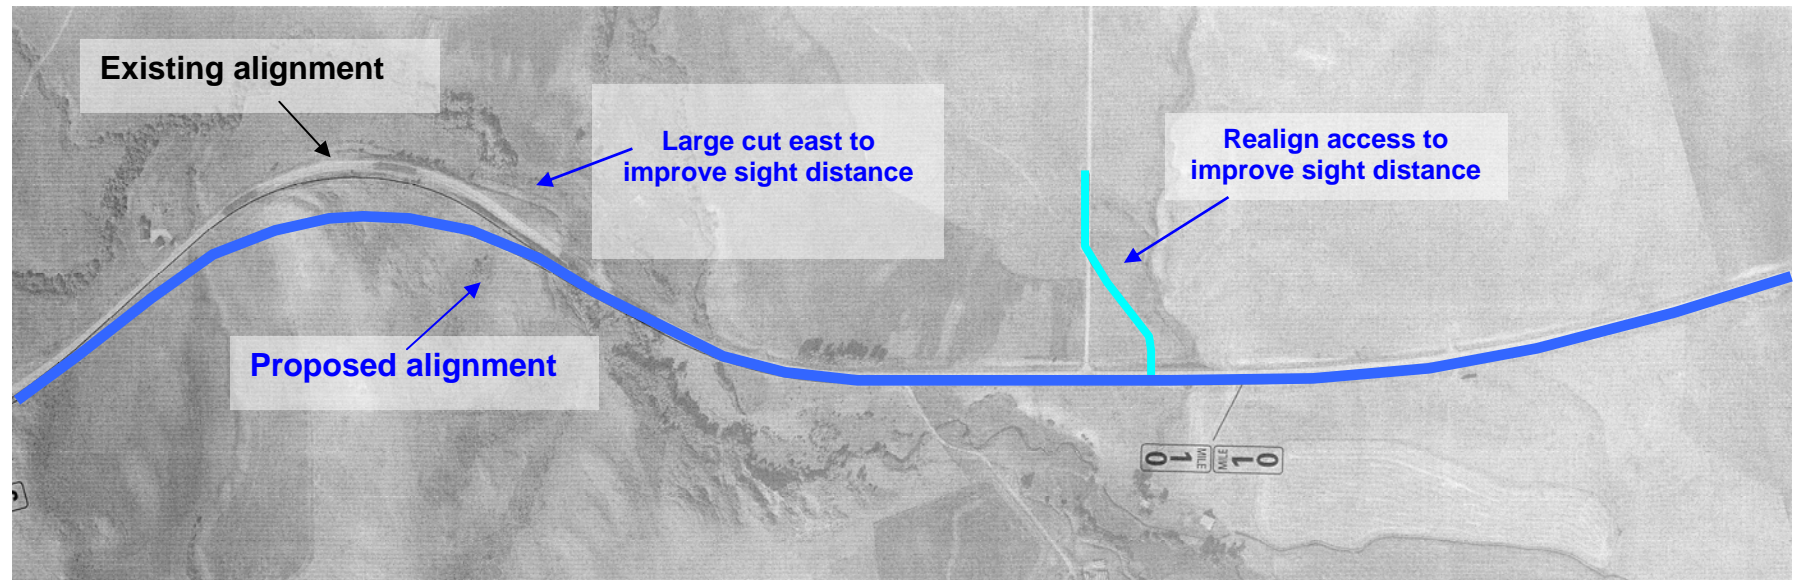
At MP 9.4±, there is a sharp horizontal curve. As noted in Figure 4.2, this curve is rated “poor” due to its inadequate curve radius.

As shown in the aerial to the right, it is proposed that the roadway be shifted to the east in this location to decrease the sharpness of this curve.

It is also proposed that the access point be realigned to improve sight distance.

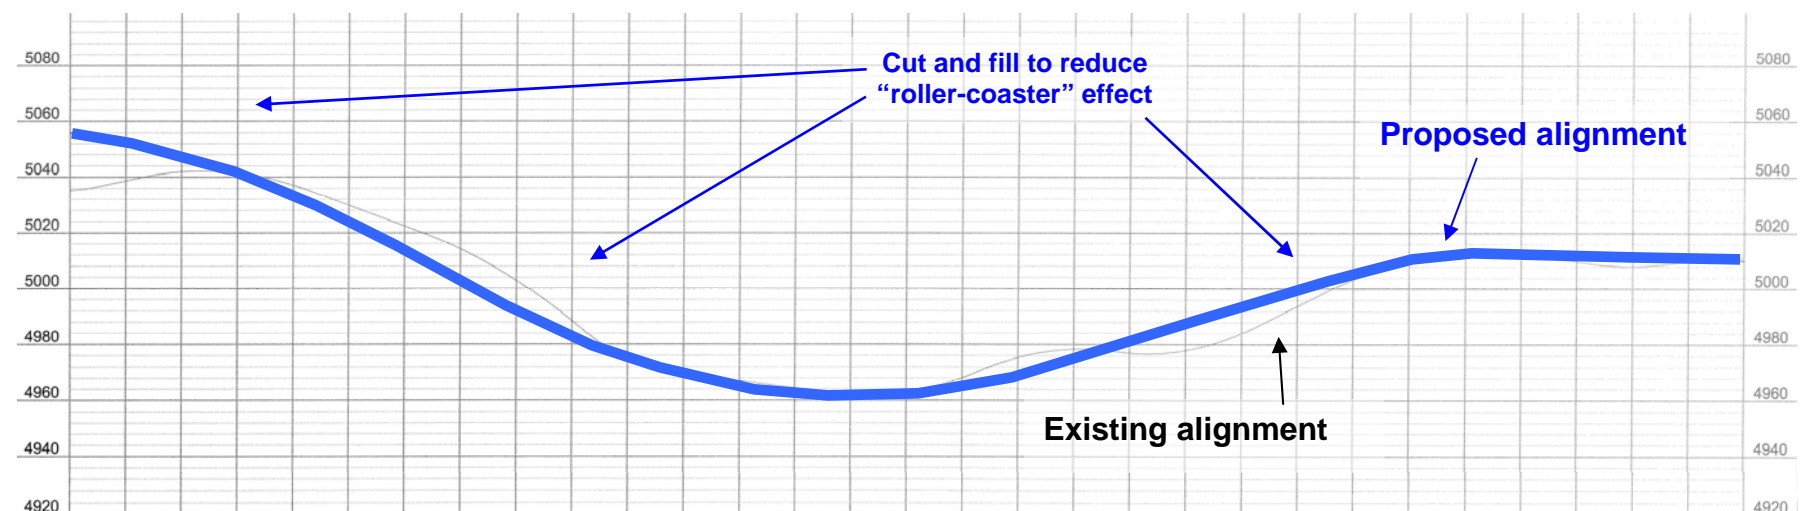
Between MP 9± and MP 10.5±, there are several sag and crest curves in the vertical alignment, creating a “roller-coaster” effect. Grades exceeding the maximum recommended grade within this portion of MT 78 range from approximately eight to nine percent. It is proposed that cut and fill be used to reduce this effect and create a more uniform grade.

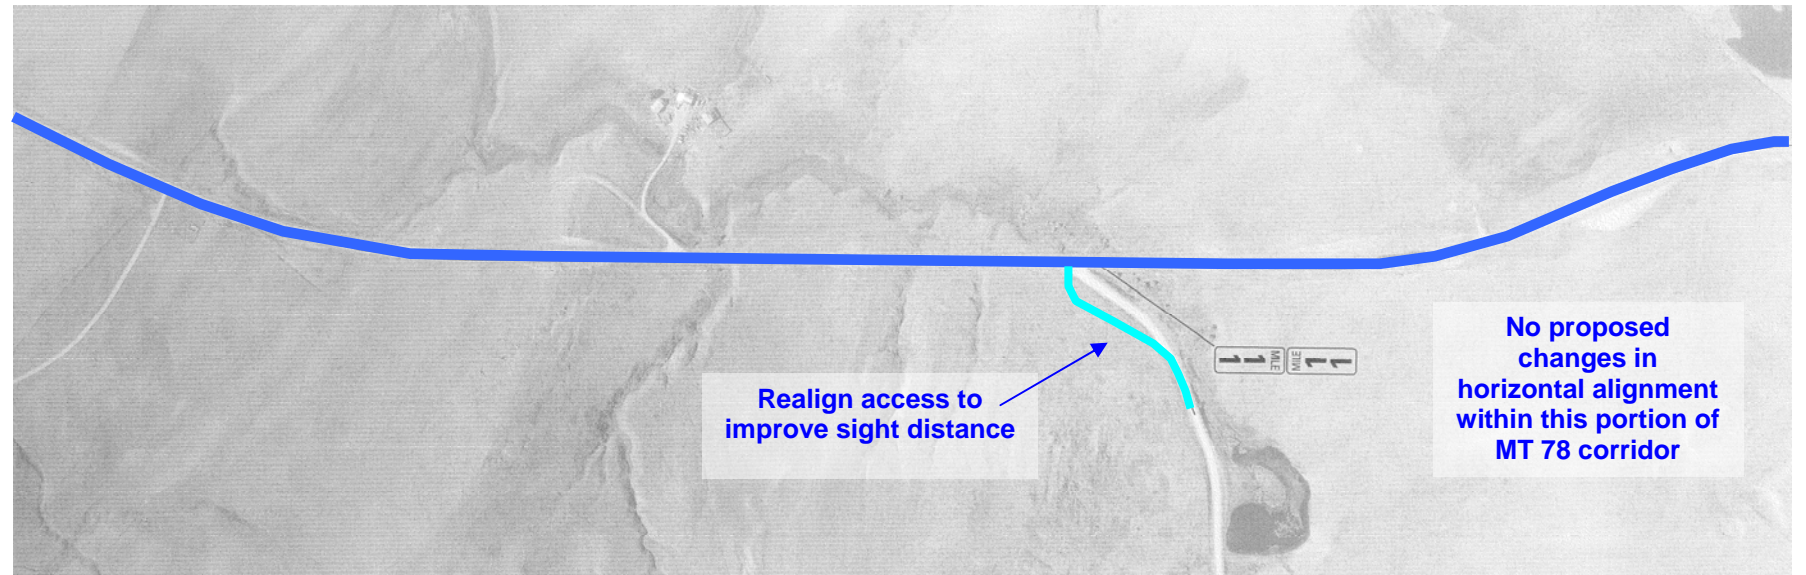
At MP 11±, it is proposed that the access road be realigned to improve sight distance. There are no proposed changes in the horizontal alignment within this portion.

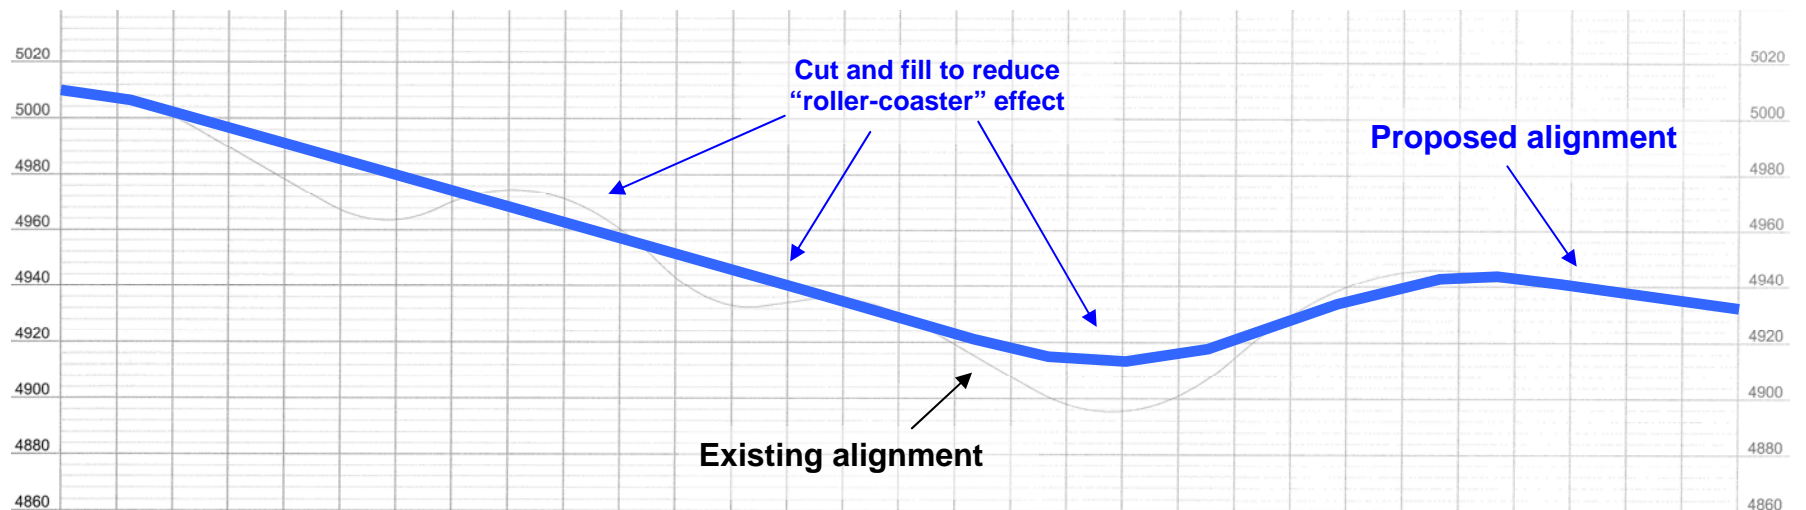
Between MP 10± and MP 11.5±, there are several sag and crest curves in the vertical alignment, creating a “roller-coaster” effect. Grades exceeding the maximum recommended grade within this portion of MT 78 range from approximately eight to ten percent. It is proposed that cut and fill be used to reduce this effect and create a more uniform grade.

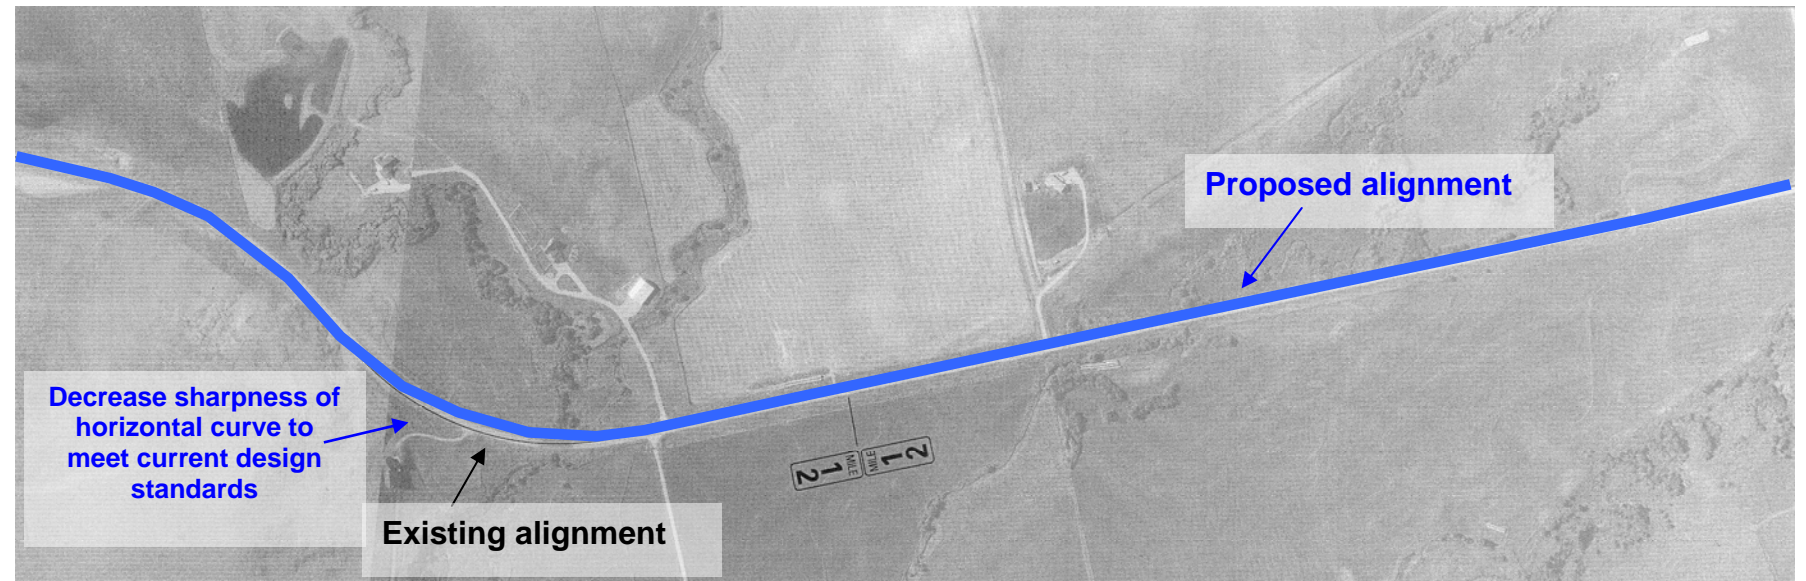
Between MP 11.5± and 12.0±, there is a sharp horizontal curve. As noted in Figure 4.2, this curve is rated “poor” due to its inadequate curve radius.

As shown in Figure 6.1, it is proposed that the roadway be shifted to slightly in this location to decrease the sharpness of this curve. The alignment was shifted only far enough to ensure that the curve meets current design standards.

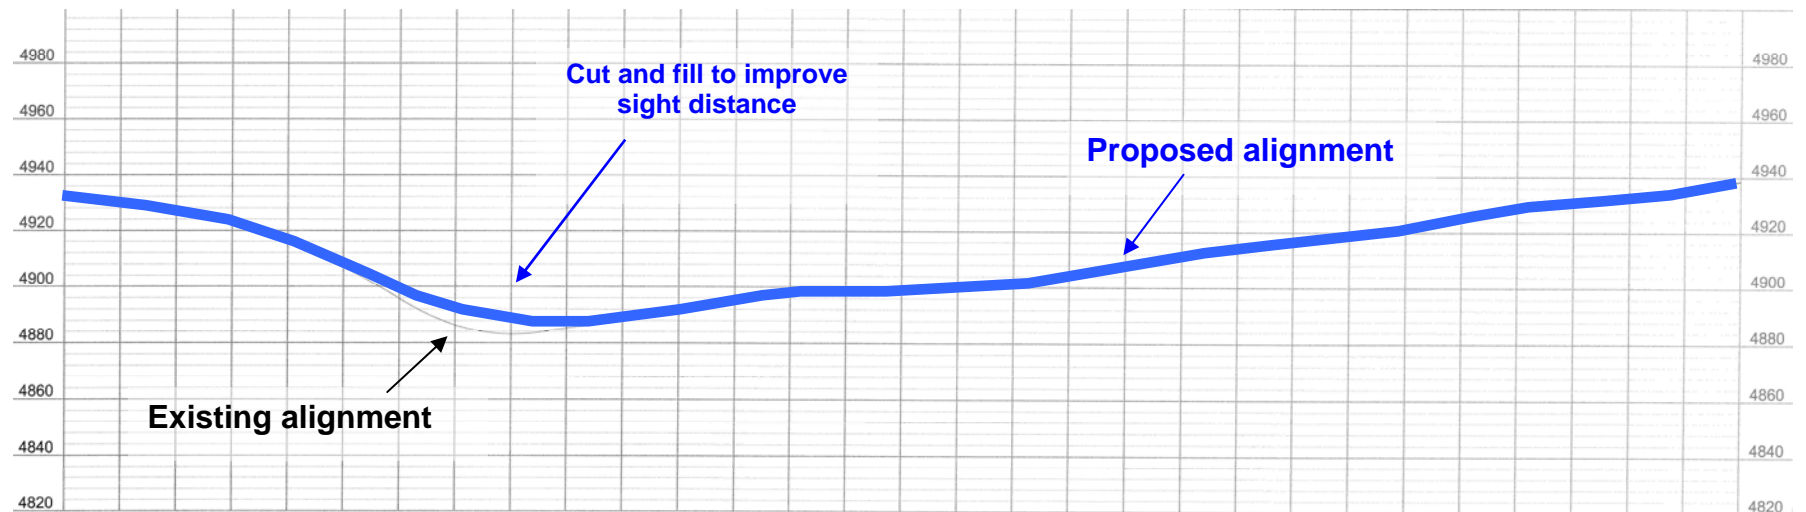
Between MP 11.5± and MP 12.0±, there is a sag curve in the vertical alignment which does not meet current design standards for sight distance. It is proposed that fill be used to improve the sight distance of this curve.

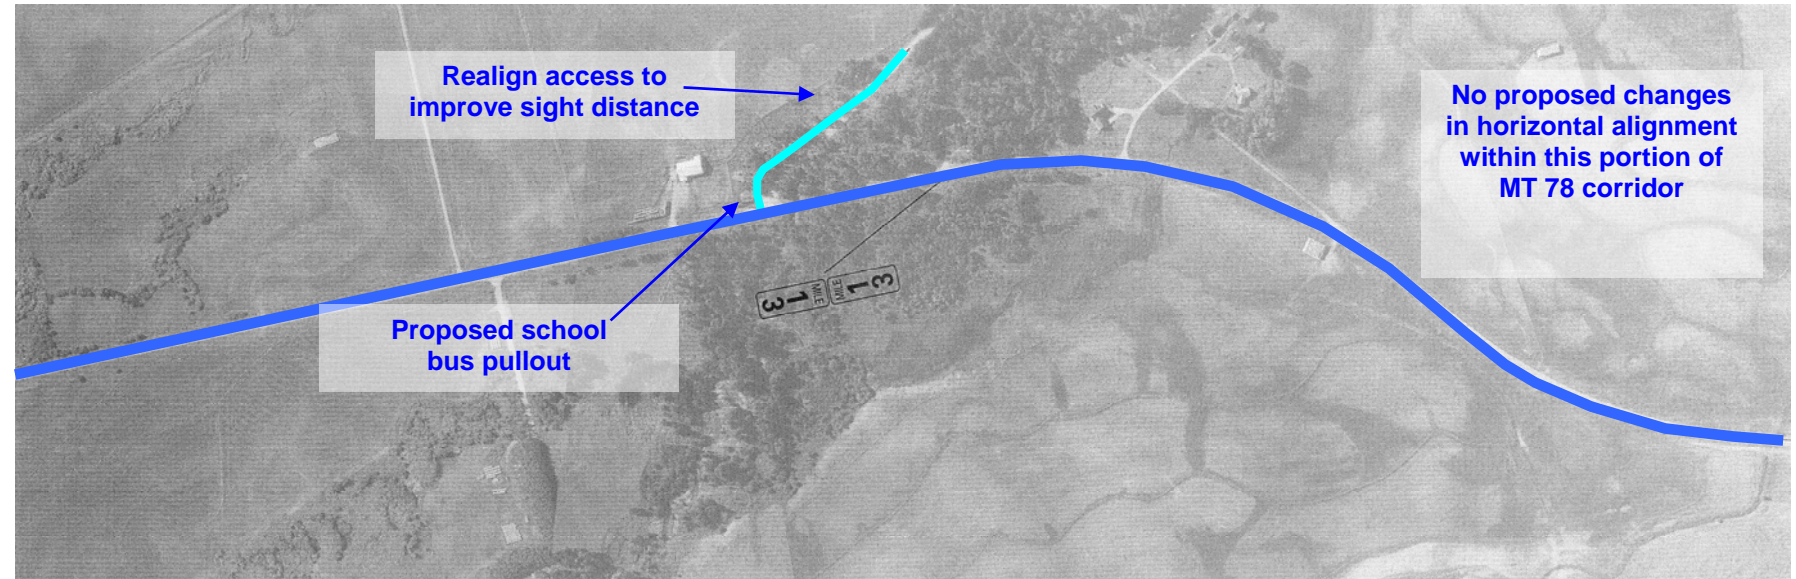
Between MP 12.5± and MP 13.5±, it is proposed that the access point be realigned to improve sight distance. At MP 13.0, a school bus pullout is proposed. There are no proposed changes in the horizontal alignment within this portion.

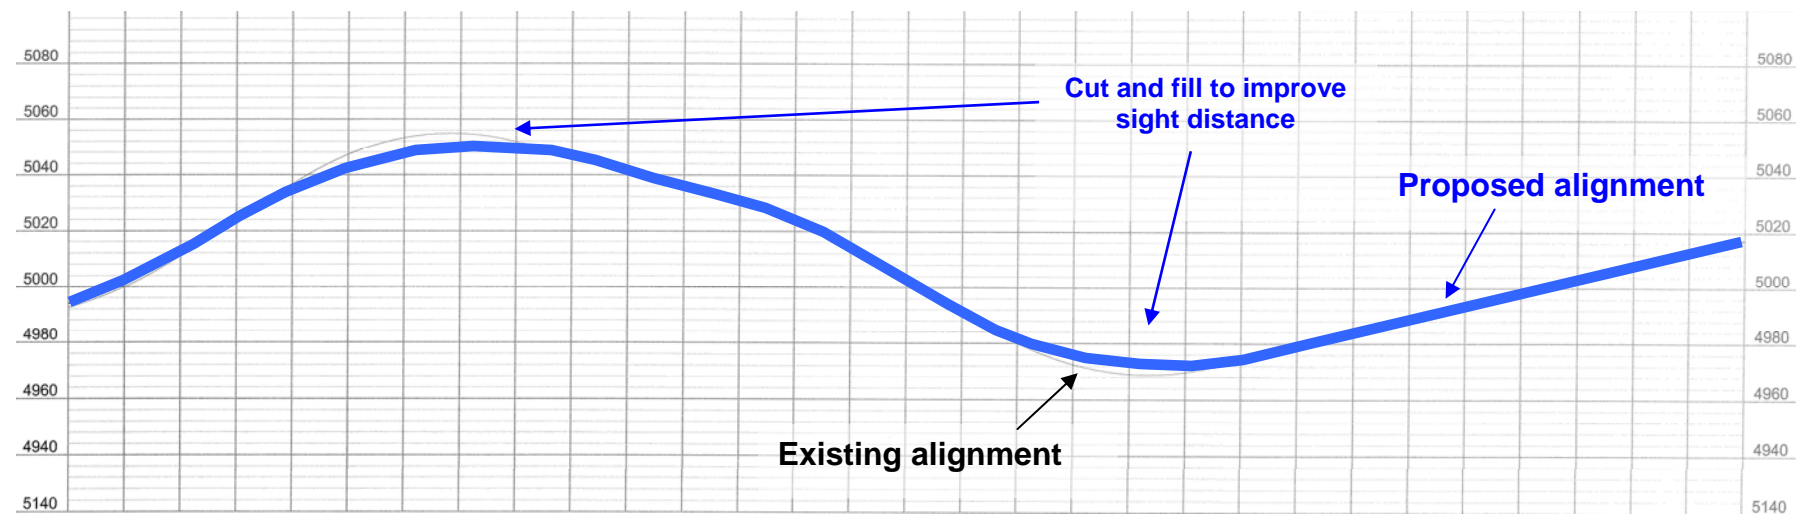
Between MP 13.5± and MP 14.5±, there is a sag and a crest curve in the vertical alignment, which do not meet current design standards for sight distance. It is proposed that fill be used to improve the sight distance of these curves.

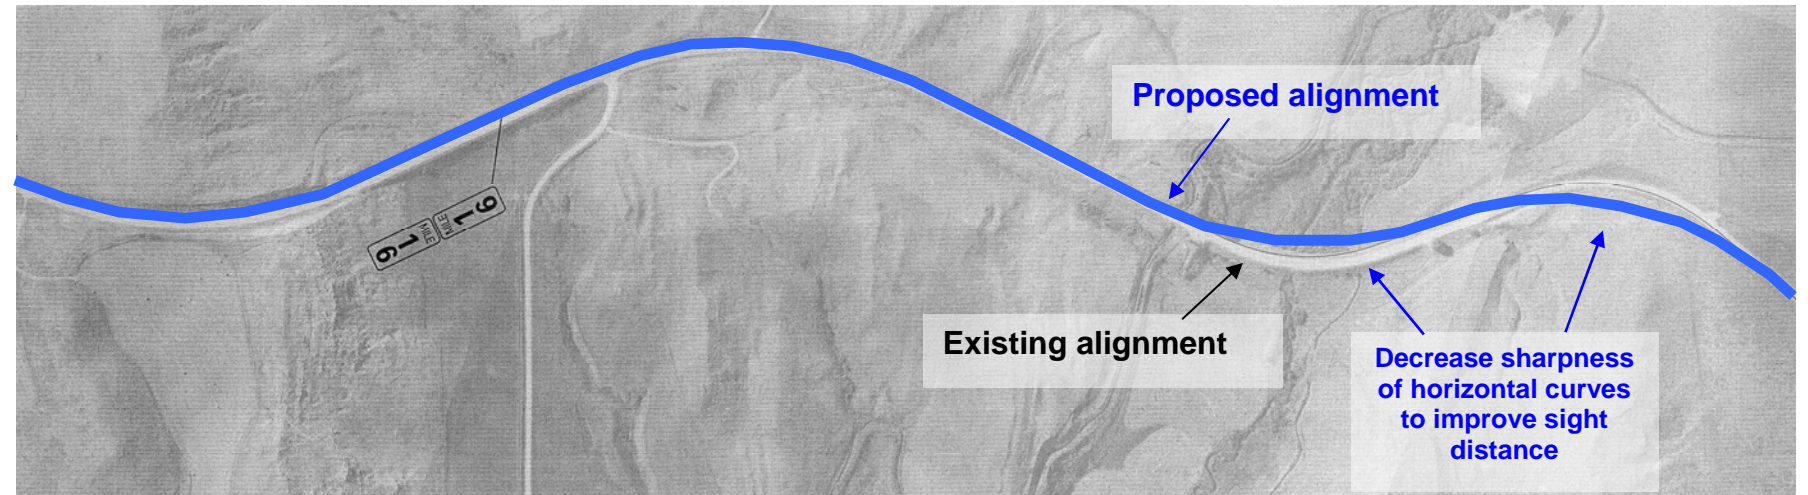
At MP 16.5± and 16.8±, there are two sharp horizontal curves. As noted in Figure 4.2, these curves are rated “poor” due to their inadequate curve radius.

As shown in Figure 6.1, it is proposed that the roadway be shifted to the north and south, respectively, to decrease the sharpness of this curve.

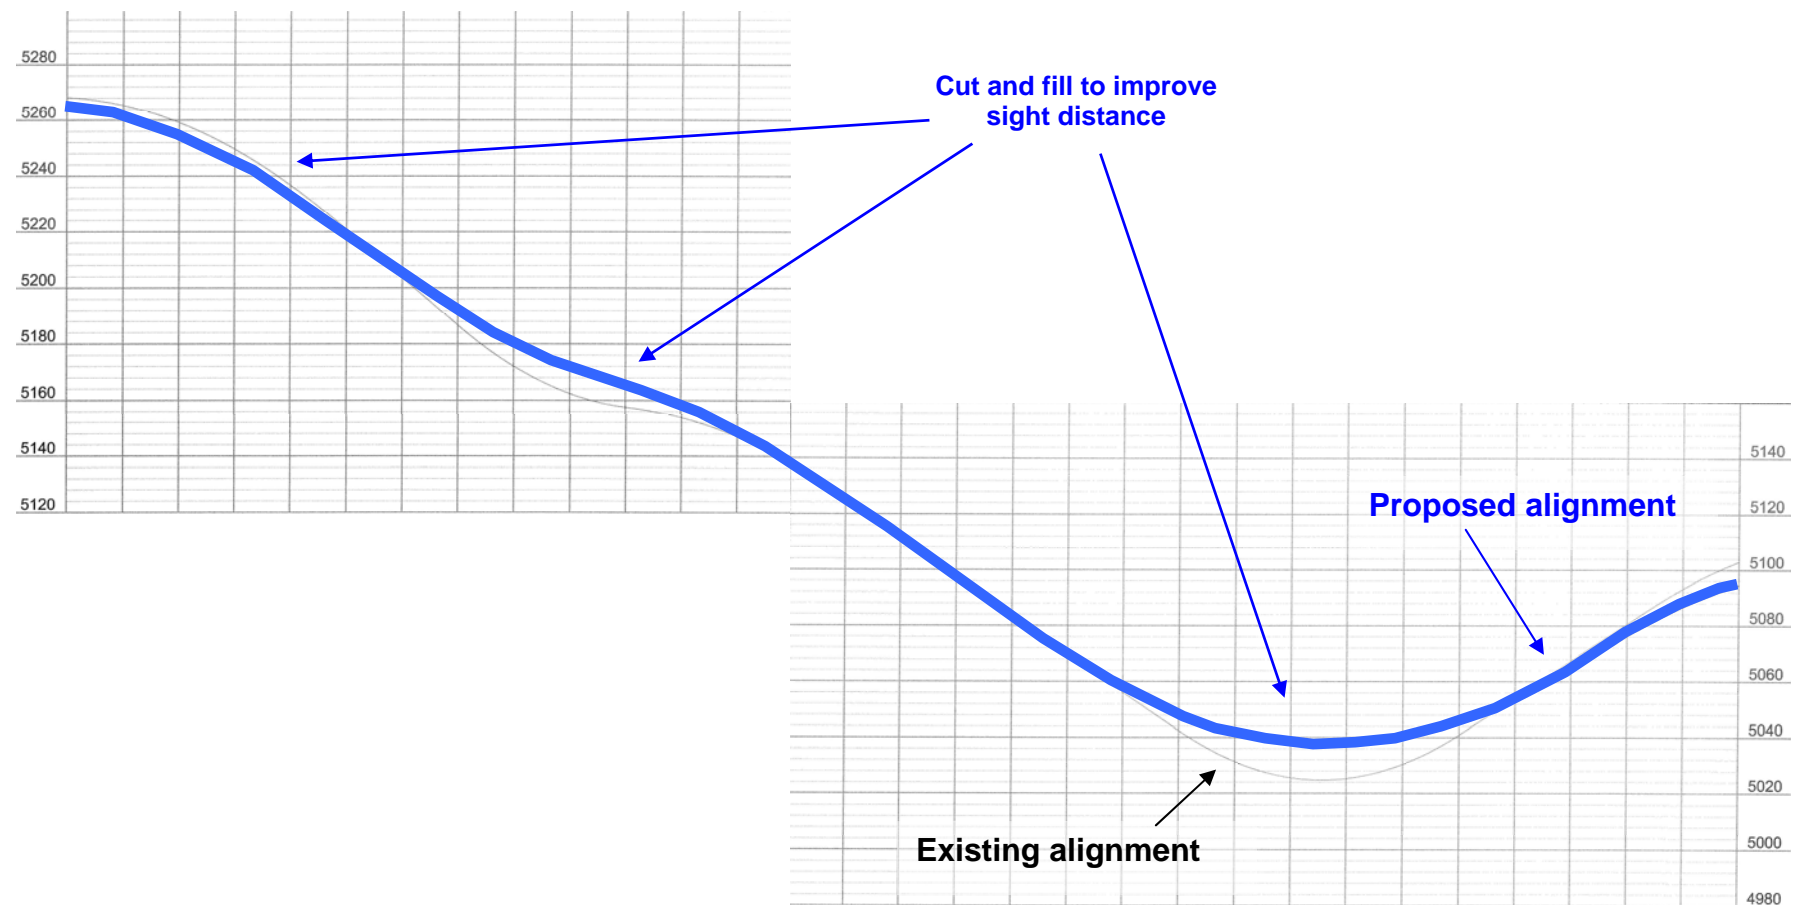
Between MP 15.5± and MP 16.5±, there are several sag and crest curves in the vertical alignment, which do not meet current design standards for sight distance. It is proposed that fill be used to improve the sight distance of these curves.

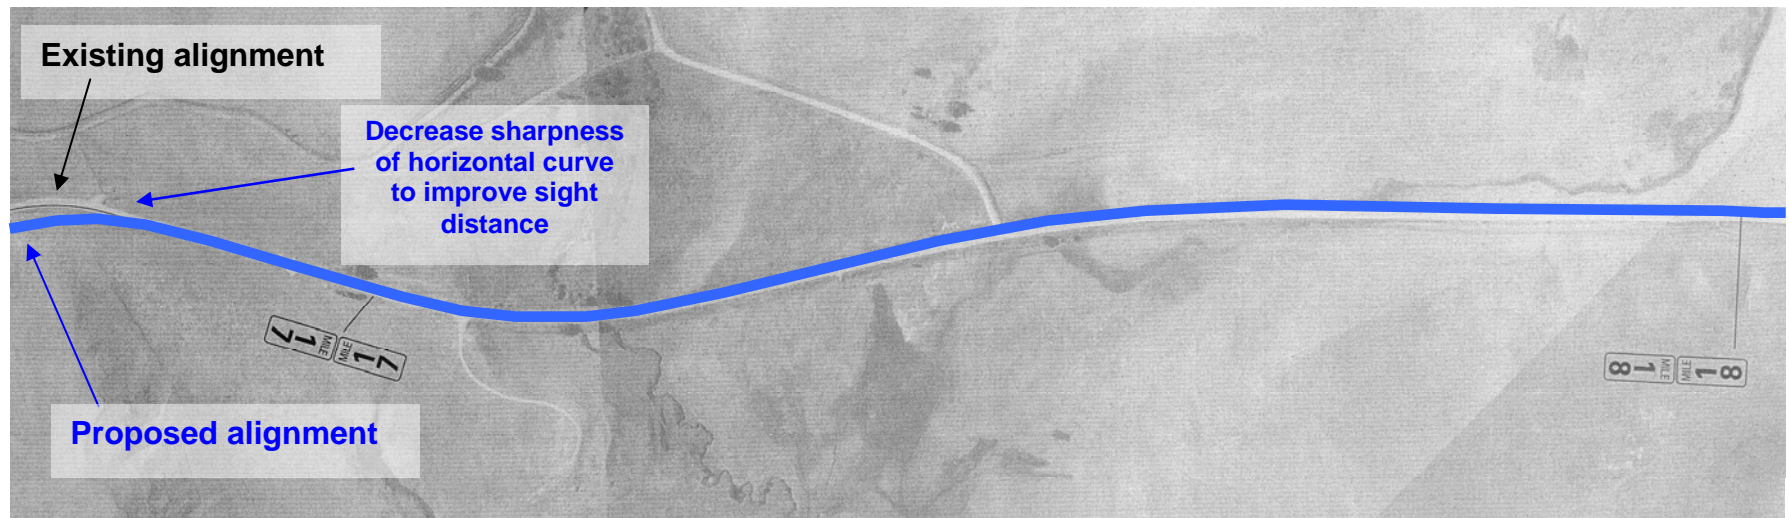
Between MP 16.5± and 17.0±, there is a sharp horizontal curve. As noted in Figure 4.2, this curve is rated “poor” due to its inadequate curve radius.

As shown in Figure 6.1, it is recommended that the roadway be shifted to the south to decrease the sharpness of this curve.

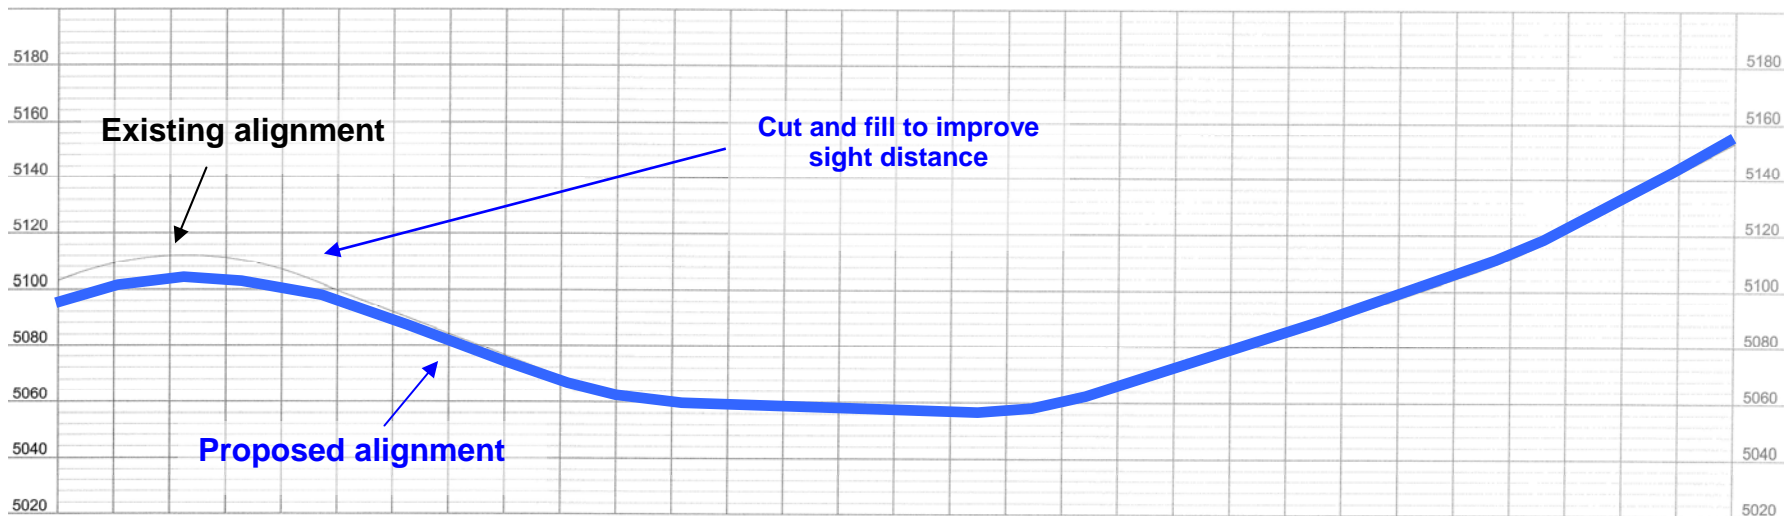
Between MP 16.5± and MP 18±, there is a crest curve in the vertical alignment, which does not meet current design standards for sight distance. It is proposed that fill be used to improve the sight distance of this curve.
