6.1 Improvement Options

MT 78 Corridor Study

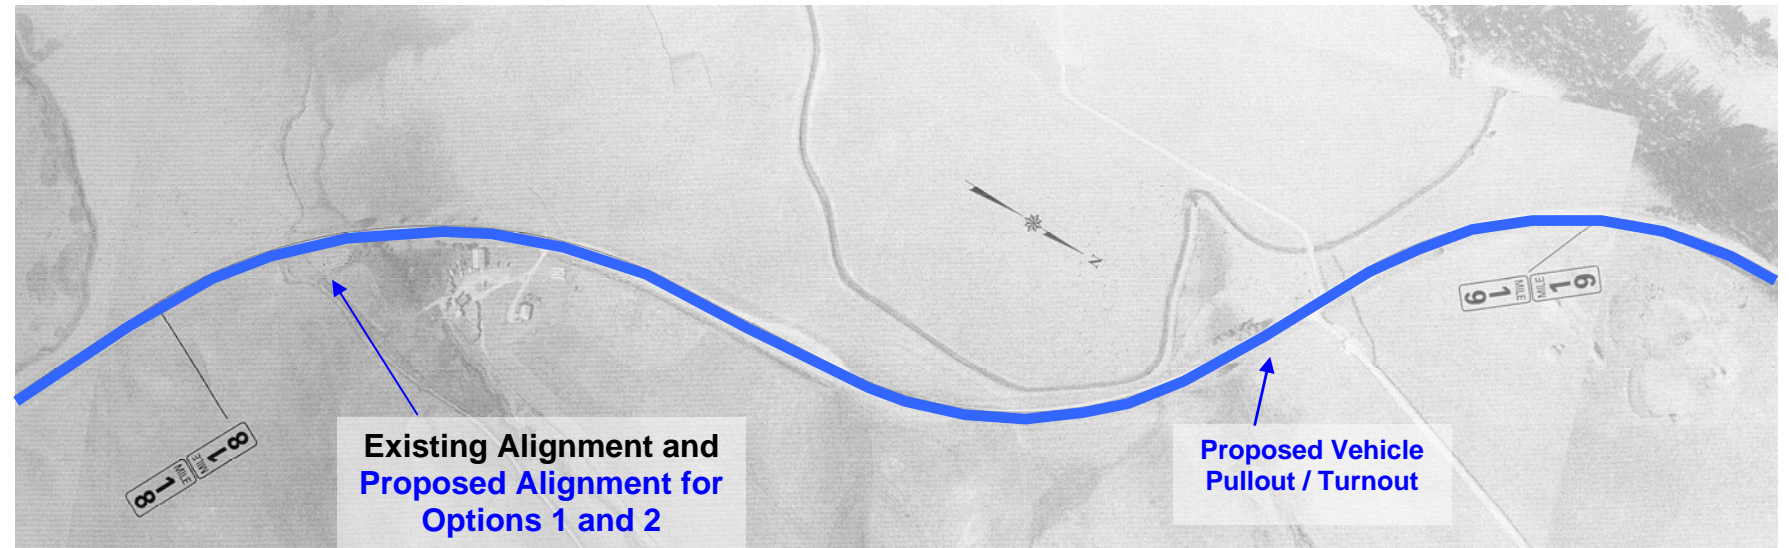
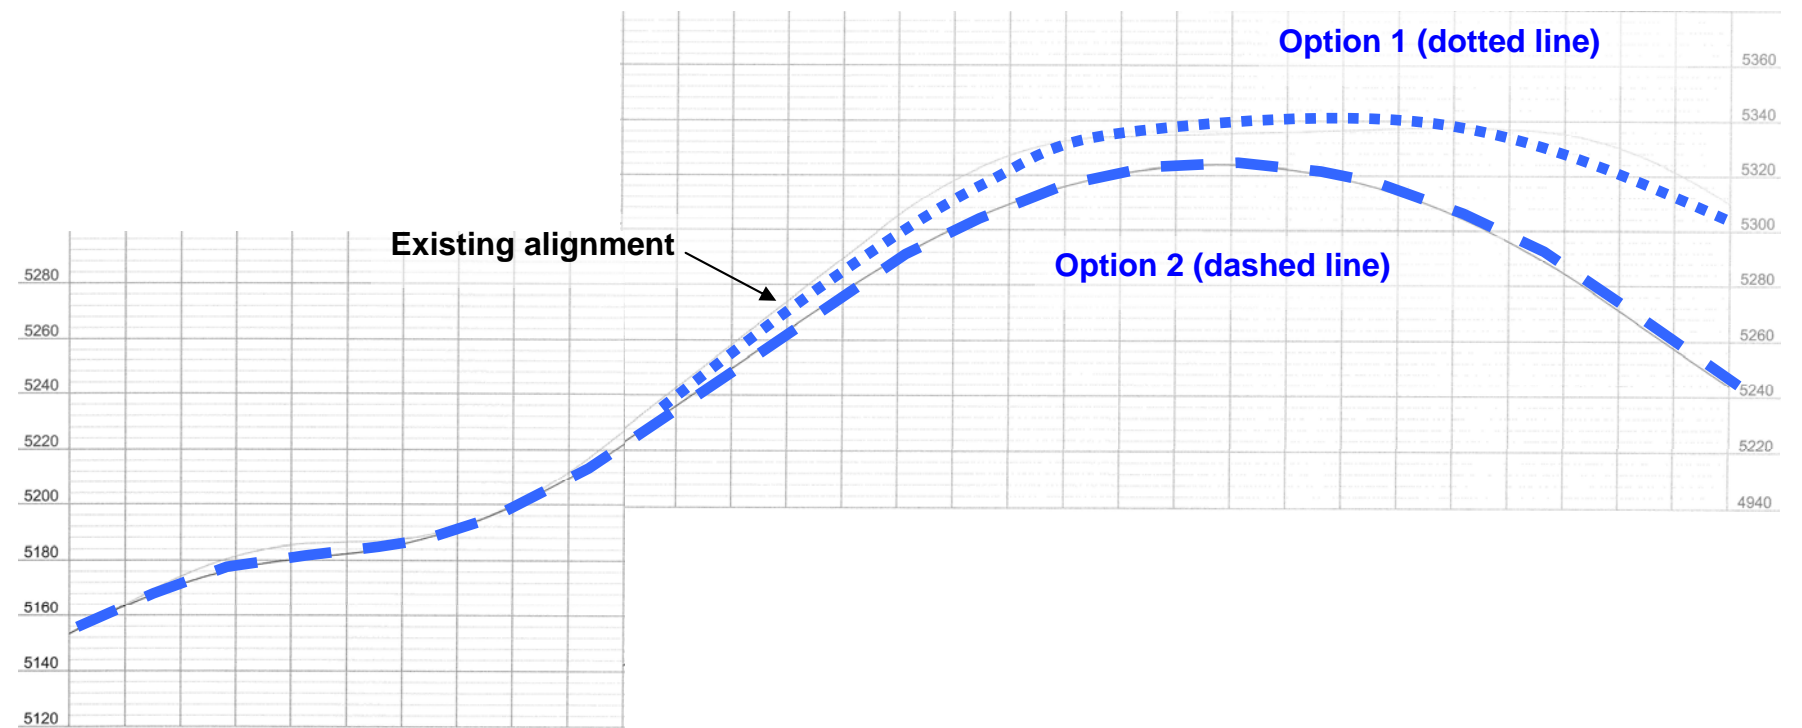
- Option 1: It is proposed that the hill faces at the top of Roscoe Hill be shaved off in order to improve sight distance.
- Option 2: The grade between MP 18± and MP 19± would be substantially reduced from nearly eight percent to just under seven percent to bring the roadway to current MDT design standards. This would require a large amount of earthwork.

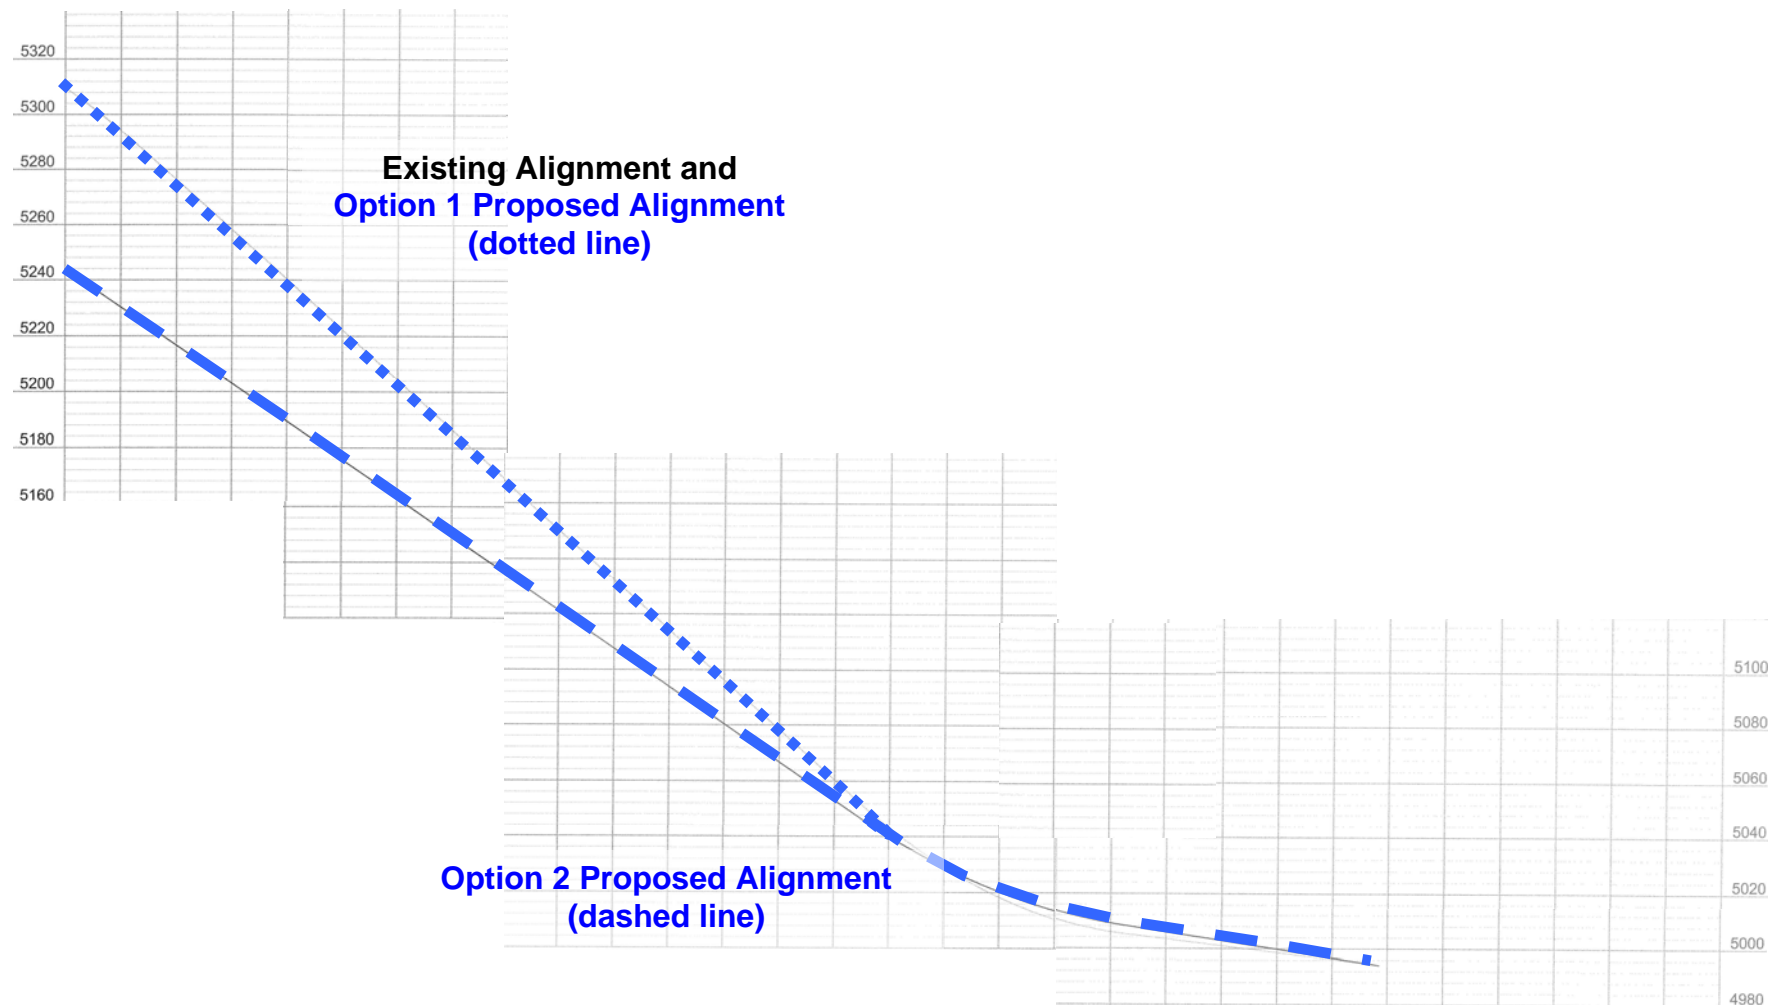
Option 1: There are no proposed changes to the grade.

Option 2: The grade between MP 19± and MP 20± would be substantially reduced from approximately nine percent to just under seven percent to bring the roadway to MDT design standards. This would require a large amount of earthwork.

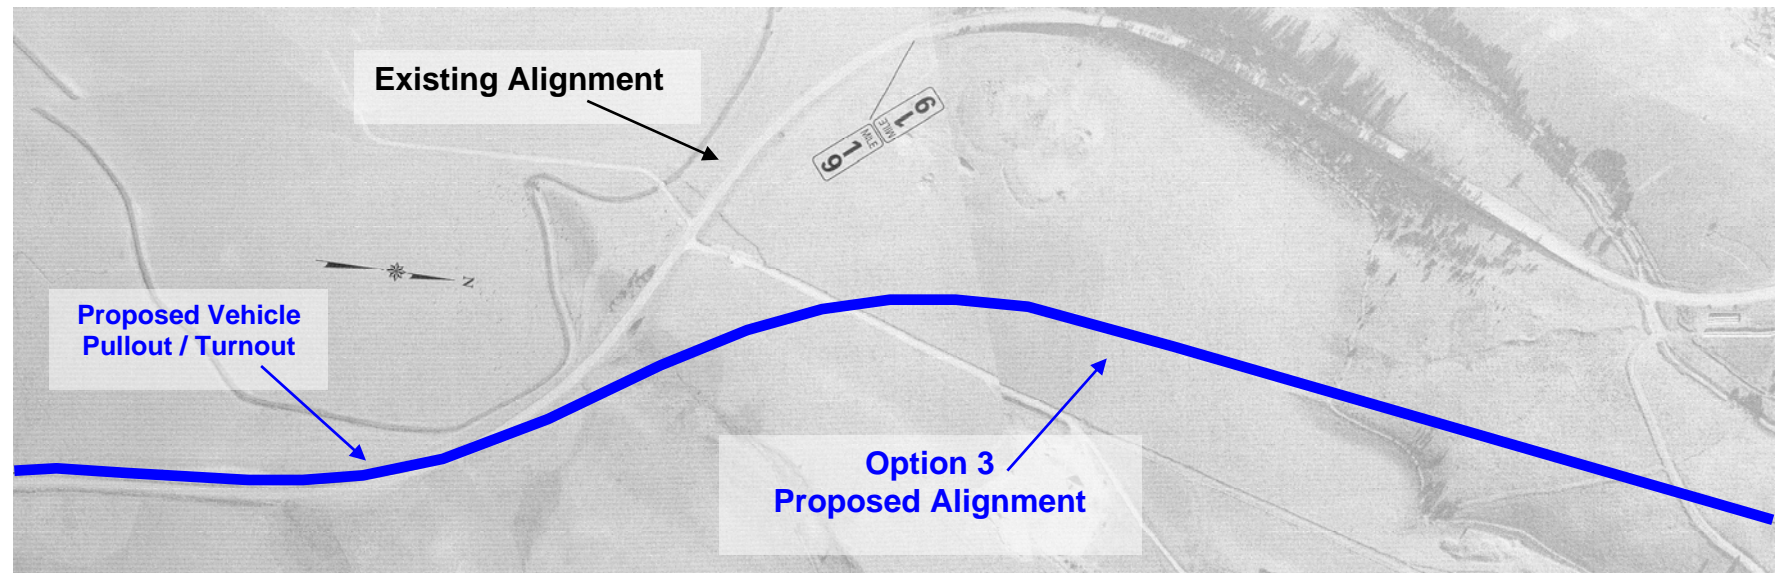
Alignment Option 3 would shift east from the existing alignment starting south of MP 19±. The new alignment would follow the natural curve of the hill to the east of Roscoe and the existing alignment.

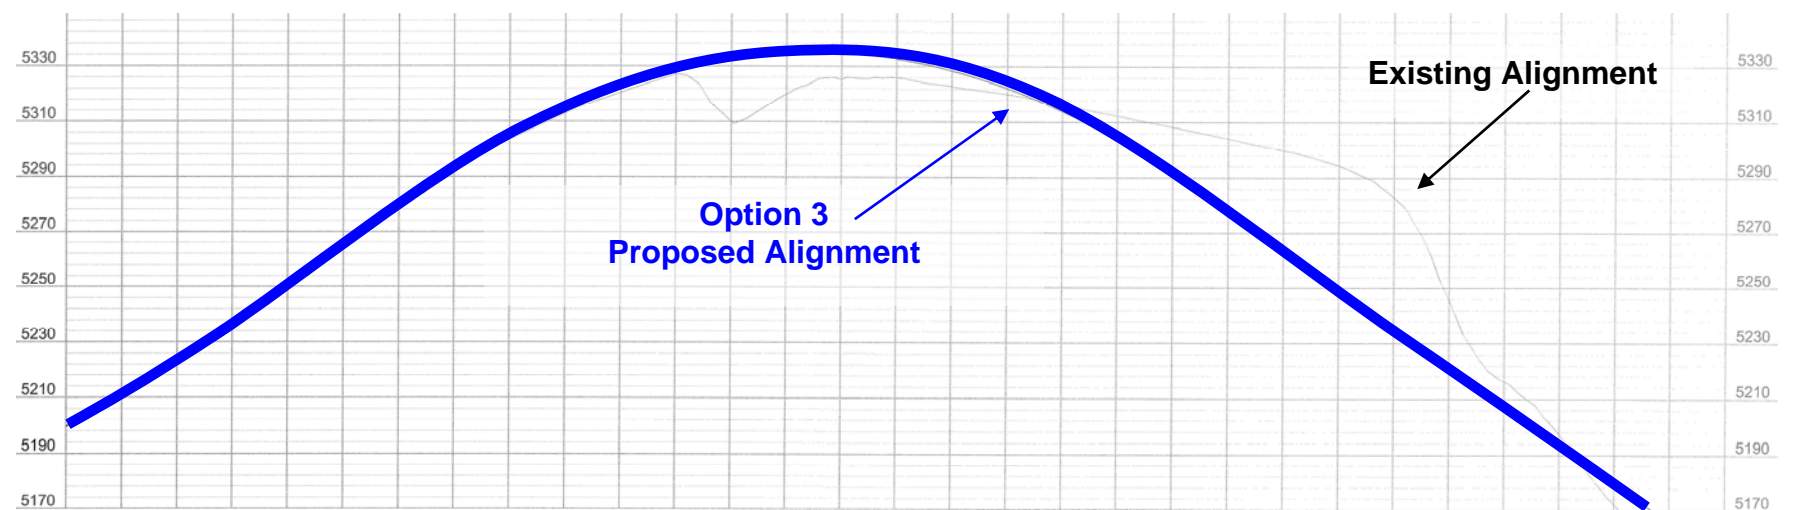
Alignment Option 3 would result in the construction of a new alignment between MP 18.5± and 19.5± which would meet MDT design standards for vertical grades.

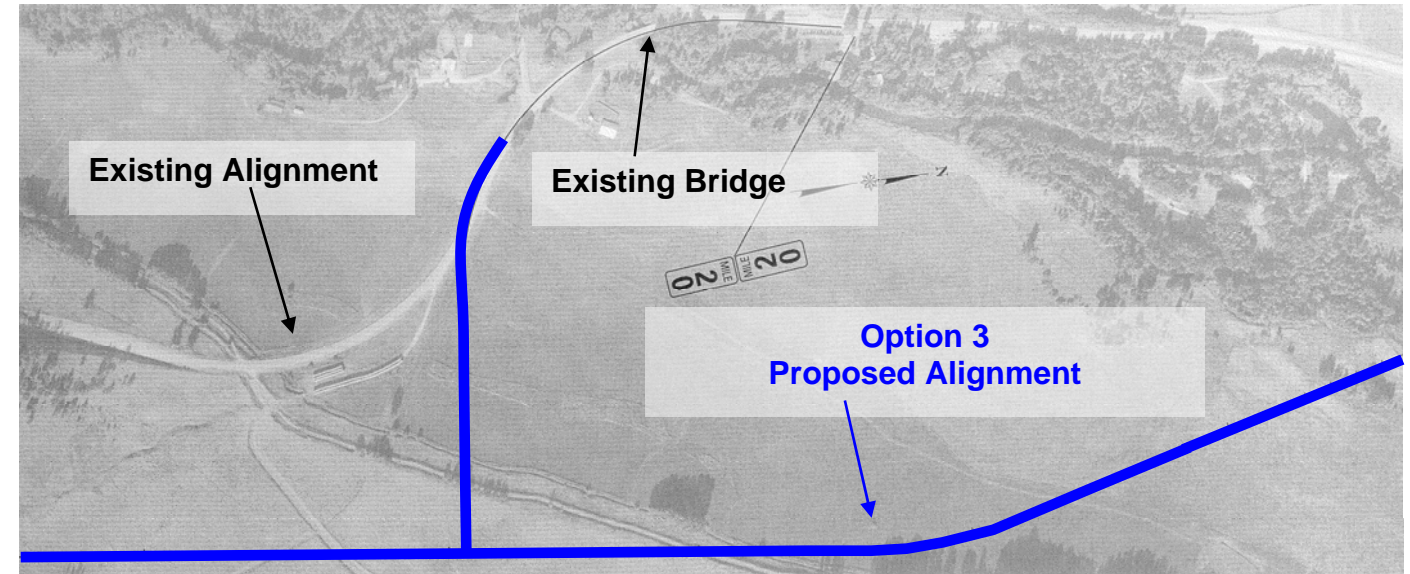
Between MP 19.5± and 20.5±, the new horizontal alignment would continue east of the current alignment and the town of Roscoe. An access to Roscoe would be built at the bottom of Roscoe Hill (MP 20±). The existing bridge on MT 78 would be used for this access road.

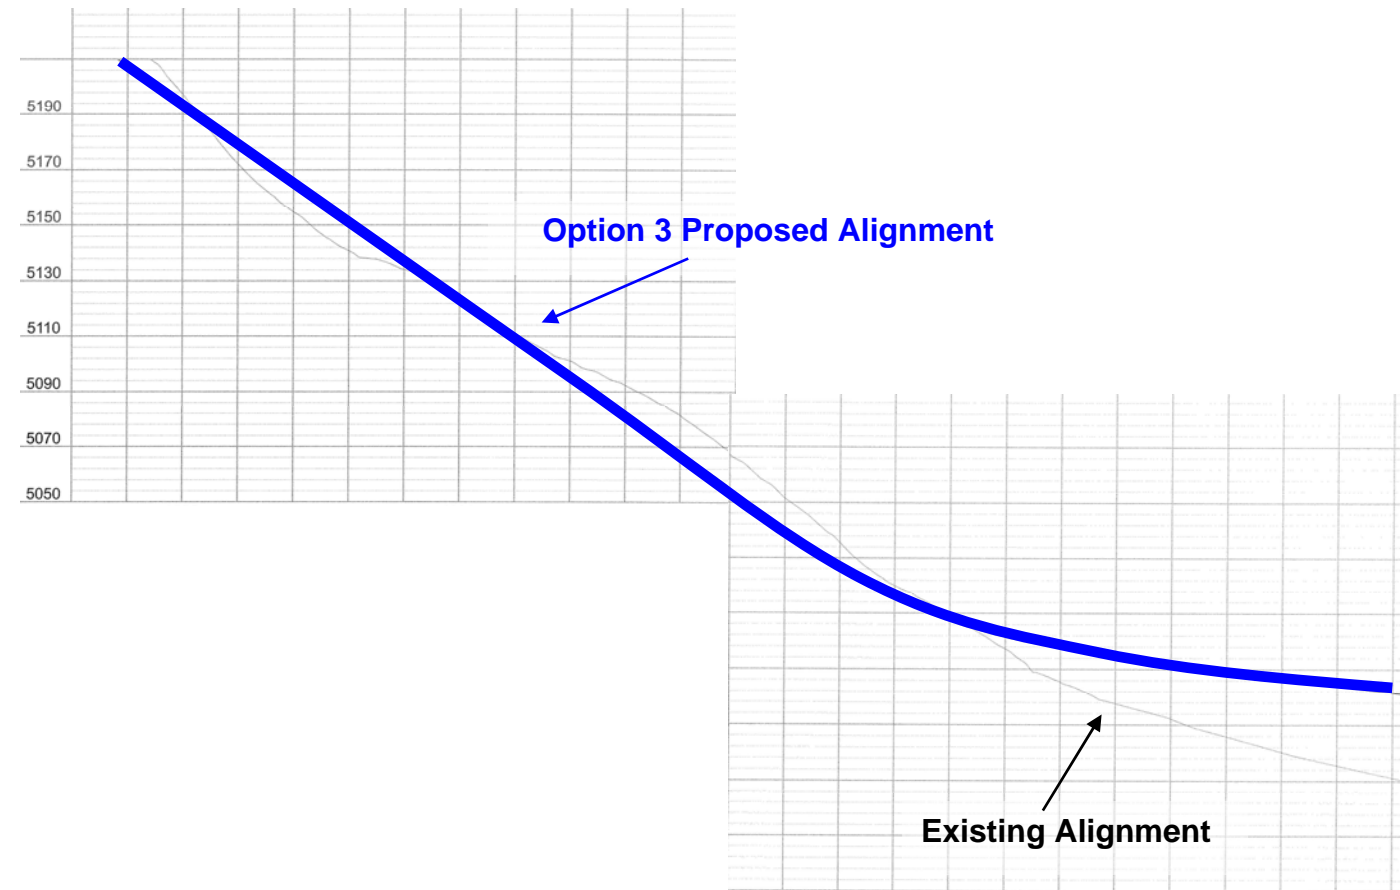
Alignment Option 3 would result in the construction of a new alignment between MP 19.5± and 20.5± which would meet MDT design standards for vertical grades.

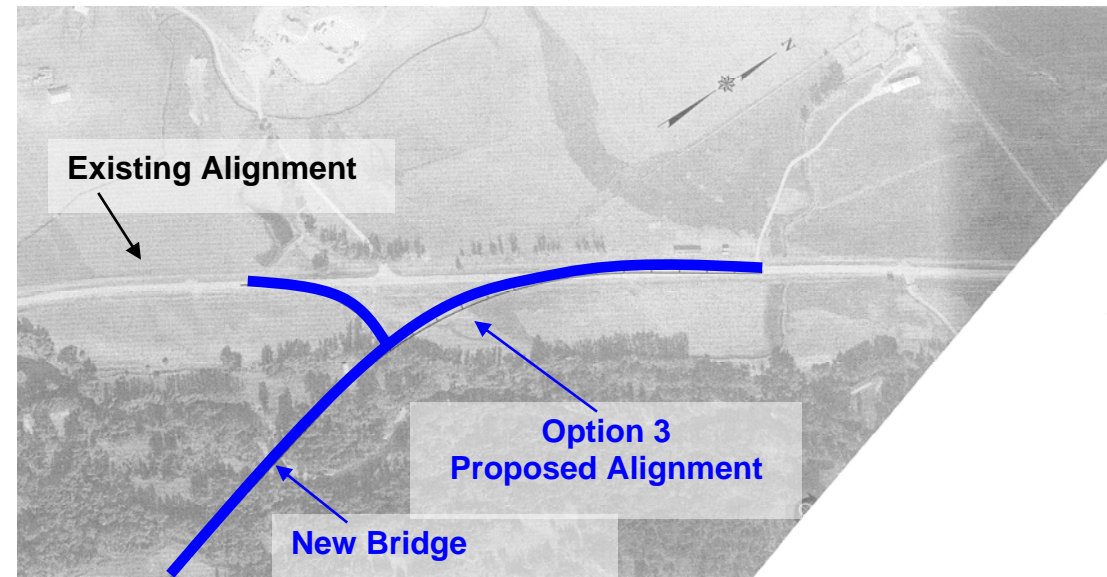
The new alignment for Option 3 would rejoin the existing alignment north of Roscoe. An access to Roscoe would be built north of Roscoe (MP 20.5±). A new bridge would be built over East Rosebud Creek.

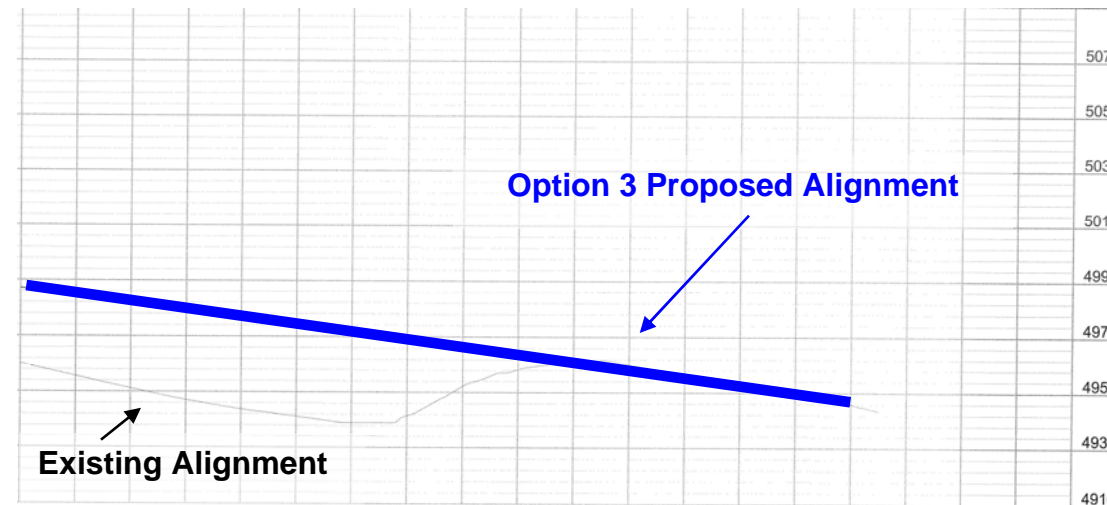
Alignment Option 3 would result in the construction of a new alignment which would meet MDT design standards for vertical grades.
