The Tire-Noise Performance of Montana Highway Pavements: On-Board Sound Intensity (OBSI) Measurements

The Montana Department of Transportation,
Helena, MT

ILLINGWORTH & RODKIN, INC.
/// Acoustics • Air Quality ///

July 30, 2010

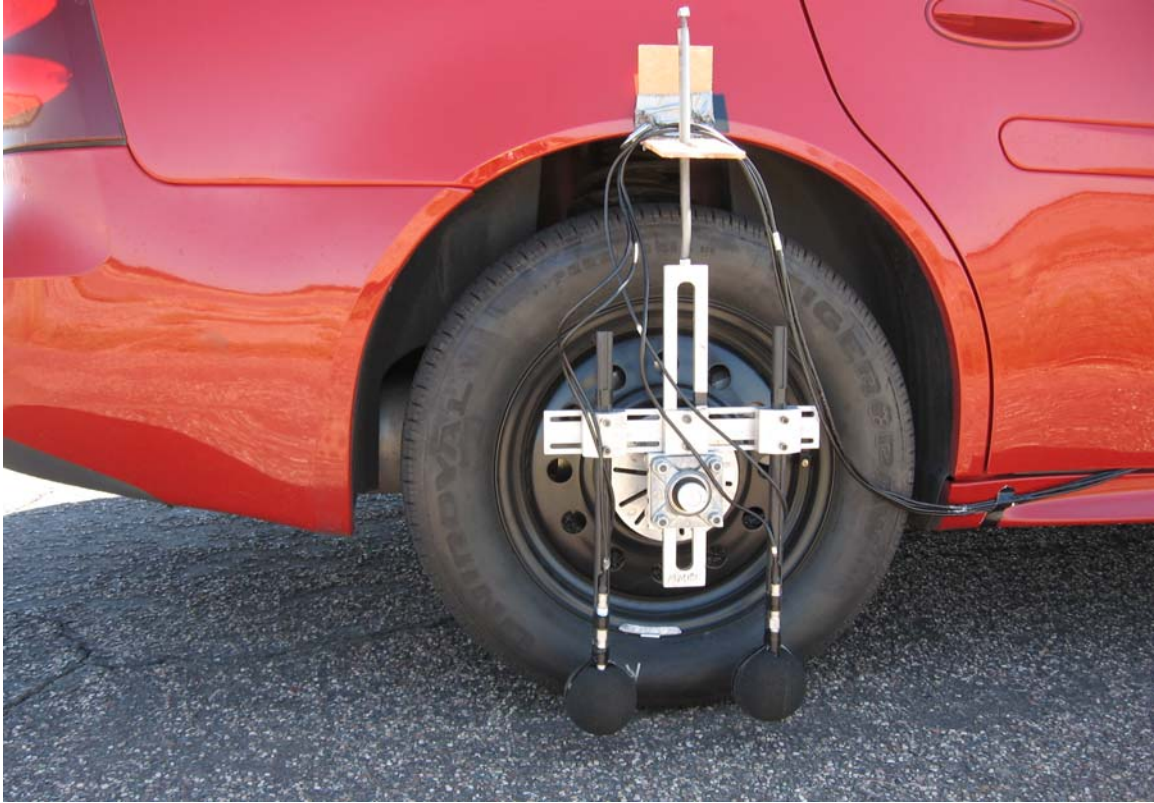
Figure 1. OBSI Equipment Installed on a Test Vehicle

On-vehicle OBSI testing is conducted following the provisional American Association of State Highway and Transportation Officials (AASHTO) Standard Method of Test TP 76-10. To accomplish this, a dual-probe sound intensity fixture with attached microphones is used. This fixture assembly is connected to and supported by the test vehicle in free space, allowing for measurement positions close to the leading and trailing edges of the tire contact patch. The dual-probe sound intensity fixture allows the leading and trailing edge positions to be measured simultaneously. Each probe consists of two ½" G.R.A.S phased-matched condenser microphones, installed on ½" G.R.A.S 26AK microphone preamplifiers, attached to a plastic probe holder at a spacing of 0.63 inches (16 mm) in a side-by-side configuration, and fitted with spherical windscreens. The probe is positioned 3 inches (75 mm) from the pavement surface and 4 inches (100 mm) from the face of the tire, at locations opposite the leading and trailing contact patch of the tire. The orientation is such that the sensitive axis is directed toward the tire. See Figure 1 for a picture of the setup as installed on the vehicle. Data from the leading and trailing edge positions are acquired separately for the same section of pavement and averaged together during post-analysis. Three or more passes are made for each test section, which are averaged together during post-analysis. Multiple sections on a site are selected and measured, assuming the length of the test site allowed for multiple measurements. During post-analysis, all measurements for the same pavement section are averaged together, resulting in an average OBSI level per site. In situations where more than one pavement type is identified along a site, each pavement was measured and documented separately.

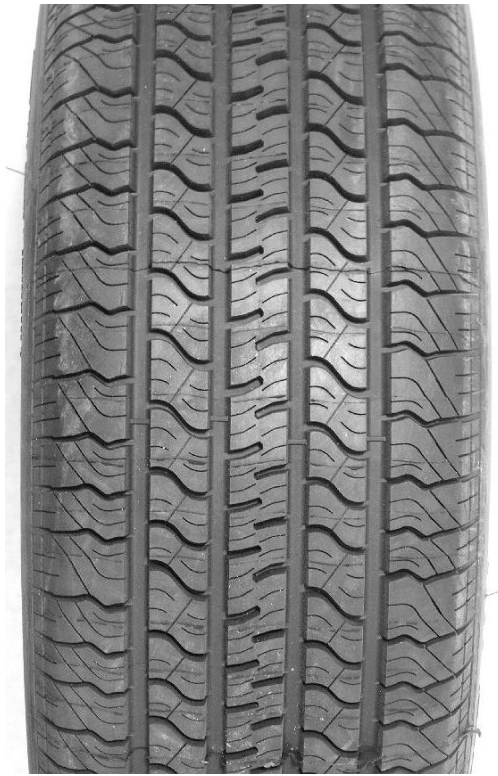
Figure 2. Photograph of Uniroyal SRTT

The measurements were taken at the end of September 2009 using a Chevrolet Impala test vehicle. A Uniroyal Standard Reference Test Tire (SRTT) was used for all measurements under free flow traffic conditions and a load of two people plus OBSI instrumentation. Prior to the sound intensity measurements, the test tire hardness was measured by means of the Durometer Hardness Test¹. The hardness was averaged across the tire at the Tiger Paw “T” and the Uniroyal “U” and was recorded to be 67 and 65, respectively. Figure 2 shows the SRTT tire. For all roadways with multiple lanes of traffic, testing took place in the right through travel lane, and where possible, in the left through lane as well. A constant vehicle speed of 60 mph (97 km/h) was used with a ‘cold’ tire inflation pressure of 30 psi.

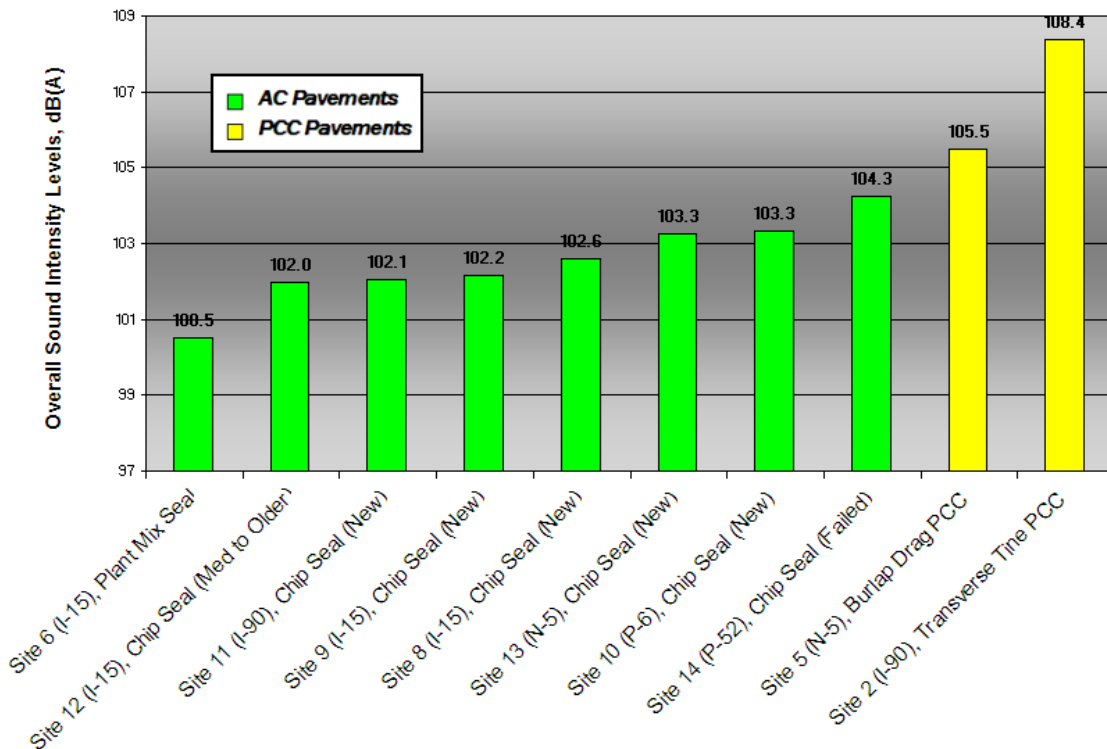
Figure 4. A-Weighted Tire/Pavement Sound Intensity Levels

Table 2 shows a summary of the test sites and the resultant overall A-weighted sound intensity levels for each site. Averages, by pavement type, are also summarized in Table 2. A comparison of the overall A-weighted sound intensity levels for each test site is shown in Figure 4.

As indicated in Table 2 and Figure 4, the PCC sections were, on average, 6.4 dBA higher than the Plant Mix section and 4.1 dBA higher than the Chip Seal sections. The transverse tine PCC segment along Site 2 (I-90) resulted in the highest overall level of 108.4 dBA. The highest AC pavement was the Failed Chip Seal measured at Site 14 (P-52), which had an overall noise level of 104.3 dBA; however, this level was only 1 dBA greater than the overall noise level measured on the New Chip Seal pavement at Site 10 (P-6).

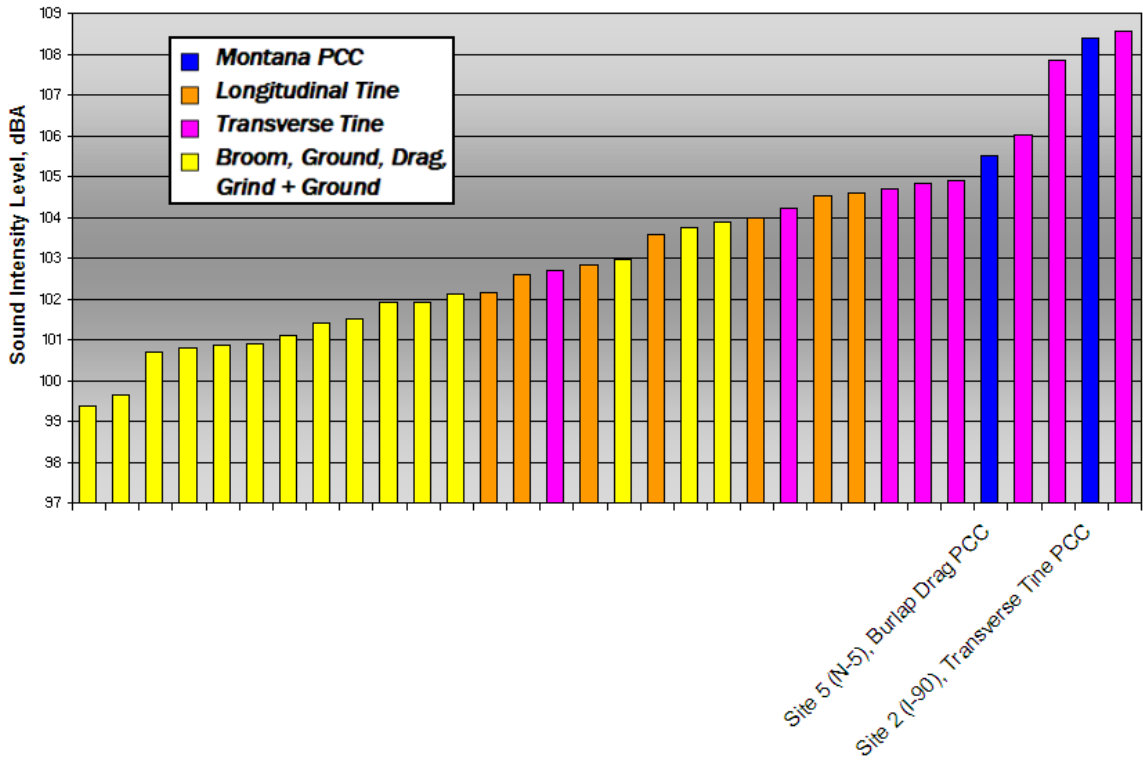
Figure 5. Overall A-Weighted OBSI Levels for PCC Pavements, 60 mph

Figures 5 and 6 show comparisons of the resulting overall A-Weighted sound intensity noise levels of the Montana sites compared with other PCC and AC pavements in California, Arizona, Ohio, Iowa, Kansas, Minnesota, and Alabama. All data shown was measured at 60 mph using the SRTT test tire. The Montana test sites are indicated in blue.

From Figure 5, the broom, ground, and drag PCC pavements from each state shown result in the lower overall noise levels. Longitudinal tine PCC make up the mid-range of the pavements, and transverse tine PCC pavements produce the upper-range shown in Figure 5. The transverse tine PCC pavement from Montana test Site 2 (I-90) produced one of the highest levels and was virtually identical to the transverse tine PCC located along I-70 in Ohio. As shown above, Site 2 (I-90) and Site 5 (N-5) have overall levels of 108.4 dBA and 105.5 dBA, respectively. According to the state of Montana Department of Transportation (MDT) specifications, concrete pavement textures are to be random spaced transverse tine followed by a burlap drag finish. The Site 5 (N-5) segment, which was laid in 2000, would be consistent with this specification; however, the older Site 2 (I-90), which was laid in 1976, was laid prior to the specification update and follows the guidelines for the original specification of regular transverse tine PCC. However, given the state-wide usage of studded snow tires in Montana, the original texturing has likely little bearing on the current pavement texture. Experience in Washington State, which also allows the use of studded snow tires, is that applied texture is typically lost within 2 to 4 years². This is further evidenced by the photograph in Figure A-1d of the Appendix that displays no evidence of the original transverse tining. Although not photographically documented, it is suspected that the Site 5 (N-5) surface has also lost its original burlap drag texture based on the WSDOT experience. Burlap drag textured PCC surface are typically more in the range of 100 to 102 dBA, with a highest level of 103.7 dBA measured on an older section of the roadway in California. The levels at Site 5 (N-5) are actually more in the range of those that have been measured on SR 520 in Seattle that

was also a stud-damaged surface devoid of its original texture. This surface produced levels in the range from 106.1 to 106.9 dBA. In considering the performance of the PCC at Site 2 (I-90) and Site 5 (N-5), these probably should not be considered to be representative of the texturing by which they are identified, but rather as unique to them.

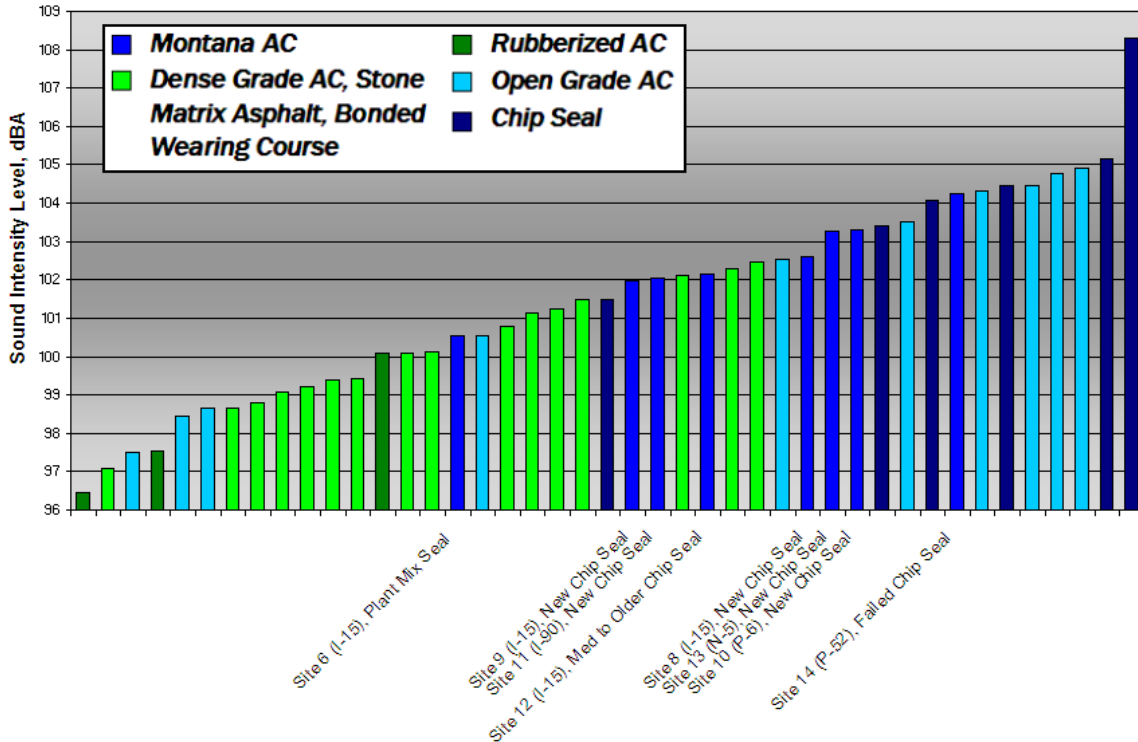
Figure 6. Overall A-Weighted OBSI Levels for AC Pavements, 60 mph

In general, the RAC and DGAC pavements yield overall noise levels in the lower range of all AC pavements shown in Figure 6. The mid- to upper range of overall noise levels consists of Chip Seal pavements. The New Chip Seal and Medium to Older Chip Seal pavement segments in Montana fell into the lower range of Chip Seals shown in Figure 6. The overall noise levels range from 102.0 to 103.3 dBA, which was about the same as the Chip Seal pavement measured at the General Motors Mesa Proving Ground in Arizona. The Failed Chip Seal pavement at Site 14 (P-52) measured an overall noise level of 104.3 dBA. This measurement was louder than the Chip Seal pavement at the Hyundai-Kia Test Track in California, which was 104.1 dBA, and quieter than the Chip Seal pavement along SR 521 in Ohio, which was 104.4 dBA. The Plant Mix Seal falls approximately in the middle of the DGAC pavements and is about 2.0 dBA lower in level than the average of the Chip Seal pavements.

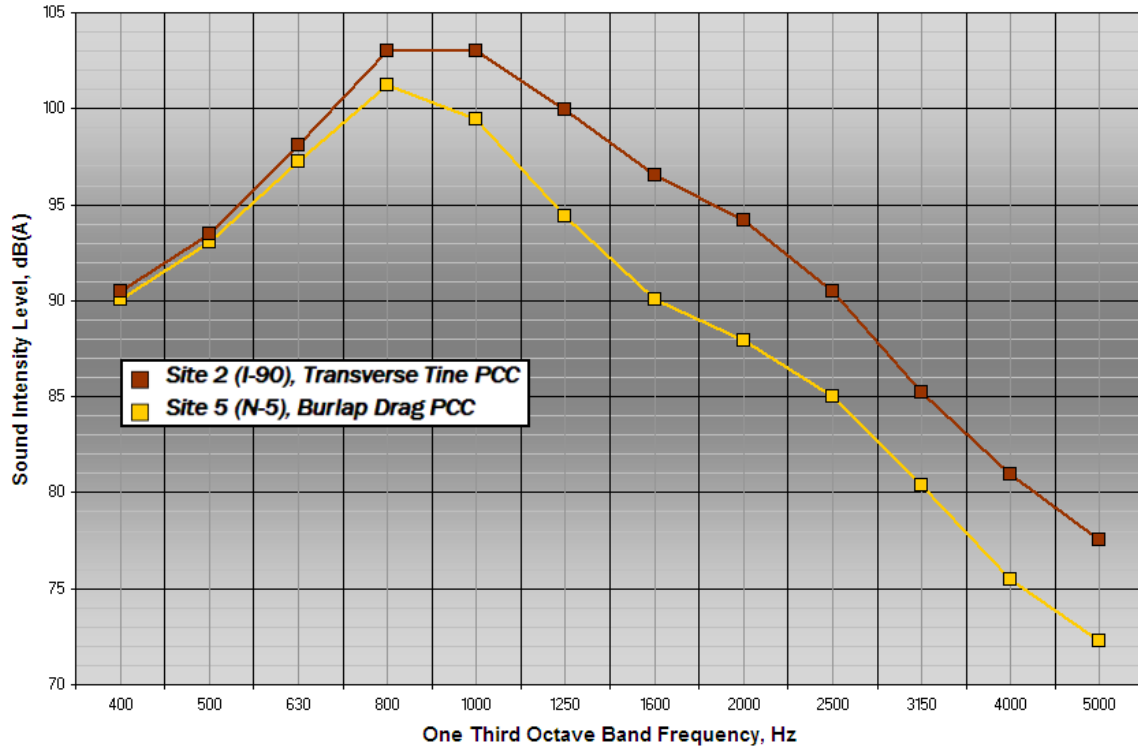
Figure 7. One-Third Octave Band Levels for Concrete Pavements

Figure 7 shows the spectra for both of the PCC pavements measured at sites Site 5 (N-5) and Site 2 (I-90). As shown by the overall levels above, the PCC pavements were, on average, higher than the Chip Seal pavements by approximately 4.1 dBA. The segment for Site 5 (N-5) shows similarities to Site 2 (I-90) in the lower frequency range but has significantly lower levels at frequencies above 800 Hz. In these frequencies, both pavements are about 10 dB higher in level than typical burlap drag or ground surfaces reinforcing the conclusion that stud/chain damage and the resultant increase in surface roughness is a major factor in the performance of these pavements. Above 800 Hz, the levels for Site 2 (I-90) become 3 to 6 dB higher than Site 5 (N-5). The magnitude and range in the levels between these two pavements is similar to that observed for the range of pavements in the OBSI data base and maybe be due to the aging effects for the much older Site 2 (I-90) pavement.

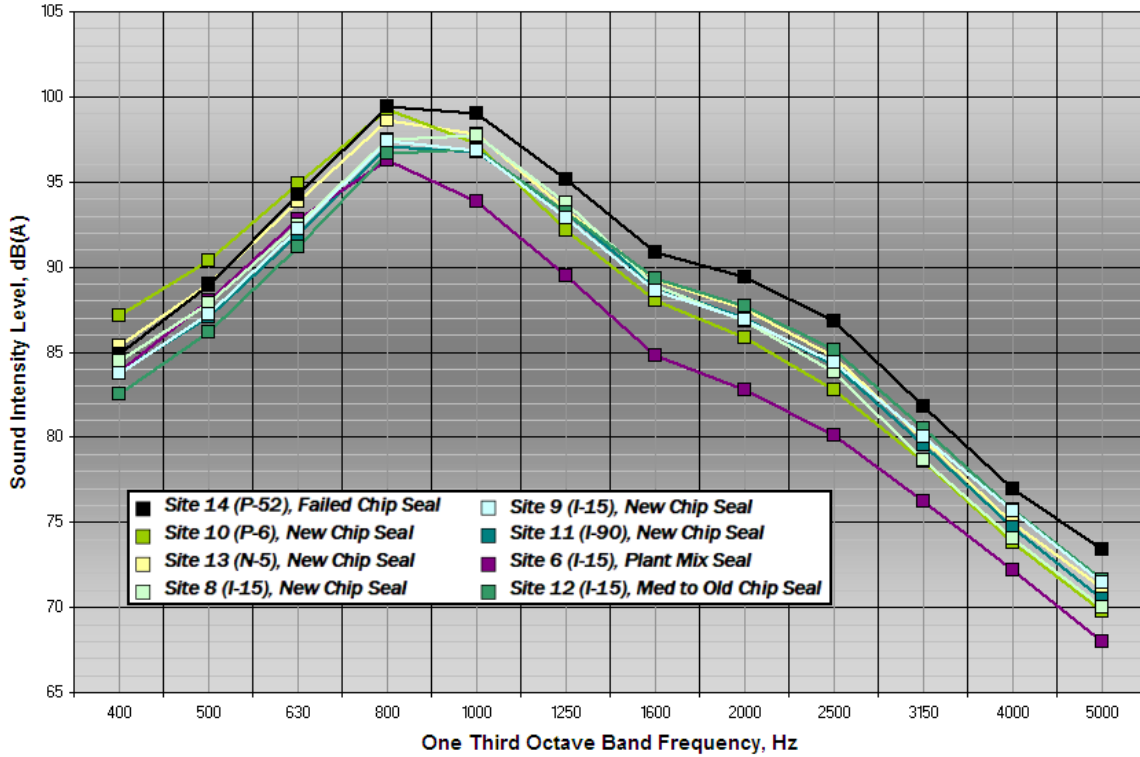
Figure 8. One-Third Octave Band Levels for AC Pavements

The spectra for all the chip seal AC pavements and the plant mix seal pavement are shown in Figure 8. The plant mix seal segment is in the low to mid-range of spectral levels at frequency bands below 800 Hz and is the quietest pavement at frequency bands above 800 Hz, averaging approximately 3.3 dBA quieter than the chip seal pavements. For each test segment with chip seal pavement, raised levels exist in the range from 800 to 1000 Hz. The peak levels are at 800 Hz for the following chip seal segments: Site 9 (I-15), Site 11 (I-90), Site 10 (P-6), and Site 14 (P-52). For the segments along Site 8 (I-15) and Site 12 (I-15), the peak levels are at 1000 Hz. The failed chip seal segment, which is Site 14 (P-52), is in the mid- to high range of spectra for frequency bands below 800 Hz, but above 800 Hz, Site 14 (P-52) shows the highest levels, averaging approximately 2.2 dBA higher than the other chip seal segments. The quietest segment at the lower frequencies is the medium to older chip seal pavement Site 12 (I-15). Site 12 (I-15) averages approximately 1.9 dBA quieter in this frequency range than the new chip seal pavements and is 2.7 dBA quieter than the failed chip seal. At the higher frequencies, however, Site 12 (I-15) is among the segments with the highest spectral levels, being an average 0.7 dBA higher than the new chip seal pavements and 1.6 dBA quieter than Site 14 (P-52). On average, the new chip seal segments fall within the mid-range of spectral levels throughout Figure 8. However, at the lower frequencies, Site 10 (P-6) and Site 13 (N-5) are slightly higher than the other new chip seal pavements, with a standard deviation of 1.2 dBA; at frequencies above 1000 Hz, all the new chip seal segments remain within 0.6 dBA of each other.

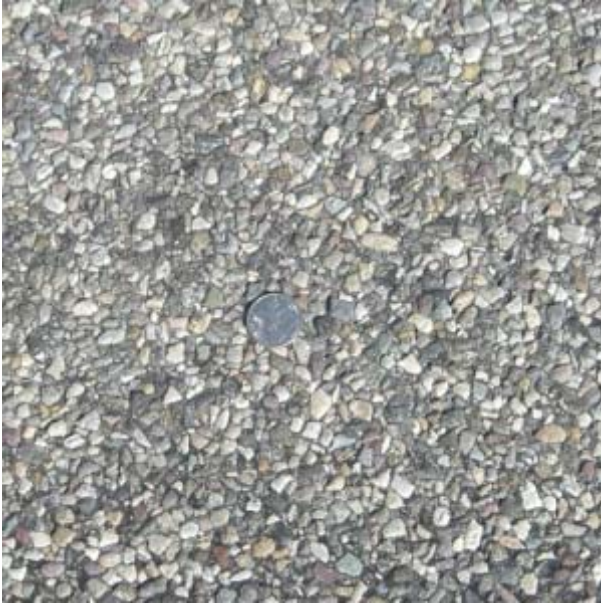
(a) Site 12 (I-15), Medium to Older Chip Seal

Figure A1. Photos of Test Pavements

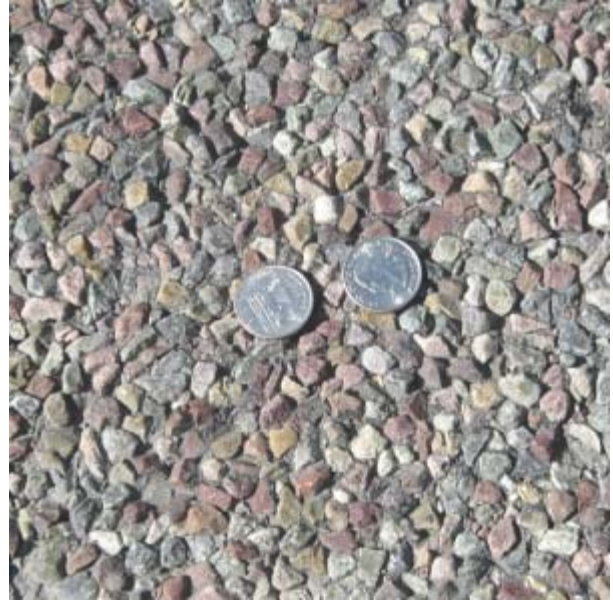
(b) Site 13 (N-5), New Chip Seal

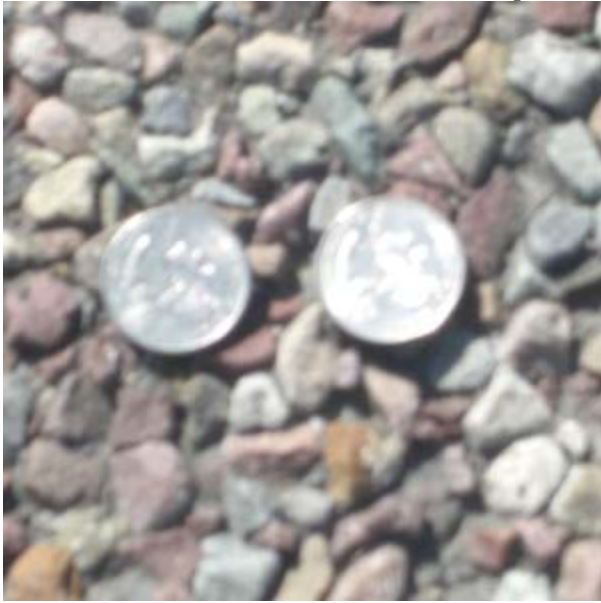
(c) Site 14 (P-52), Failed Chip Seal

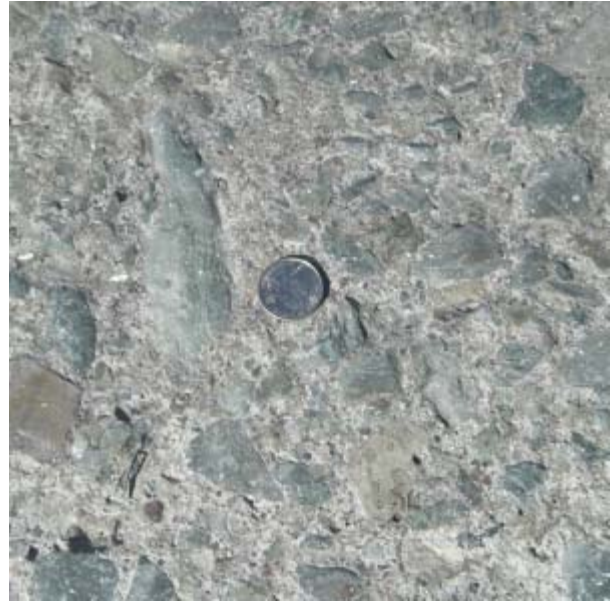
(d) Site 2 (I-90), Transverse Tine PCC

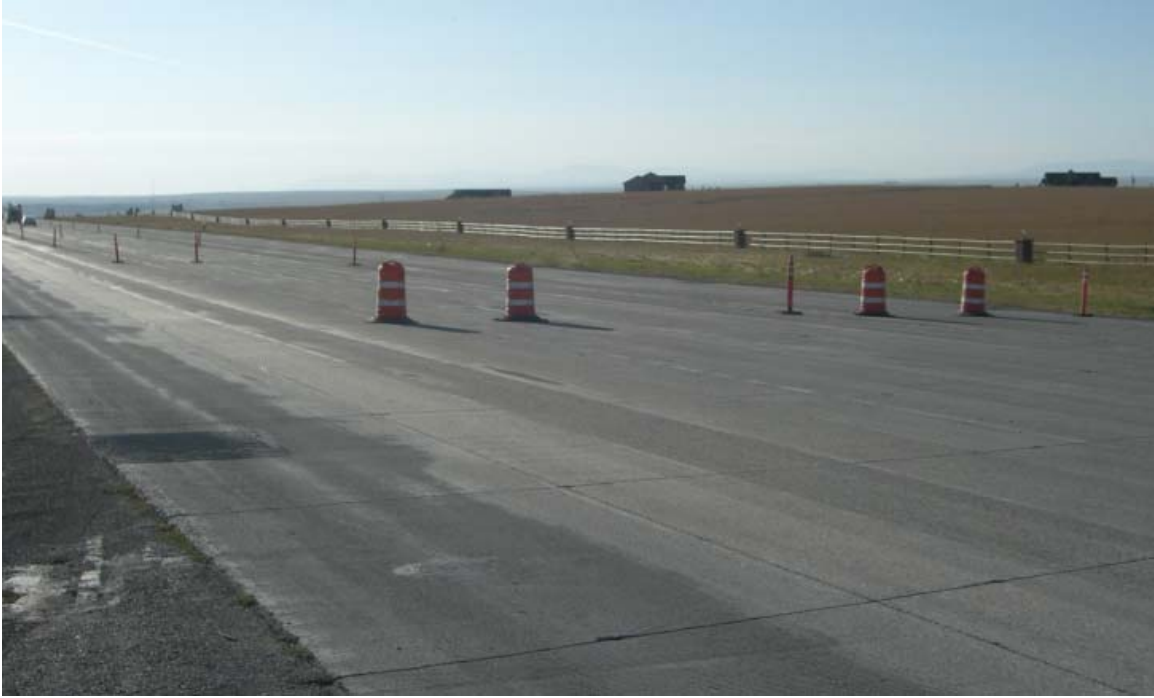
Figure A2. Site 15 (N-60) Test Site Photos

(a) Roadway Construction

(b) Existing Pavement

***due to existing construction, testing did not occur at Site 15 (N-60)**

For some of the selected test sites, the entire section identified in Table 1 was not used, depending upon traffic conditions, roadway topography (i.e., elevation changes, curvatures, etc.), and speed limits. Sites 5, 10, and 14 were all two-lane highways, and measurements were taken in each lane at these sites. The other sites had 4 lanes, and with the exception Site 2, measurements were made in each lane. At Site 2, measurements were taken in the right and left through lanes in westbound direction only; the downward grade in the eastbound direction prevented the vehicle from traveling at a constant 60 mph and could not be tested. As indicated in Table 1, Sites 1, 3, 4, 7, and 15 were not measured. Site 1, which was located along US Highway 12 in Helena, and Site 15, which is located along US Highway 87/89 in Great Falls, consisted of local traffic congestion, speed limitations, and stop lights that prevented OBSI testing. Site 3 was partially located within a construction zone along I-90 with one lane blocked off and a lower speed limit. The part of the segment not in a construction zone contained steep grades and sharp turns with speed limits as low as 35 mph. Additionally, Site 4 on I-90 and Site 15 on US Highway 89/87 were completely within construction zones, which contained lane shifts, blocked lanes, pavement changes, and lowered speed limits. Photographs of the test pavements were taken at selected test sites, as shown in Figure A-1 (note: photos for each test pavement are not shown due to roadside safety concerns). Figure A-2 shows the construction existing at Site 15 at the time of testing.

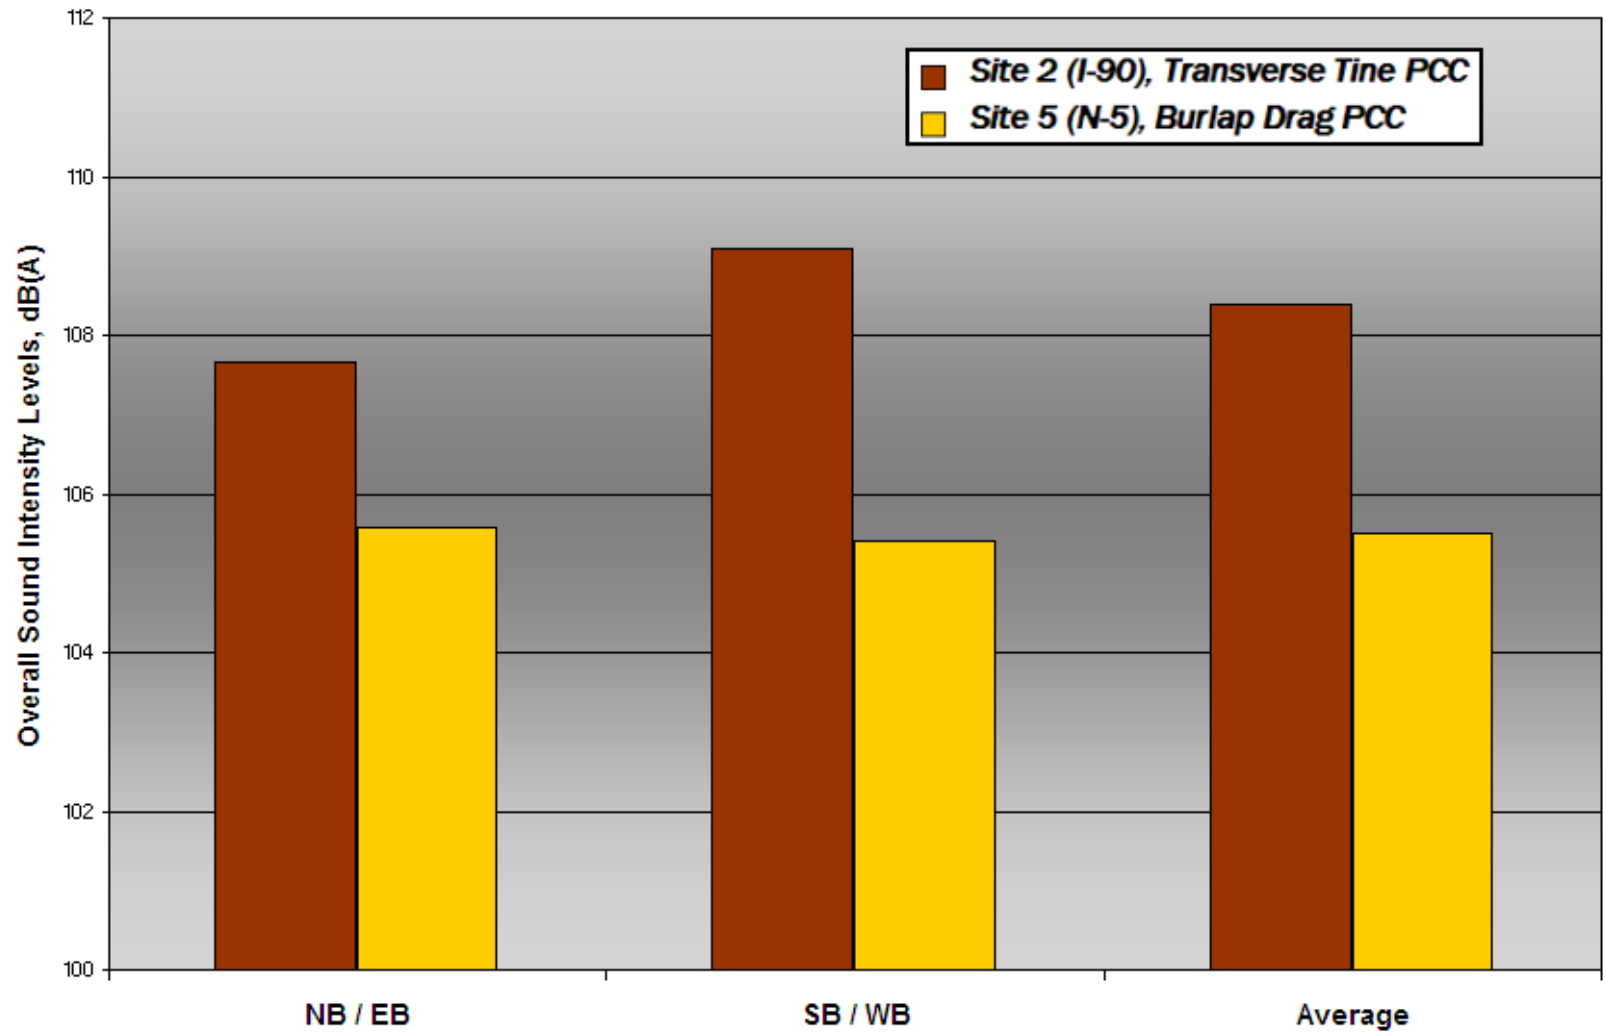
Figure A3. Overall A-Weighted OBSI Levels for PCC Pavements in Each Direction, 60 mph

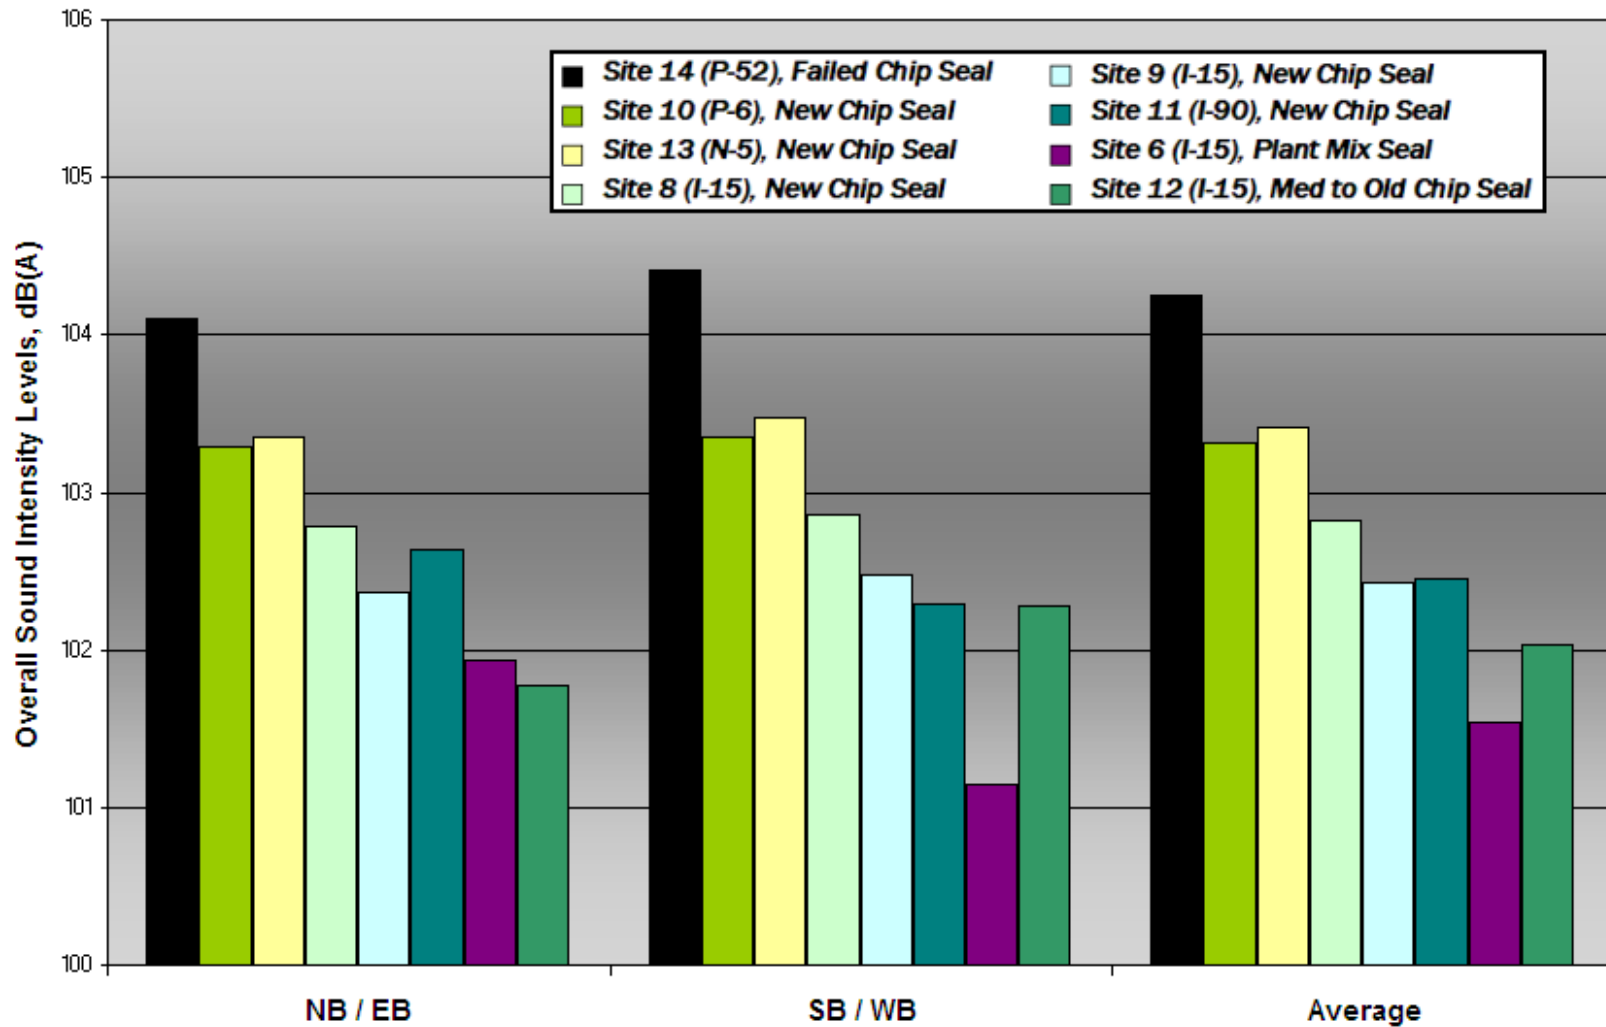
Figure A4. Overall A-Weighted OBSI Levels for AC Pavements in Each Direction, 60 mph

Site Number	Surface Type	OBSI Level, dBA
Site 6 (I-15) – see Figures A4 & A7	AC – Plant Mix Seal	100.5
Site 12 (I-15) – see Figures A4 & A8	AC – Med to Older Chip Seal	102.0
Site 11 (I-90) – see Figures A4 & A8	AC – New Chip Seal	102.1
Site 9 (I-15) – see Figures A4 & A8	AC – New Chip Seal	102.2
Site 8 (I-15) – see Figures A4 & A8	AC – New Chip Seal	102.6
Site 13 (N-5) – see Figures A4 & A8	AC – New Chip Seal	103.3
Site 10 (P-6) – see Figures A4 & A8	AC – New Chip Seal	103.3
Site 14 (P-52) – see Figures A4 & A8	AC – Failed Chip Seal	104.3
Site 5 (N-5) – see Figures A3 & A6	PCC – Burlap Drag	105.5
Site 2 (I-90) – see Figures A3 & A5	PCC – Transverse Tine	108.4
<i>Average AC – New Chip Seal</i>		<i>102.6</i>
<i>Average All Chip Seals</i>		<i>102.8</i>
<i>Average Concrete</i>		<i>106.9</i>

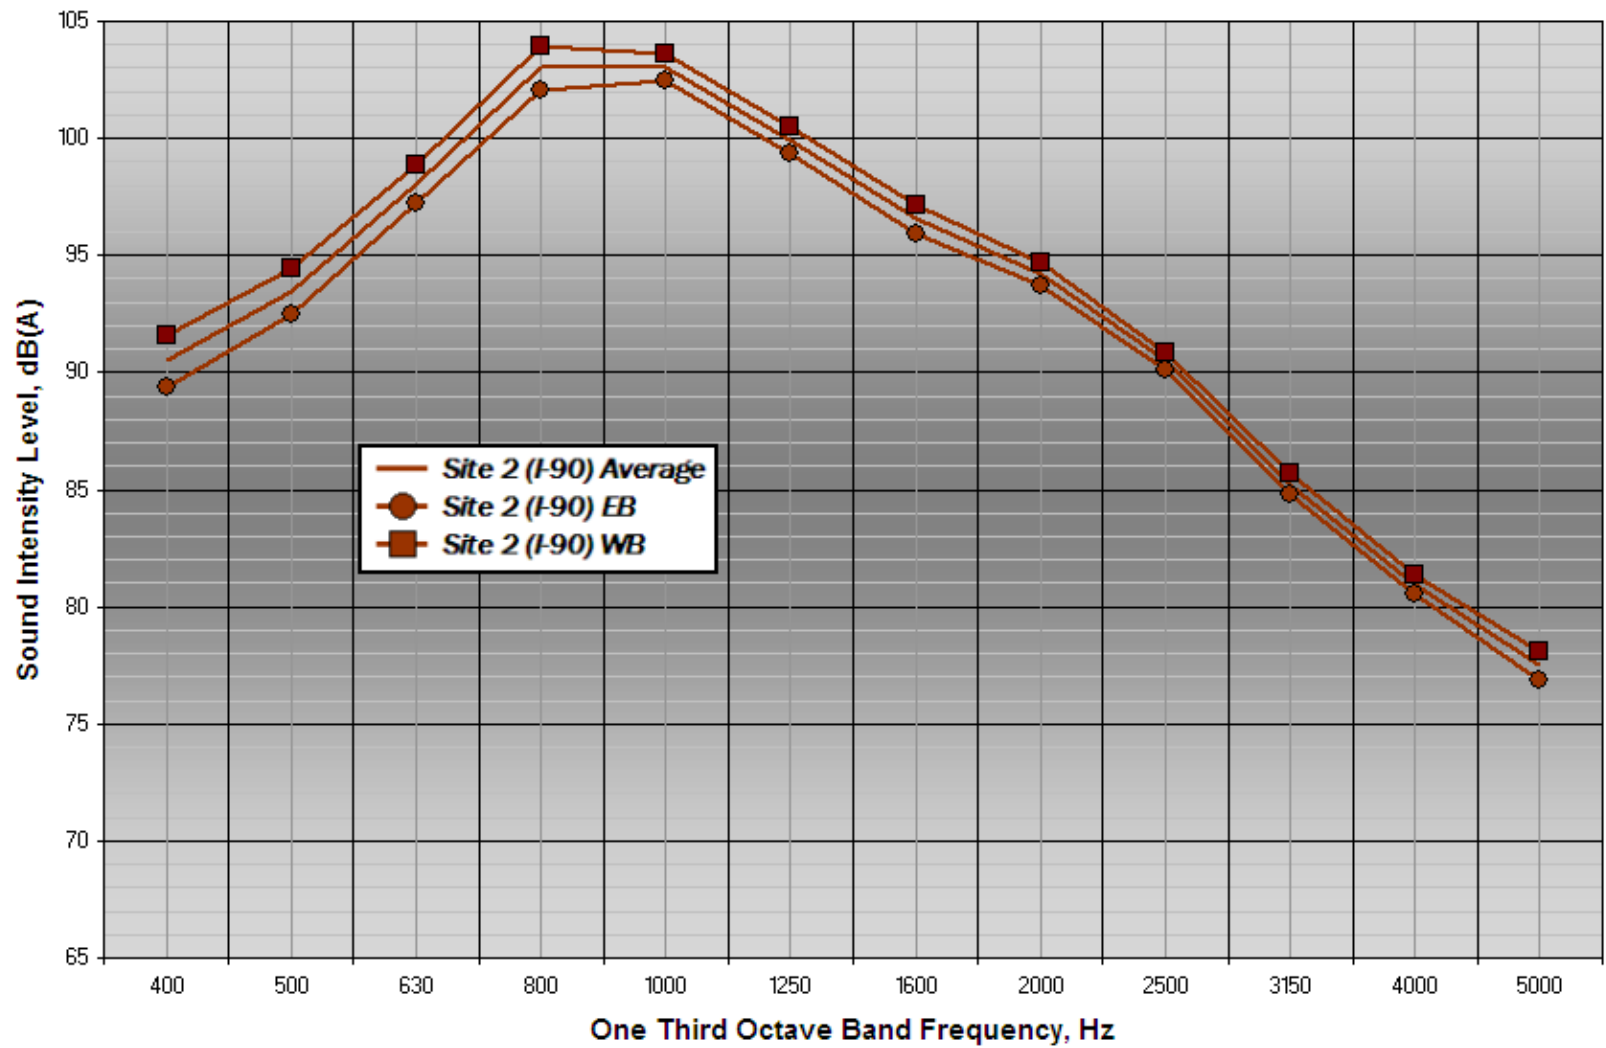
Figure A5. One-Third Octave Band Levels for Site 2 (I-90), Transverse Tine PCC Pavement in EB & WB Directions

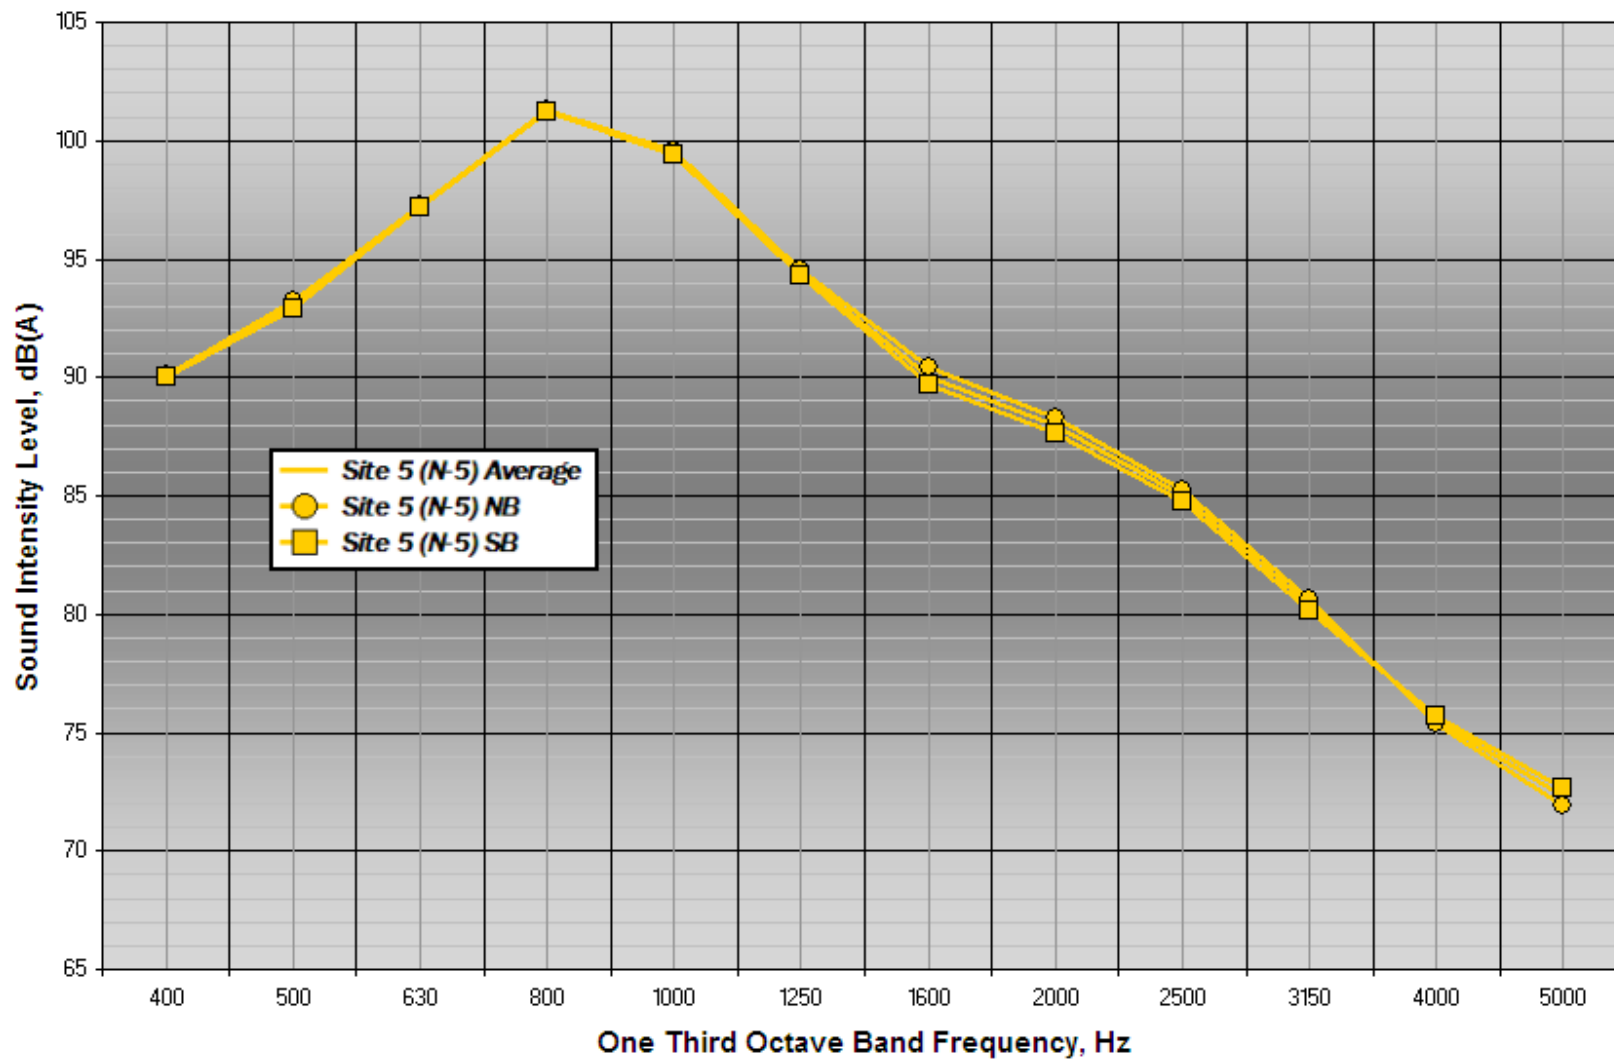
Figure A6. One-Third Octave Band Levels for Site 5 (N-5), Burlap Drage PCC Pavement in NB & SB Directions

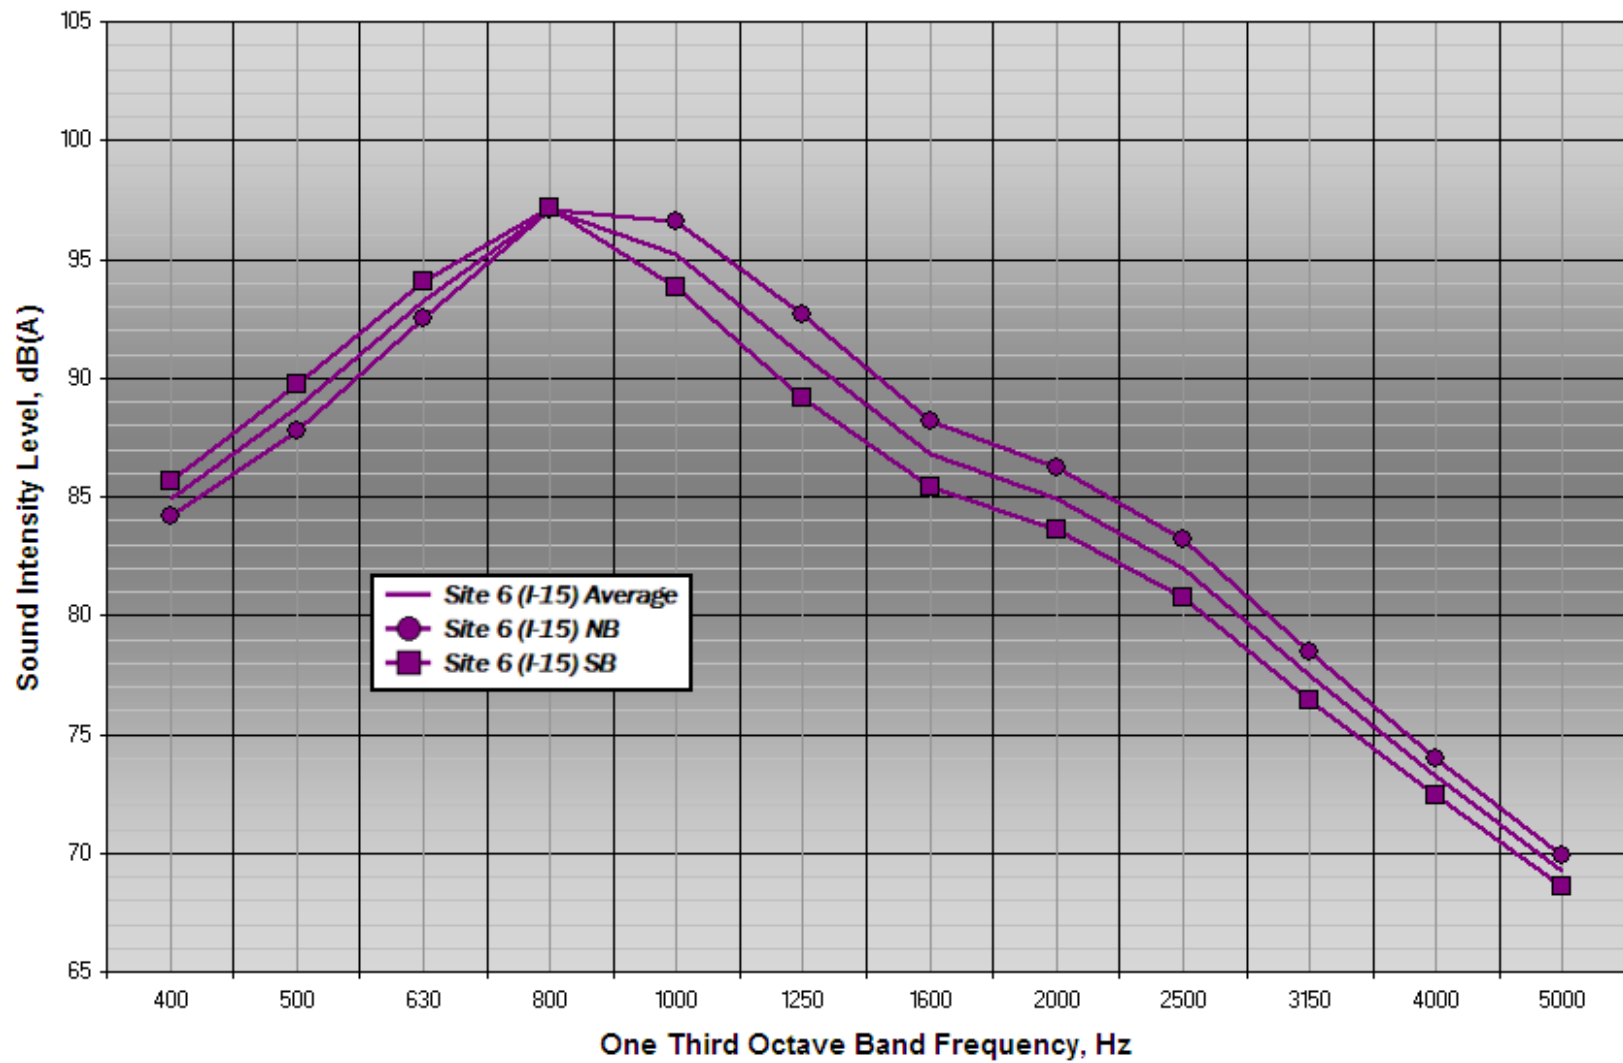
Figure A7. One-Third Octave Band Levels for Site 6 (I-15), Plant Mix Seal AC Pavement in NB & SB Directions

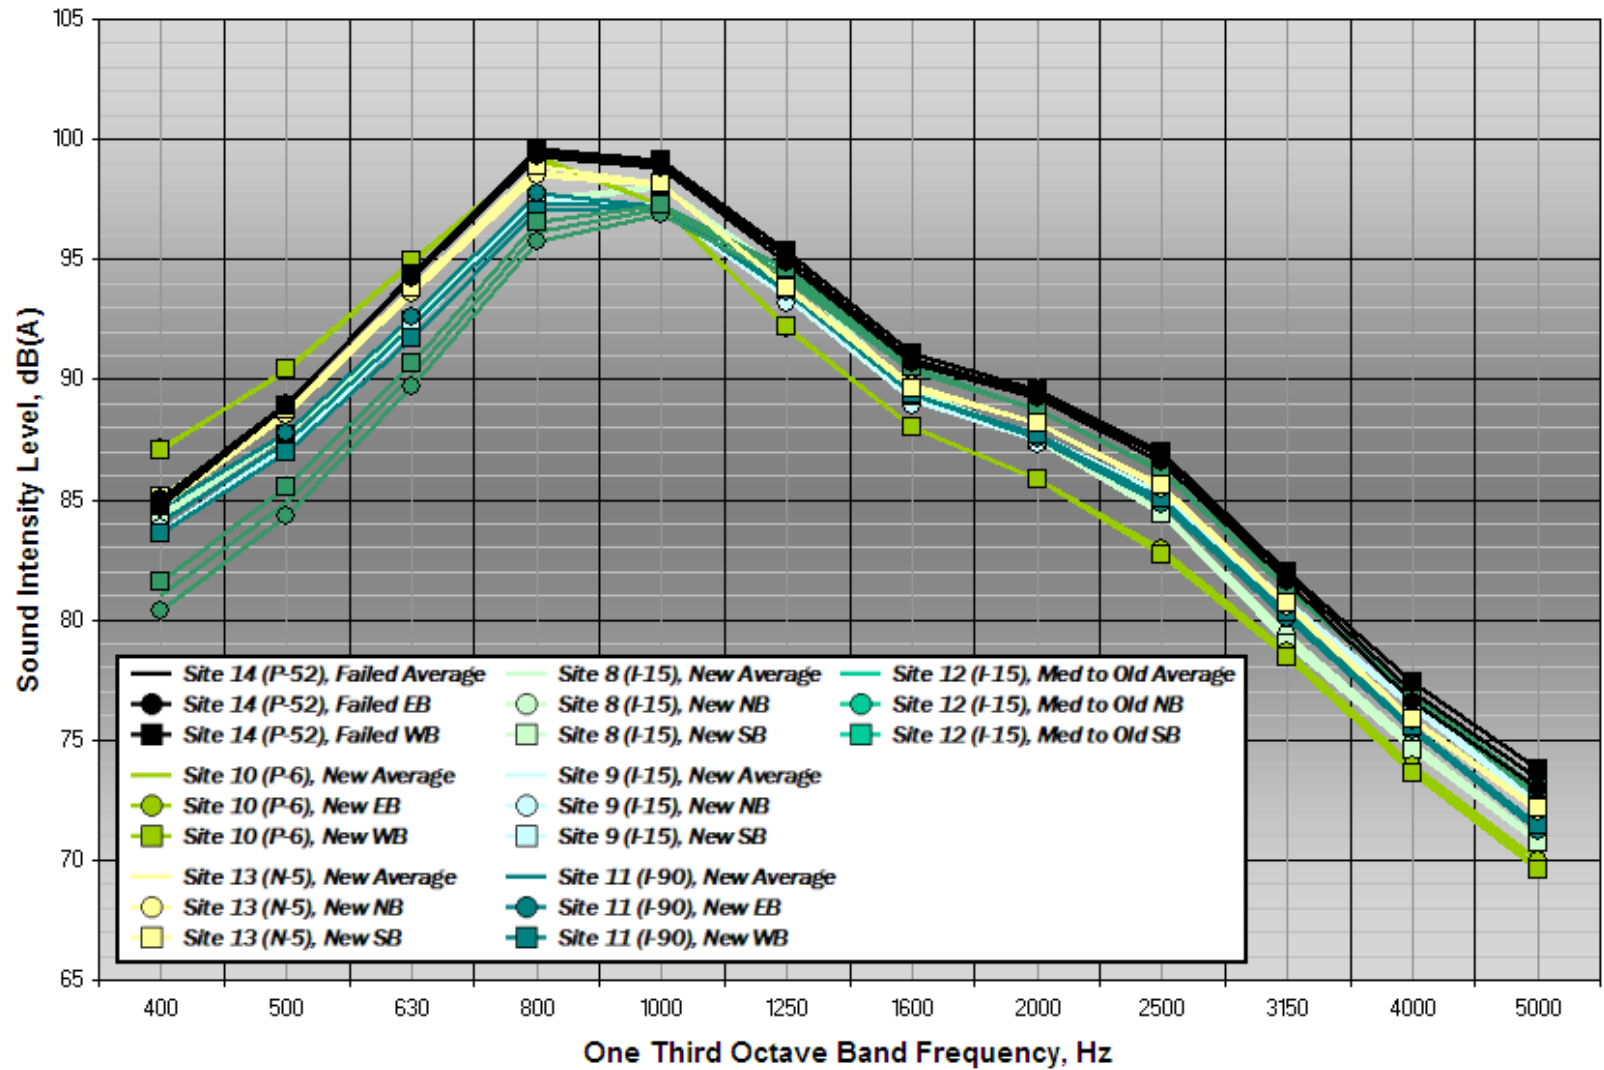
Figure A8. One-Third Octave Band Levels for All Chip Seal AC Pavements in Each Direction
