**Experimental Feature Construction Report
 February 2022**

Experimental Feature:	CAC Slope Treatment
Location:	Glendive District, Dawson County, I-94, Bad Route Interchange, RP 192.6 – 199.2
MDT Project Name:	Bad Route Interchange – NE
MDT Project Number:	IM 94-6(59)193[8150]
Experimental Project Number:	MT-21-04
Principle Investigator:	Chad DeAustin, Experimental Project Manager, (ExPM)
Construction Date:	Spring 2021

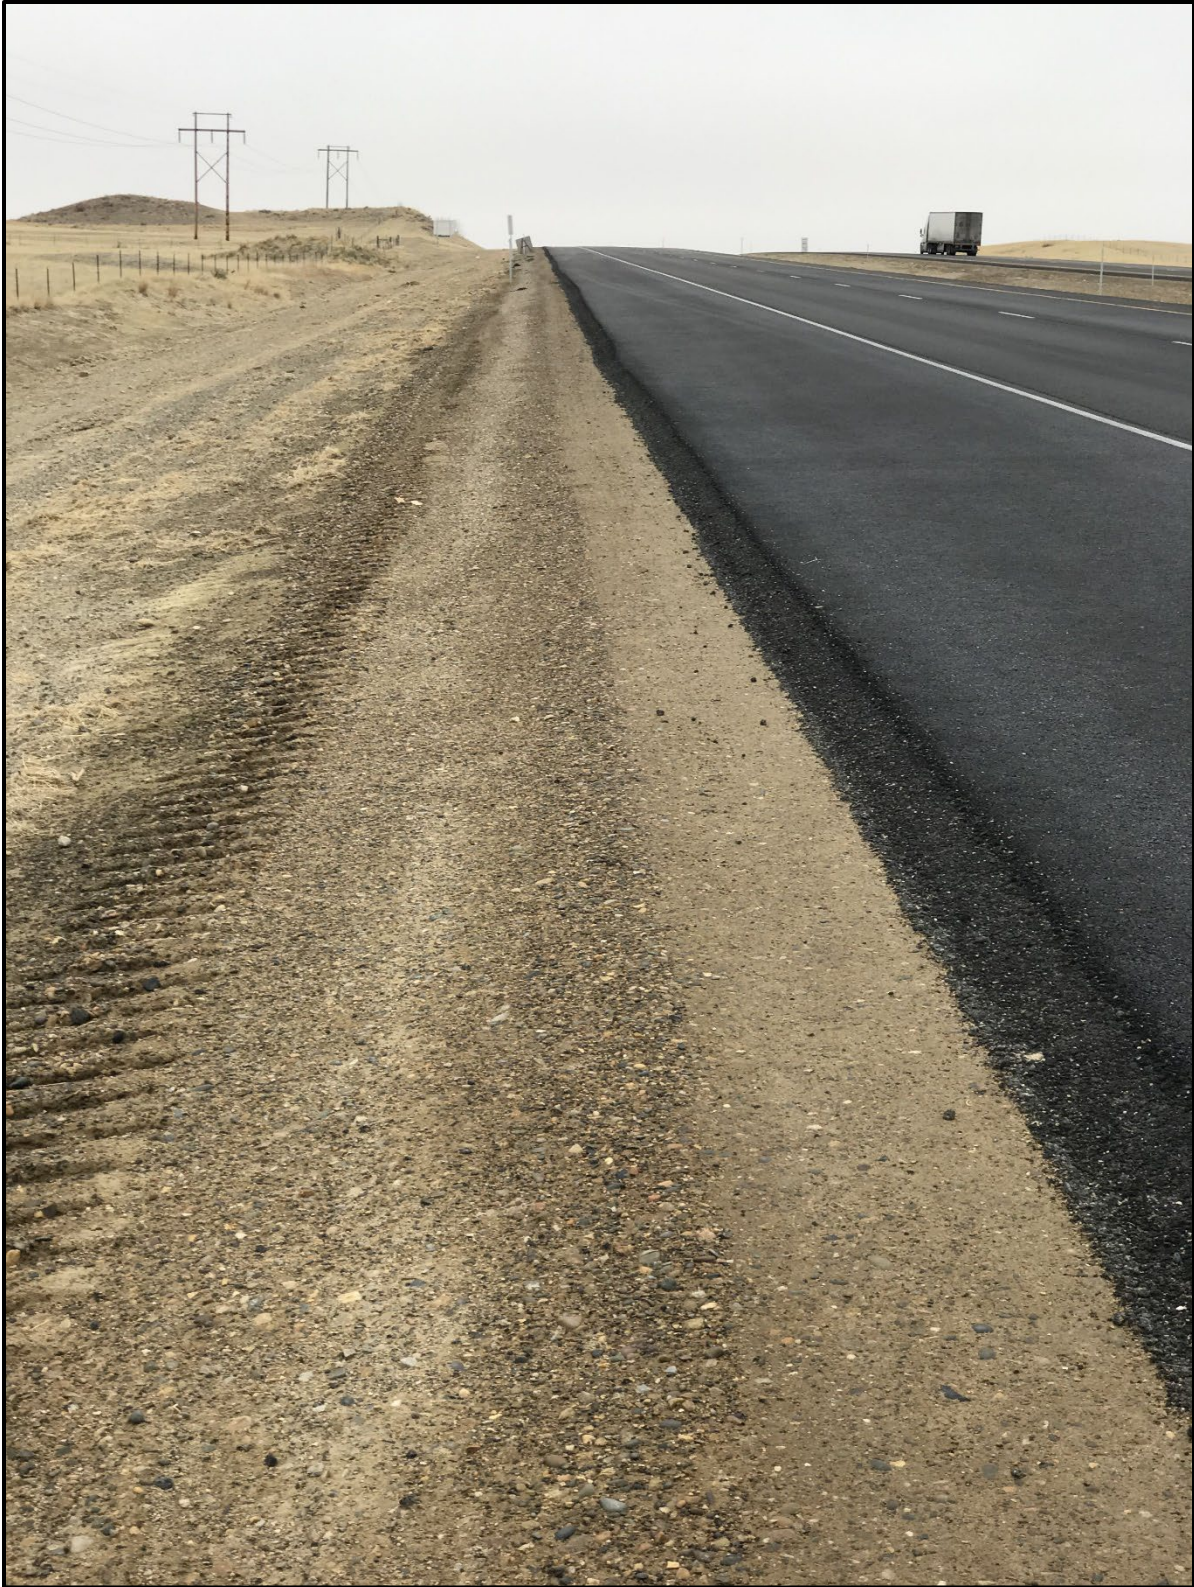
↑ RP 192.60, view east. Westbound shoulder, west end of the project, test section.

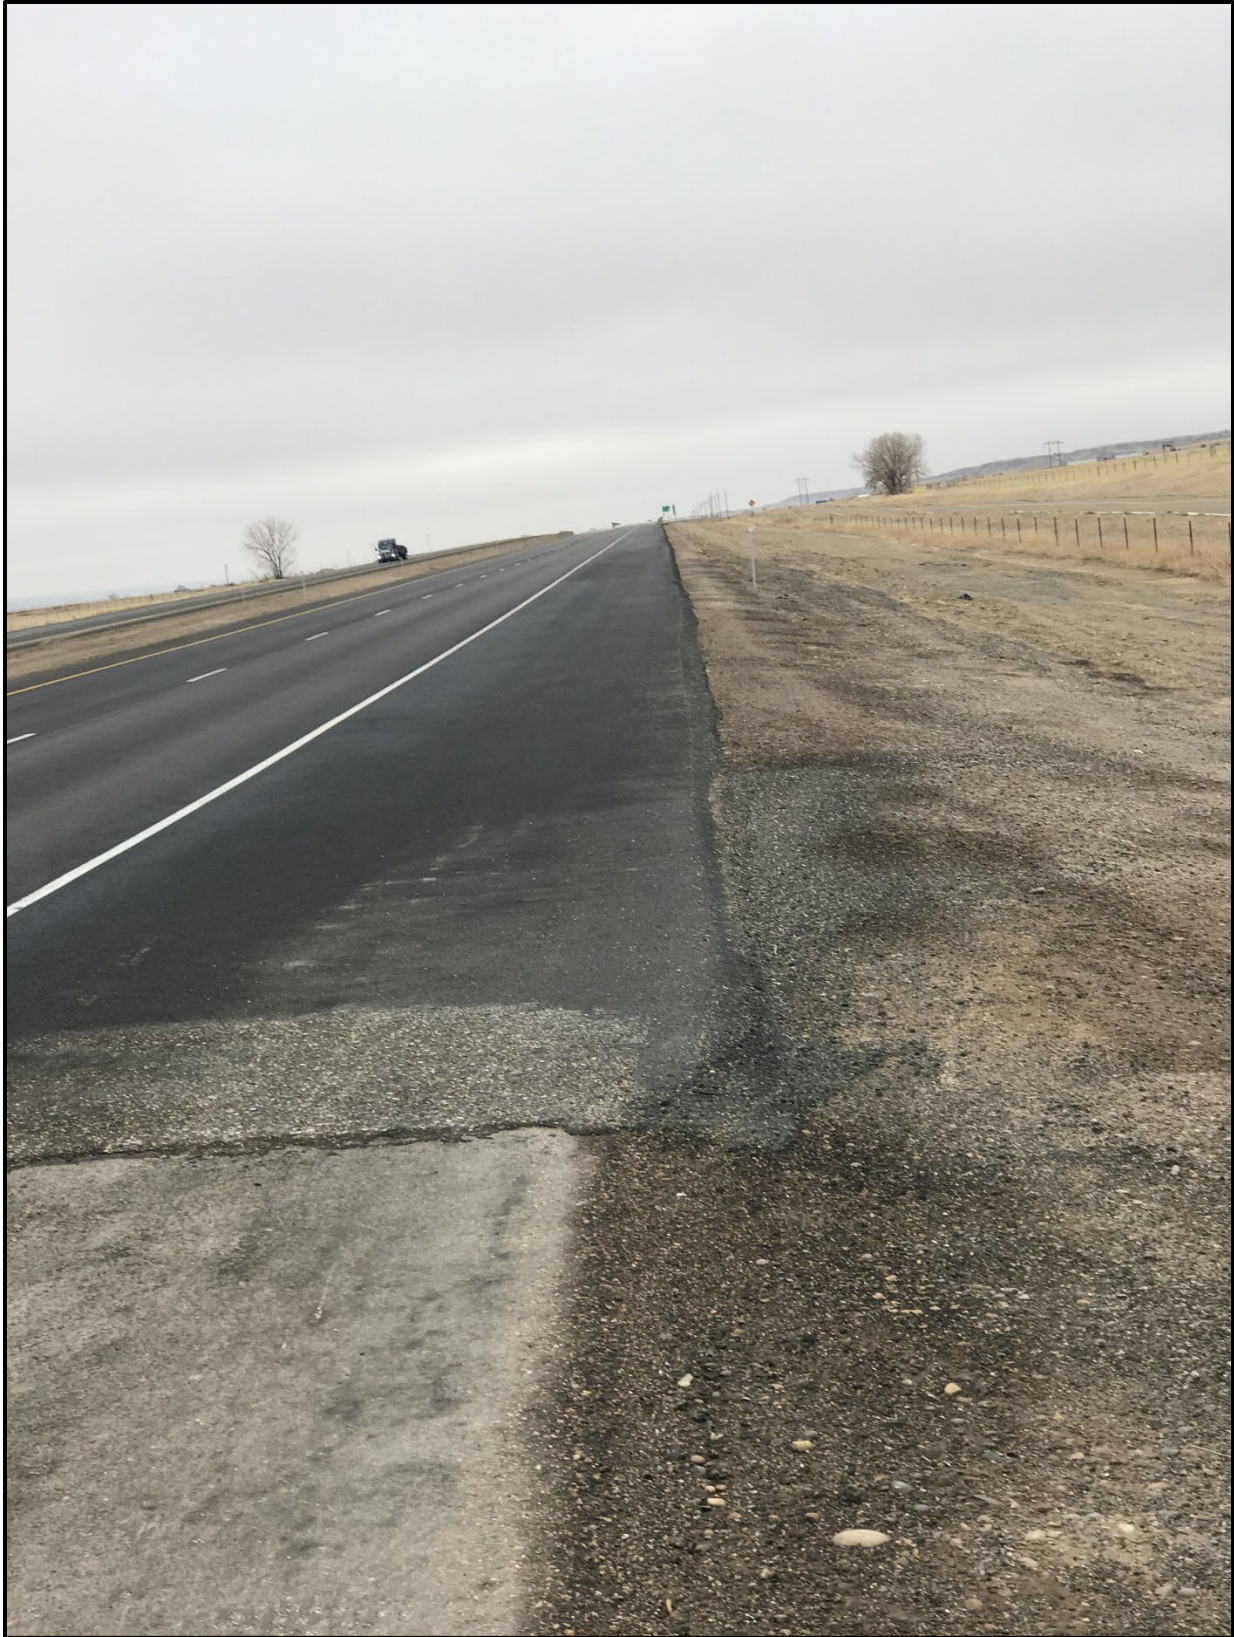
↑ RP 199.20, view west. Westbound shoulder, east end of the project, test section.

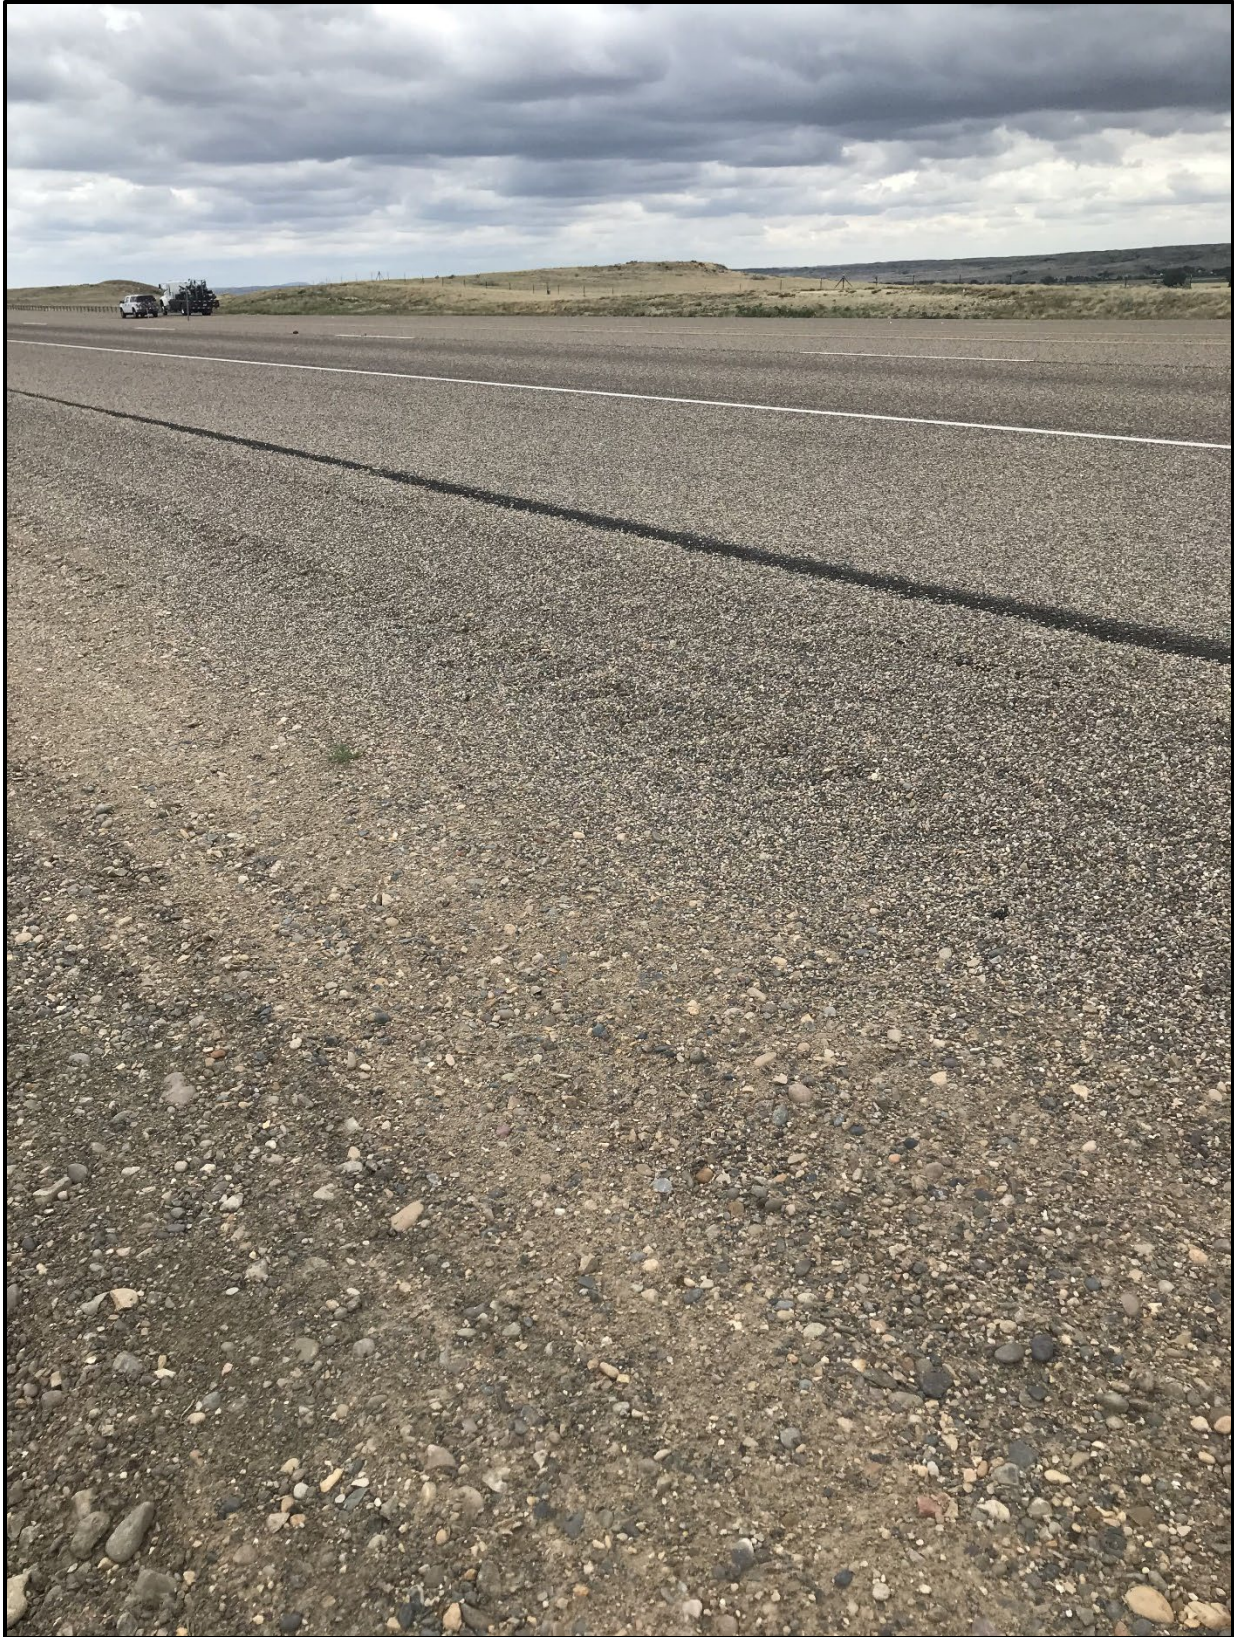
↑ RP 193.50, view east. Westbound shoulder, test section, typical 1.

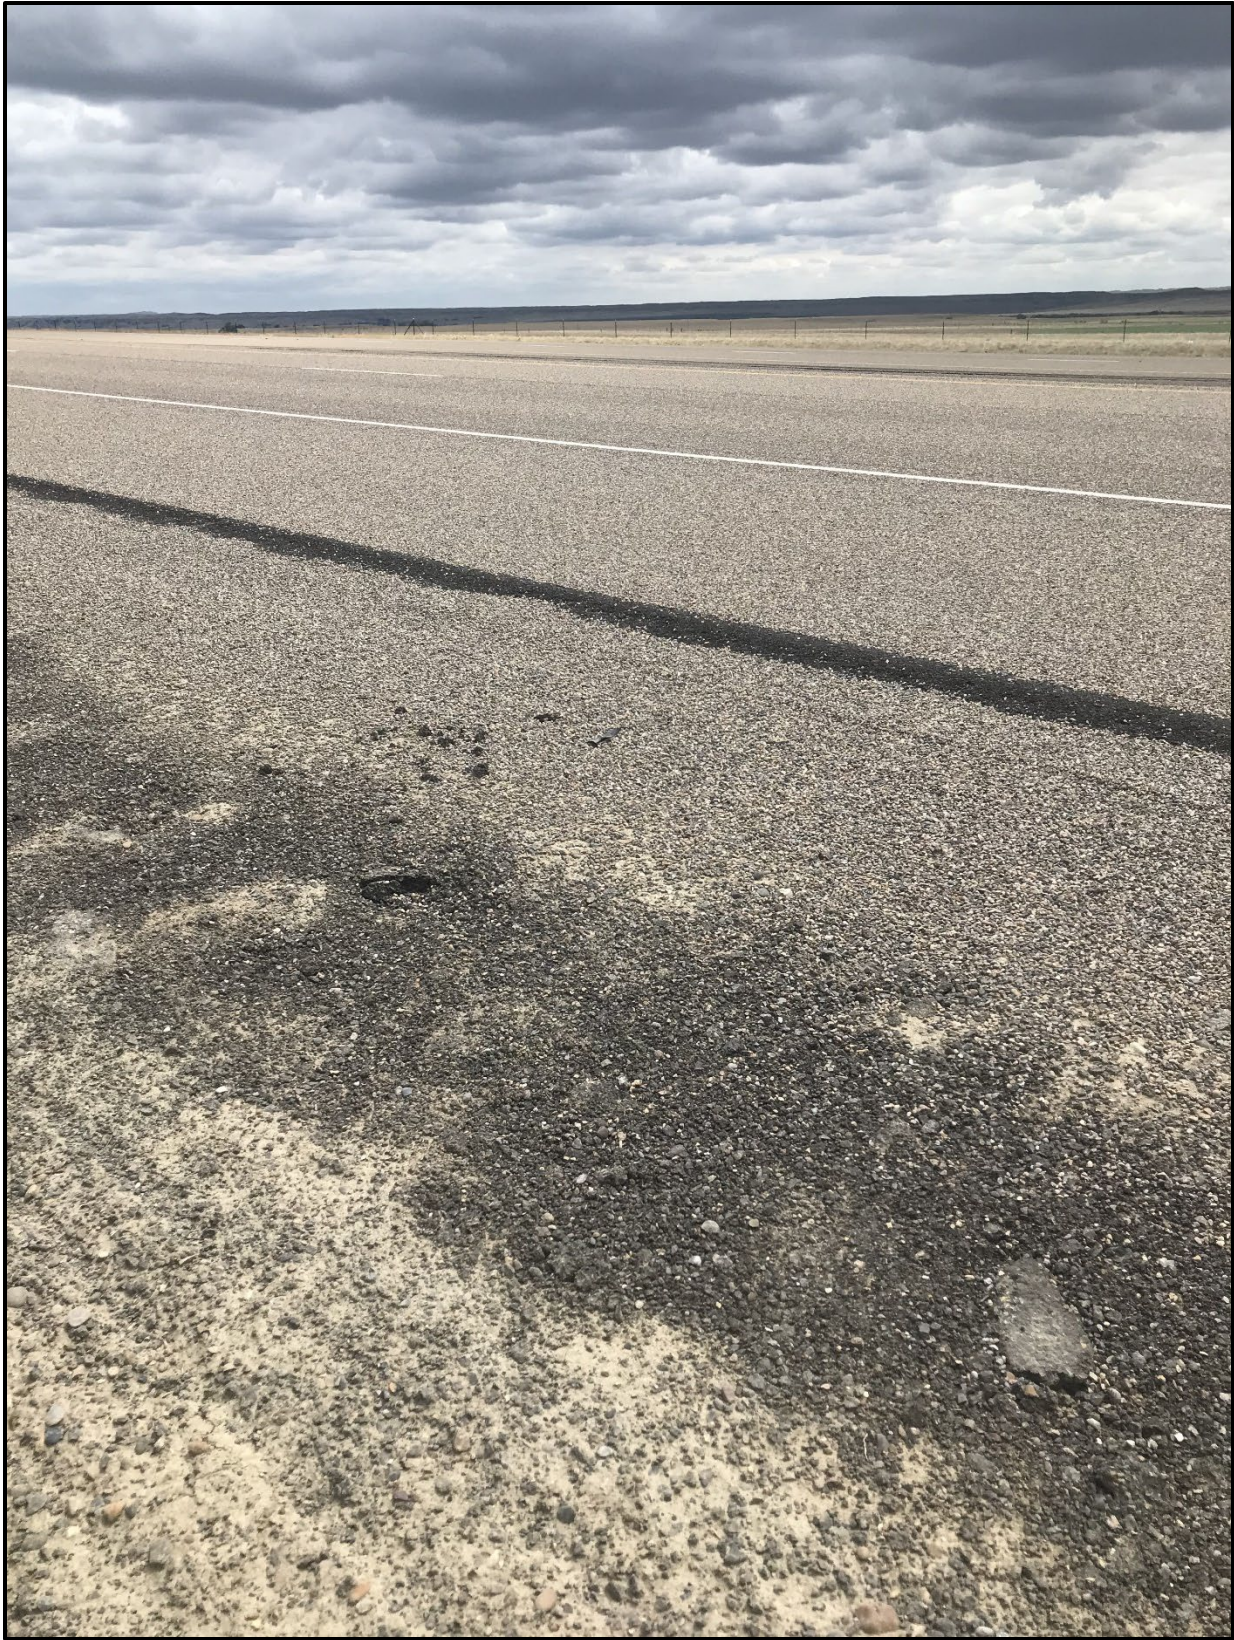
↑ RP 197.60, view east. Westbound shoulder, test section, typical 1.
