# Snow Accumulation and Snow Melt BMPs

**Table 2-3 Snow Accumulation and Snow Melt BMPs**

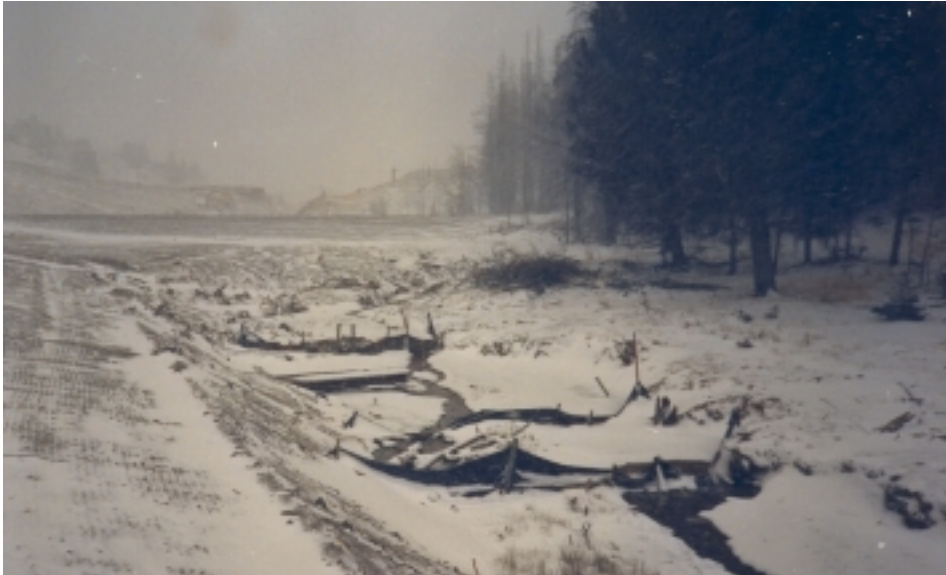
Winter conditions such as heavy snow and ice can cause BMP failure.

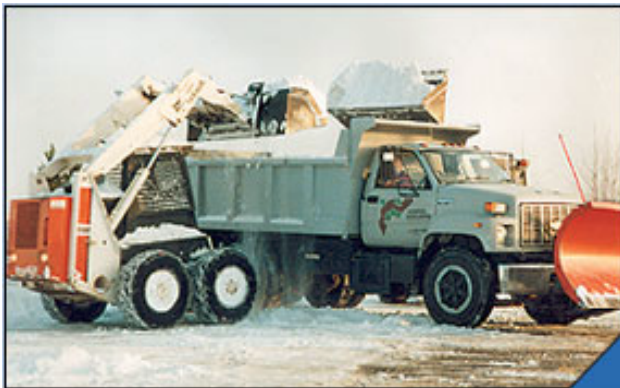
Removal of snow in sensitive areas prior to Spring melting can reduce erosion (BMP SN-1).

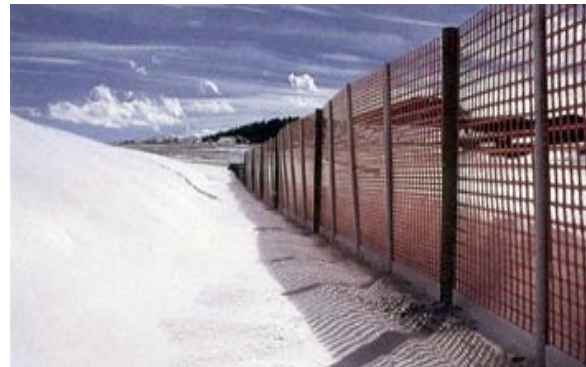
Fence can be used to limit snow accumulation in selected areas (BMP SN-2).
