EVALUATION OF HIGH FRICTION POLYMER OVERLAYS ON MONTANA BRIDGES

Project title: Evaluation of Thin Polymer Overlays for Bridge Decks

Project number: 9757-705

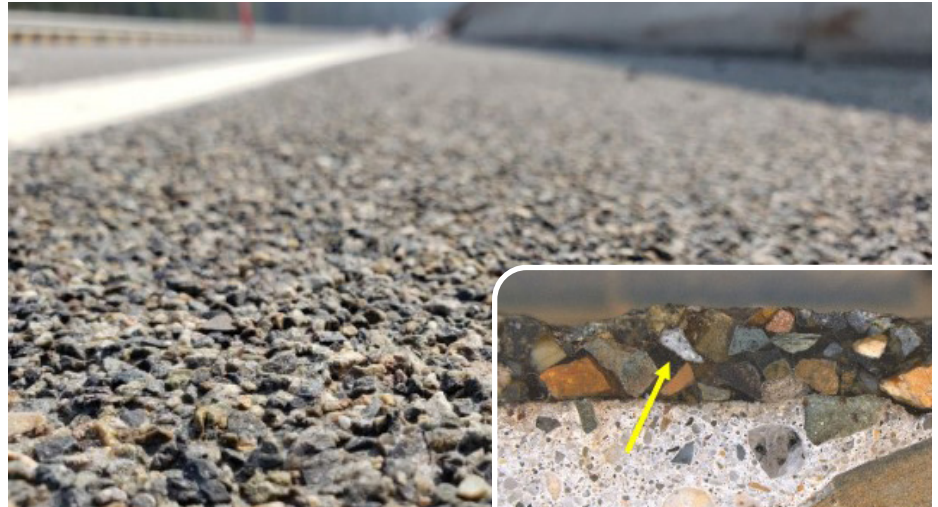
Polymer overlays with high friction materials can extend the life of a bridge and provide skid resistance.
