MONTANA DIVISION

"NATIONWIDE" PROGRAMMATIC SECTION 4(f) EVALUATION FOR HISTORIC BRIDGES

PROJECT #: BR 9032(65); CN 6296000	DATE: August 30, 2019
PROJECT NAME: Bitterroot River – W of Missoula (South Avenue Bridge Project)	LOCATION: Maclay Bridge, Missoula County; Latitude 46°51'11", Longitude 114°05'52"

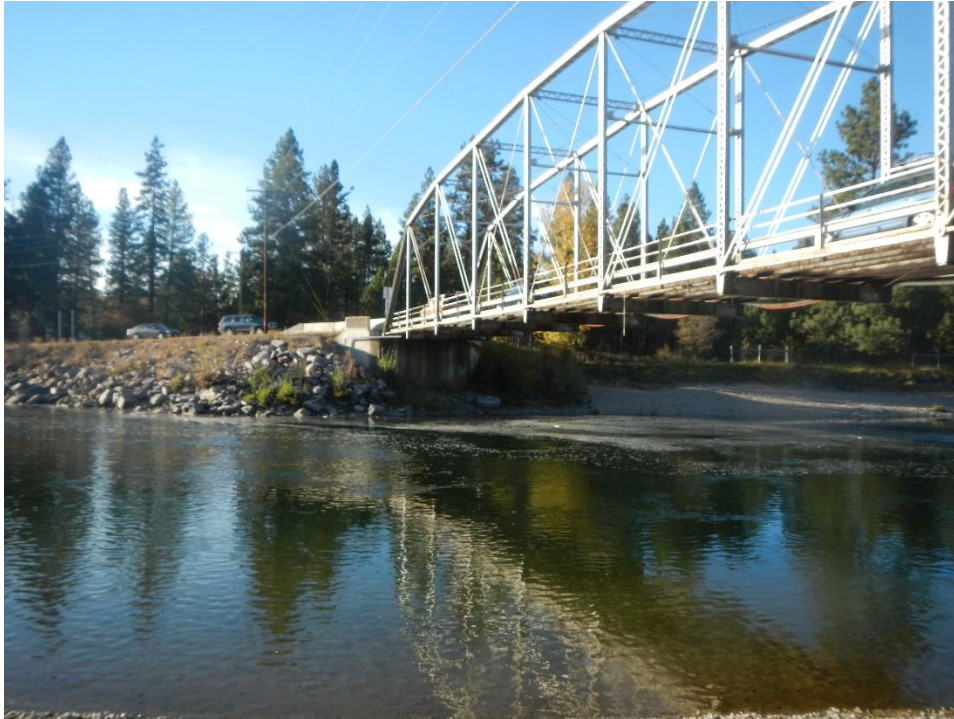
Photo 1: Maclay Bridge and the west approach and abutment area, view from the Bitterroot River

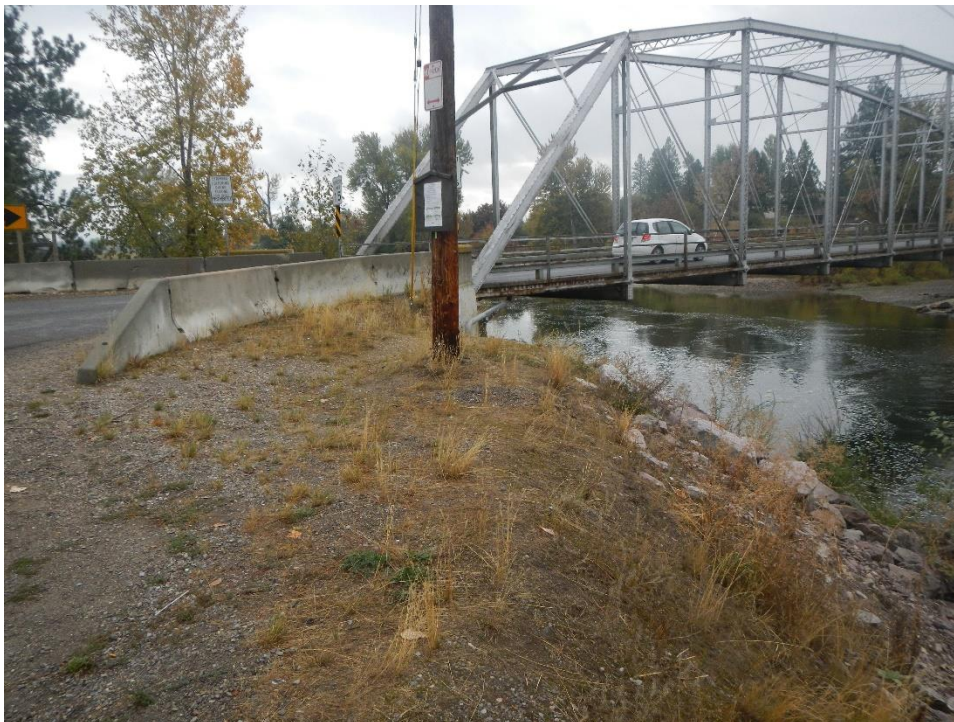
Photo 2: Maclay Bridge and the west approach and abutment area, view from the shoulder of River Pines Road

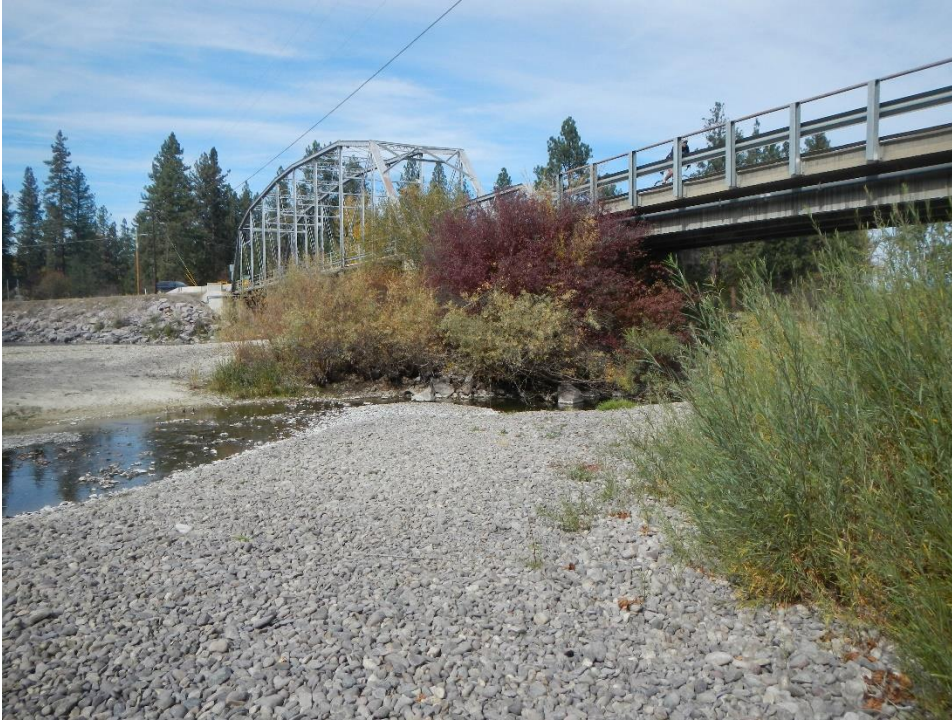
Photo 3: Maclay Bridge and east concrete approach span

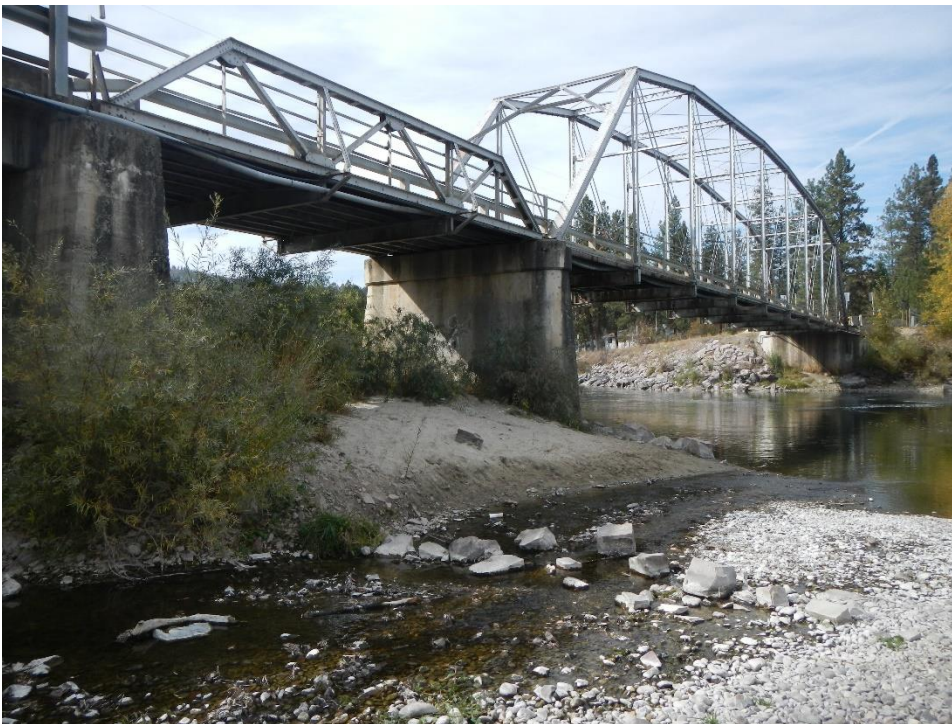
Photo 4: Maclay Bridge and the pony truss segment

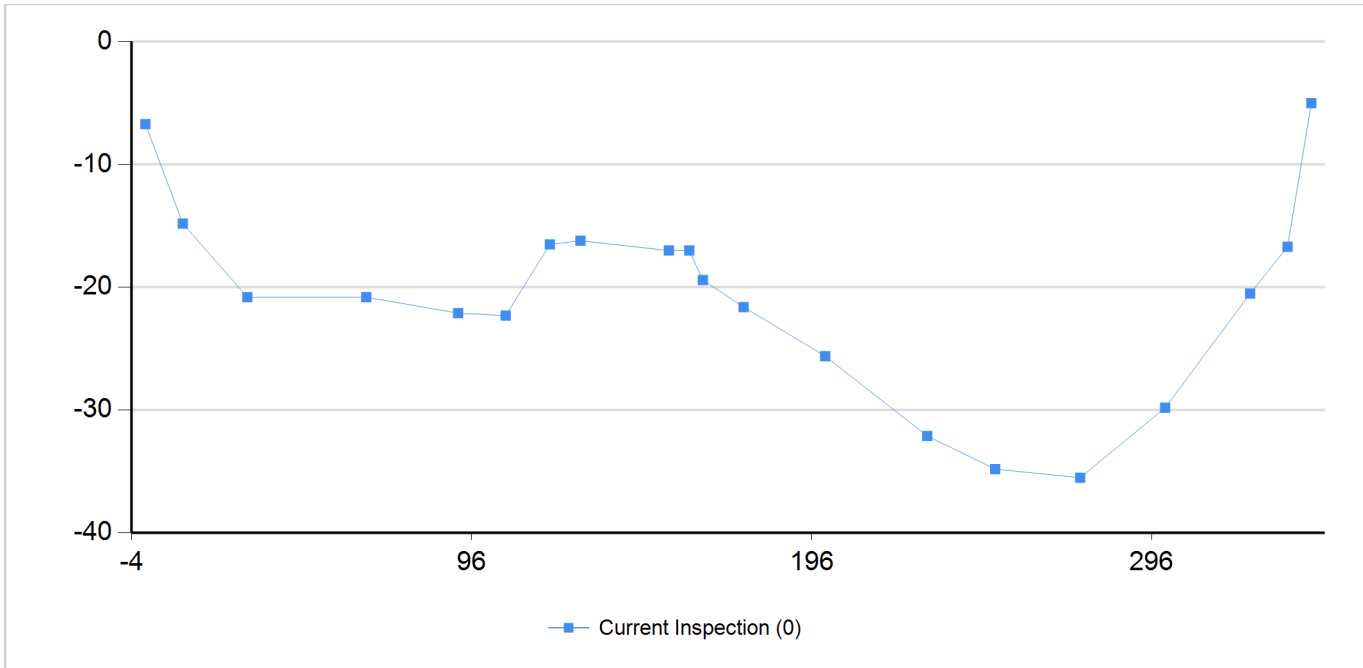
Underwater Measurements Points Table

Measure #	Line Depth	Line Distance
1	0	-6.7000000000000002
2	11	-14.8000000000000010
3	30	-20.8000000000000010
4	65	-20.8000000000000010
5	92	-22.1000000000000010
6	106	-22.3000000000000010
7	119	-16.50
8	128	-16.1999999999999990
9	154	-17
10	160	-17
11	164	-19.3999999999999990
12	176	-21.6000000000000010
13	200	-25.6000000000000010
14	230	-32.1000000000000010
15	250	-34.7999999999999970
16	275	-35.50
17	300	-29.8000000000000010
18	325	-20.50
19	336	-16.6999999999999990
20	343	-5
