MONTANA DEPARTMENT OF TRANSPORTATION STREAM MONITORING REPORT

*Little Rock Creek at Judith Slide Repair
Fergus County, Montana*

*Project Completed: 2013
Monitoring Report #2: December, 2015*

MDT Project Number: STPS 426-2(12) 15
Control Number: 7726000

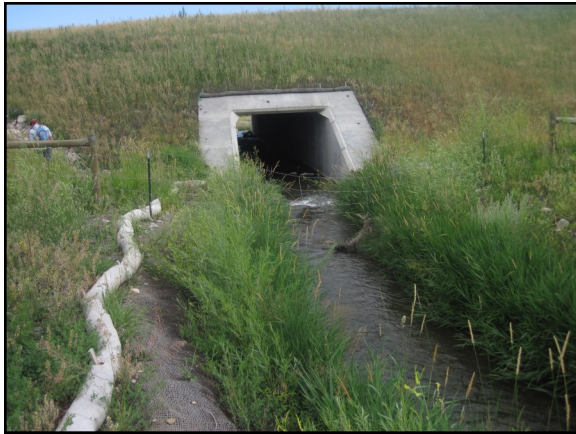
Photo Point 1—2014

Description: Upstream end of project looking downstream. **Compass:** 0 (North)

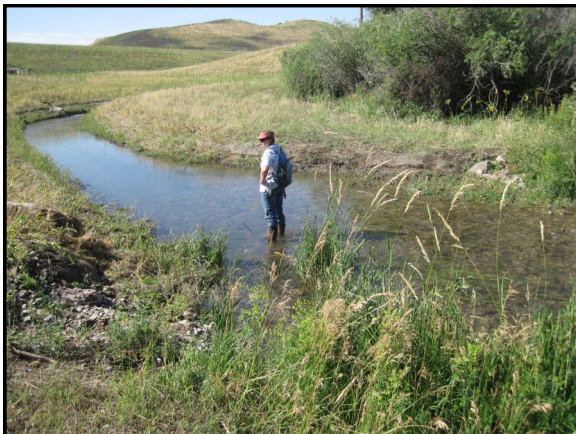
Photo Point 5.2—2014
Description: Downstream end of project, looking at cattle crossing. **Compass:** 225 (Southwest)

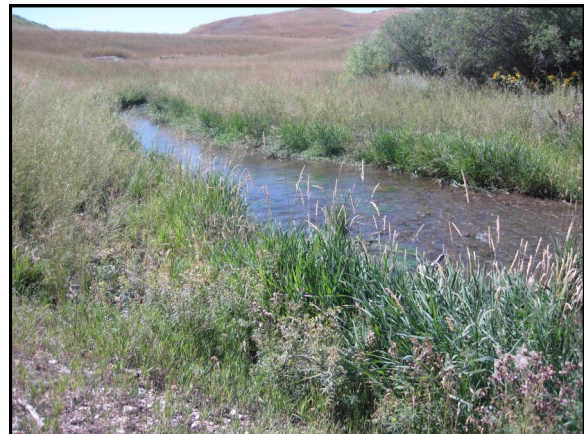
Photo Point 5.2—2015
Description: Downstream end of project, looking at cattle crossing. **Compass:** 225 (Southwest)

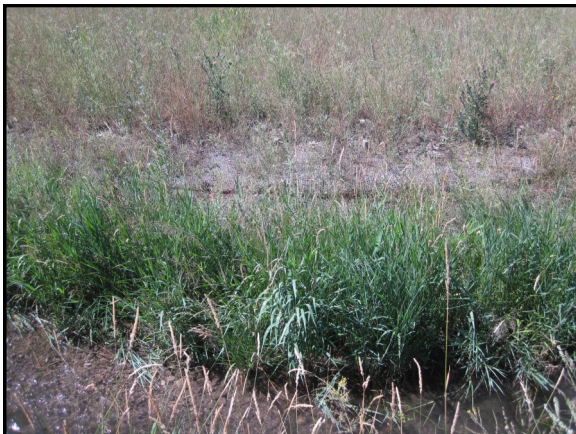
Additional Photo 3

Description: Poor veg on upper soil lift
Taken in 2015 looking north @ STA 10+25

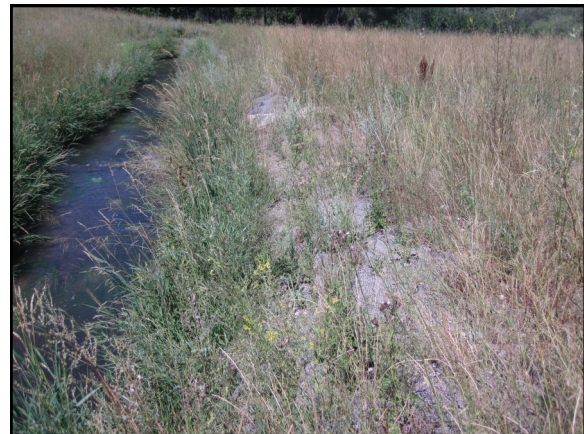
Additional Photo 4

Description: Poor veg on upper soil lift
Taken in 2015 looking downstream @ STA 10+25

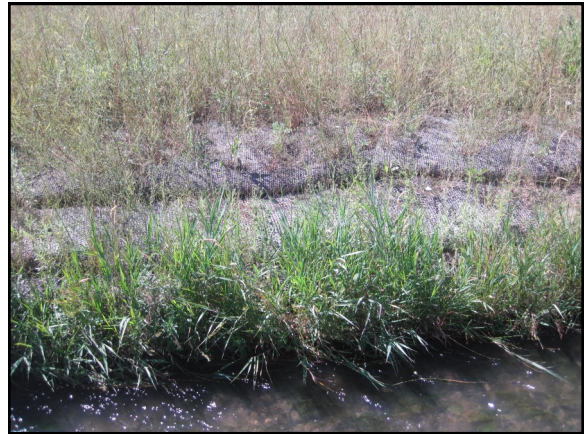
Additional Photo 6
Description: Unvegetated upper soil lift
Taken in 2015 looking across channel @ STA 11+00

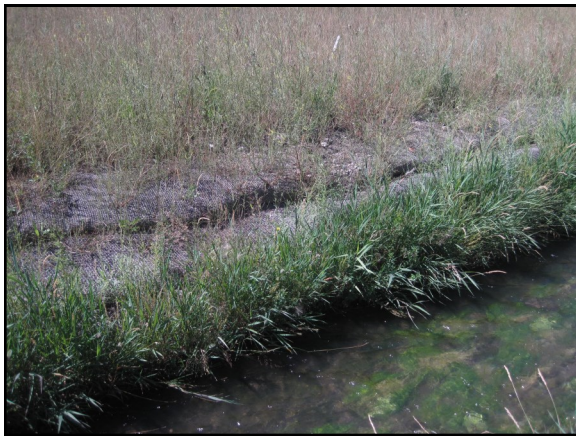
Additional Photo 7
Description: Unvegetated upper soil lift
Taken in 2015 looking across channel @ STA 11+00

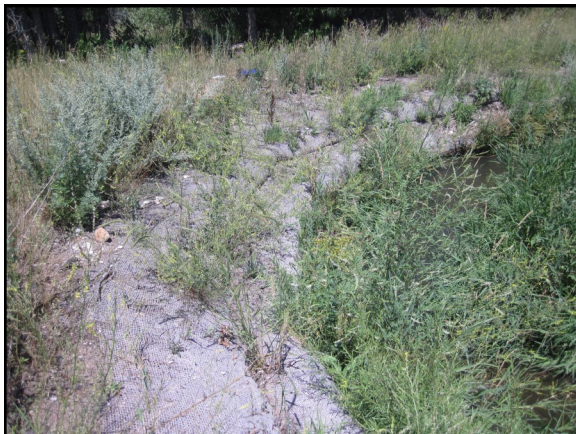
Additional Photo 9
Description: Unvegetated upper soil lift
Taken in 2015 looking downstream @ STA 11+25

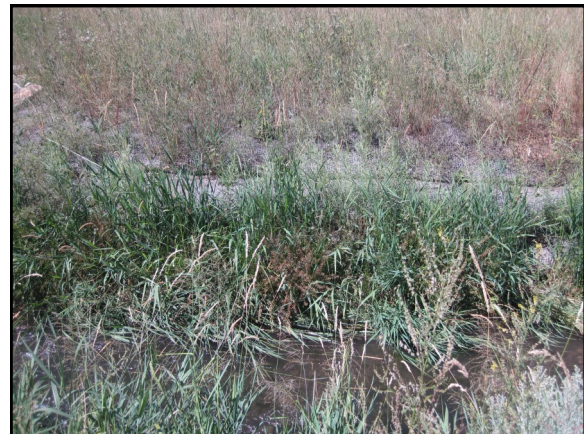
Additional Photo 10
Description: Unvegetated upper soil lift
Taken in 2015 looking north from STA 11+25

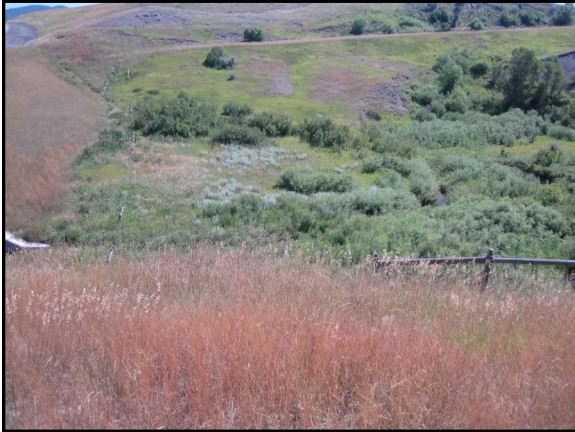
Additional Photo 11
Description: Floodplain south of road embankment
Taken in 2015

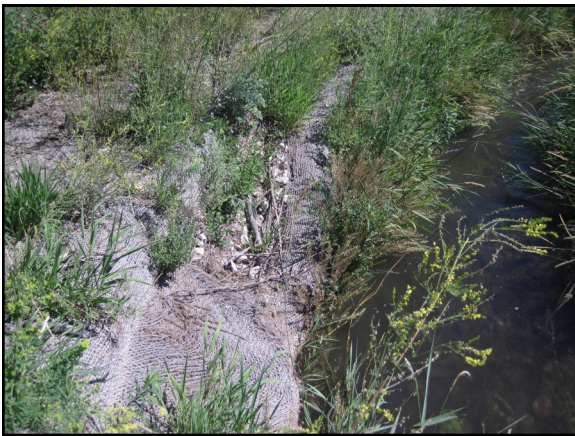
The reconstructed channel alignment includes a relatively sharp bend approximately 250' downstream of the newly installed culvert. This bend was constructed using multiple coir wrapped soil lifts over a native gravel toe. The stream has undercut beneath the soil lifts, causing them to begin slumping into the void created. A 10' segment of the left stream bank along this bend is beginning to erode as the coir fabric has begun to degrade and no longer has the strength to hold the bank together (See Additional Photos 13 and 14 in Appendix C). A thin band of vegetation has begun to establish along the toe of the bank, but may not be capable of maintaining the undercut bank over the long term. In general, vegetation establishment along the upper coir fabric lifts is relatively sparse; as a result, this bank may continue to slough into the channel over the next several years until the bank slope stabilizes.

Additional Photo 13
Description: Eroding Bank EBL1
Taken in 2015 looking downstream from STA 11+50

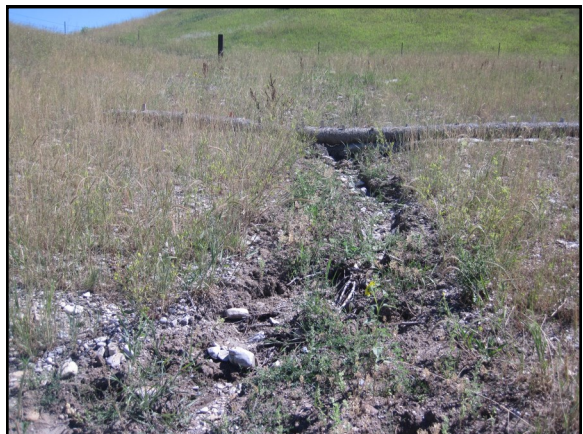
Additional Photo 16
Description: Gully forming east of new channel
Taken in 2015

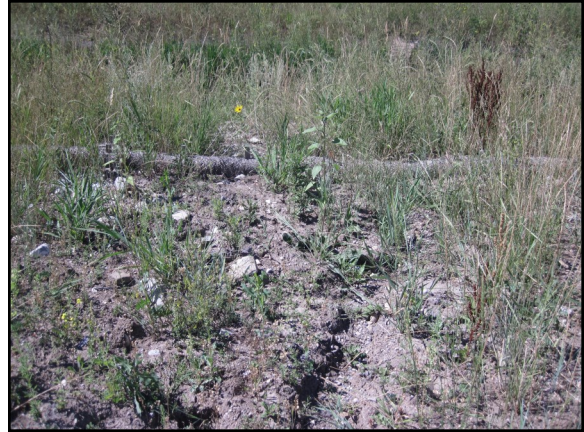
Additional Photo 18
Description: Gully forming east of new channel
Taken in 2015
