MONTANA DEPARTMENT OF TRANSPORTATION STREAM MITIGATION MONITORING REPORT

*Sweathouse Creek
Ravalli County, Montana*

*Year Project Completed: 2011
Monitoring Report #3: Submitted December, 2015*

MDT Project Number: NH 7-1(114)59
Control Number: CN 201 5004

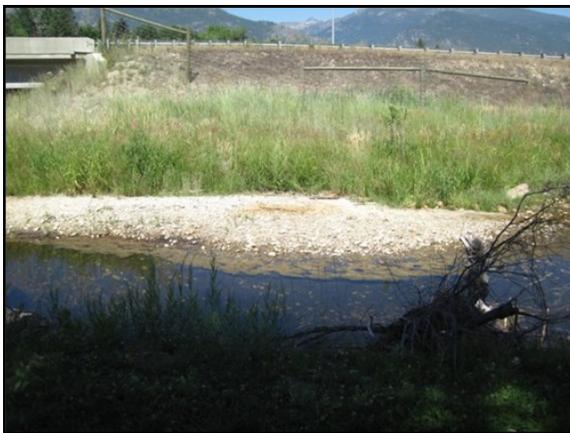
Photo Point 4.2—2013
Description: View of north bank and point bar development. **Compass:** 315 (Northwest)

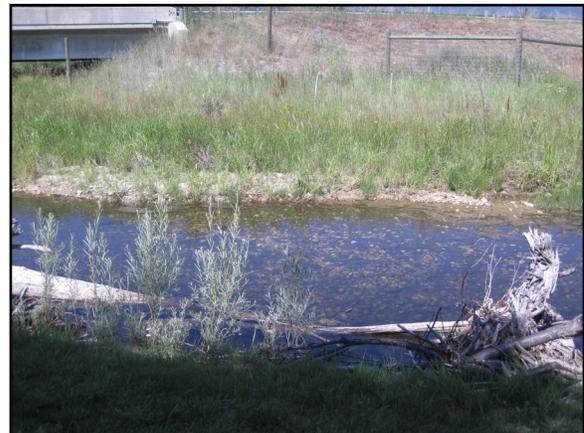
Photo Point 4.2—2015
Description: View of north bank and point bar development. **Compass:** 315 (Northwest)

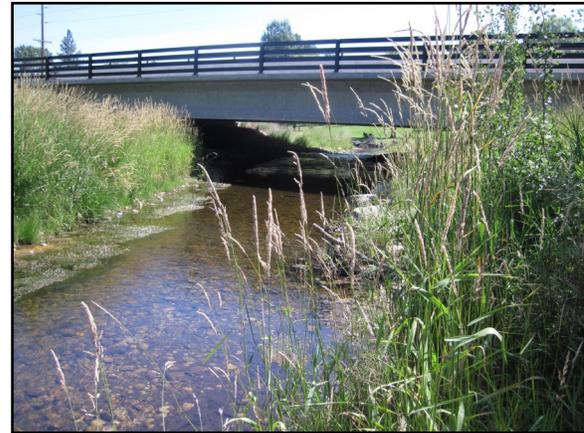
Photo Point 7.2—2015
Description: View looking downstream beneath bridge. **Compass:** 90 (East)

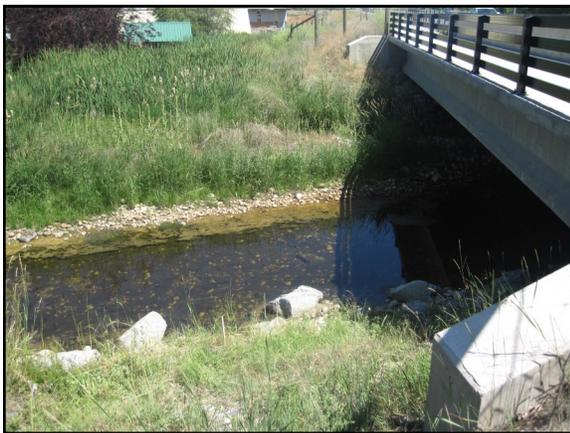
Photo Point 7.3—2013
Description: View of north bank looking across stream channel. **Compass:** 0 (North)

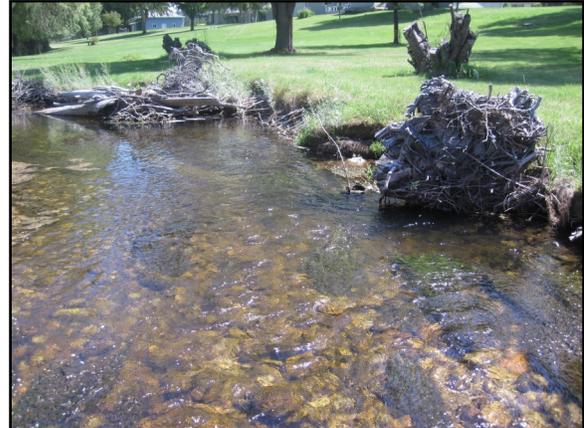
Additional Photo 1 - 2015
Description: Root wads along south streambank.
Compass: 45 (Northeast)

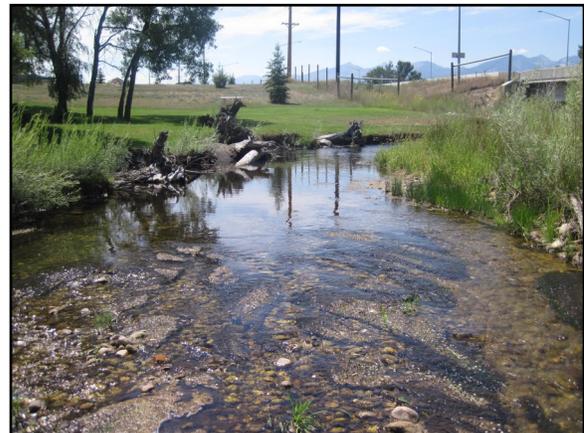
Additional Photo 2 - 2015
Description: Point bar formation on north side of channel. **Compass:** 250 (West-Southwest)

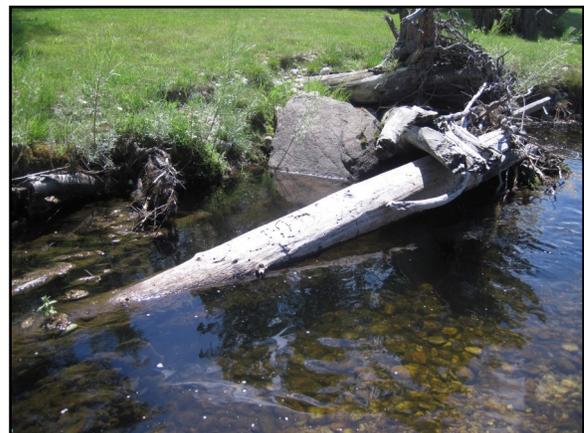
Additional Photo 3 - 2015
Description: Log structure along south streambank.
Compass: 110 (East-Southeast)

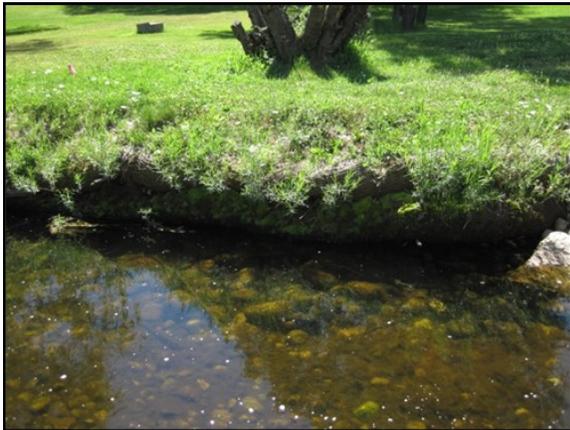
The erosion inventory conducted in 2015 did not reveal any new bank erosion within the project reach. A 15-foot long eroding stream bank documented in 2014 along the right (south) bank between the first and second root wads downstream of the Highway 93 Bridge (see Additional Photo 4 on page 8 of Appendix C) does not appear to have eroded further laterally in the past year. Erosion along this bank appeared due to scour of gravels and cobbles that had been placed beneath the coir logs to construct the bank. Movement of these cobbles has resulted in a 15-foot segment of the bank to undercut, loss of one coir log, and bank calving adjacent to a second coir log. Erosion along this bank is considered moderate due to the relatively short segment exhibiting erosion and no evidence of continued lateral migration one year following its initial discovery.

Additional Photo 4 - 2015
Description: Eroding bank EBR1 along right (south bank). **Compass:** 90 (East)

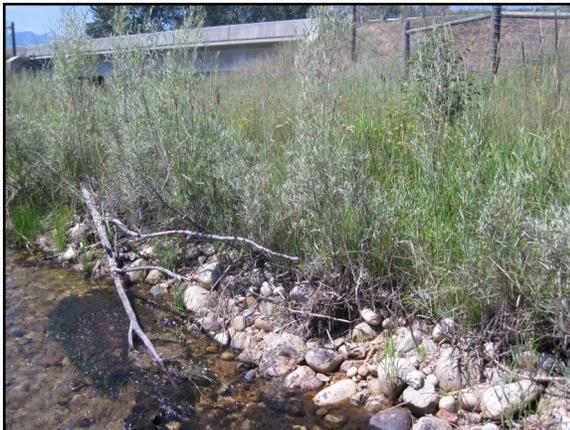
Additional Photo 5 - 2015
Description: Willow cutting growth along north bank **Compass:** 270 (West)

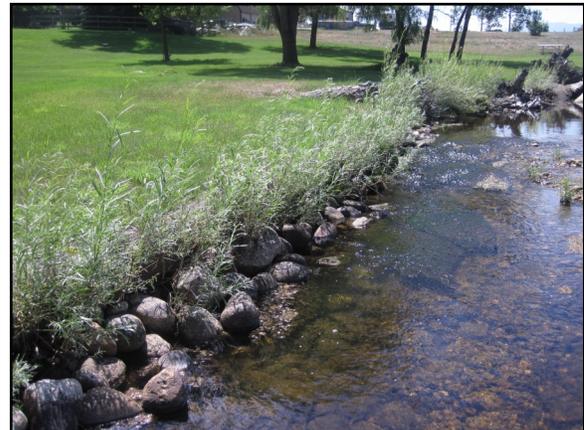
Additional Photo 6 - 2015
Description: Willow cutting growth. **Compass:** 180 (South)

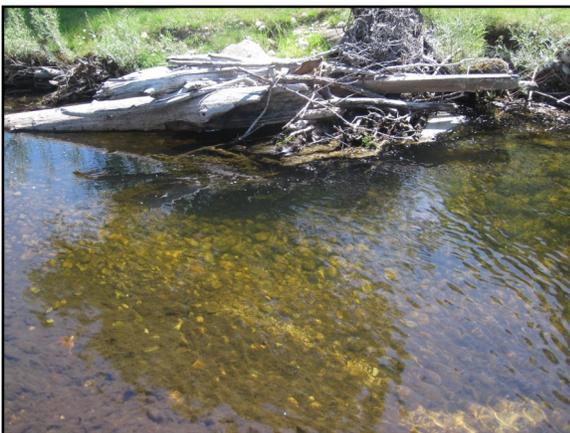
Additional Photo 7 - 2015
Description: Pool development along root wads **Compass:** 90 (East)

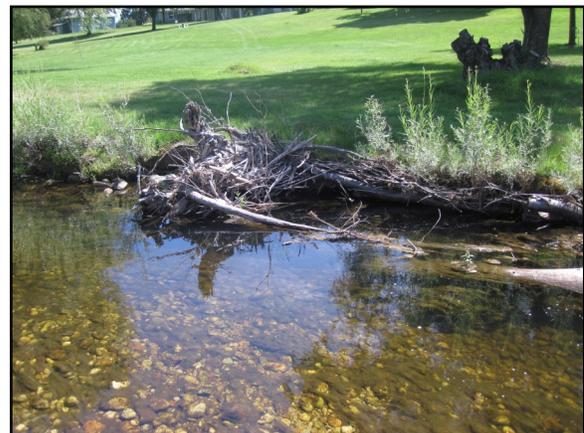
Additional Photo 8 - 2015
Description: Pool development along woody debris **Compass:** 45 (Northeast)
