Montana Department of Transportation Stream Mitigation Monitoring Report

MILL CREEK MITIGATION SITE

Monitoring Year: 2020

Monitoring Conducted By: Confluence Consulting Inc.

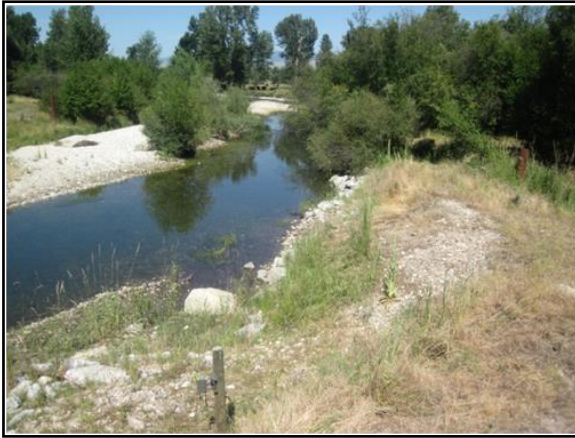
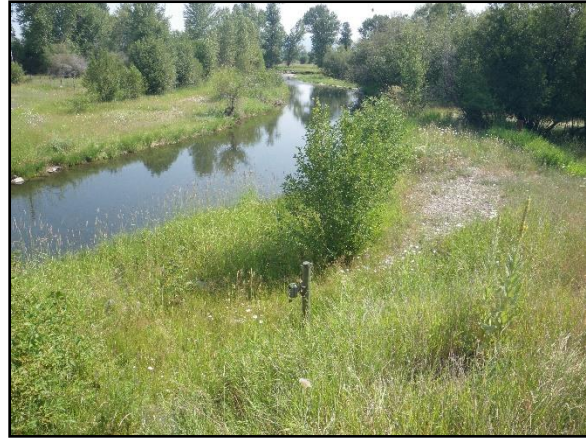
Photo Point 1.2: View from southeast corner of bridge looking downstream. **Compass:** 45° (Northeast)

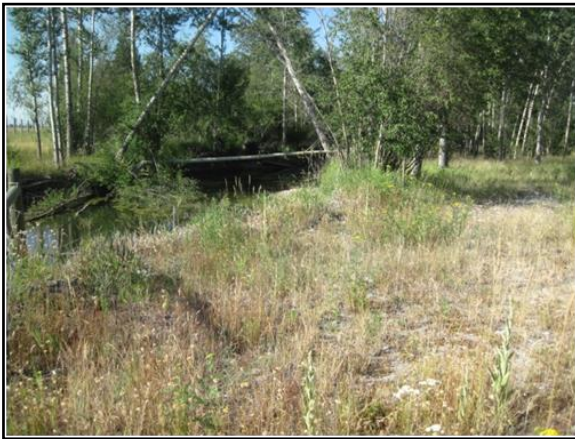
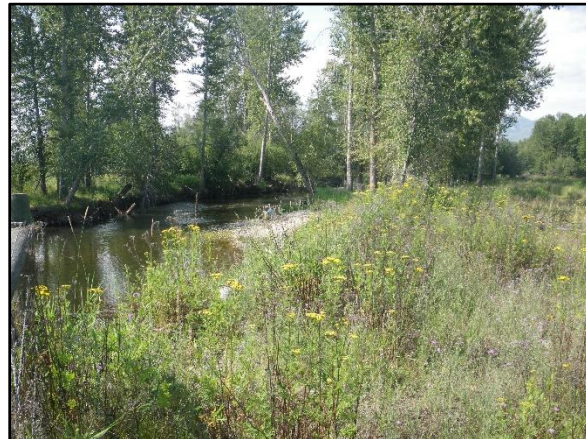
Photo Point 2.3: View from Photo Point 2 looking upstream. **Compass:** 248° (West-Southwest)

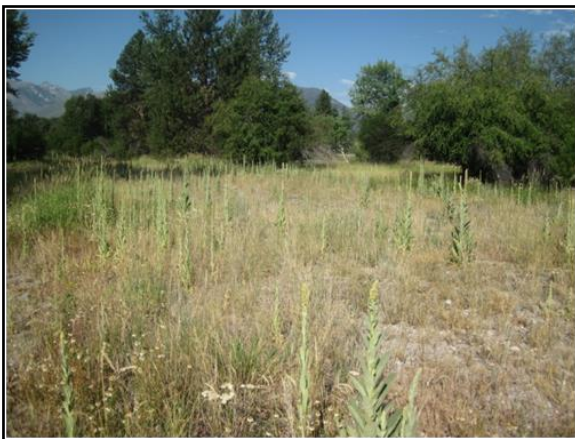
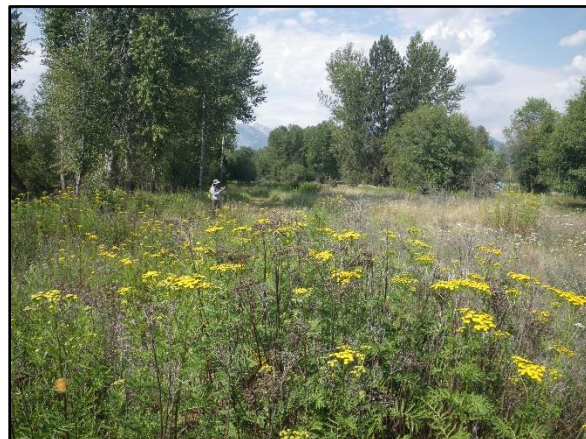
Photo Point 2.5: View of deactivated channel alignment. **Compass:** 248° (West-Southwest)

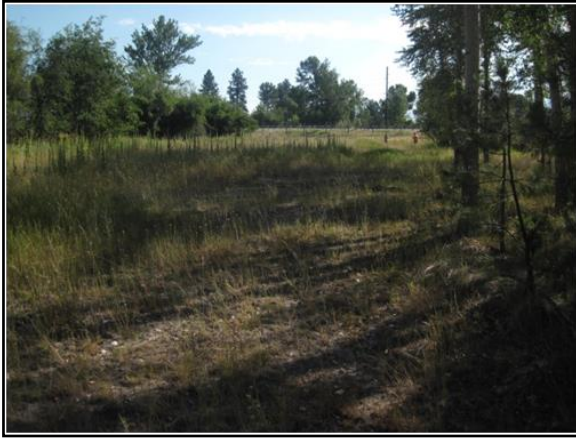
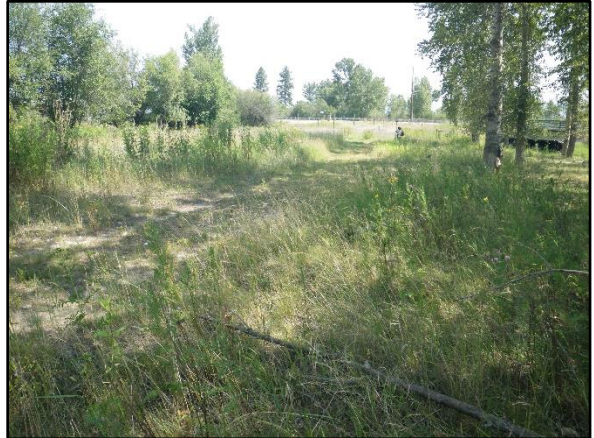
Photo Point 3.1: View of deactivated channel segment from Photo point 3. Compass: 68° (East-Northeast)

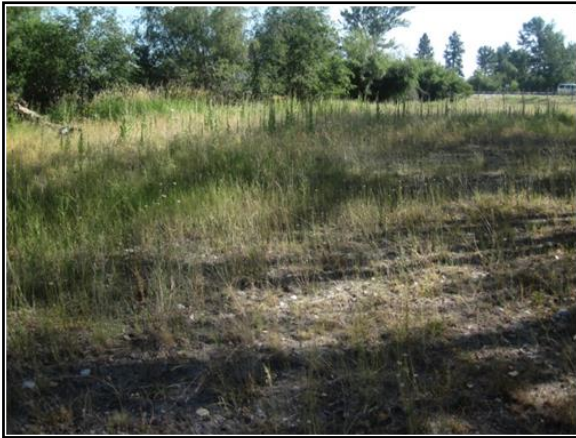
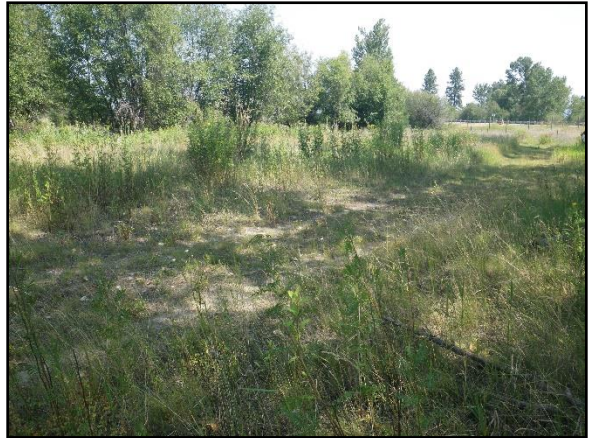
Photo Point 3.2: View of deactivated channel plug. Compass: 45° (East)

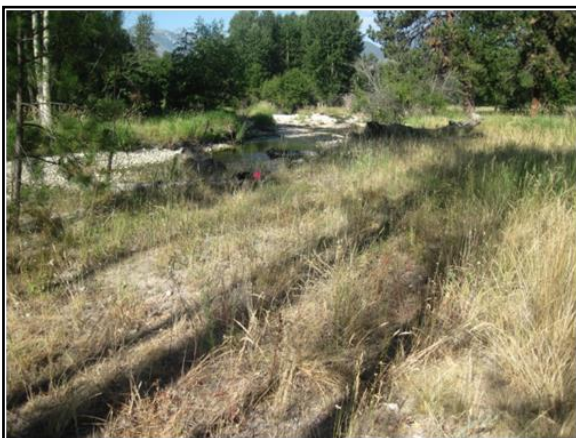
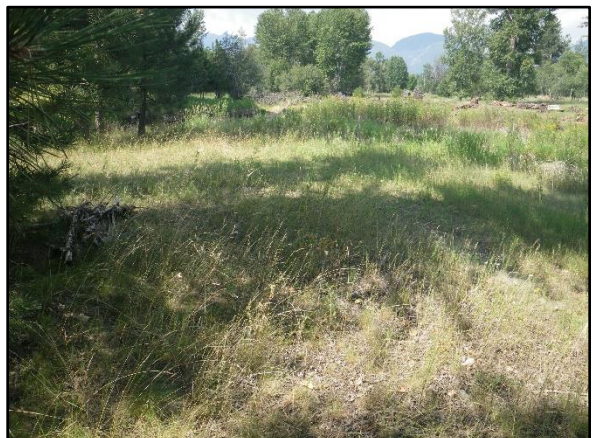
Photo Point 3.5: View of upstream extent of deactivated channel segment. Compass: 270° (West)

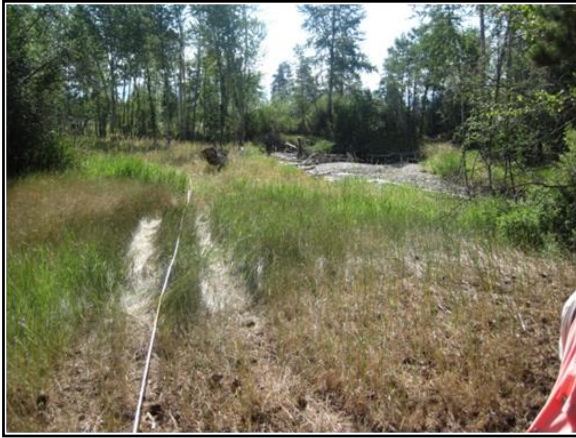
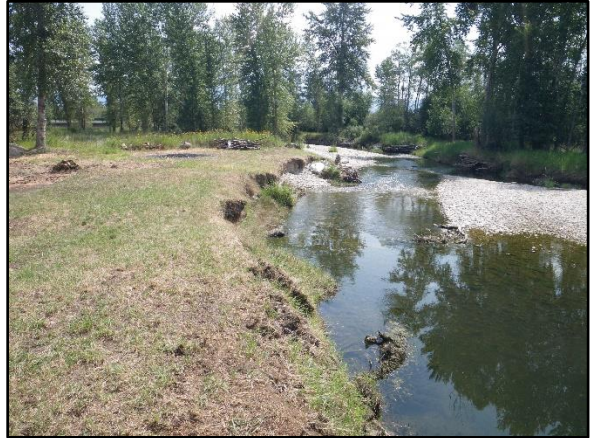
Photo Point 3.8: View looking across deactivated channel segment. Compass: 90° (East)

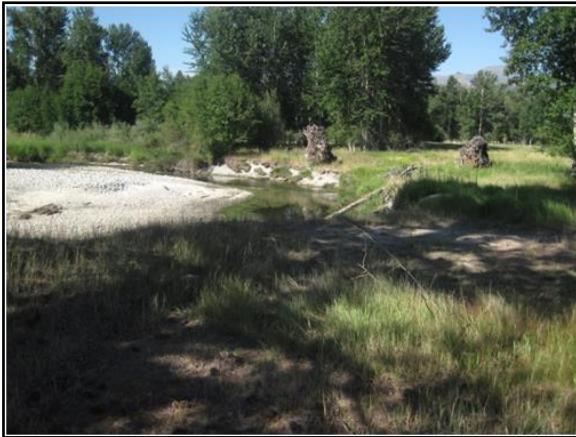
Mill Creek has recently developed several depositional features, including mid-channel and point bars, and the stream banks have shown signs of increased erosion within the last year (see bank erosion section above). The point bar adjacent to the right bank on the upstream end of the project reach has increased in height and width in the last year (Additional photo 2, Appendix B), and a mid-channel bar has deposited on the left side of the channel adjacent to EBL4 (Additional photo 5, Appendix B). The point bar on the upstream end of the project area is forcing the thalweg against the left bank and is thus contributing to the erosion on EBLs 1-2 and 5. The dimensions of the mid channel bar adjacent to EBL4 were captured in the Transect #3

Photo Point 4.3: View of point bar formation from Photo Point 4. Compass: 225° (Southwest)

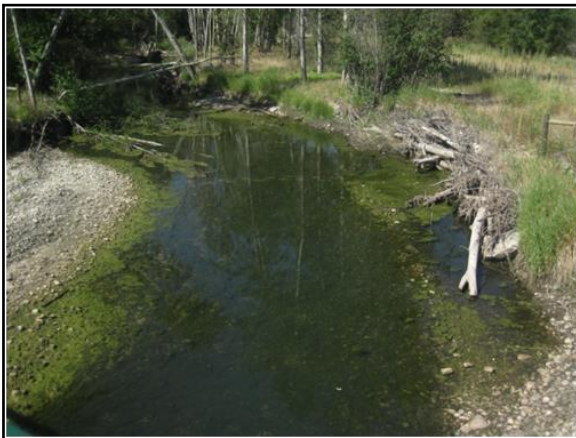
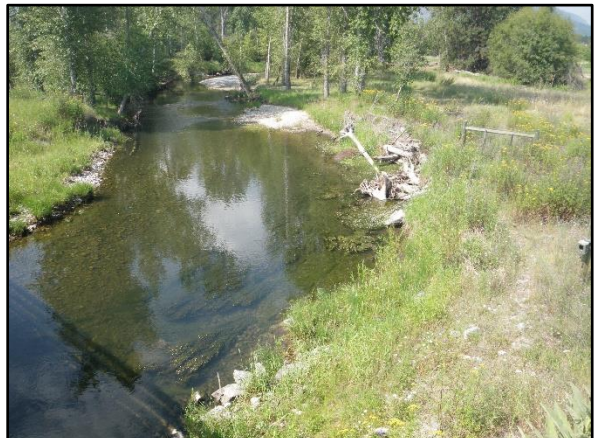
Photo Point 5.2: View looking upstream from bridge. Compass: 203° (South-Southwest)

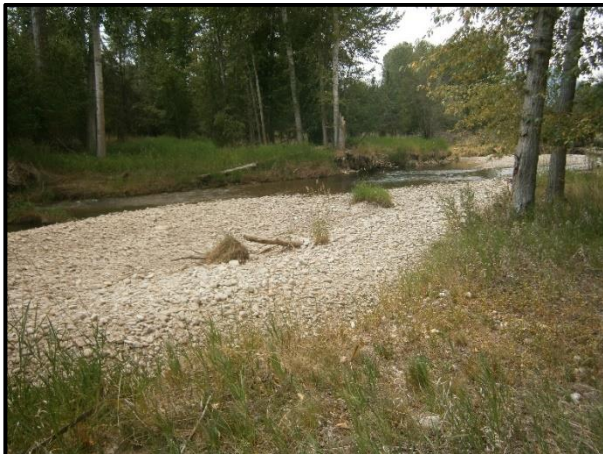
Survey Photo 23. T3 looking West upstream from North bank.

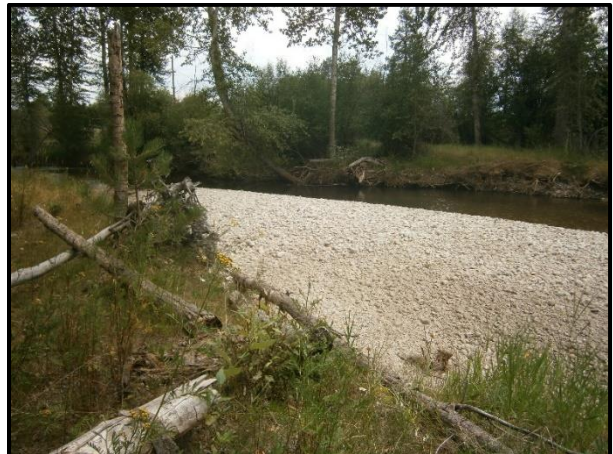
cross sections survey (Appendix D). This gravel bar is increasing water surface elevations at higher flows and forcing higher velocity water against both banks, thus placing erosive forces on EBL3 and EBL4 (See photo of T3 looking East, Appendix B). Such features are commonly observed in streams that transport large bedloads, and Mill Creek is one of the many tributaries that flow east out of the Bitterroot Mountains which contain a high bedload.

Transect #3 generally maintained the same geometry from 2013 to 2019, although increased pool depth was observed in 2019. However, between the 2019 and 2020 monitoring events, a large gravel bar developed along the left bank, forcing the thalweg and the majority of the flow to shift to the right side of the channel. A secondary flow path now runs along the left bank (Appendix D).

Survey Photo 24. T3 looking East downstream from North bank.

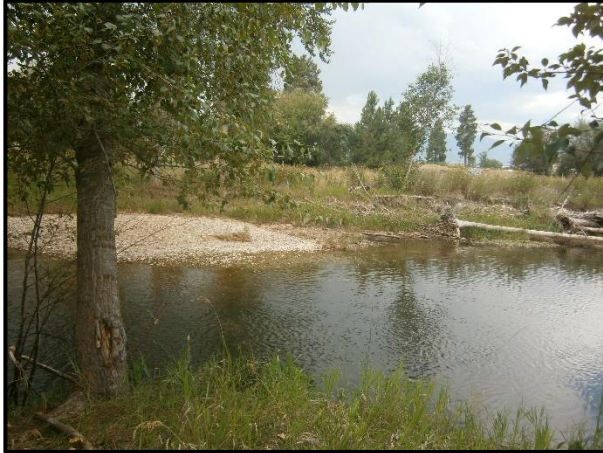
Survey Photo 25. T4 looking North upstream from T4 South bank.

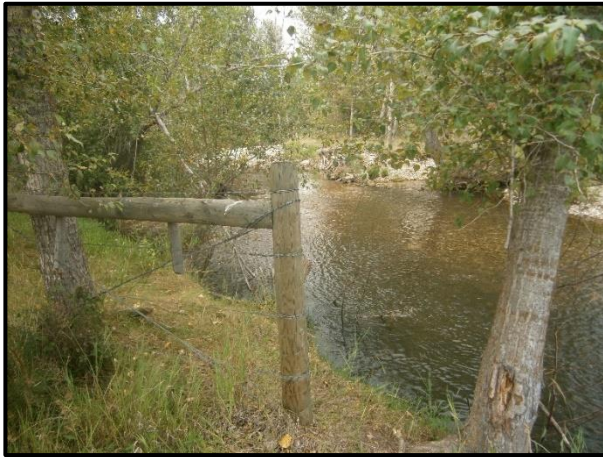
Survey Photo 27. T4 looking West upstream from South bank.

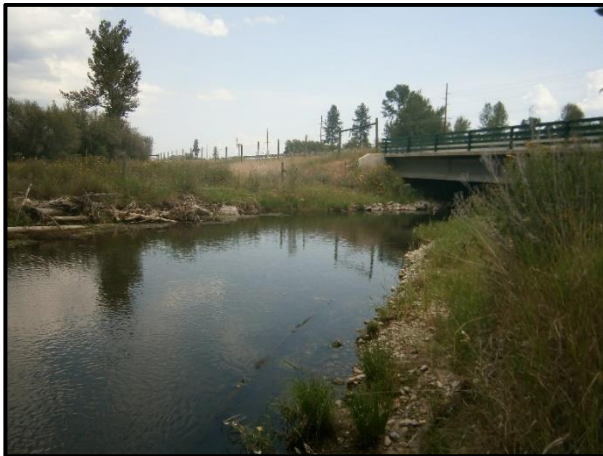
Survey Photo 29. T4 looking West upstream from middle creek.

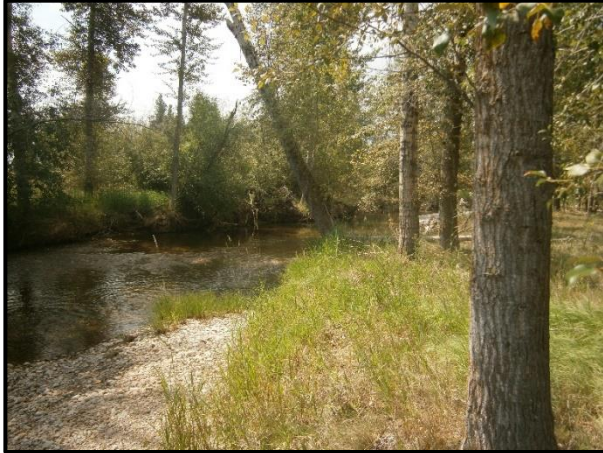
Survey Photo 31. T4 looking West upstream from North bank.

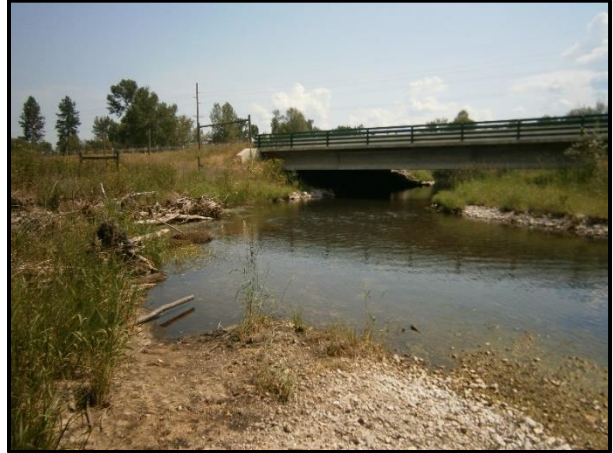
Survey Photo 32. T4 looking East downstream from North bank.
