## EXPERIMENTAL PROJECTS CONSTRUCTION REPORT

### HIGH FRICTION SURFACE TREATMENTS (HFSTs) FOR BRIDGE DECKS

| <b>FHWA Project Number:</b> | MT-12-10/13-01/14-05 |
| <b>Date of Inspections:</b> | March 2015 |

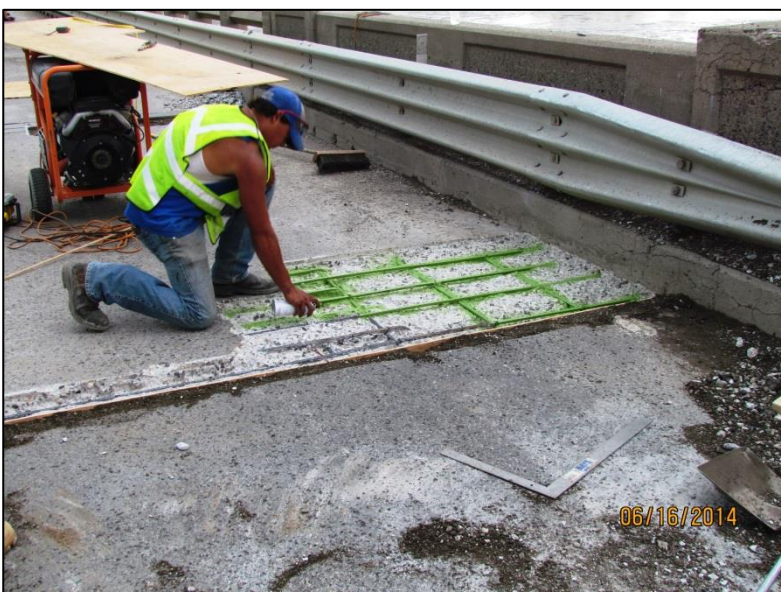
← Exposed rebar was coated with two-component aerosol epoxy.

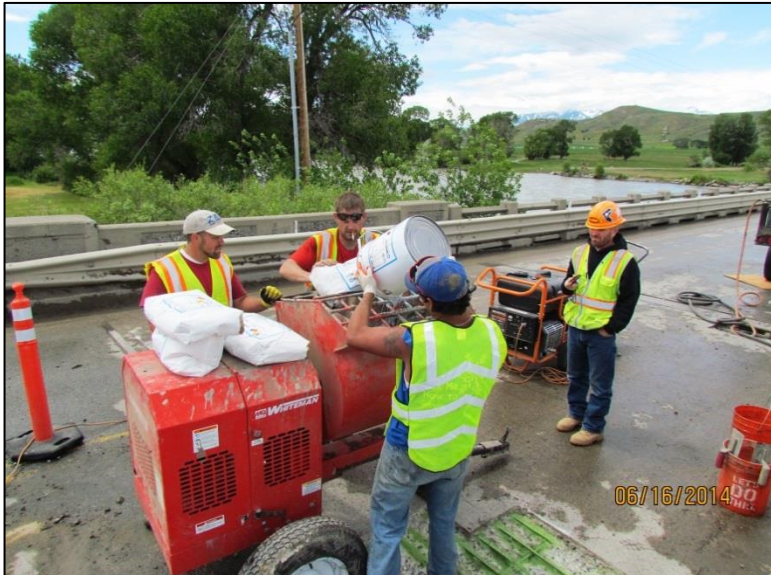
◀ The repair material used is the Dayton Sure Patch.

This is an epoxy resin mixture consisting of three parts: component "A" epoxy resin, component "B" modified amine curing agent, and component "C" specially graded aggregate.

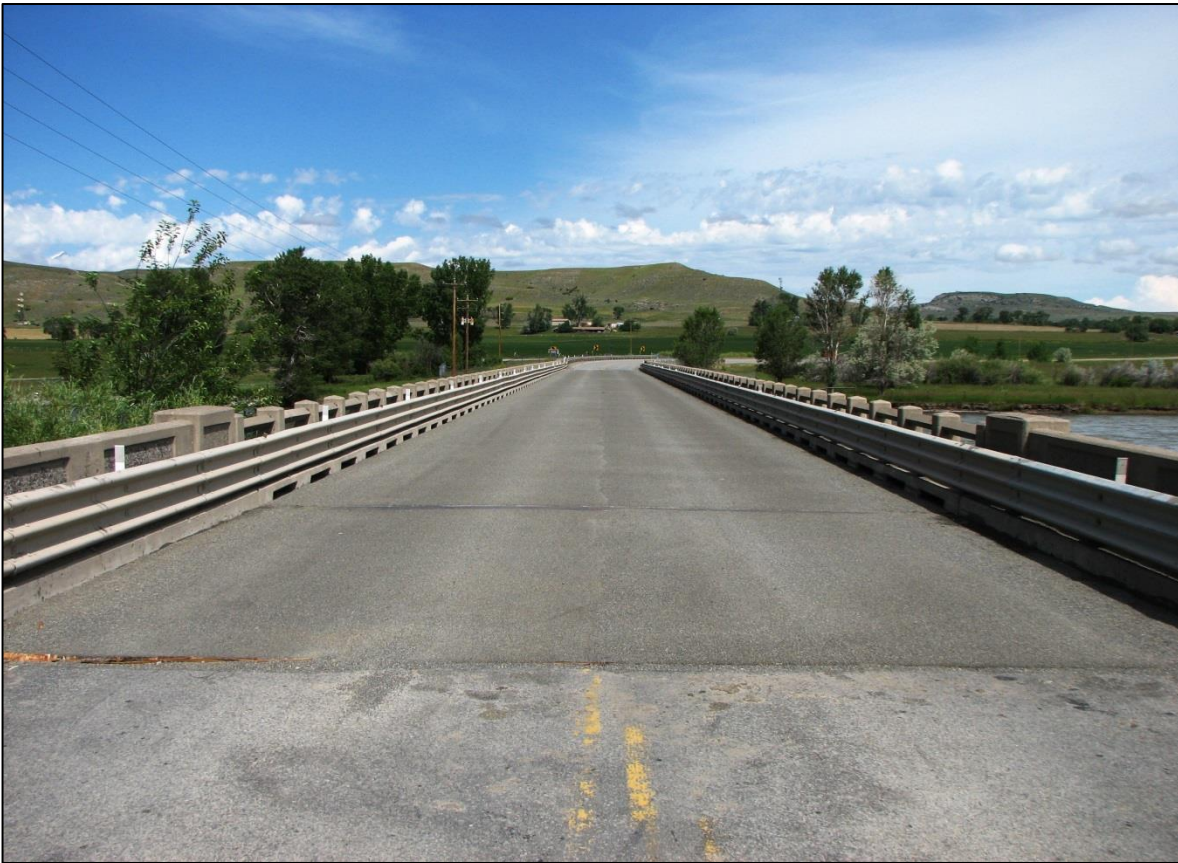
↑ Completed project with two fully cured lifts of epoxy and stone; view north.

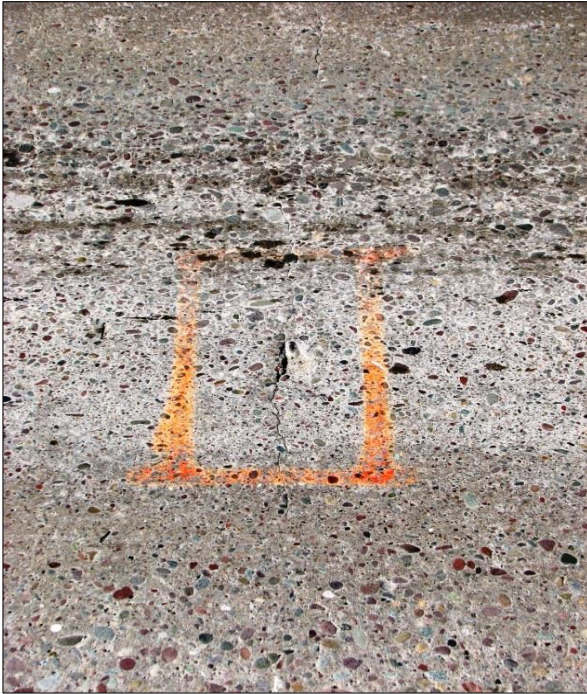
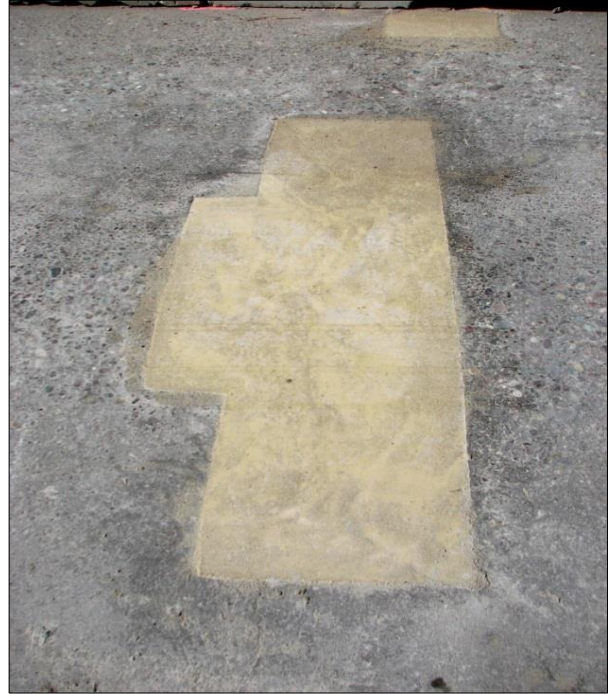
↑ The project begins with the Class A deck repairs; orange paint delineates selected areas to be chiseled out to the top layer of rebar. Image on right shows completed section using Dayton Sure Patch: See pages 6 & 7 (Big Timber site), for specific examples of the repair which were similar to this deck.

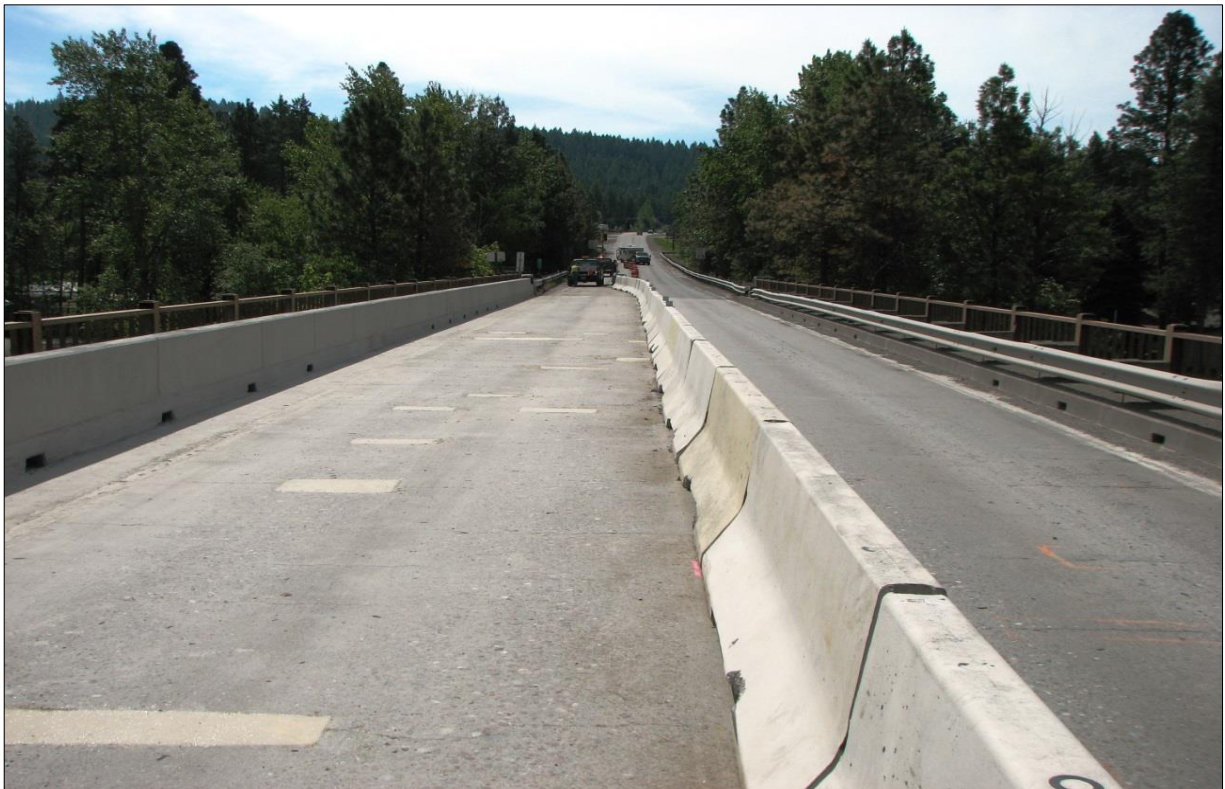
↓ Class A repair completed on the north bound lane; view south.

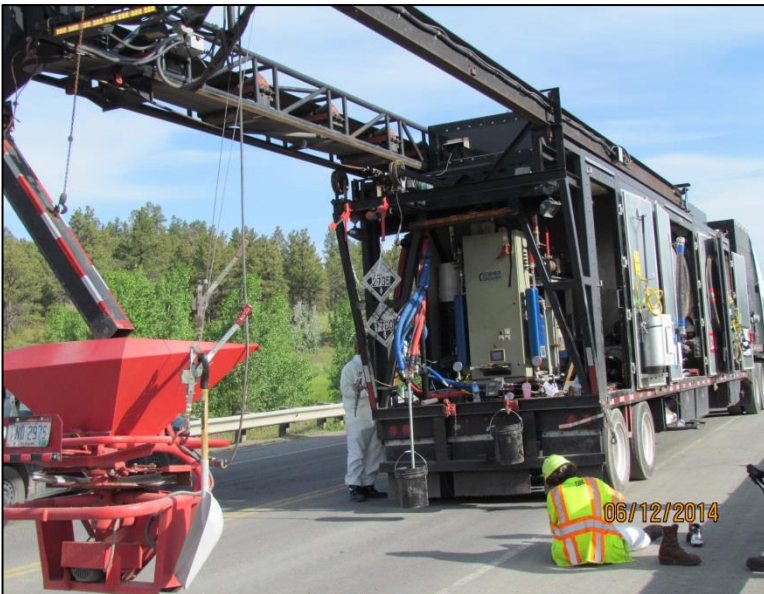
← The blended copolymer epoxy is being injected on the deck through a single tube at the rear of the vehicle (yellow arrow).

Workman have spread the epoxy in an area that may allow the material spreader to start broadcasting the aggregate.

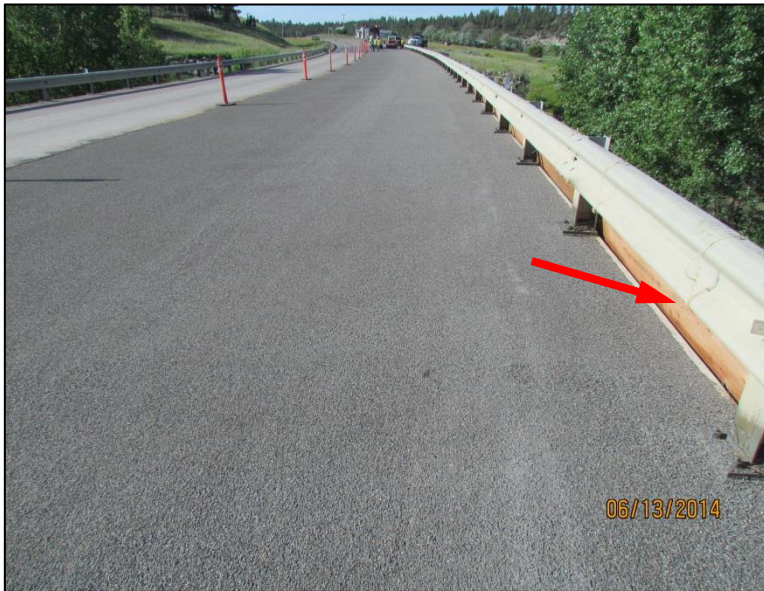
← The first lift of the overlay is completed and allowed to cure overnight (It was too late in the previous day to perform the second lift, which may be applied 2-4 hours after the first under normal conditions).

Note plywood planks were hung from the edge of the deck from the guardrails in an effort to prevent epoxy from entering the stream (red arrow).

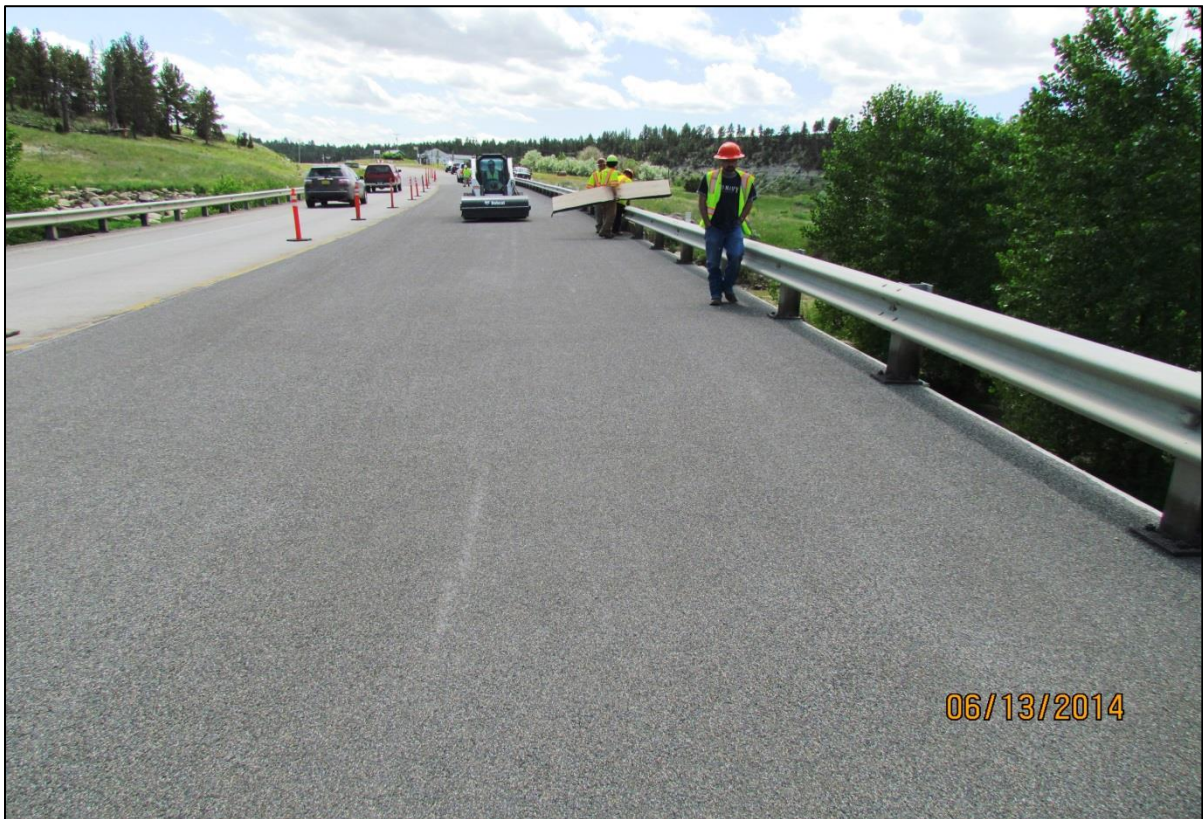
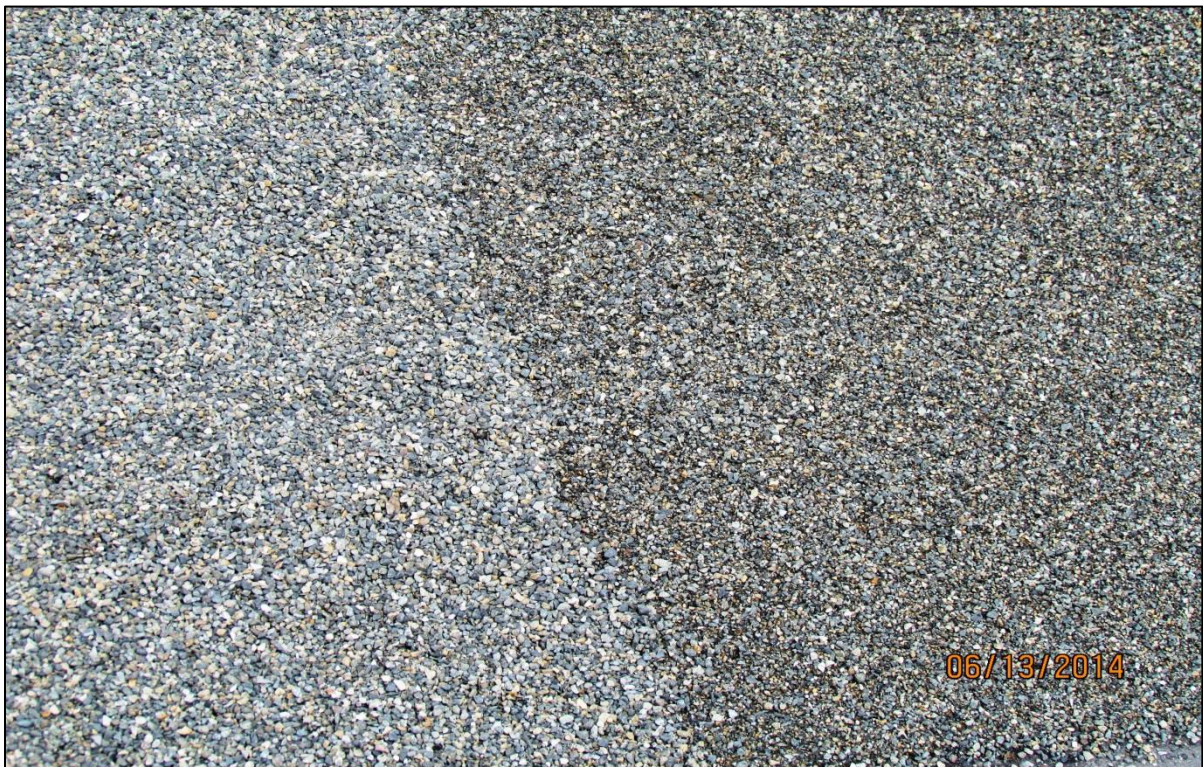
- ↑ The second lift is complete, and the workmen remove the guardrail boards to begin preparation of the northbound lane to receive the PolyCarb overlay.
- ↓ Close-up of the difference in surface appearance between the first overlay application (right side of image) and the second overlay (left side of image).

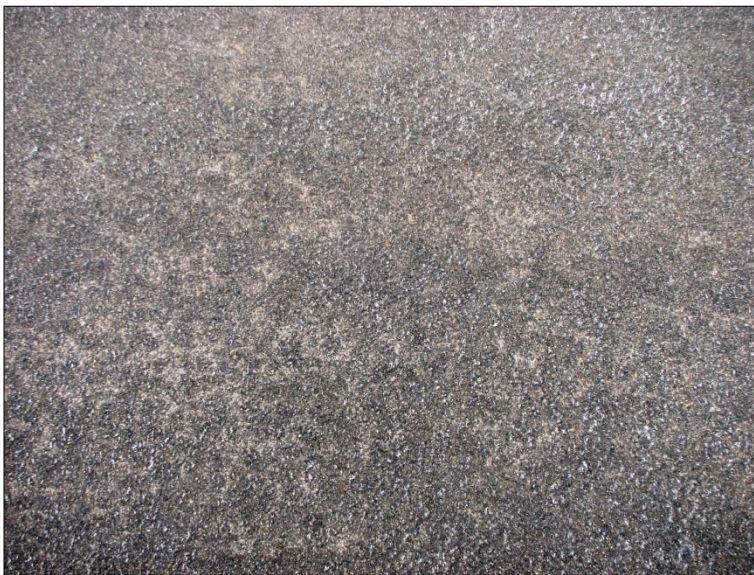
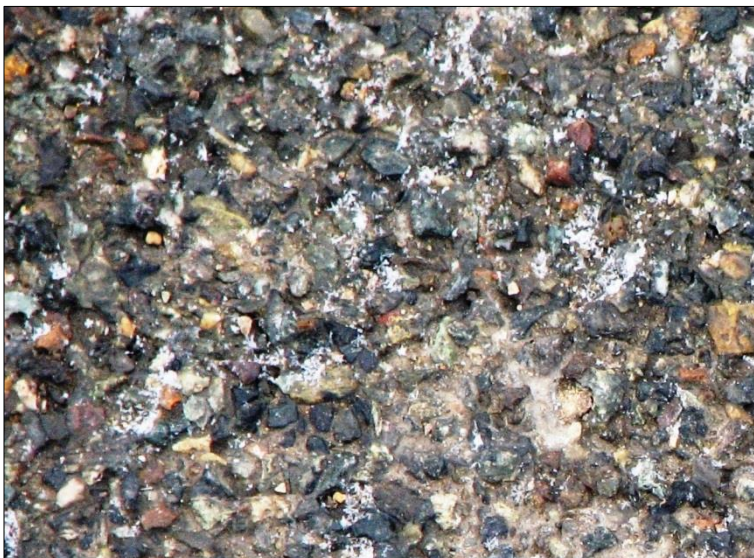
↩↓ The following are images (deck overview and surface texture) depicting the general condition of the HFST.

No issues to date to report; aggregate surface has uniformity in texture and appearance. No areas of delamination or debonding visible.

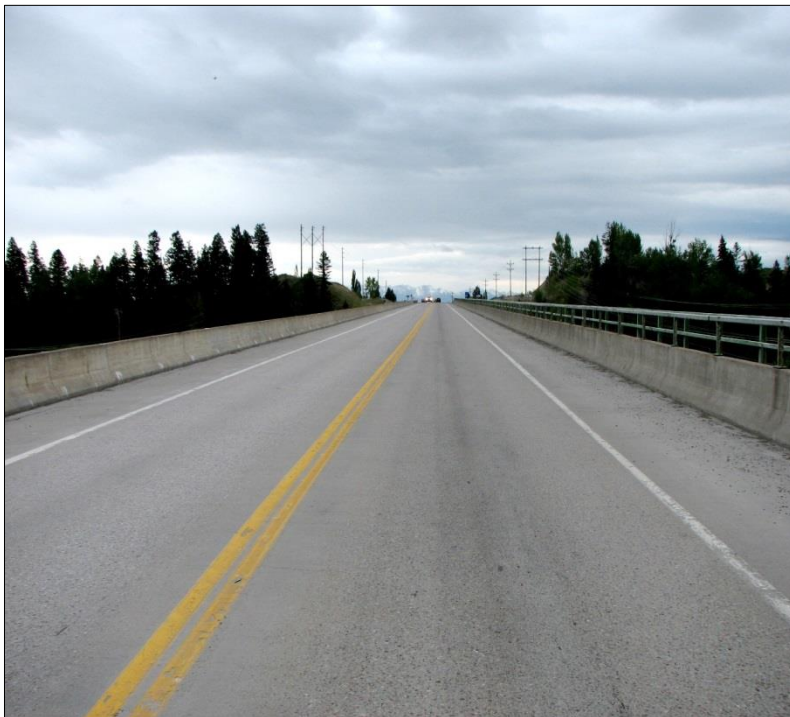
← Representative image of deck prior to overlay (view east).

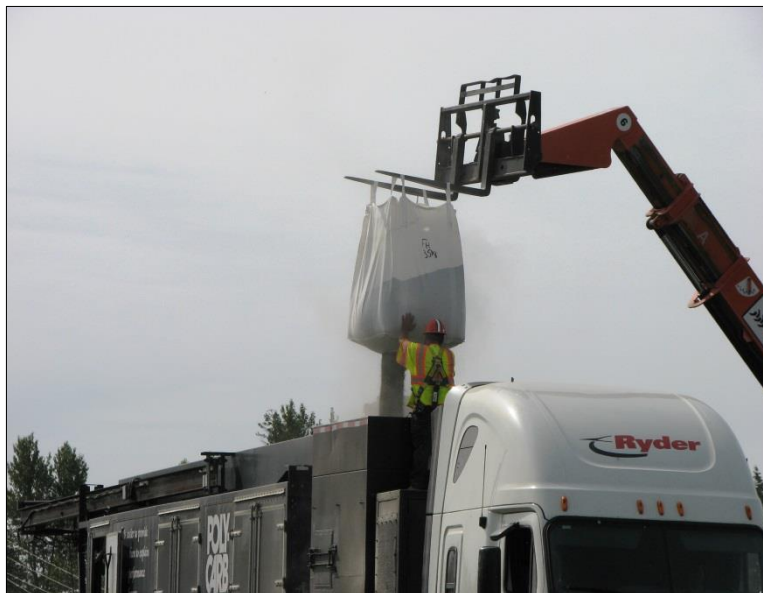
◀ About midway through the run, the Poly-Carb truck was replenished with a tote of the Armor Stone aggregate.

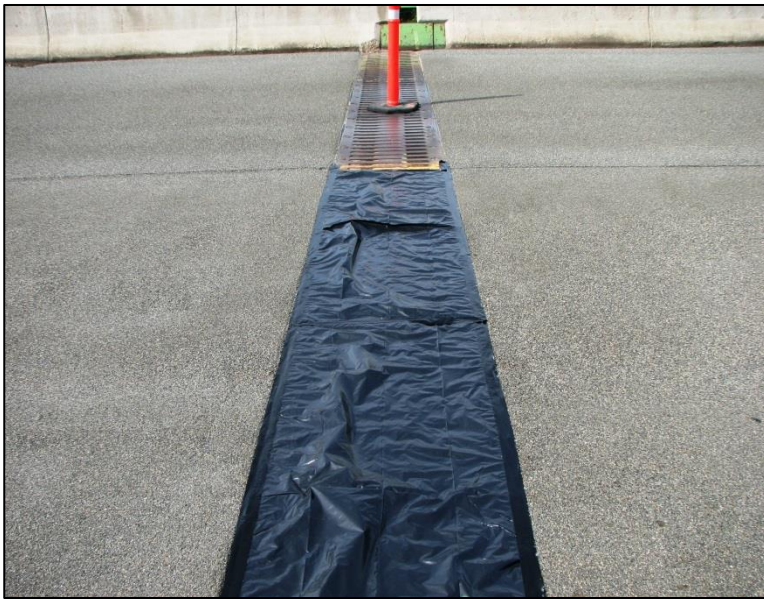
← The bridge finger plate joints were covered with plastic prior to the polymer overlay.

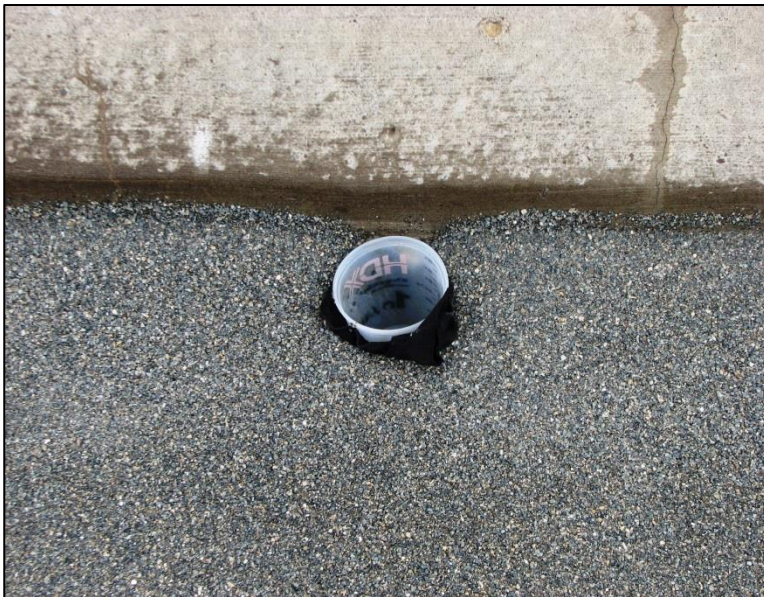
← Drainage inlets were plugged with black plastic and a conventional plastic cup was used as a stopper.

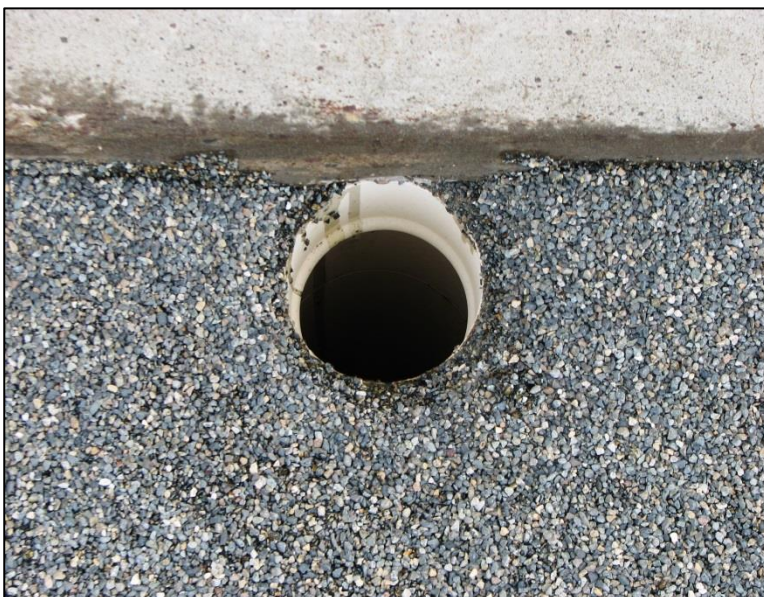
← Drain inlet with plastic block and cup removed after cured second lift.

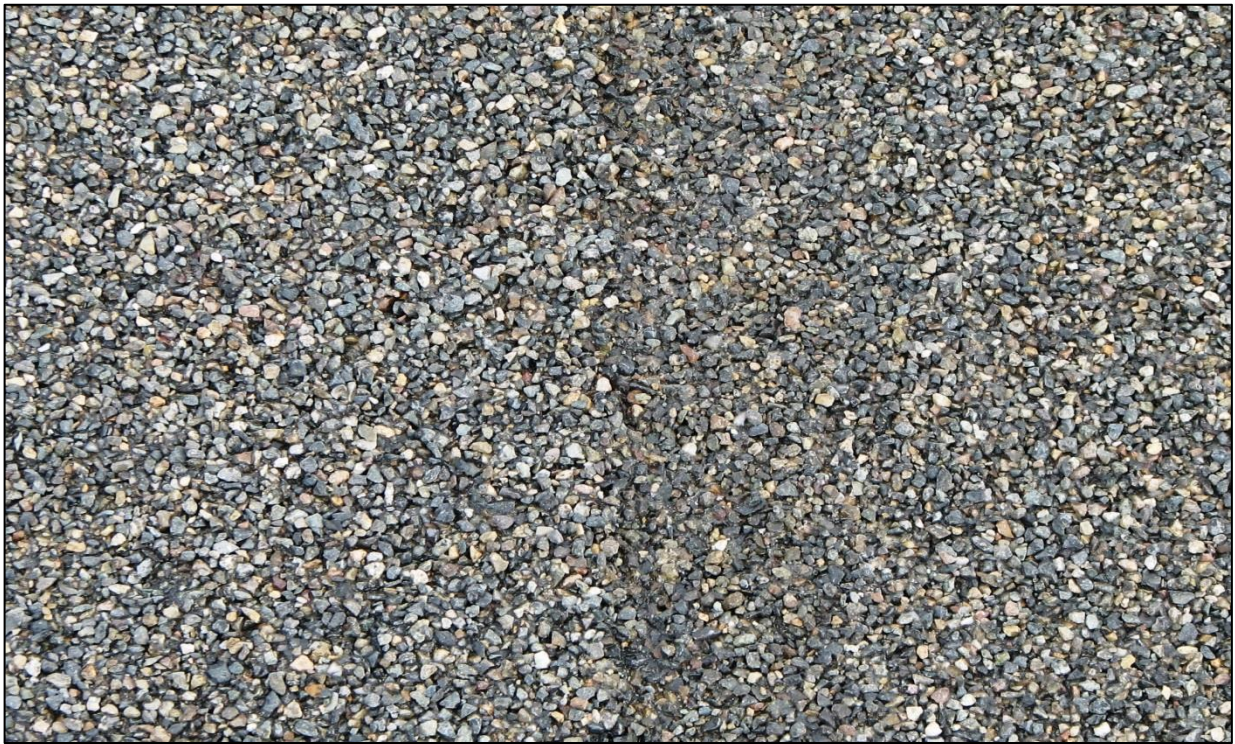
↑ Close-up of the difference of surface texture of the first lift (right side of image) and the second lift (left side of image).

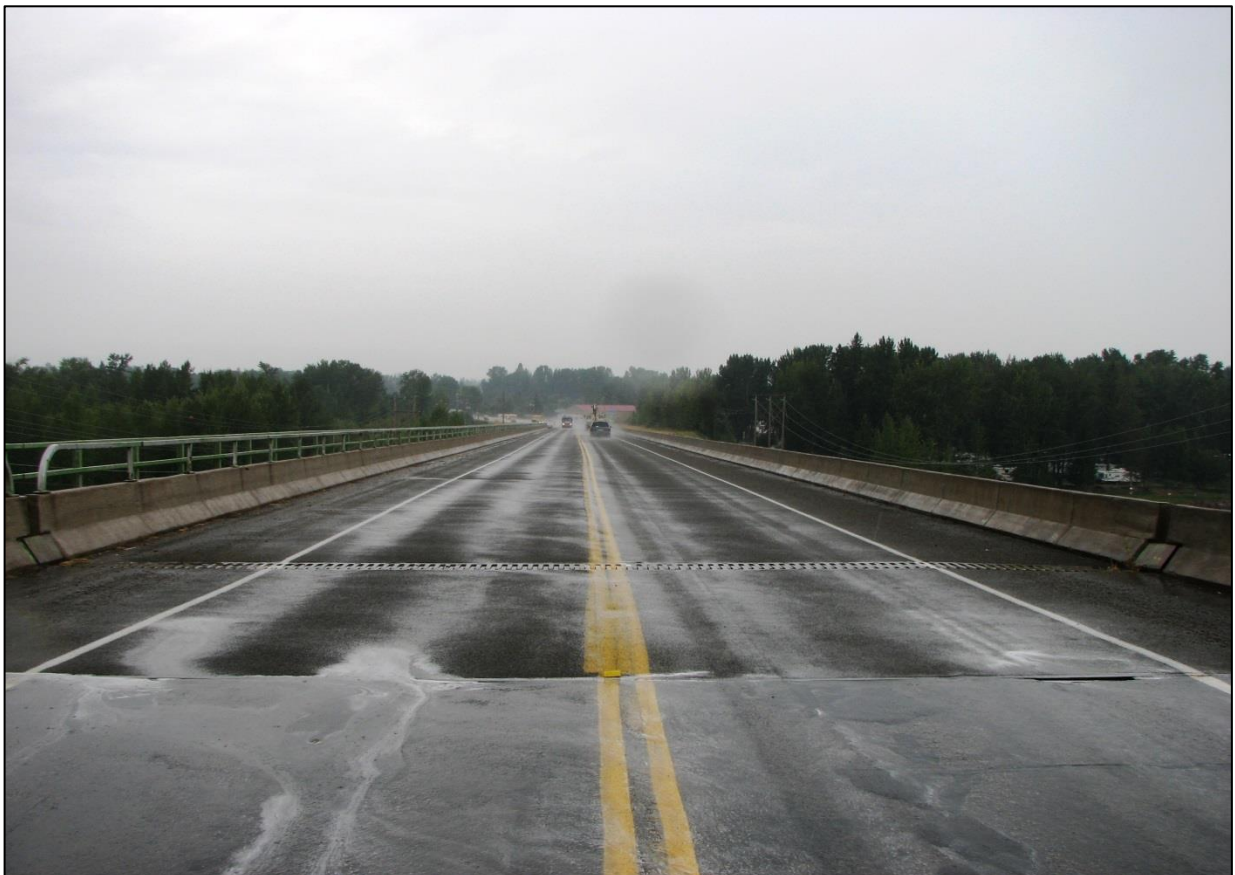
↓ Completed project, (view west). Image taken during active rain.
