**PRELIMINARY GEOTECHNICAL CORRIDOR STUDY  
11 KM NORTH OF LIBBY – NORTH  
PROJECT STPS 567-1(4)7  
CONTROL NO. 4789  
LIBBY, MONTANA  
TETRA TECH, INC.  
PROJECT NO. 6570885**

SUBJECT: Preliminary Geotechnical Corridor Study  
11 km North of Libby – North  
Project STPS 567-1(4)7, CN 4789  
Libby, Montana

At your request, we have completed our preliminary geotechnical corridor study for the Montana Department of Transportation (MDT) 11 km North of Libby – North Project referenced above. The report that follows describes in detail our study, summarizes our findings, and presents our Preliminary Geotechnical Evaluation (460).

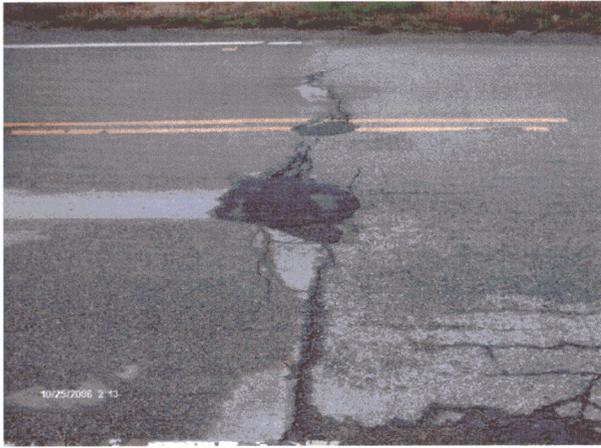
**PHOTOGRAPH 1** RP 7.0, looking west at end of good pavement.

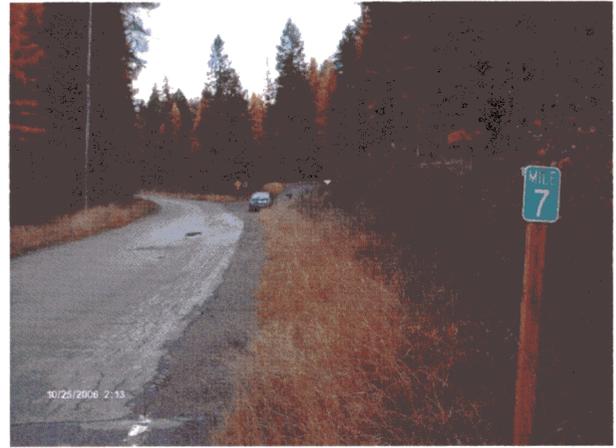
**PHOTOGRAPH 2** RP 7.0, looking north.

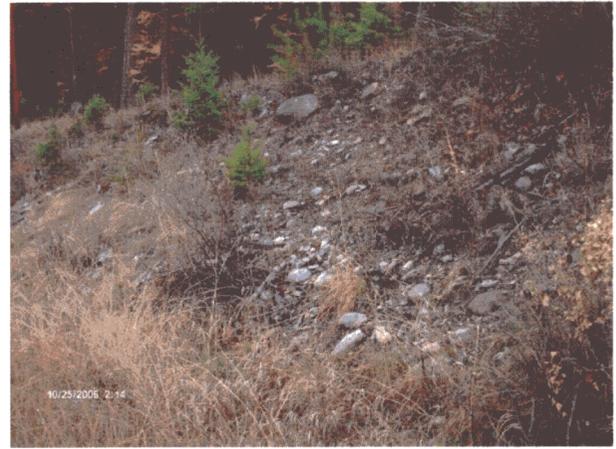
**PHOTOGRAPH 4** RP 7.0, looking NE, at soil slope on east side of road.

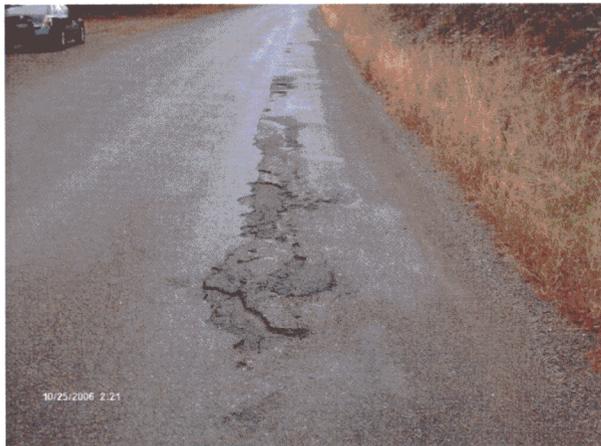
**PHOTOGRAPH 5** RP 7.2, looking north, pavement

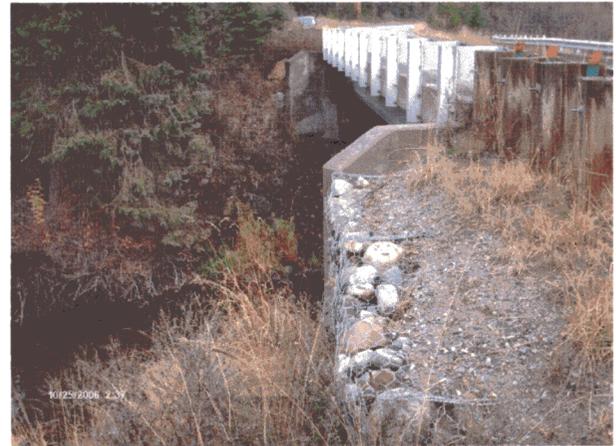
A single-span, concrete deck and steel girder bridge over Pipe Creek is located at approximate RP 7.6 and was observed to be in good condition (see Photographs 6 and 7, Appendix B). The bridge is approximately 34 feet wide and approximately 60 feet long. No other bridges were observed along the project route. Several culverts of varying type, size, and condition were observed at tributary drainage crossings (see Photographs 34, 50, and 51, Appendix B).

**PHOTOGRAPH 6** RP 7.6, looking north on west side of

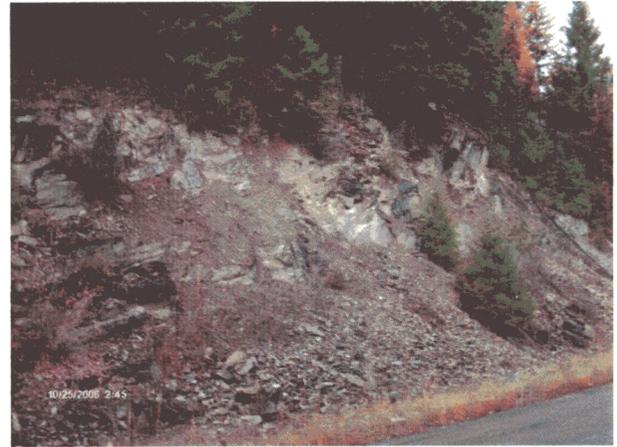
**PHOTOGRAPH 10** RP 8.0, looking northwest at rock slope on west side of road.

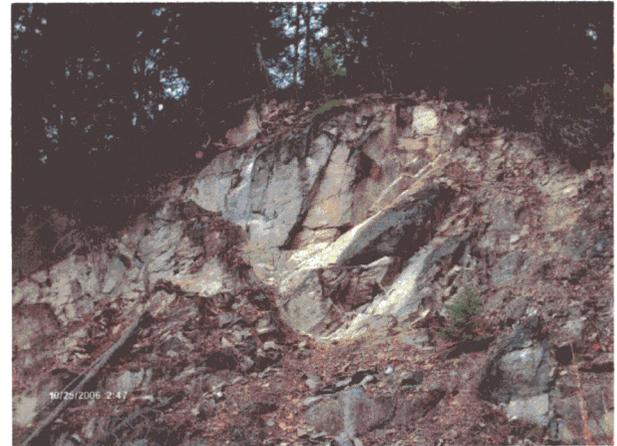
**PHOTOGRAPH 12** RP 8.0, looking west at rock slope on west side of road.

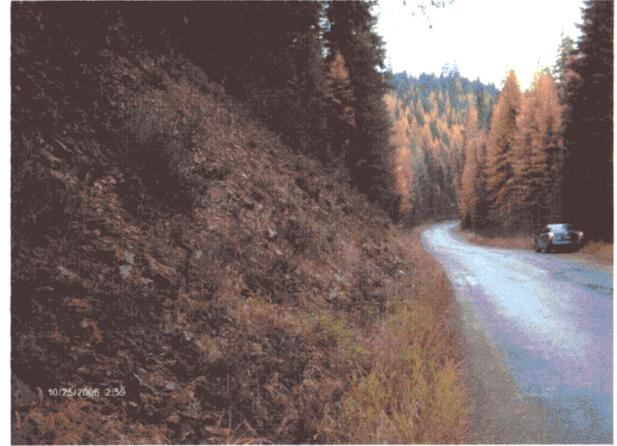
**PHOTOGRAPH 14** RP 8.6, looking north at soil slope on west side of road.

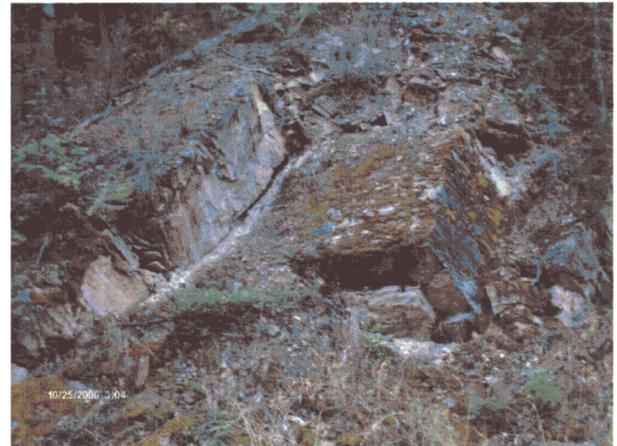
**PHOTOGRAPH 16** RP 8.7, looking west at rock outcrop on west side of road.

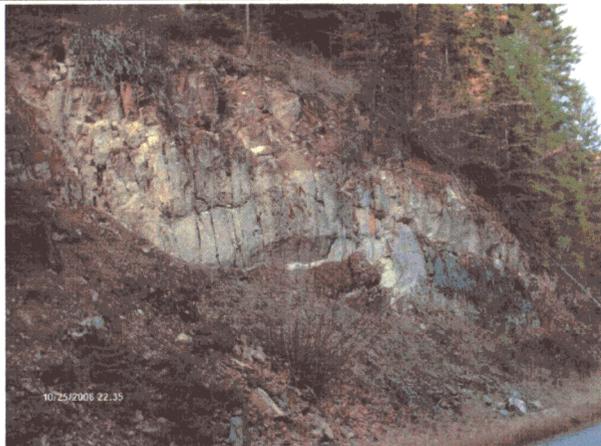
**PHOTOGRAPH 17** RP 9.7, looking northwest at rock outcrop on west side of road.

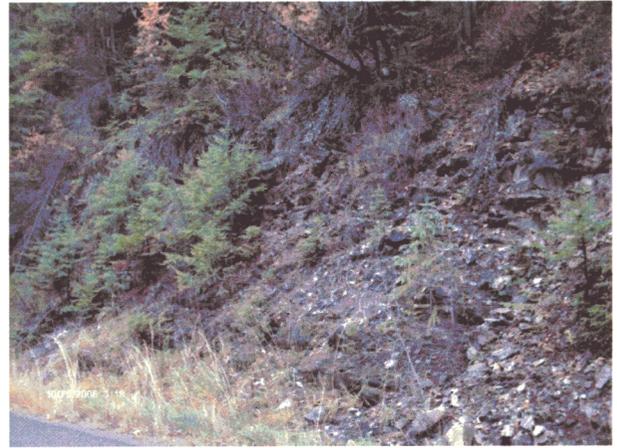
**PHOTOGRAPH 20** RP 10.3, looking southwest at weathered rock slope on west side of road.

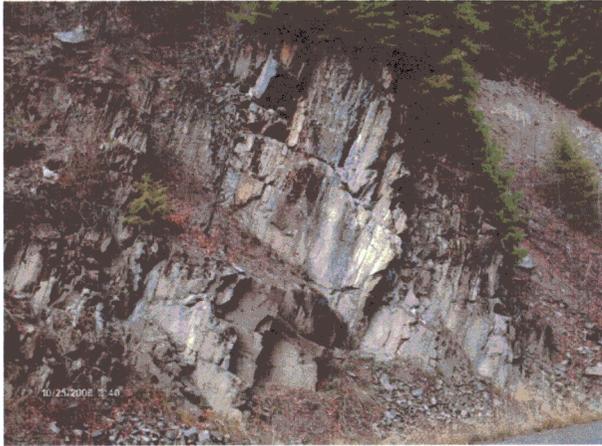
**PHOTOGRAPH 25** RP 11.0, looking west at rock slope on west side of road.

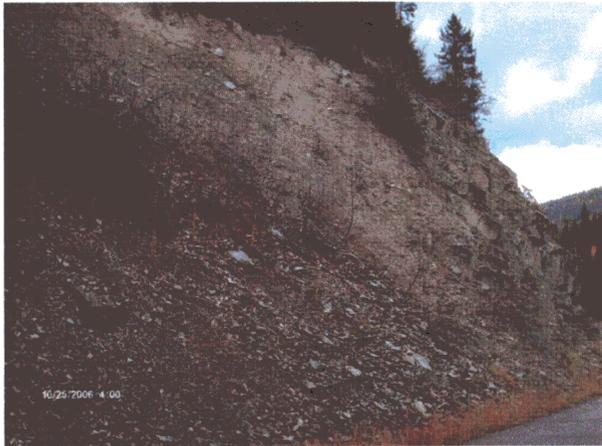
**PHOTOGRAPH 27** RP 11.0, looking north at rock slope on west side of road.

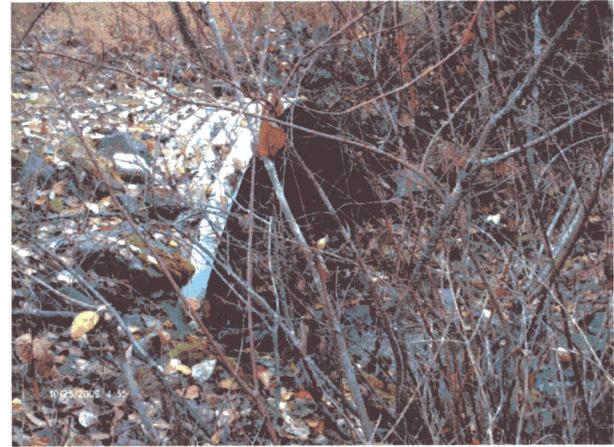
**PHOTOGRAPH 34** RP 14.2, Shafer Creek crossing, CSP culvert inlet.

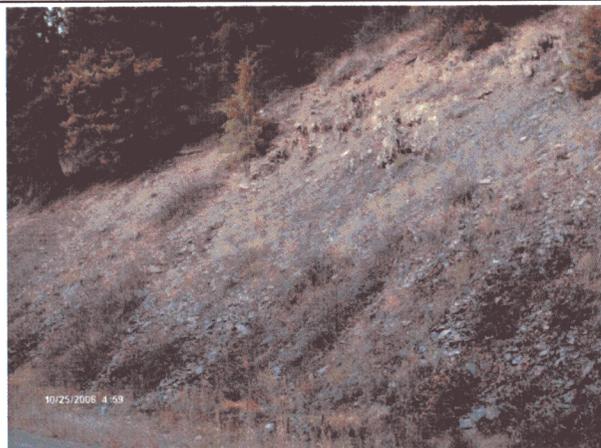
**PHOTOGRAPH 35** RP 14.7, looking northeast at weathered rock slope on east side of road.

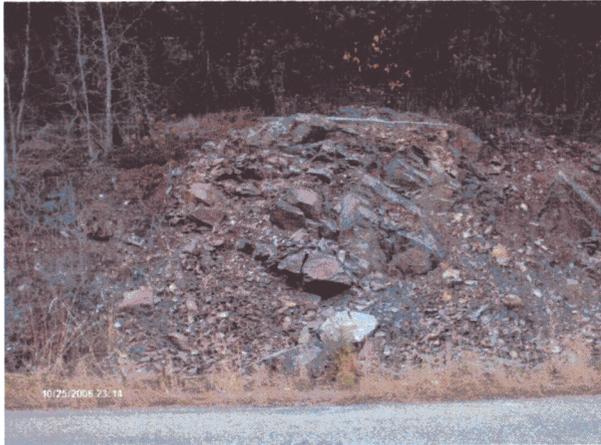
**PHOTOGRAPH 37** RP 15.2, looking northeast at rock outcrop on east side of road.

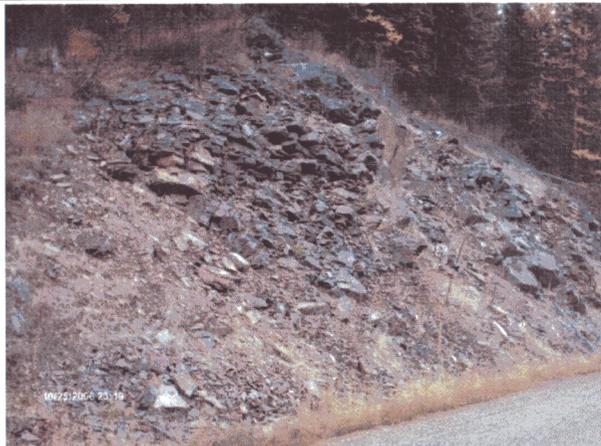
**PHOTOGRAPH 39** RP 15.3, looking southeast at rock outcrop on east side of road.

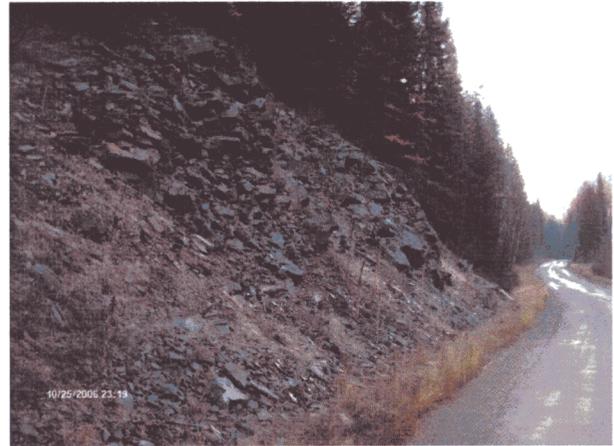
**PHOTOGRAPH 40** RP 15.3, looking south at rock outcrop on east side of road.

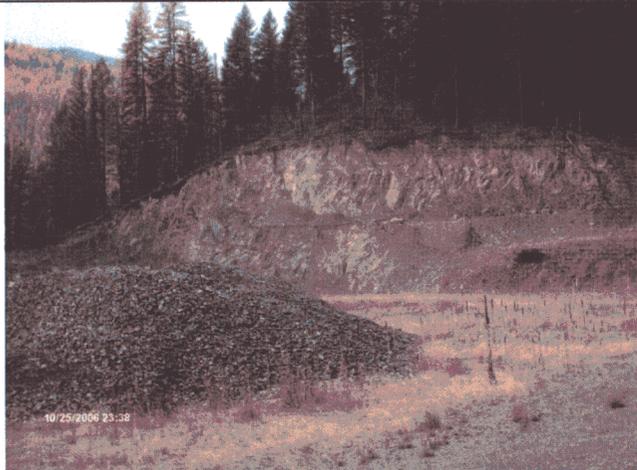
**PHOTOGRAPH 43** RP 15.8, existing stockpiled aggregate and cut slope at source west of road on Forest Road 68X.

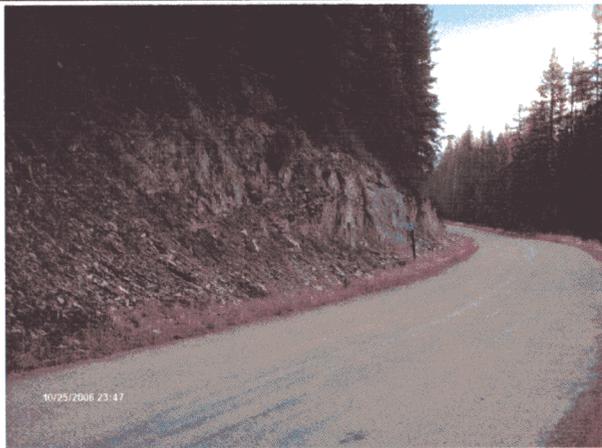
**PHOTOGRAPH 45** RP 16.0, looking southeast at rock slope on east side of road.

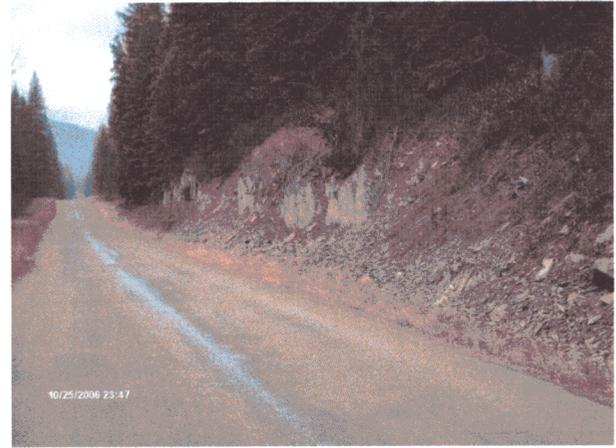
**PHOTOGRAPH 46** RP 16.0, looking north at rock slope on east side of road.

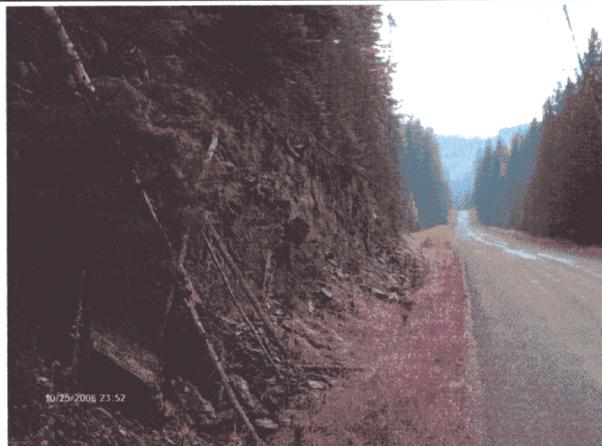
**PHOTOGRAPH 47** RP 16.2, looking south at rock slope on

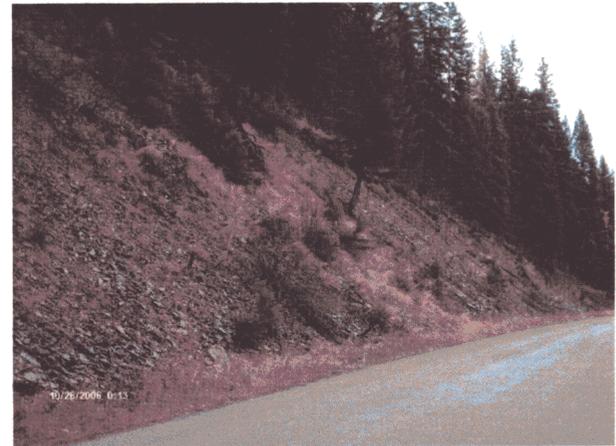
**PHOTOGRAPH 48** RP 18.2, looking southeast at

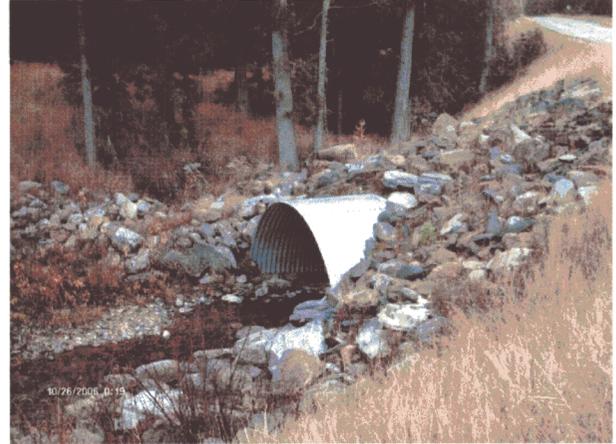
**PHOTOGRAPH 50** RP 18.8, looking south at East Fork Pipe Creek crossing CSP inlet on east side of road.

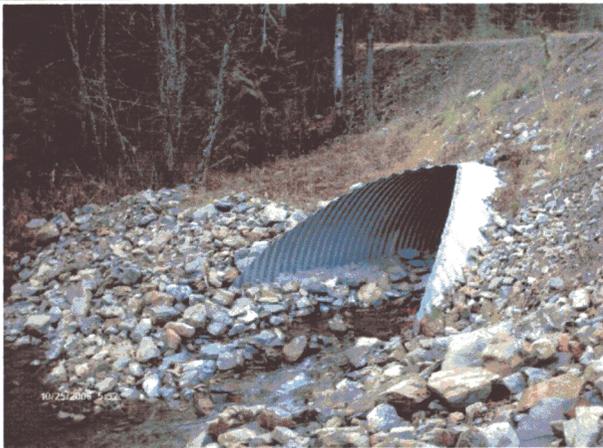
**PHOTOGRAPH 51** RP 18.9, looking northwest at Pipe Creek crossing CSP outlet on southwest side of road.

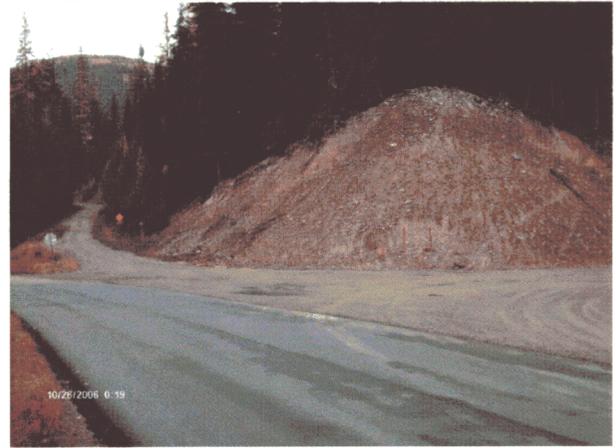
**PHOTOGRAPH 52** RP 18.9, looking north at soil slope at intersection with two Forest Service Roads on eastside of road.

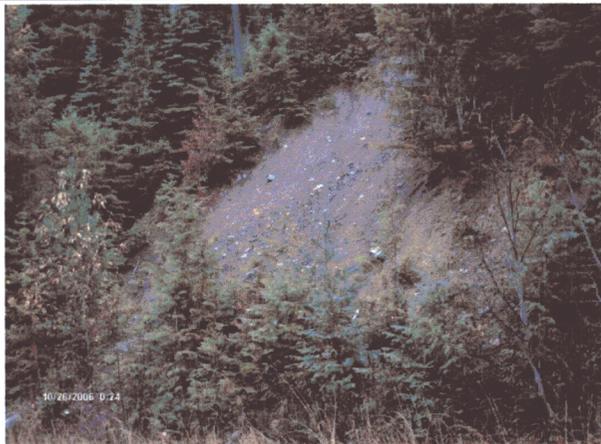
**PHOTOGRAPH 53** RP 18.4, looking southwest at steep soil

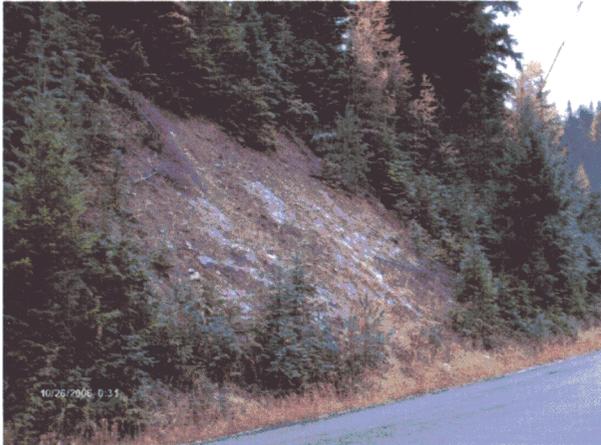
**PHOTOGRAPH 55** RP 19.6, looking west at steep soil slope on southwest side of road.

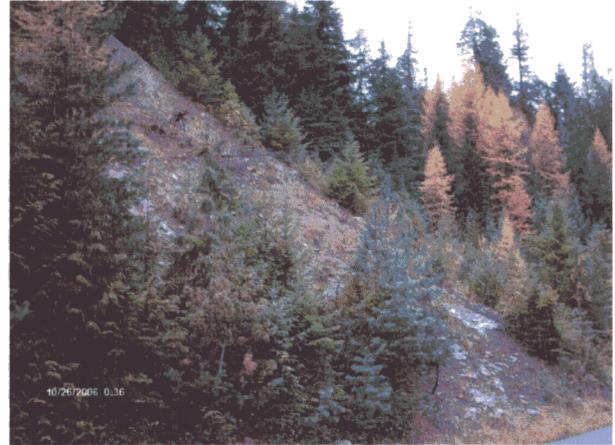
**PHOTOGRAPH 56** RP 19.7, looking west at steep soil slope on southwest side of road.

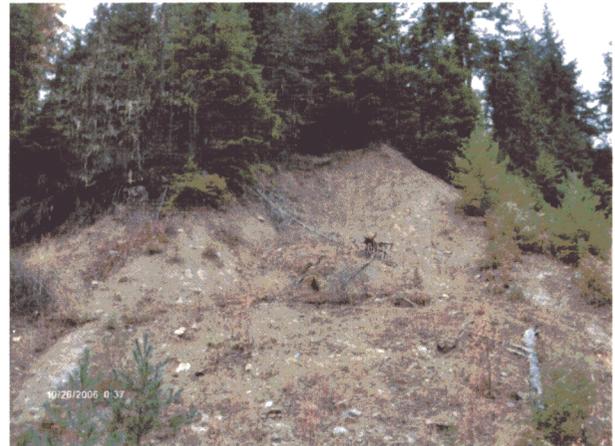
**PHOTOGRAPH 58** RP 19.7, looking west at steep soil slope on southwest side of road.
